Waterman Tree Co.

## **TREE REPORT**

39 South View

We inspected 5 x trees at the above address and propose the following recommendations. Locations are shown on the following sketch plan (Fig 1) with the approximate site boundary denoted in yellow.

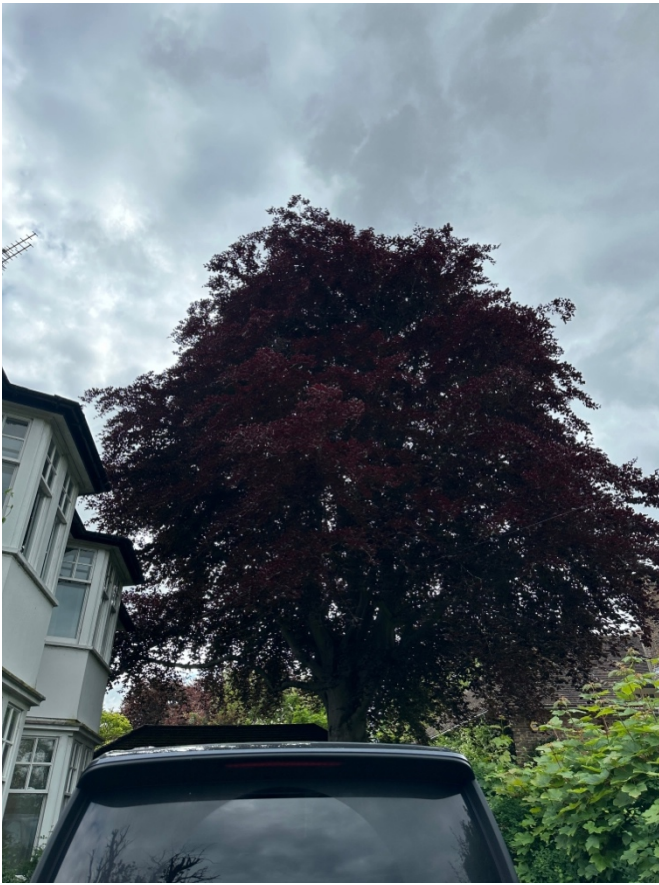
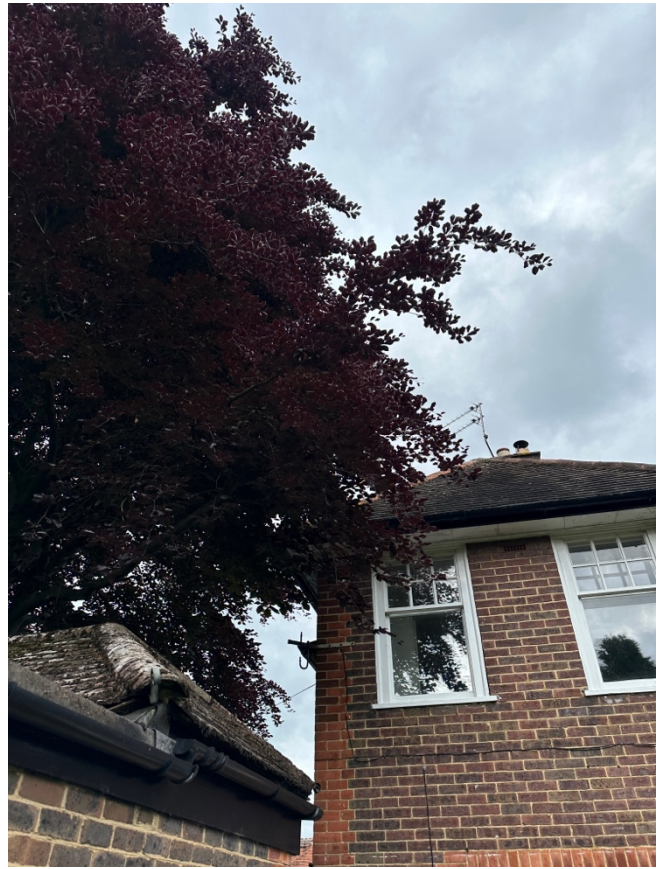
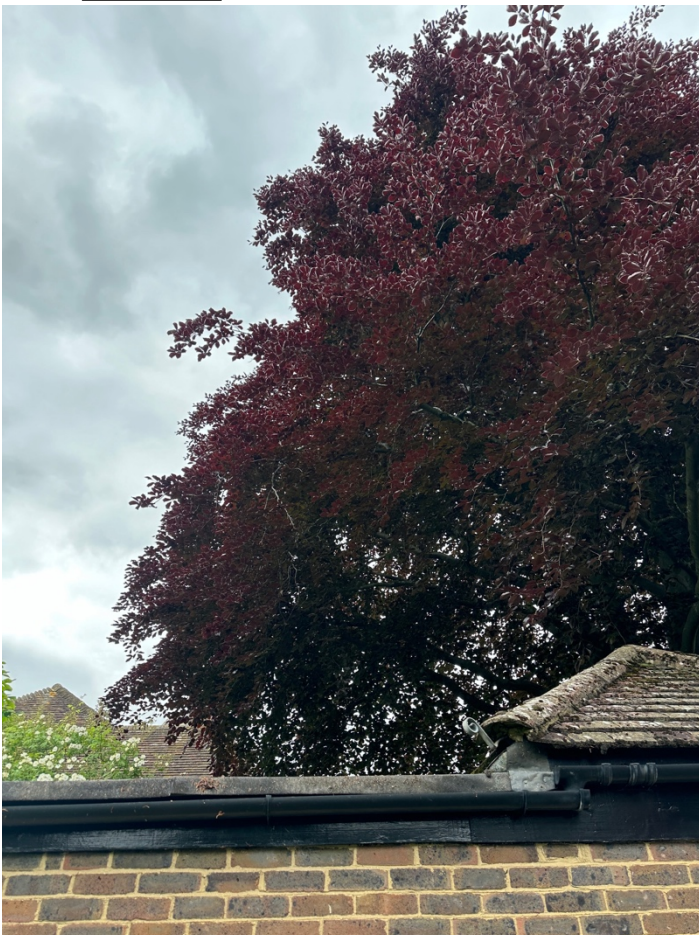
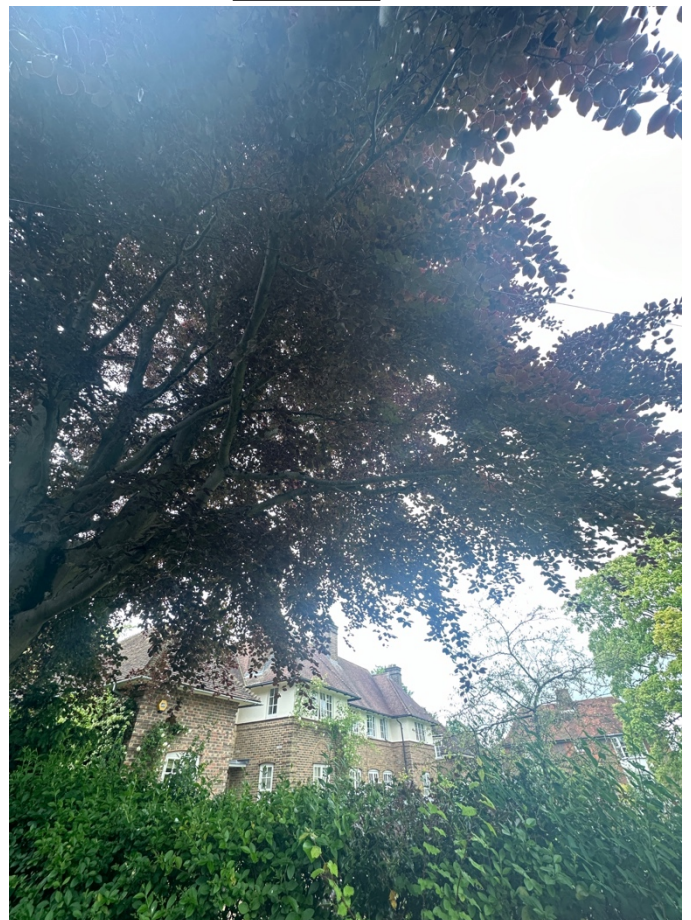
T1 (Blue) – Copper Beech (Fig 2,3,4,5) – Prune branches by approximately 2 to 3 metres, particular focus on Eastern and Western aspects which are encroaching on neighbouring properties.

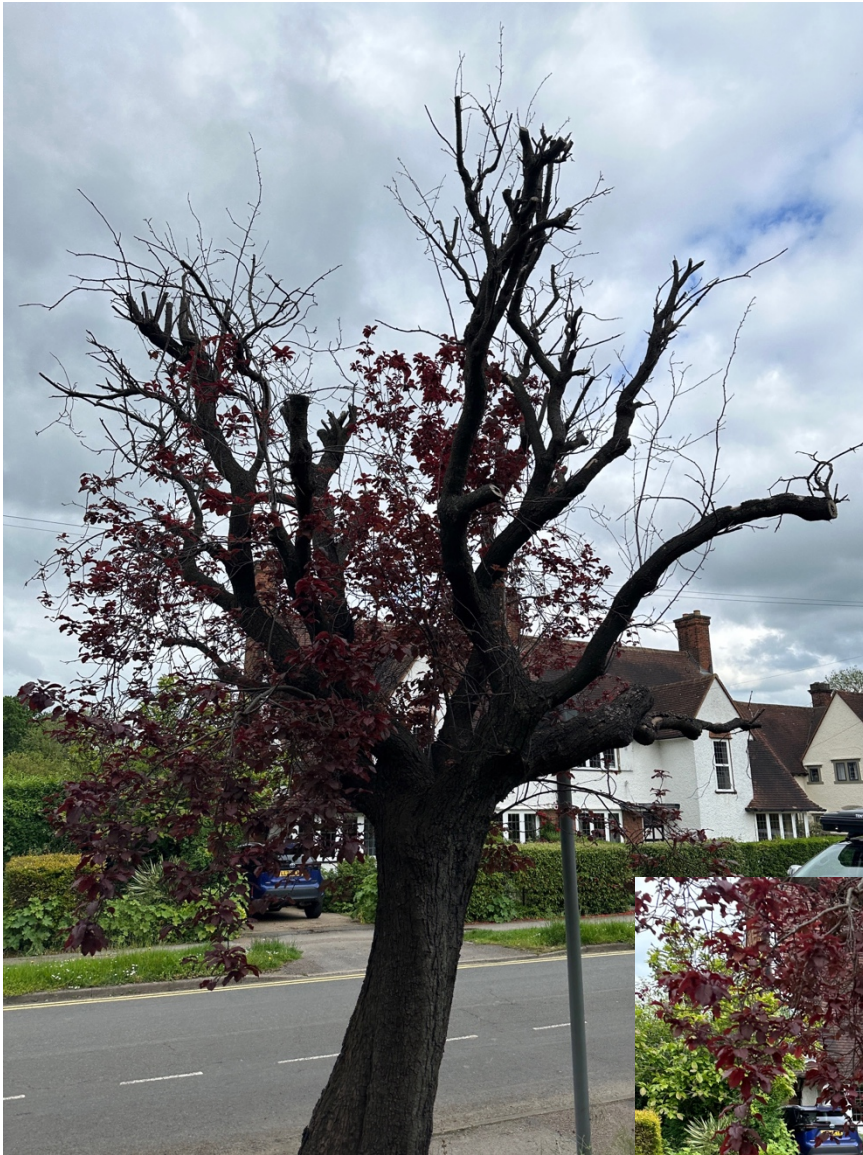
Fig 6.

T2 – (Black) – Cherry tree – This tree is in poor health, potentially following inadequate pruning practices (Fig 6 & 7). The client wishes to remove and replant with either the same species or a suitable native species.

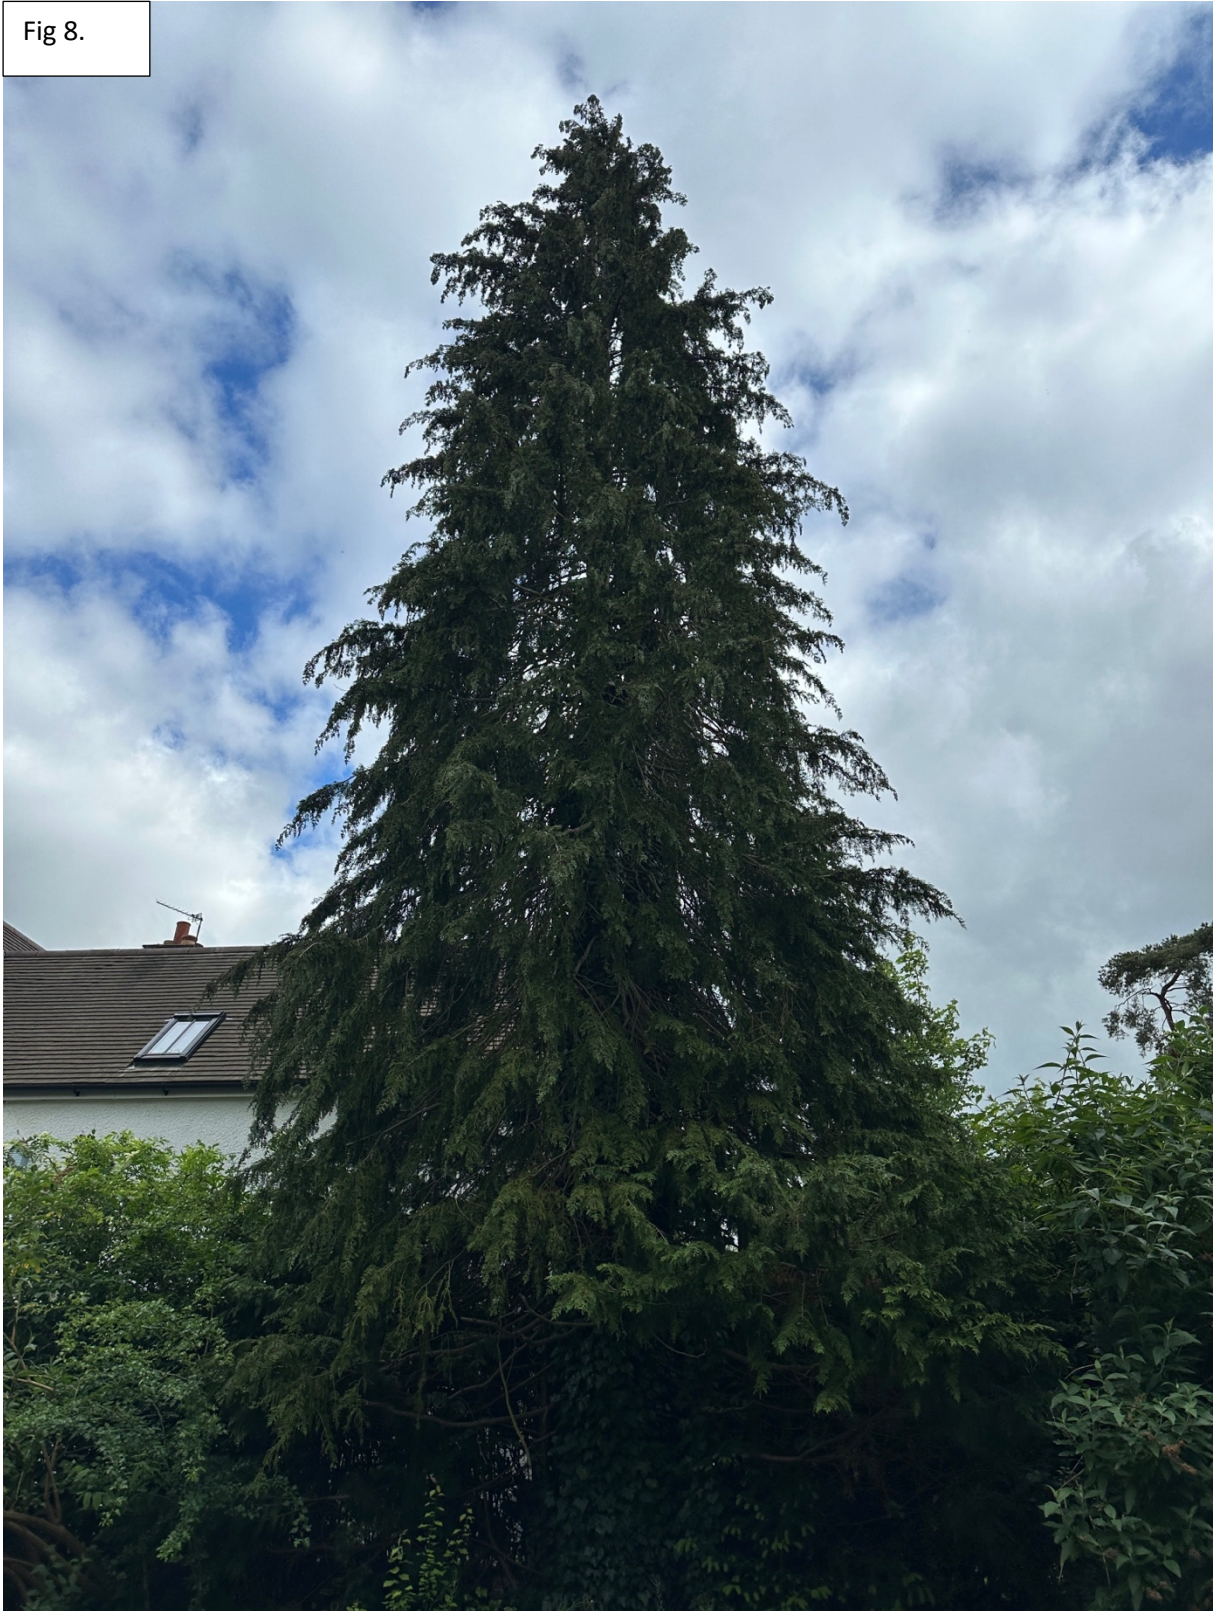
Fig 8.

T3 – Cypress – (Red) (Fig 8) – Concerns are raised with the proximity of this species to neighbouring properties. The client wishes to fell and replant with a more suitably sized native species in a different area, such as a Rowan.

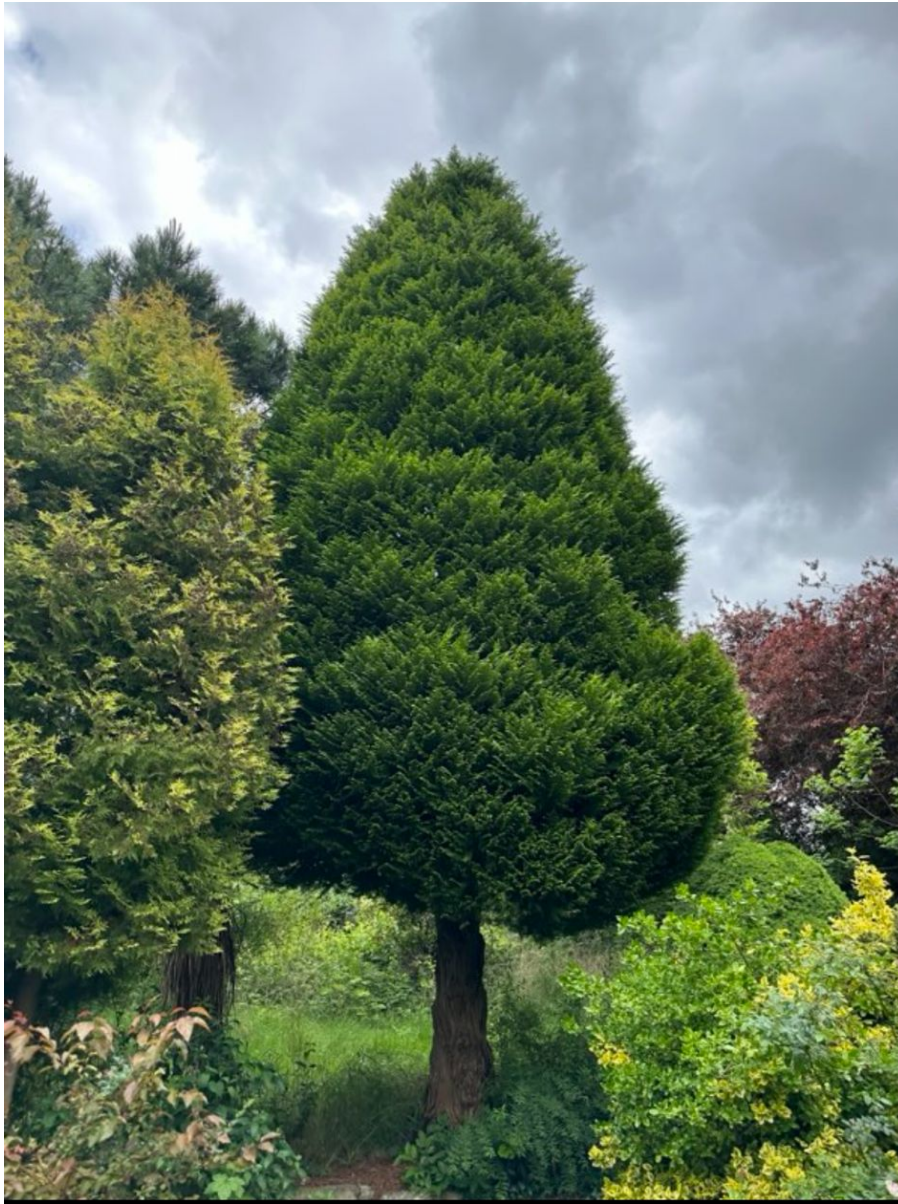
Fig 9.

T4 – Cypress (Green) – This tree is causing damage to the pond and as such, is not in a suitable location (Fig 9). The client wishes to fell and replant elsewhere with a suitably sized native species such as a Birch.

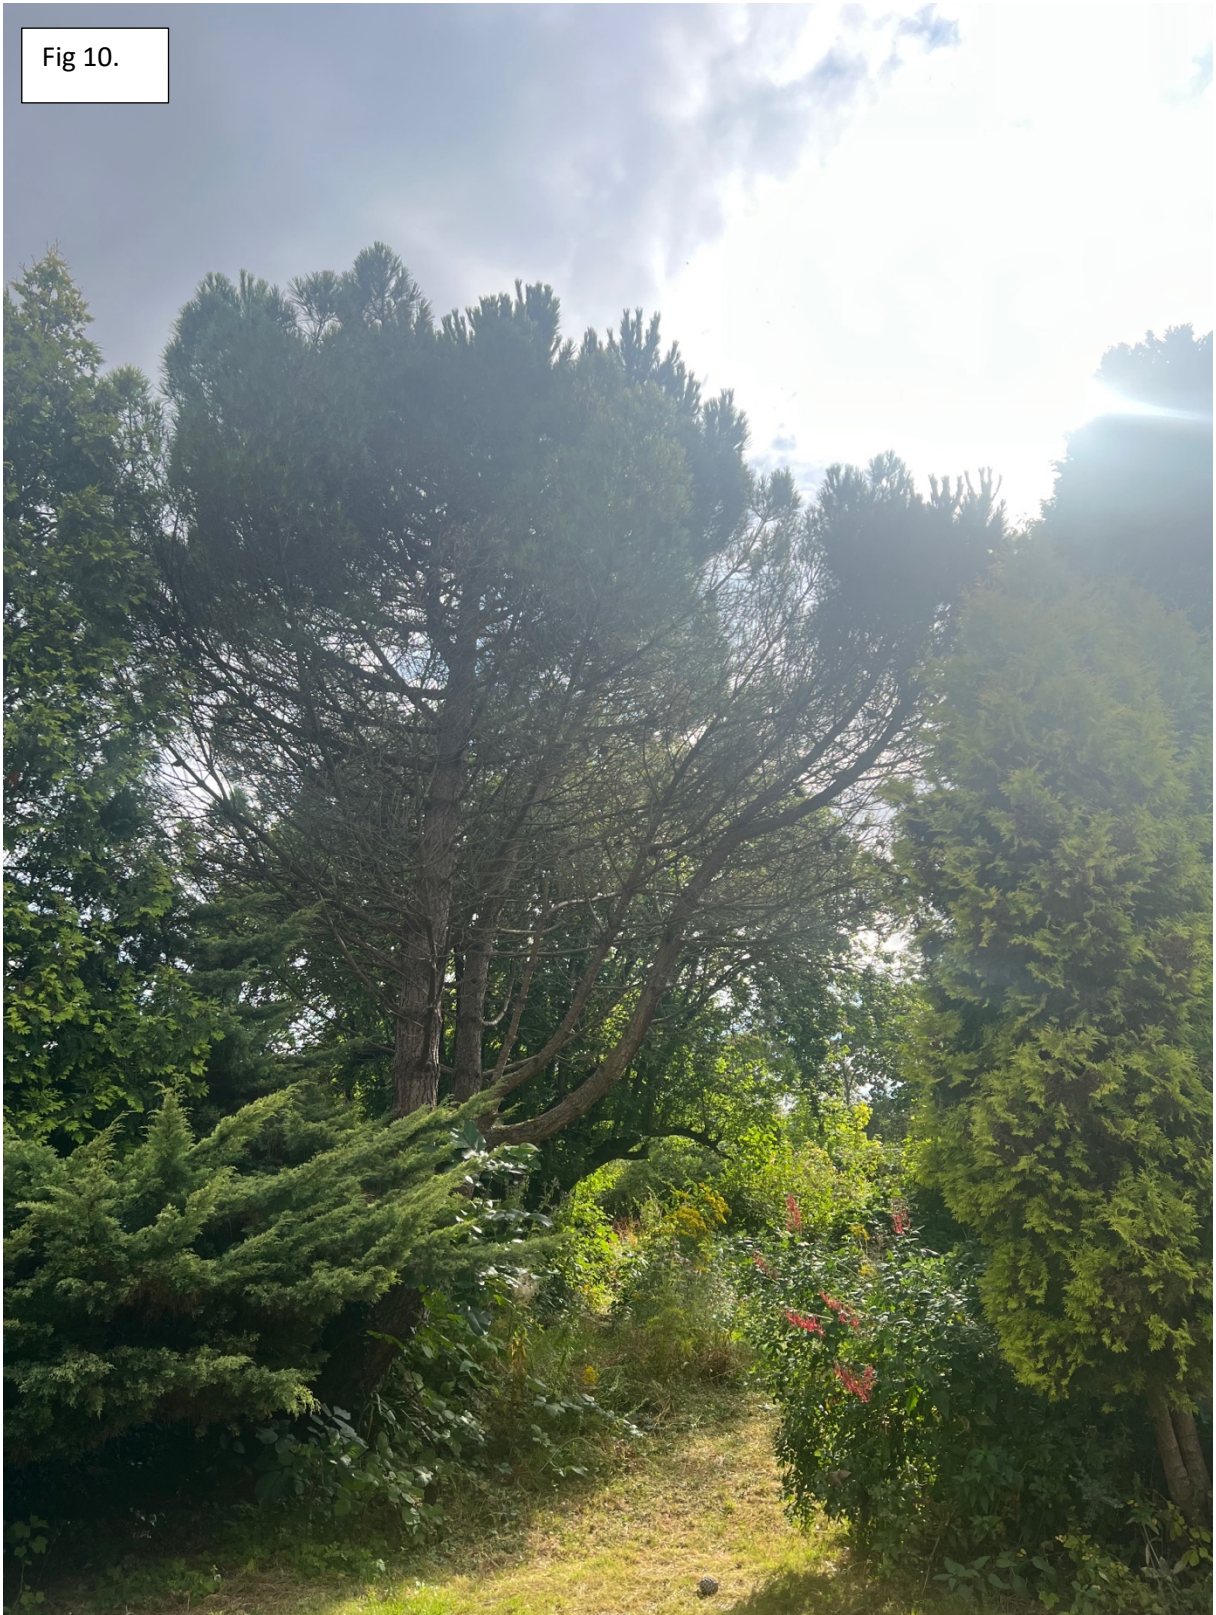
T5 – Pine – Fig 10. Prune branches overhanging boundary line back to main stem to balance the crown of the tree as an asymmetrical crown can increase the risk of failure
