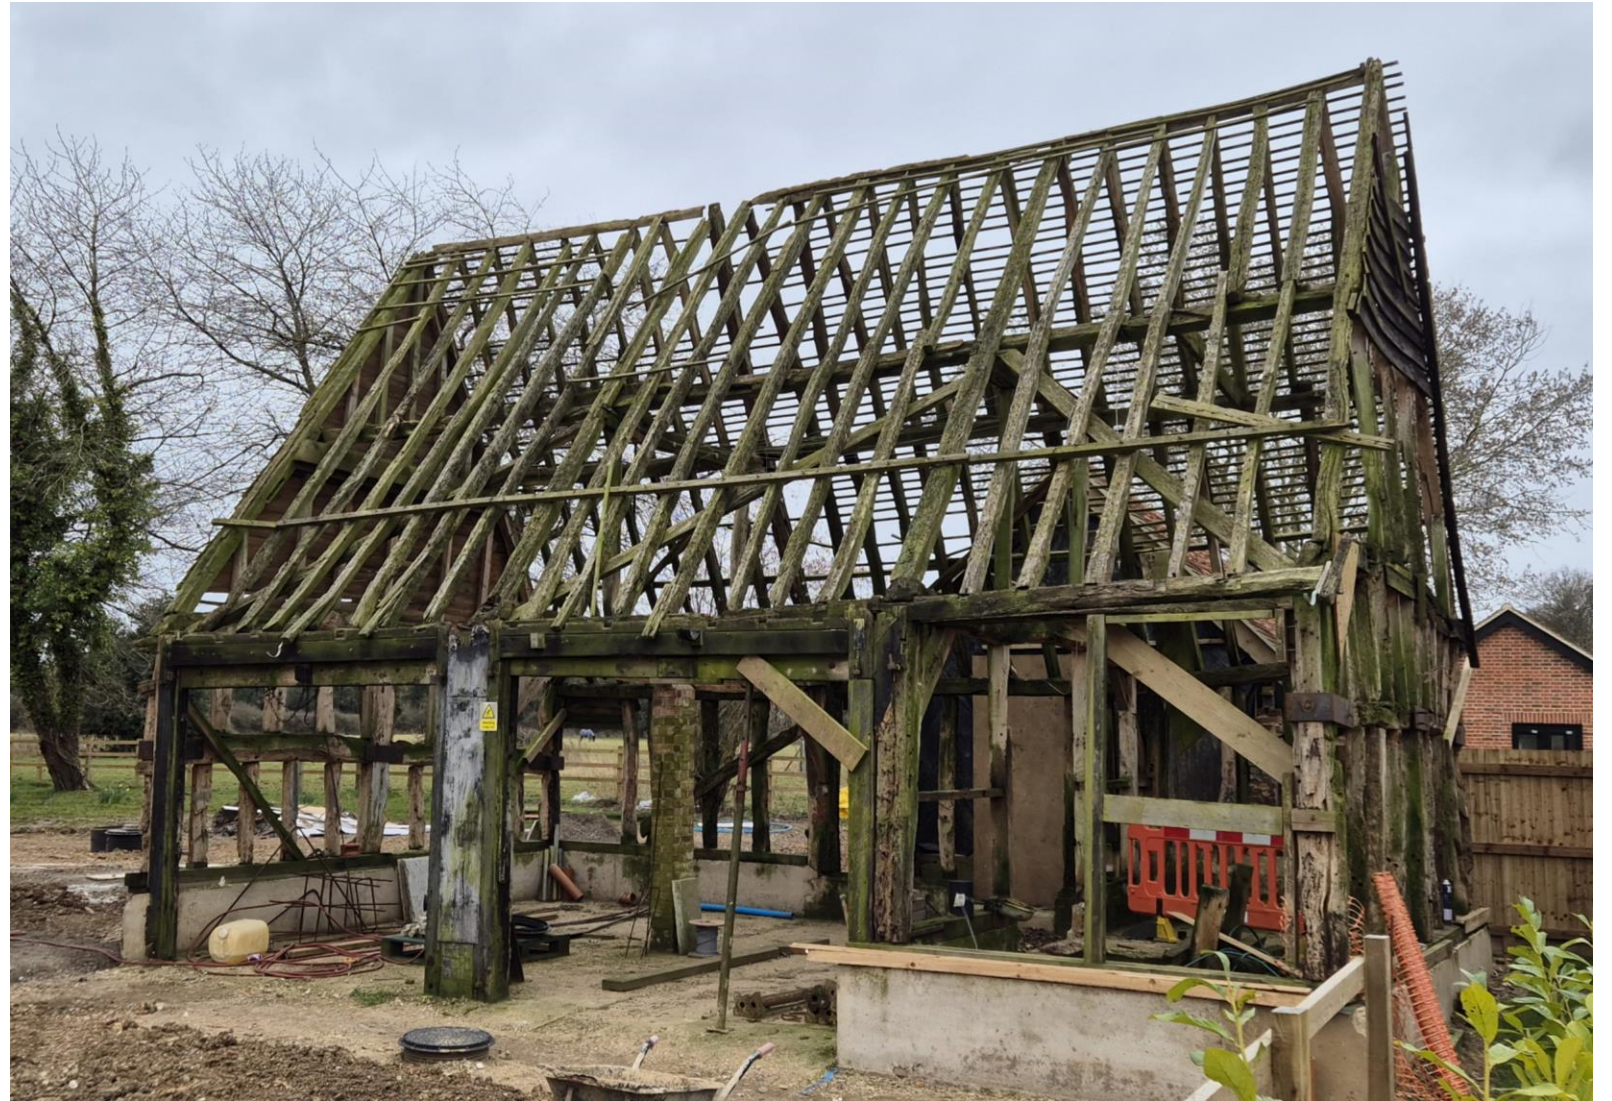
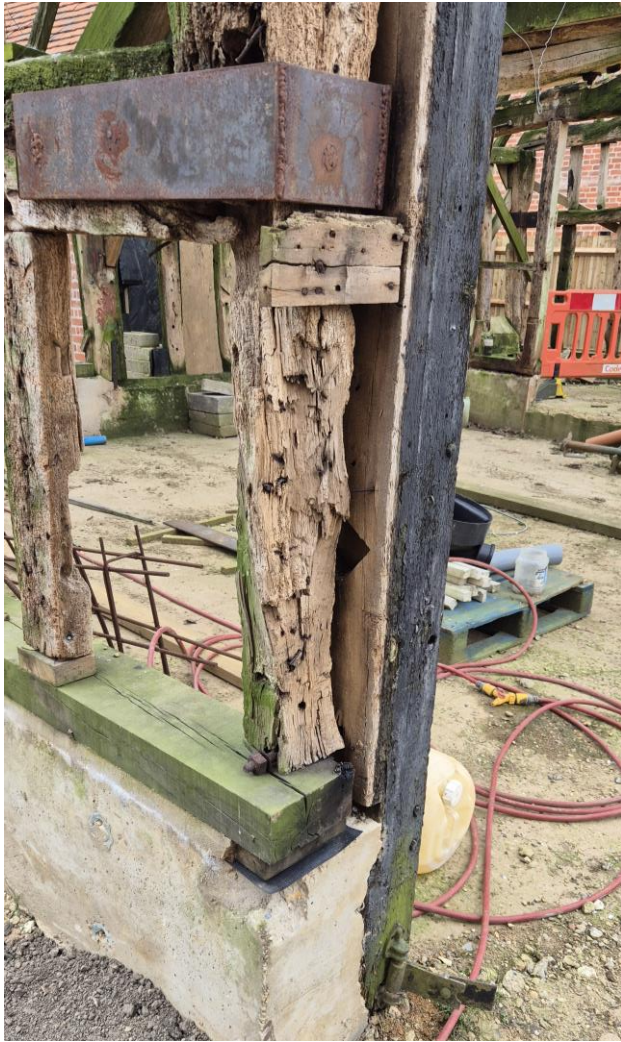
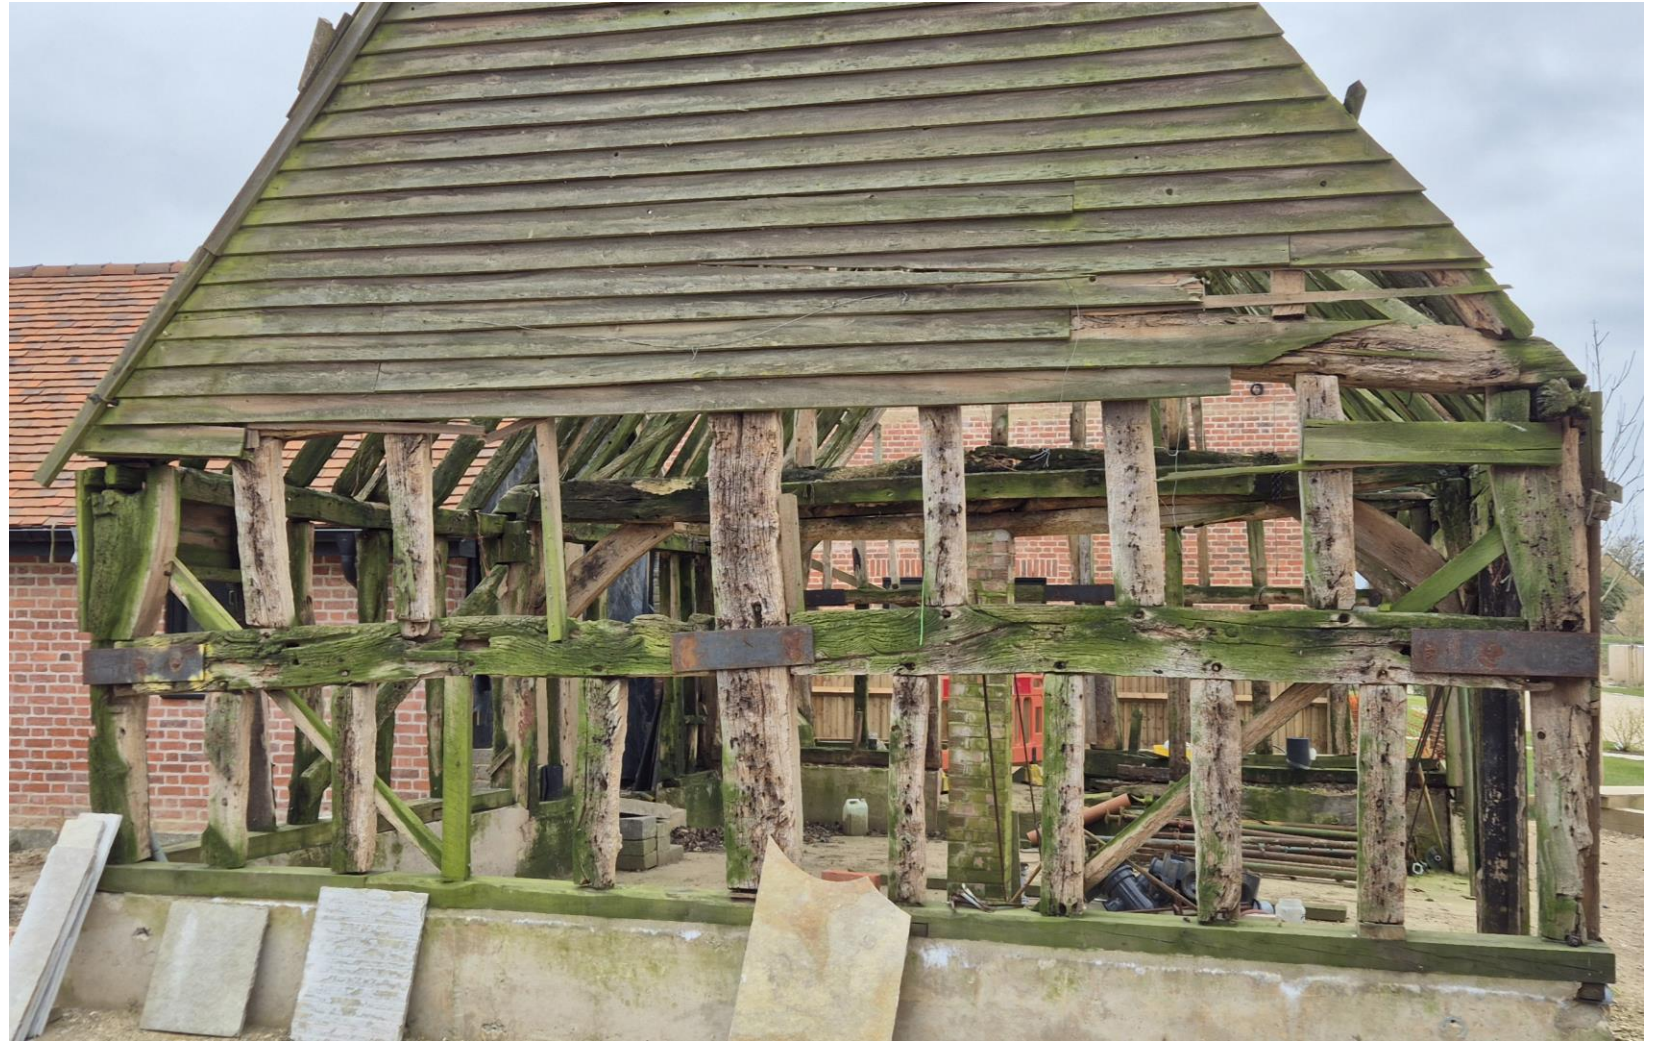
The barn has been carefully stripped back to remove all the original cladding so a full assessment of its structure can be carried out. It was determined that all the original sole plates had completely failed/rotted out and were therefore cut in situ with a new oak sole plate added to a newly constructed concrete wall below. Any timbers that were salvaged during this process were then kept to one side so they could be used to strengthen the main frame once this had been exposed.

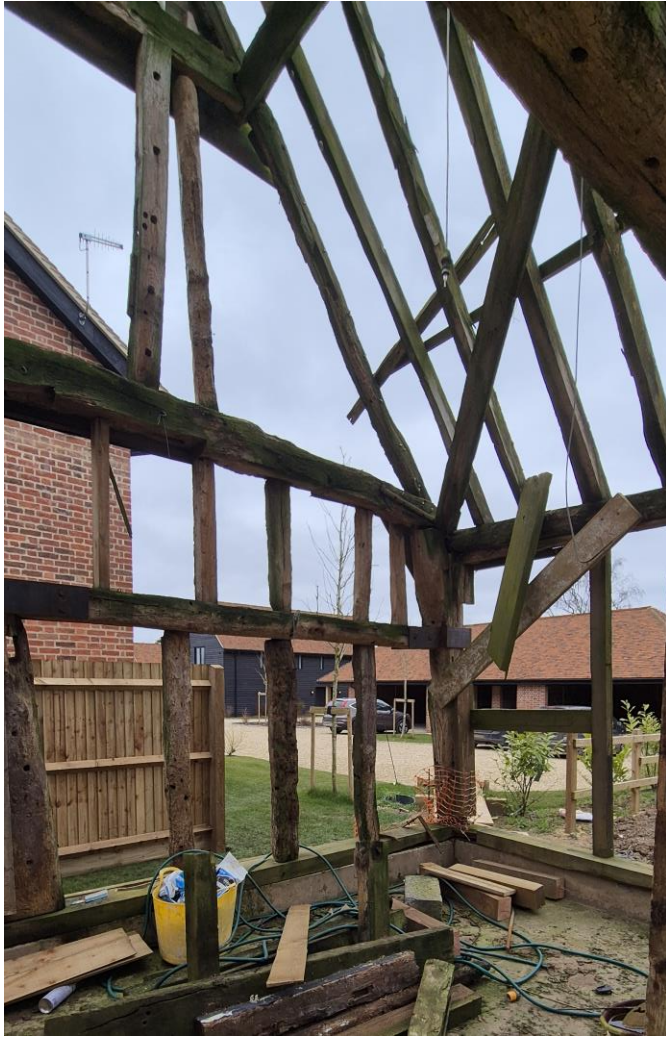
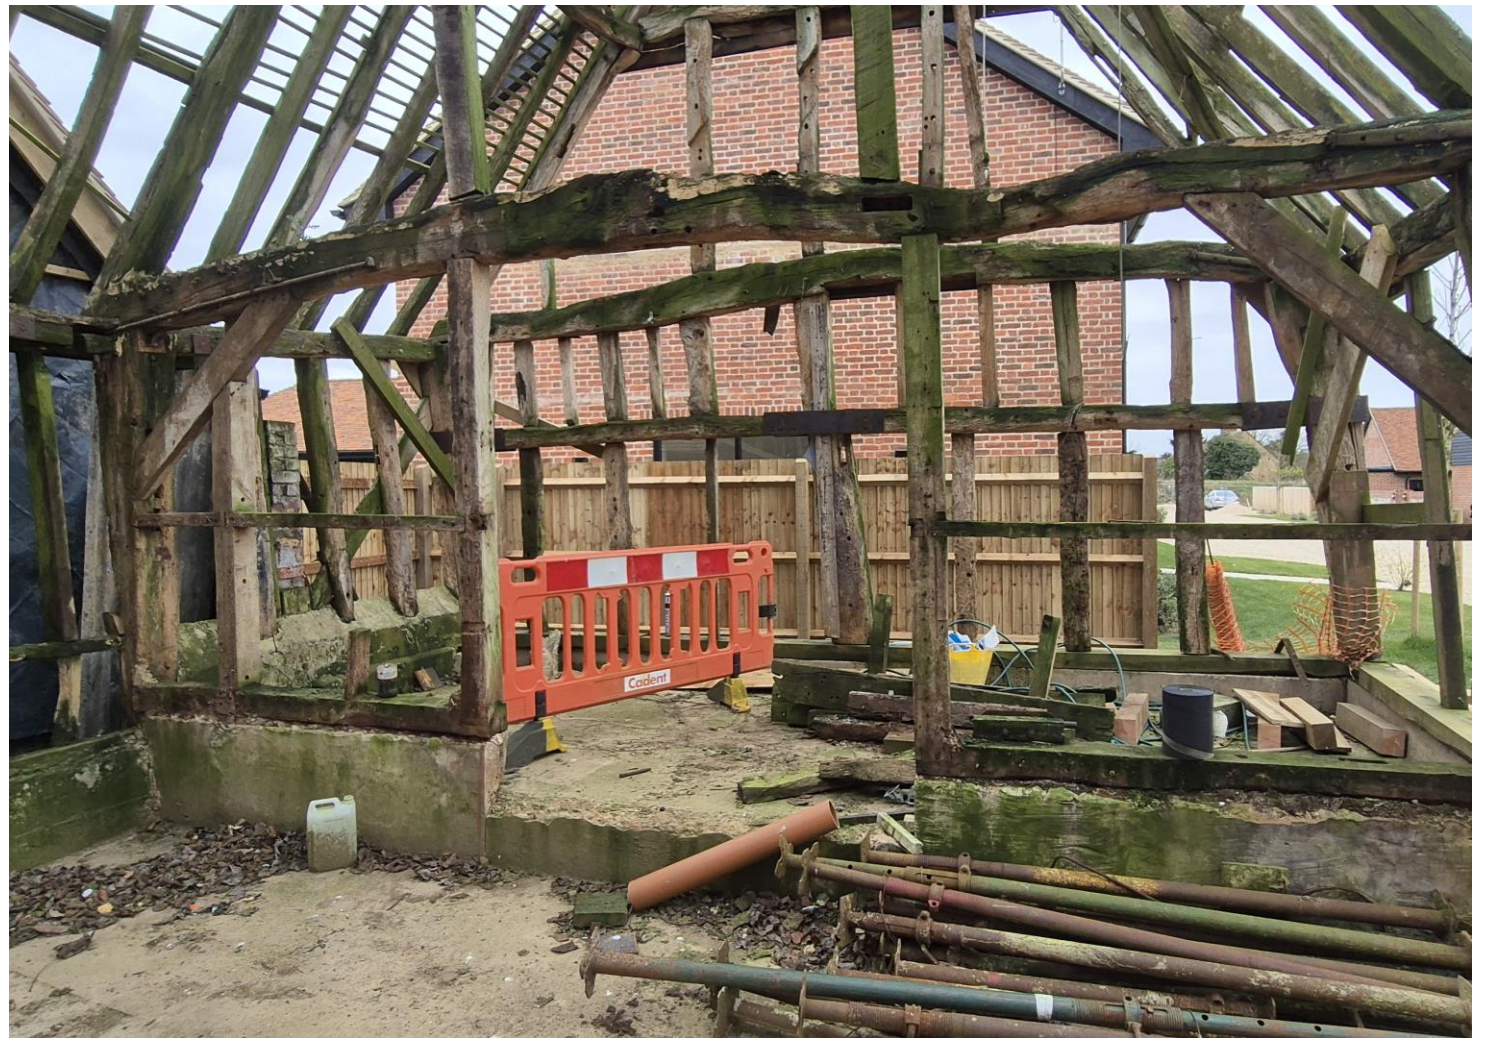
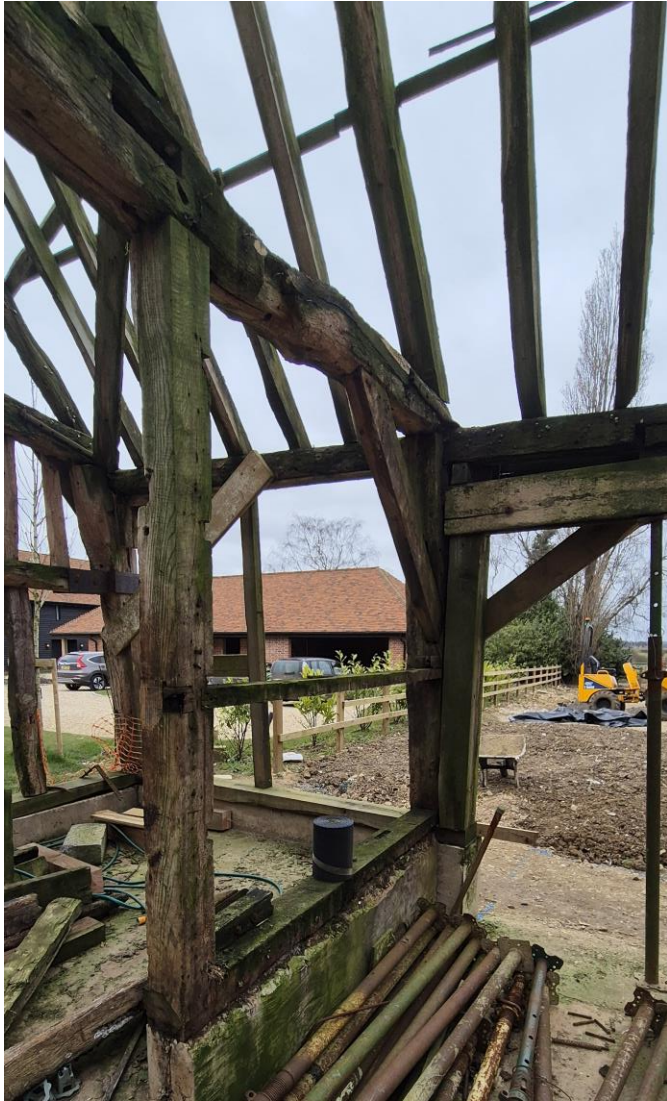
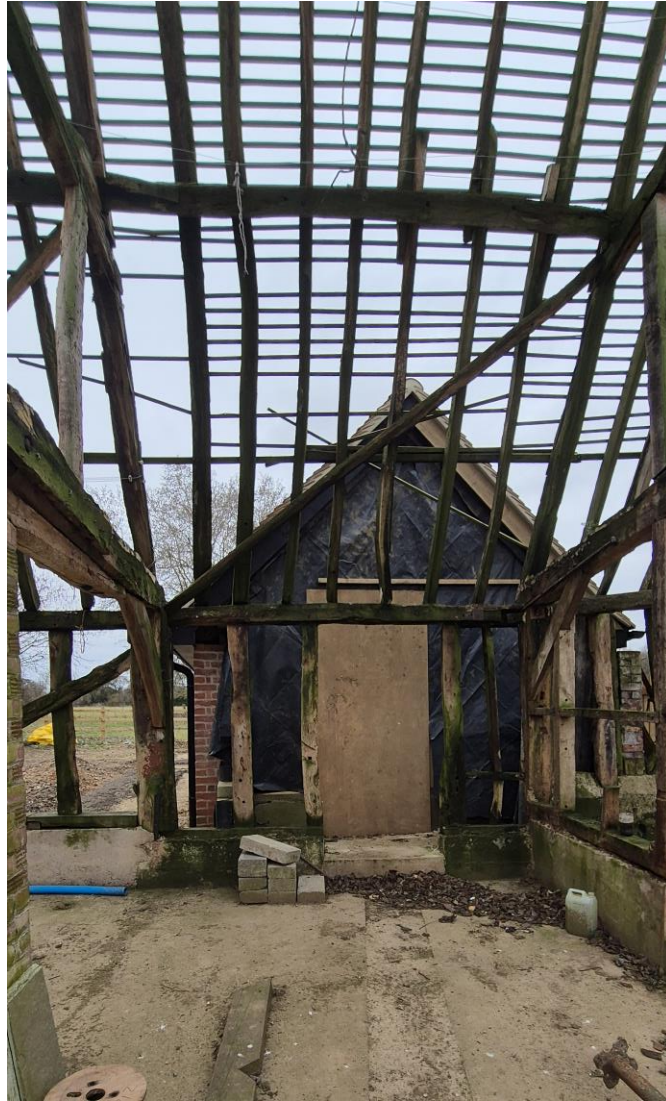
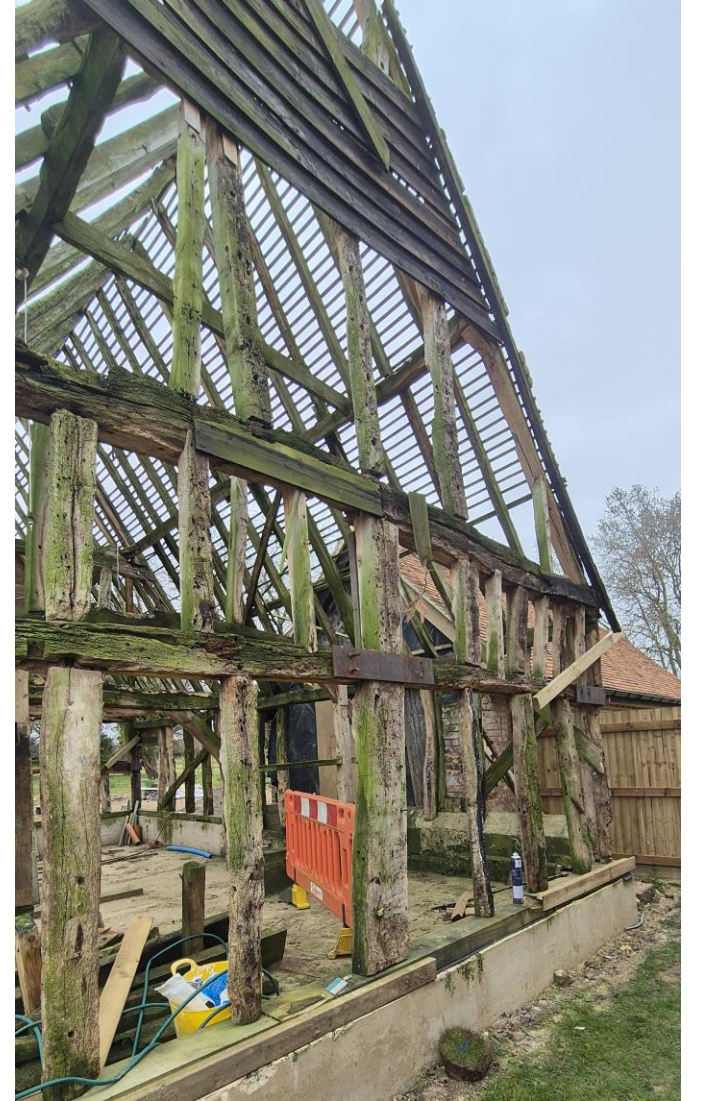
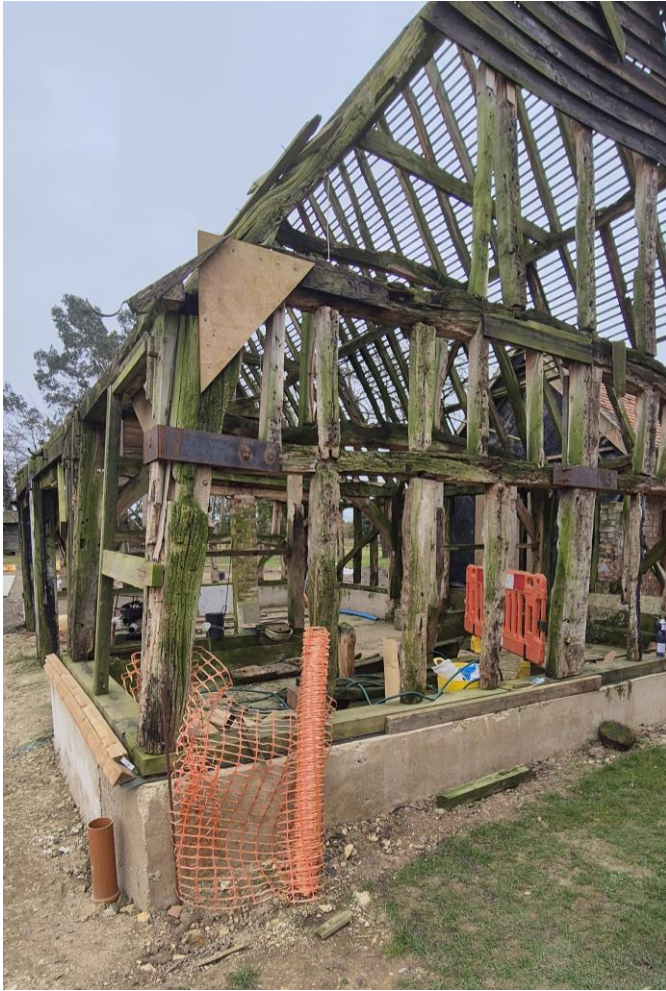
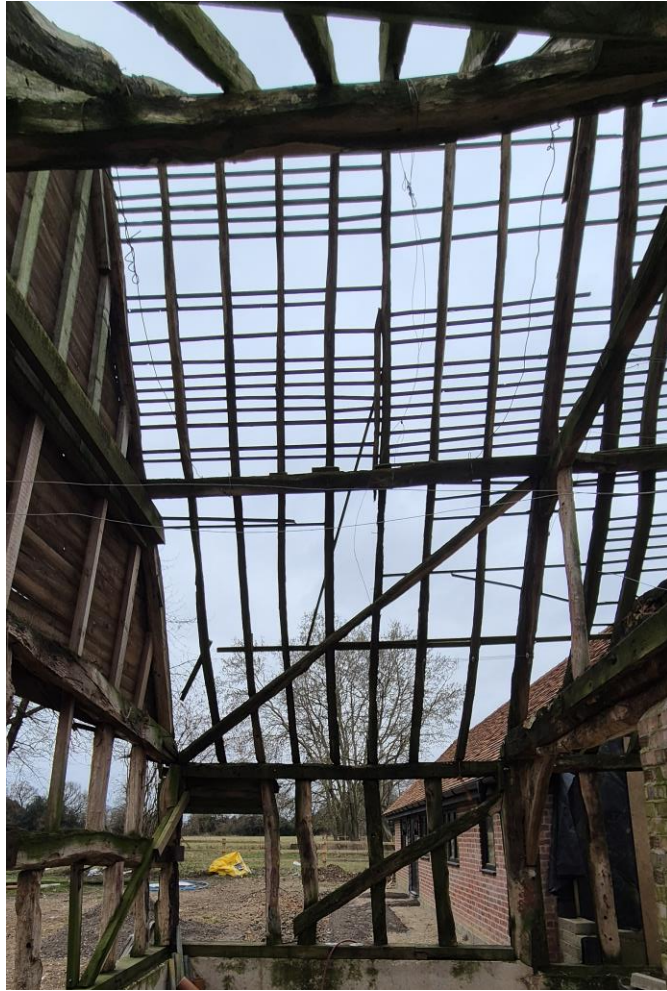
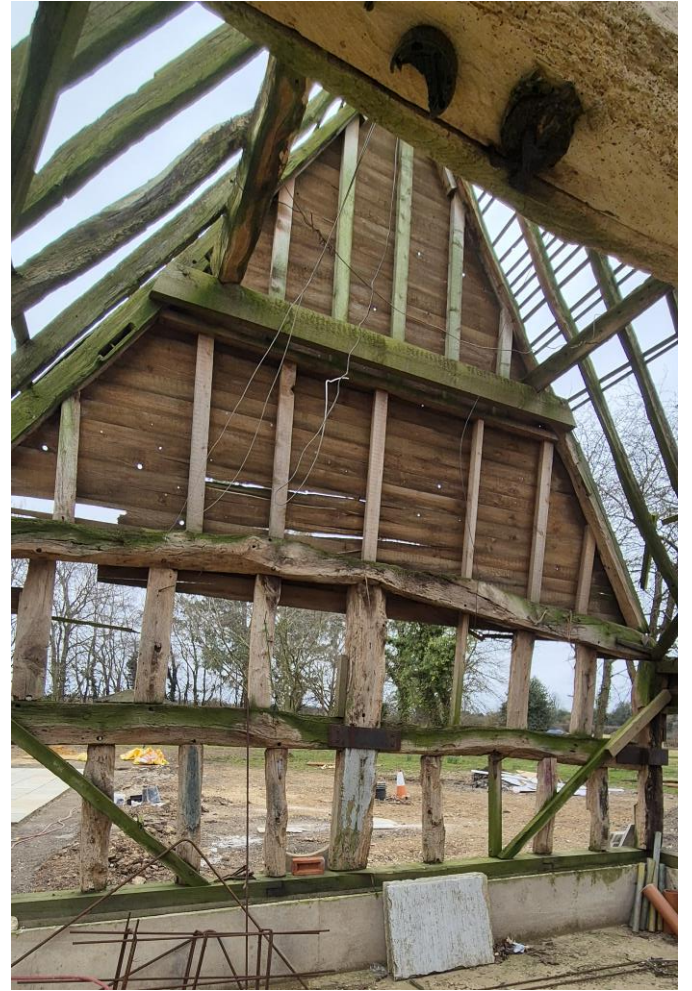
Metal straps were cut and fixed on site to support areas of weakness highlighted during the cladding removal. You will see from the supporting images that the sole plate has been added and the straps down the sides of the frame.
