# Arboricultural Impact Assessment and Method Statement

**Site:** Hillcrest and Tussocks  
The Causeway  
Therfield  
SG8 9PP

**Date:** October 2024

**Reference:** TCTC-18755-C

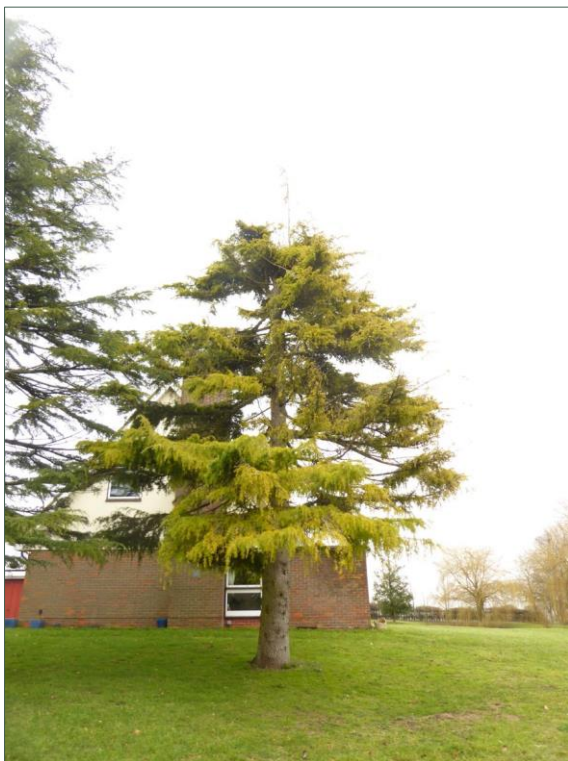
| Activity | Potential Impact | | | |
|---|---|---|---|---|
| | The long term retention of this tree is limited, it is in serious decline, along with other nearby cedar tree T58, and cannot be sustainably integrated into the development proposal without damage to roots. | | | |

TC1 (16.02.23) T58 cedar of low value, in decline

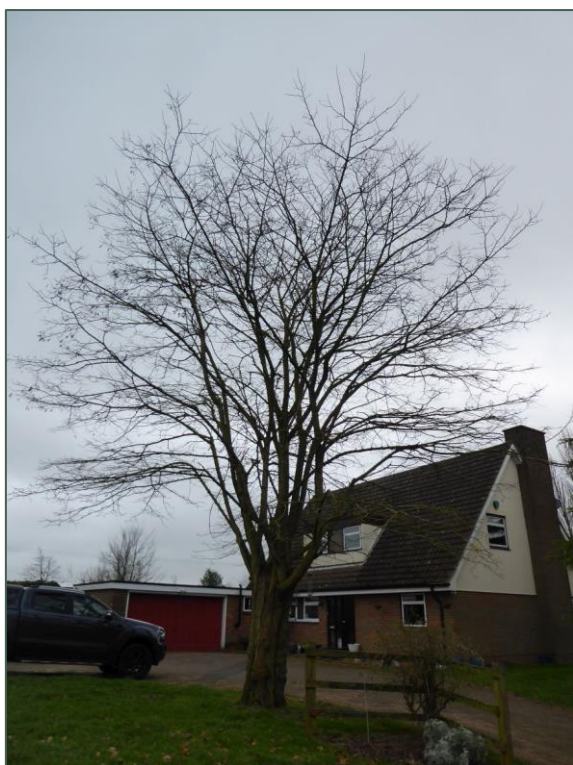
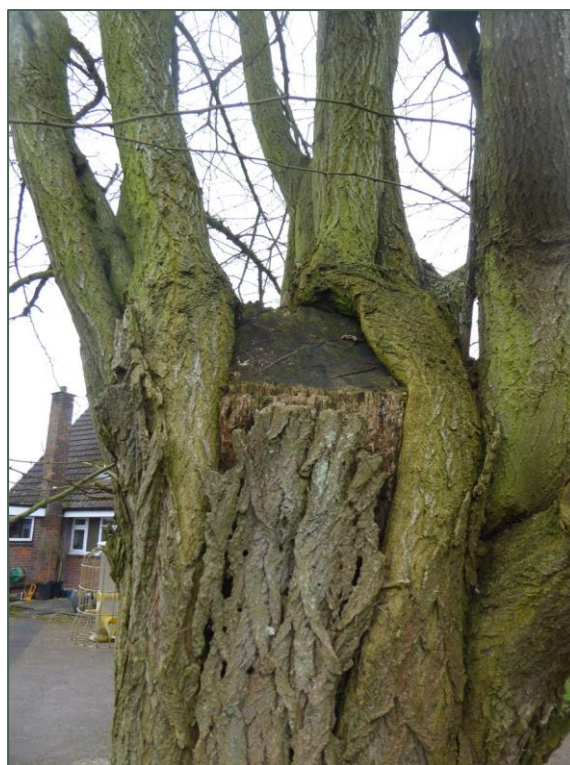
TC2 (16.02.23) T60 Acacia of low value, with poor crown structure and decay in main supporting stem

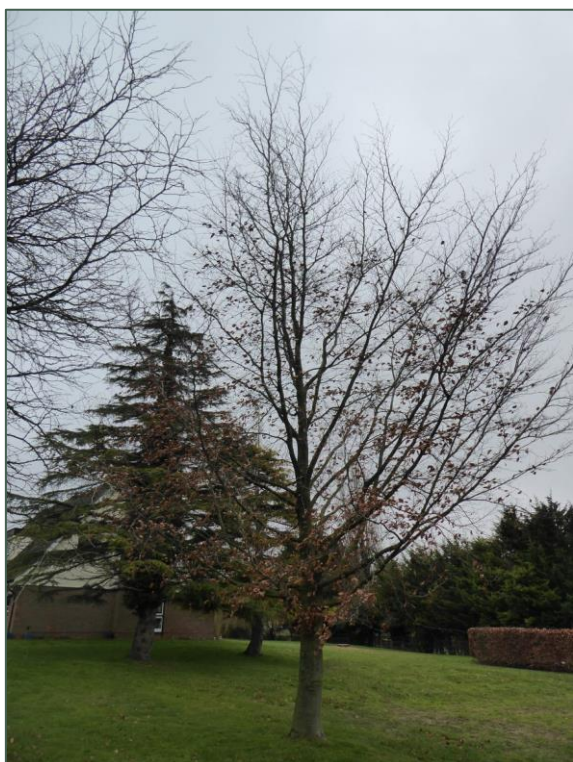
TC3 (16.02.23) T62 beech of moderate quality

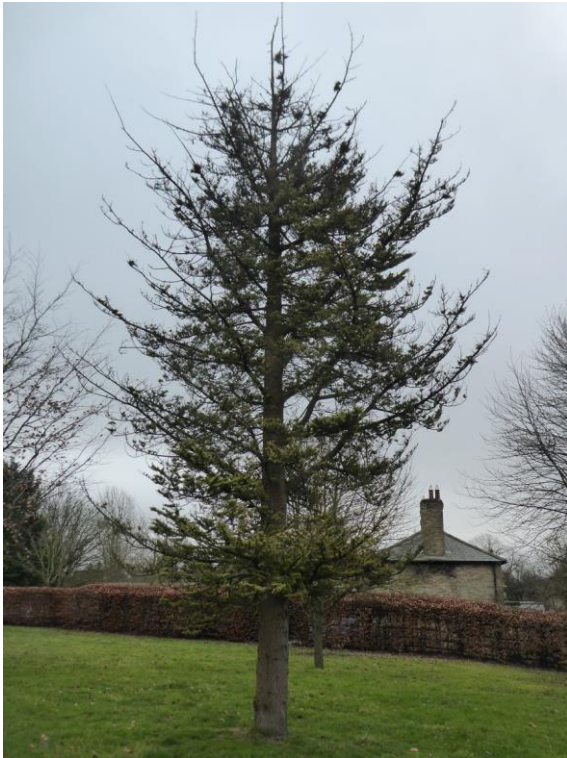
TC3 (16.02.23) T63 Cedar of poor value, in significant decline.
