Derek LOFTY & Associates

Project: Porters End Barns

# Report on the Existing Barn Structure at

**Porters End House Barns  
Porters End House  
Porters End Lane  
Kimpton  
SG4 8ER**

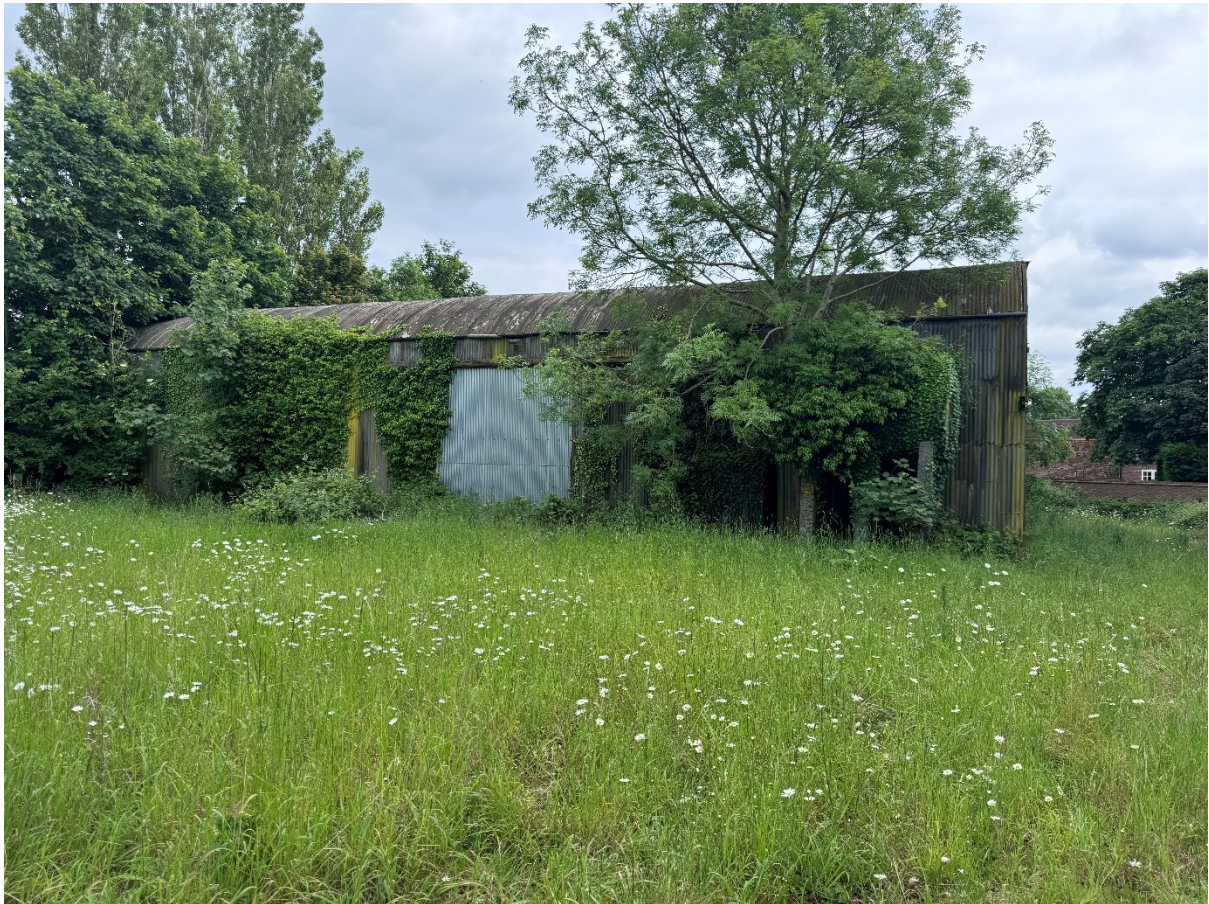
Figure 3 - Front (North) Elevation

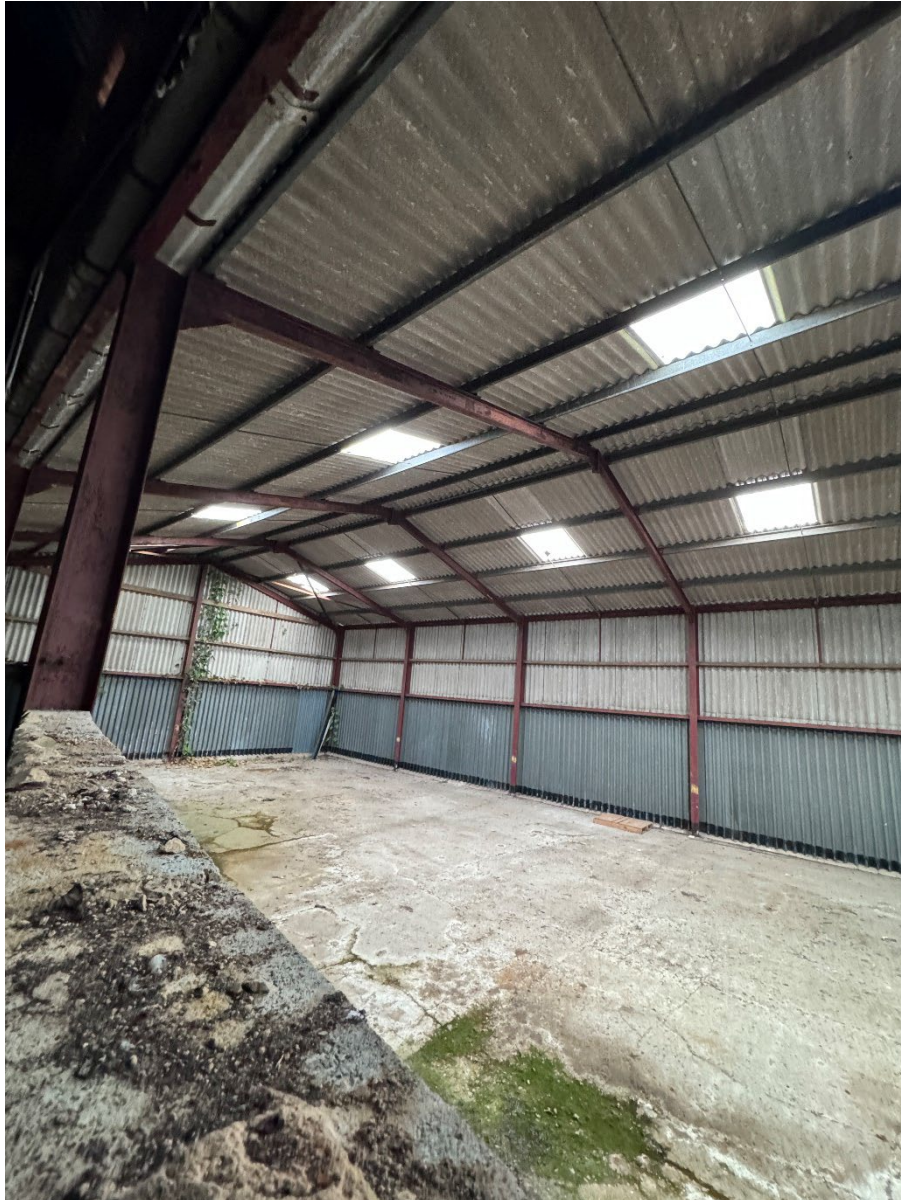
- 3.13 At the time of our inspection the south barn is presented in good structural condition. The ridge line is reasonably level and the roof planes even.

Figure 5 – Internal South Barn

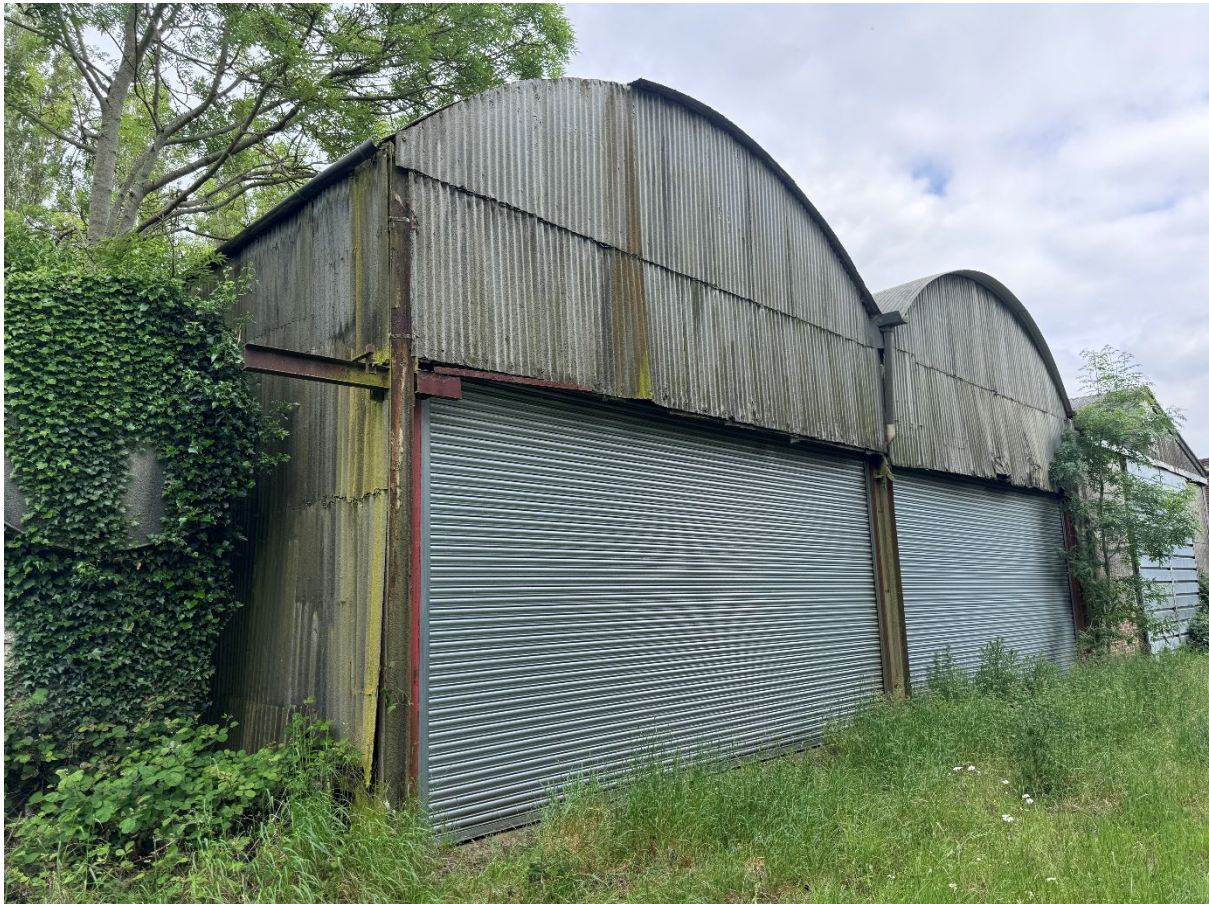
Figure 6 – Barn Doors and West Elevation
