## **Julians Park, Rushden, Buntingford, Herts. SG9 0TD.**

Historic building recording and analysis of the Outbuildings. Recorded 08 05 2024.

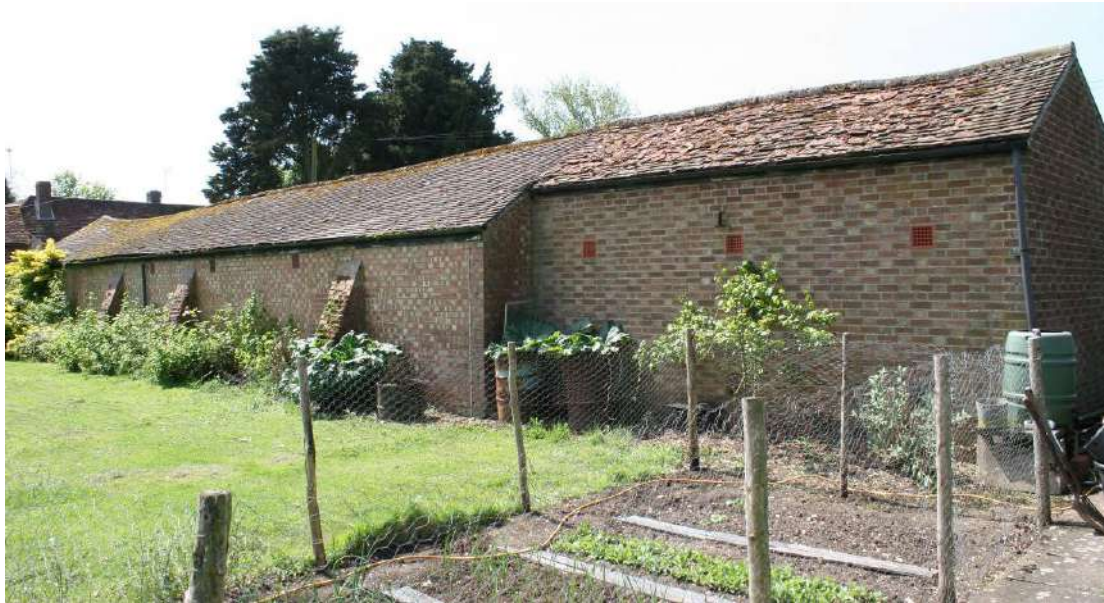
The Stables is made from textured Flettons set in grey cement. There are three ceramic air grates and three lower ones bricked up. The Stable roof facing the House has been clad with nibbed tiles that have been storm damaged and many are loose.

The NE elevation of the Workshop and Stables.

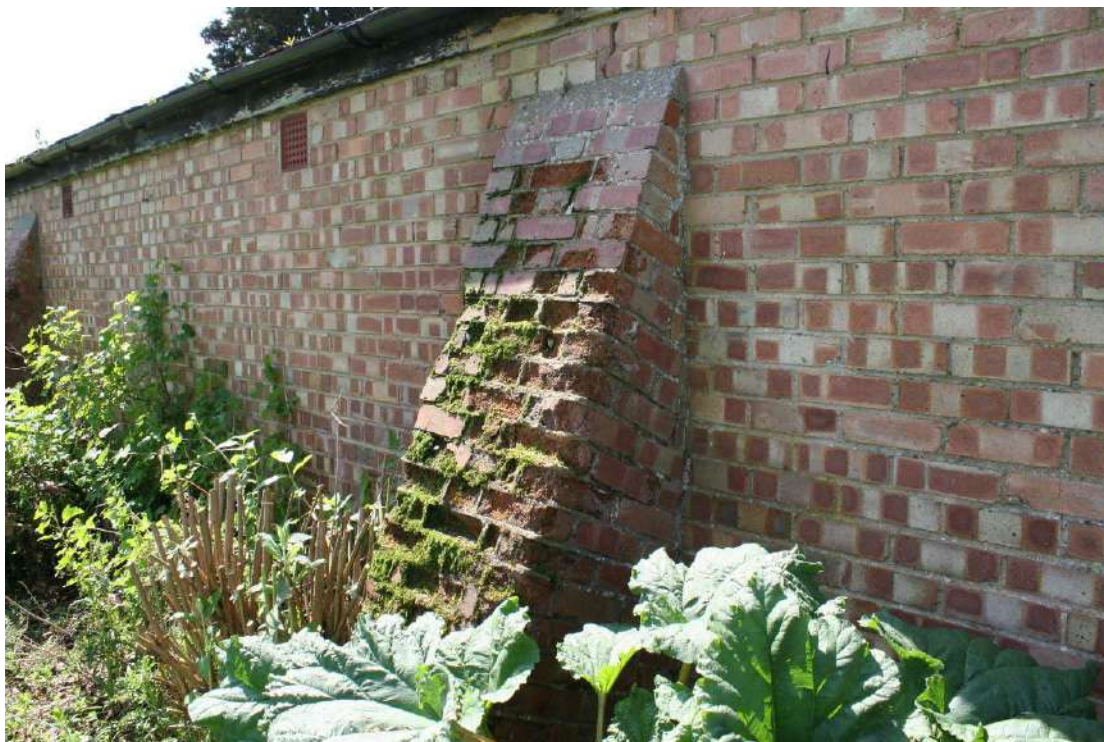
Detail of the NE elevation of the Workshop. Note the cracking and spalling.

The Workshop NE wall is made from Flettons set in beige sandy cement with small stone inclusions. The air grates have been inserted just under the eave's boards. The bricks are laid in stretcher bond and the single skin wall has cracked significantly in several places. Angled buttresses have been added but have spalled badly from frost damage.

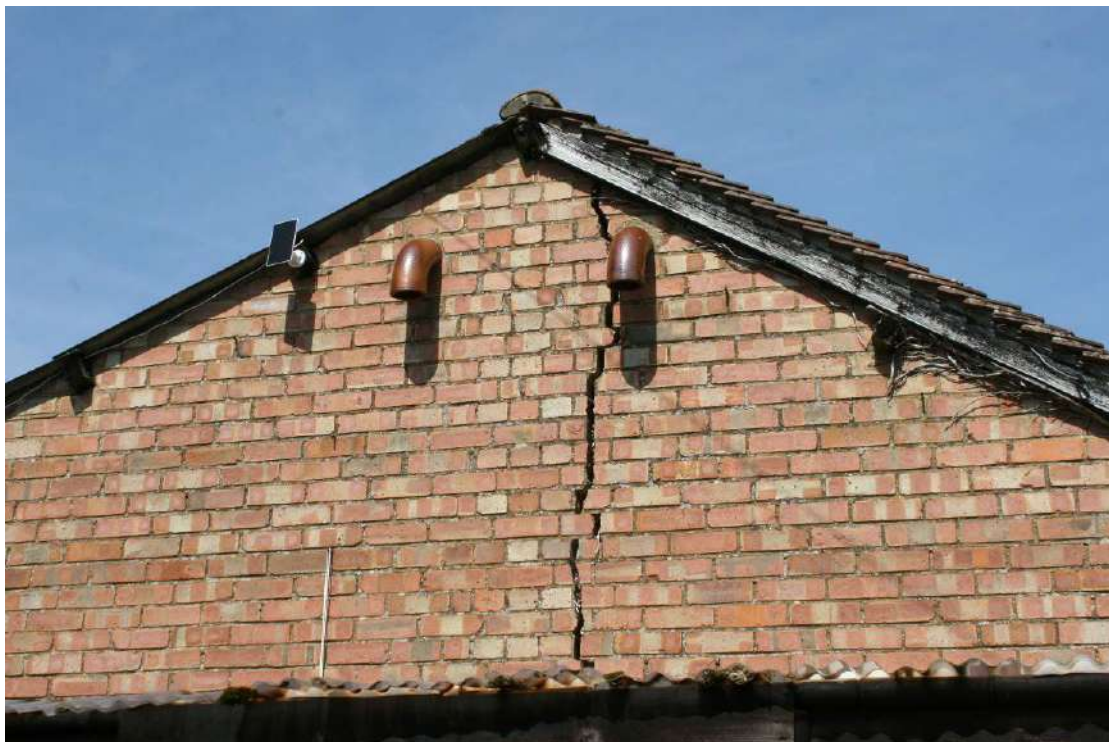
The SE elevation has a serious crack. The vents are sewer pipes.

The SE elevation faces the cottage and a potting shed has been built against it. The wall has serious structural cracks and the roof has shifted. The air vents are sewer pipes.

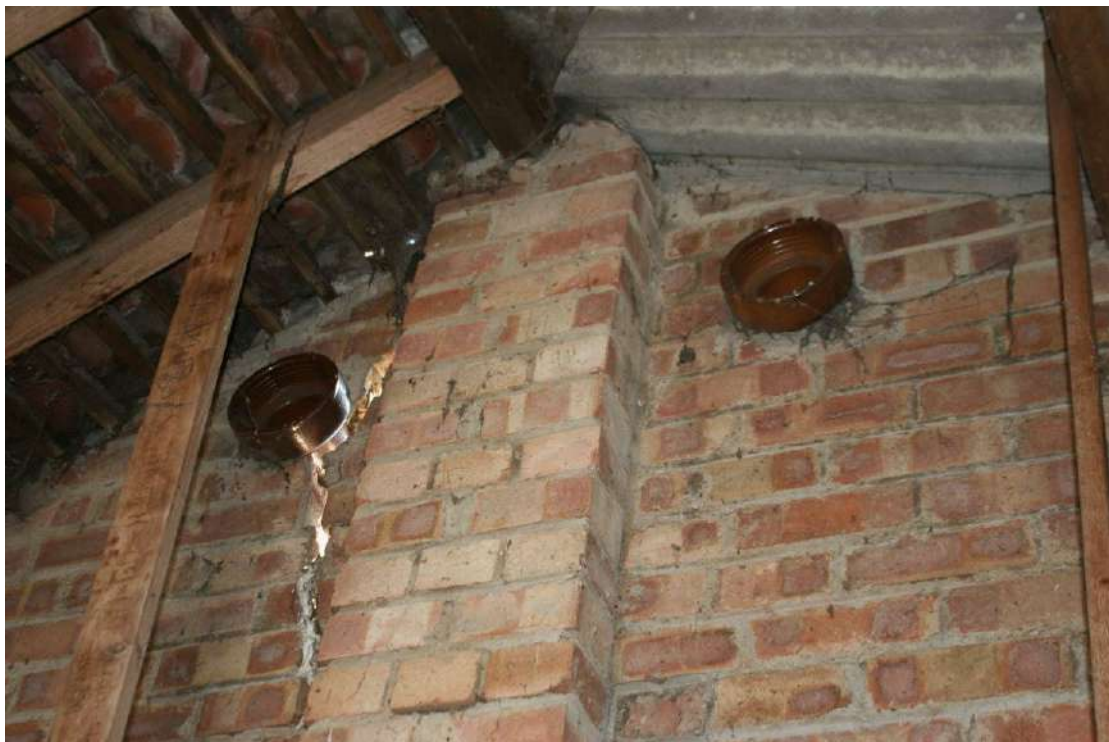
Air ducts made from sewer pipes. One has started off a massive crack.

There is evidence that the building may have been used to dry and store produce. There is large wooden air duct and sewer pipes have been inserted to provide high level ventilation. Unfortunately, this has caused serious structural cracks in the SE wall.

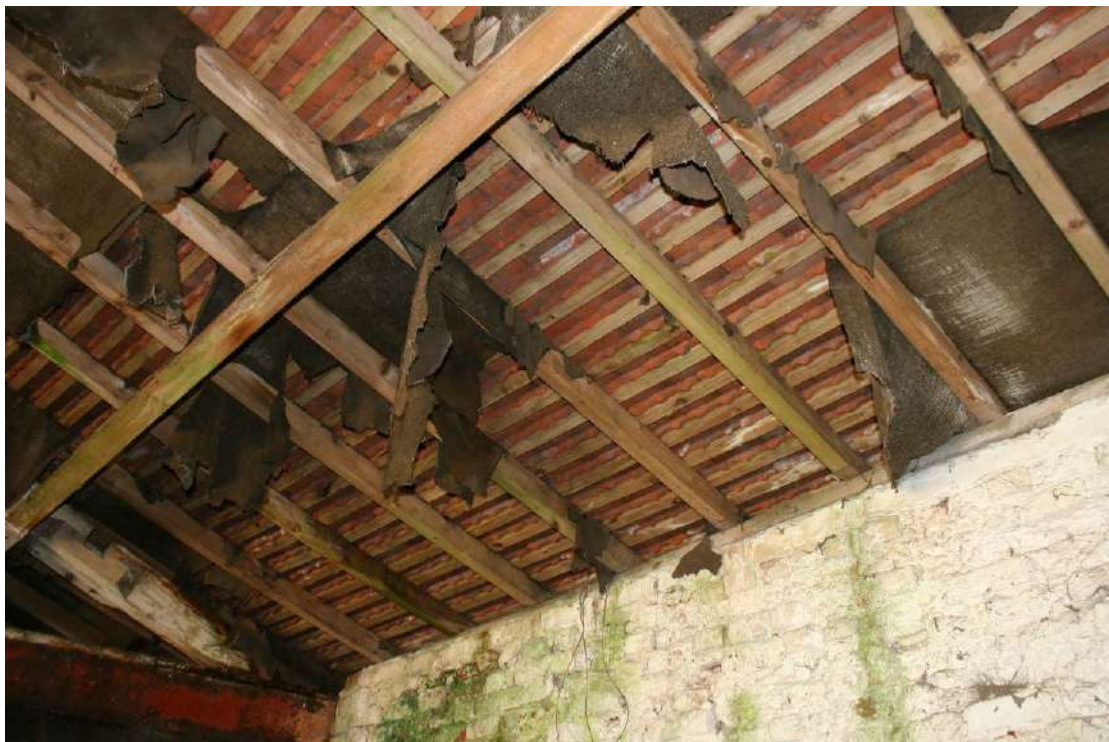
Detail of the failed asphalt membrane.

The SE side of the roof has an asphalt membrane which would indicate the roof has been re-battened between 1965 and 1985. The type of membrane with a cotton mesh would indicate early in this period. The membrane has failed and there has been considerable water damage to one of the trusses which has been reinforced with steel fish plates.

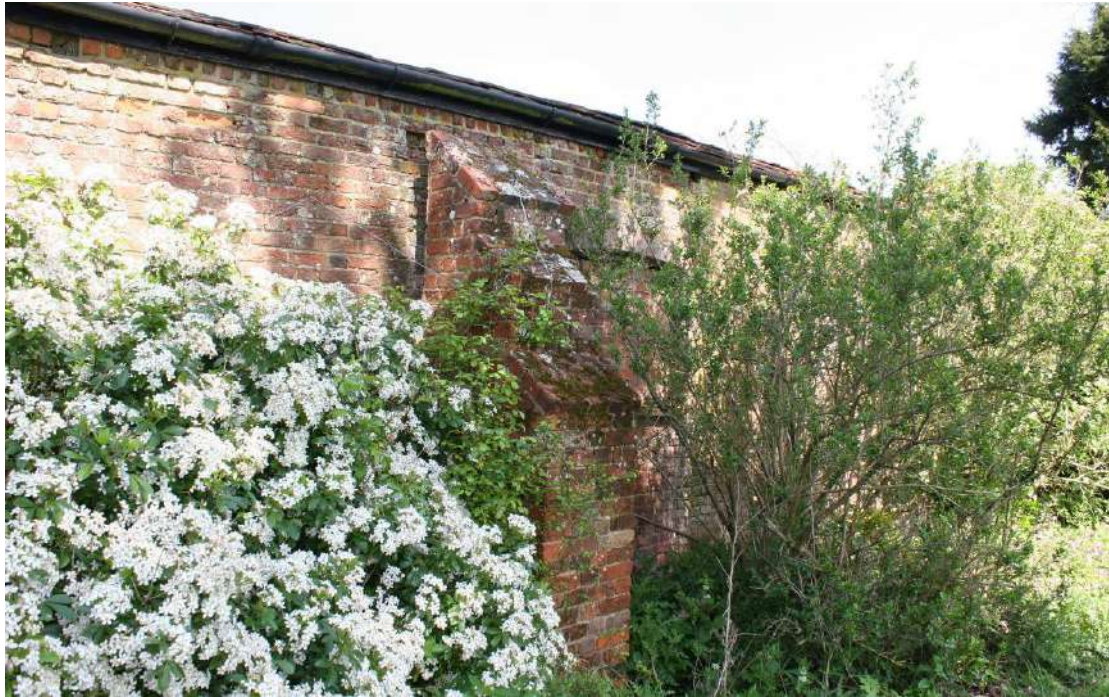
The wall has shifted away from the buttress.

The building has been built off an earlier 13in thick perimeter wall made of 55-60x105x210mm red bricks with creased faces and soft arrises set in beige sandy mortar and mostly in English bond. There are sections near the carriage arch which are H-S-H-H-S-H-H-H-S bond which approximates to Flemish Garden Wall bond. The wall has shifted away from its added buttresses. Mapping might indicate a wall here from between 1777 and 1806.

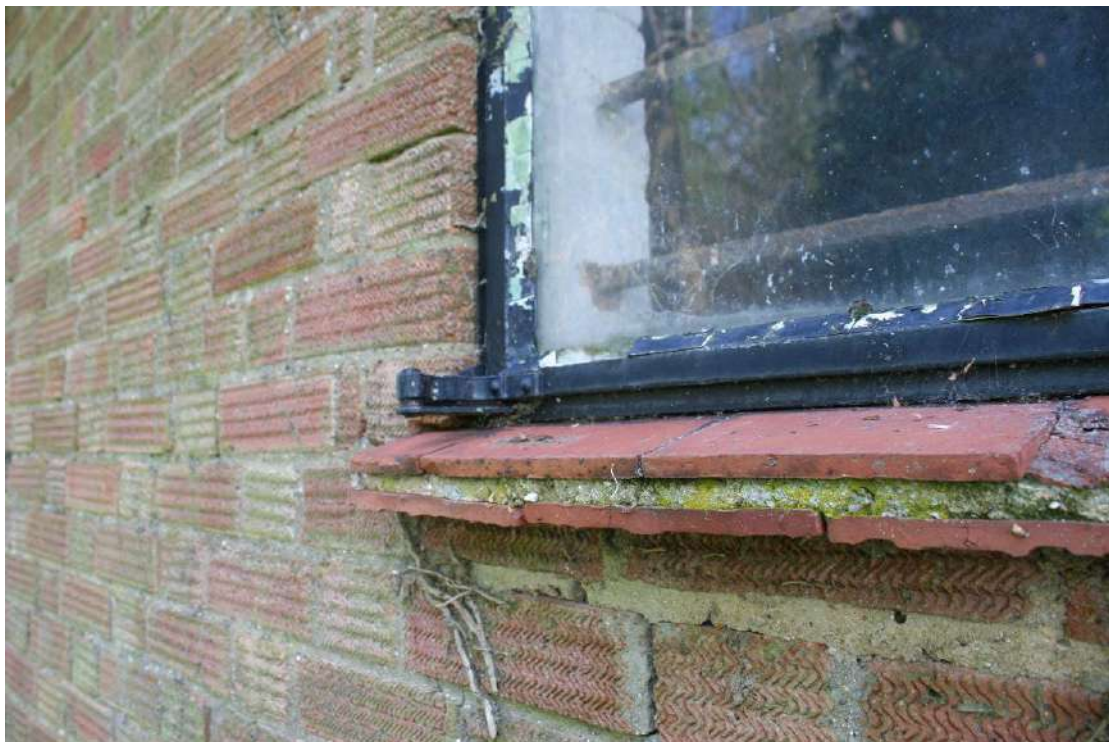
Detail of the brickwork, windowsill and Crittall style windows.

The brickwork is set in grey cement joints and the windows have queen closer bricks (which are lacking on the quoins). The windows have steel reinforced concrete lintels and have internal steel bars which might suggest that animals were kept inside and the windows needed protection. There is also some serious cracking near the windows.
