## Julians Park, Rushden, Buntingford, Herts. SG9 0TD.

Historic building recording and analysis of the Kitchen. Recorded 26 05 2023.

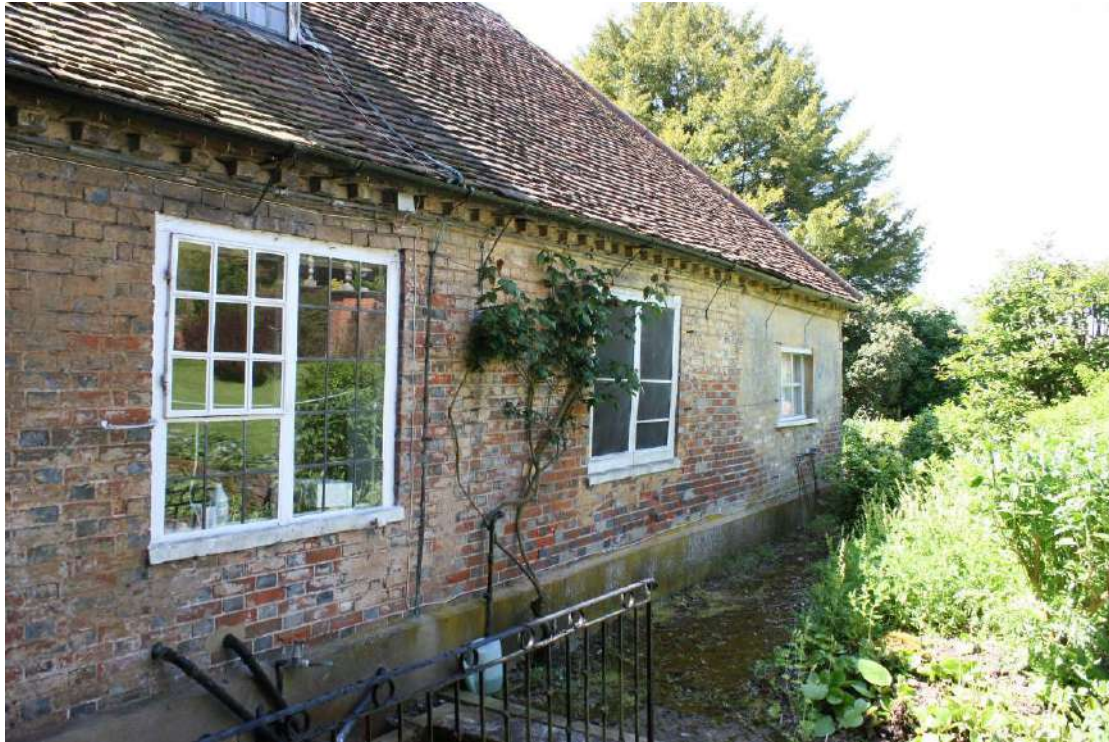
MC20th fenestration. Note the chequerwork was hidden by thick layers of limewash.

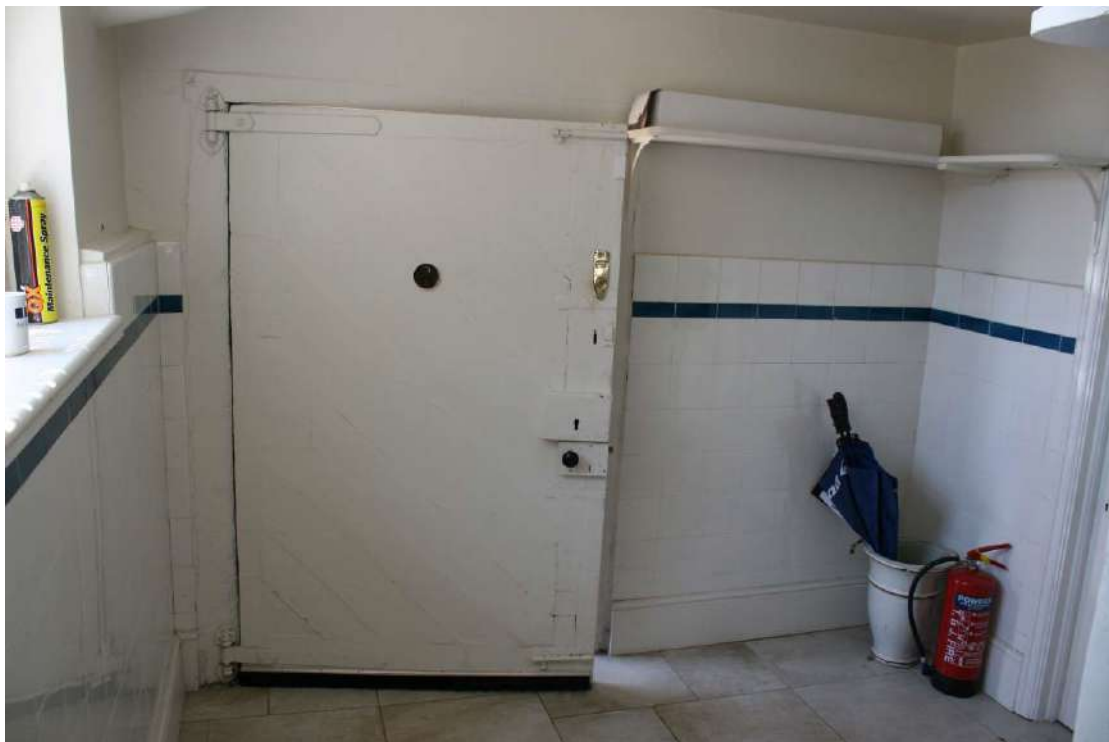
The back of the side door has been reinforced with diagonal boards.

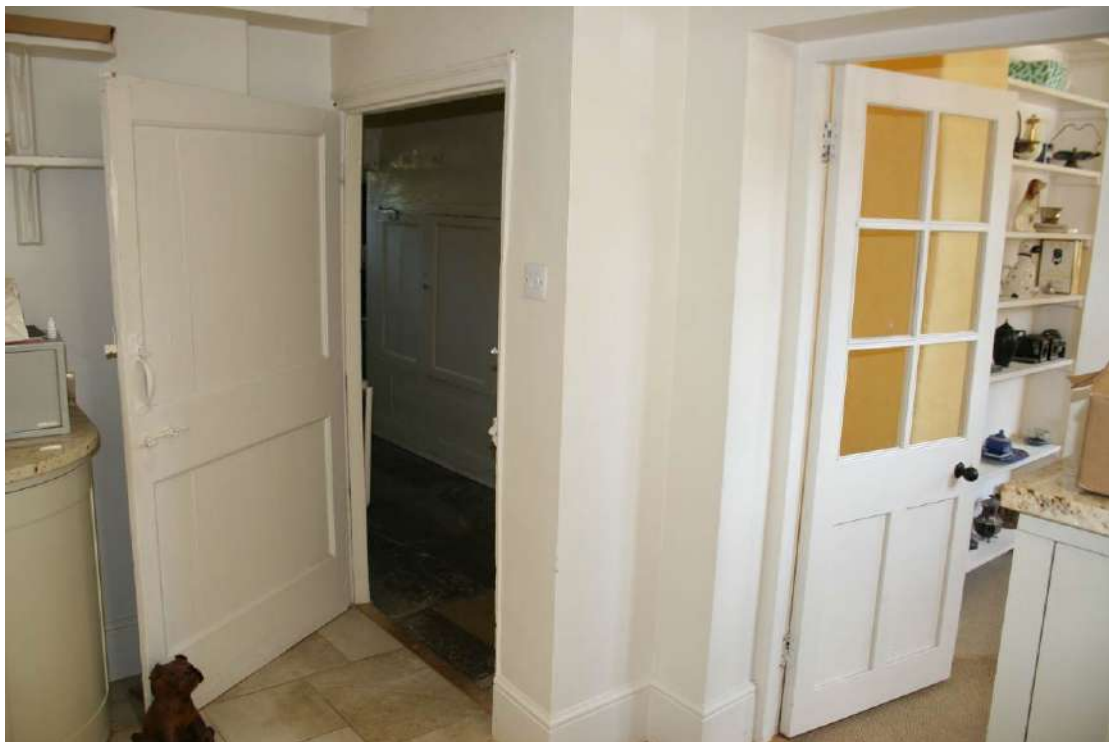
Detail of the Butler's Pantry Corridor and the Hallway doors.

The door into the Hallway is from the 1939 works. The door into the Butler's Pantry Corridor is a two panel Georgian style servant's door with C19th bolt and an C18th or EC19th Suffolk Latch nailed in position. Currently hung on butt hinges it has a broken off T-strap hinge and L-hinge. The top has an added fillet and the mid-rail has been quite badly damaged.

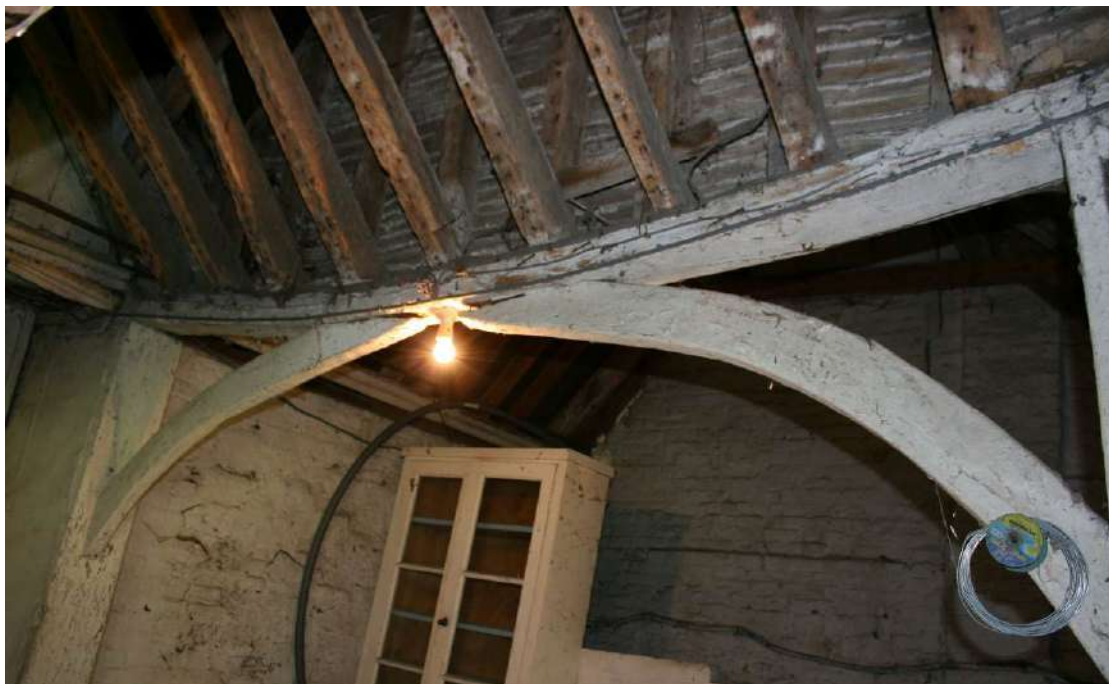
Looking E in the Store. Inserted braces.

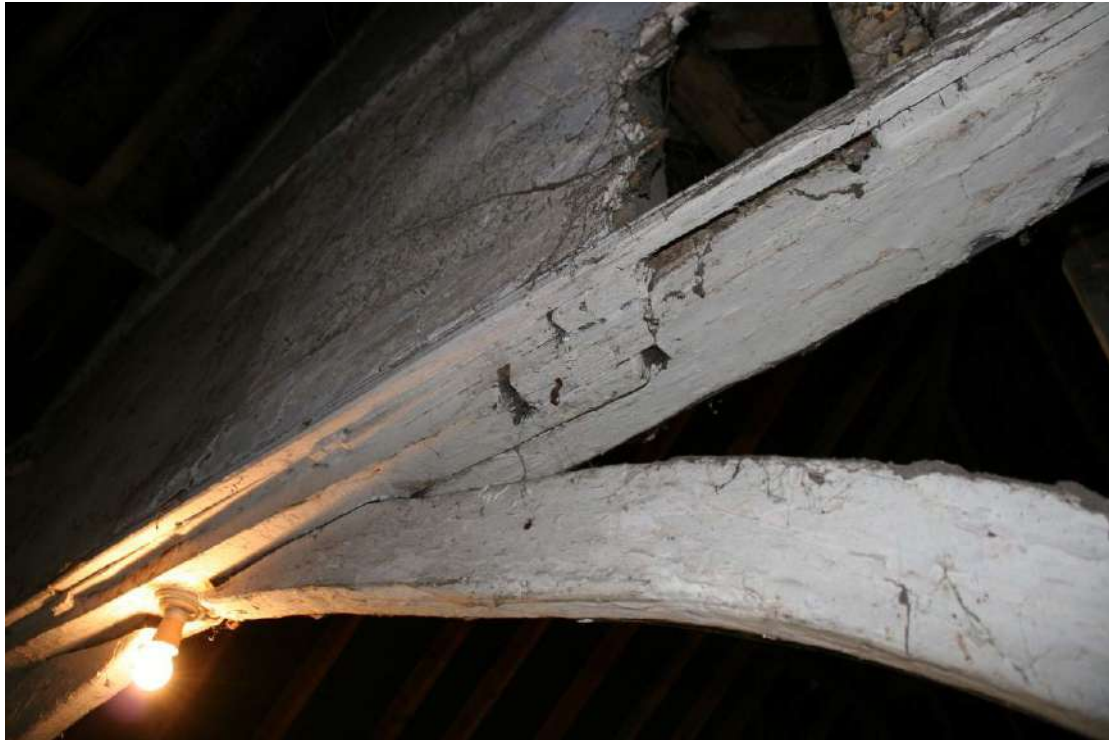
The form of the roof is quite difficult to resolve because the 1939 works have built over an earlier form that has also evolved quite organically. Where the lath and plaster has been removed it can be seen there was a full height timber-framed wall, plastered on one side only. The lower wall is supported on two long, curved spandrels nailed into the mid-rail which has bowed badly because it has a very long scarf joint failing in the middle.

The east side of the partition wall showing the failing scarf joint.

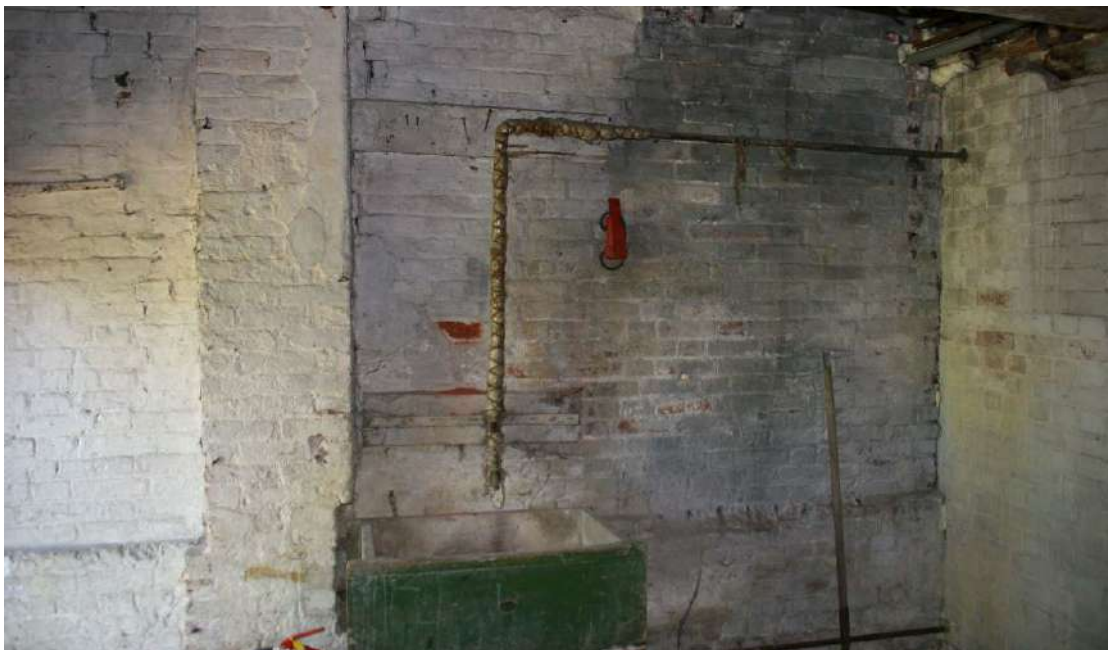
The brickwork has been remade where a fireplace has been removed.

A wooden sink (for washing glasses without breaking them) is in place under a tap but it occupies where a fireplace has been removed. The wall has been remade as the 1939 plan shows the fireplace. The sink has a brass badge with Staines Establishment Everlast and must be MC20th. The floor is covered in cement screed that levels a brick pavior floor of which a small section is still visible under a workbench.

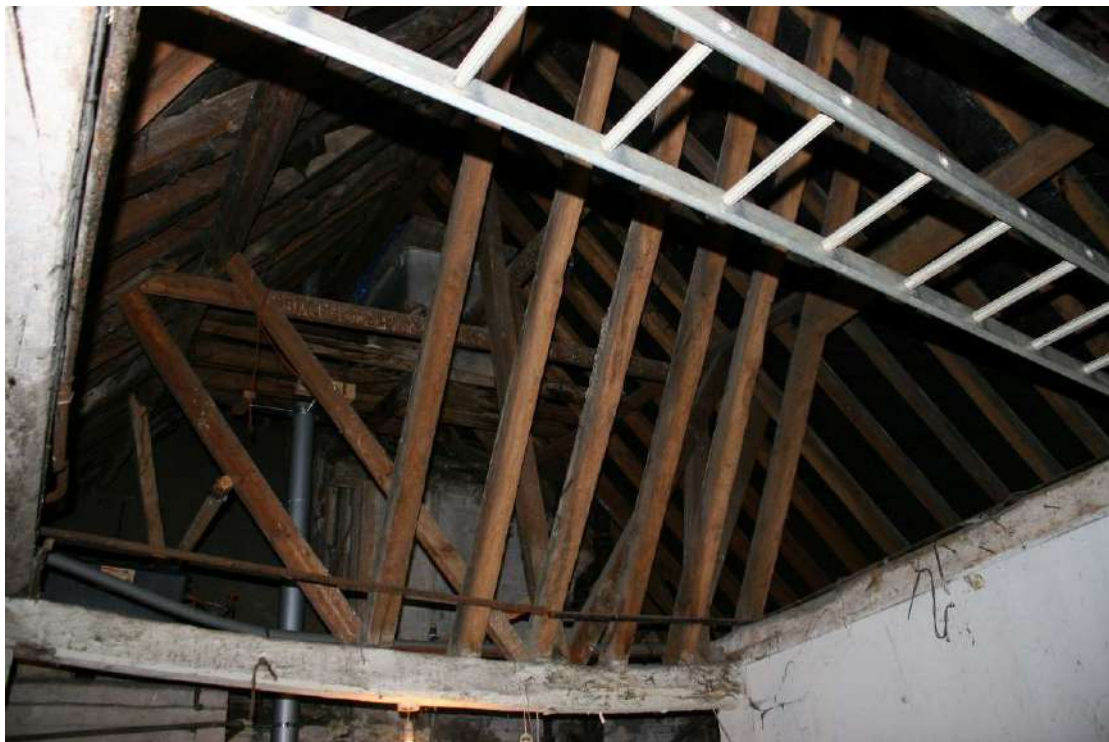
The roof looking N towards the chimney.

The roof is largely made from machined softwood as part of the 1939 works and again has been retiled between 1965 and 1985 with an added asphalt membrane. The partition wall has been removed and now the support beam has deflected.

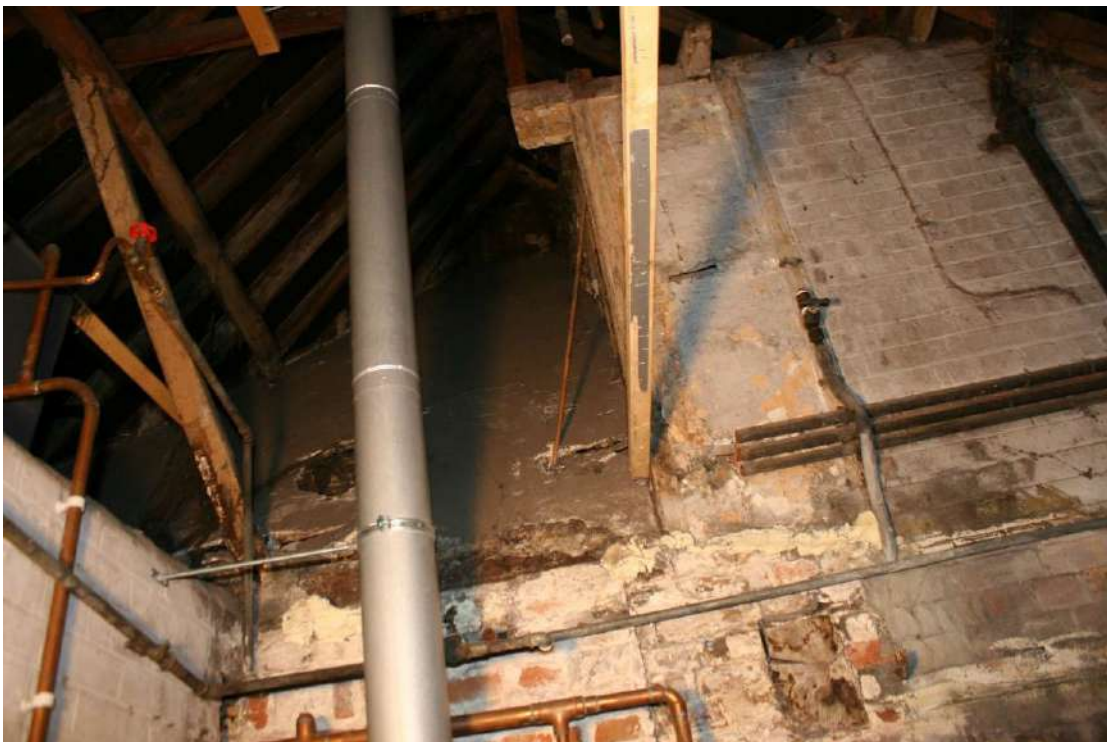
The chimney for the 1939 boiler has been taken down and new flue added.

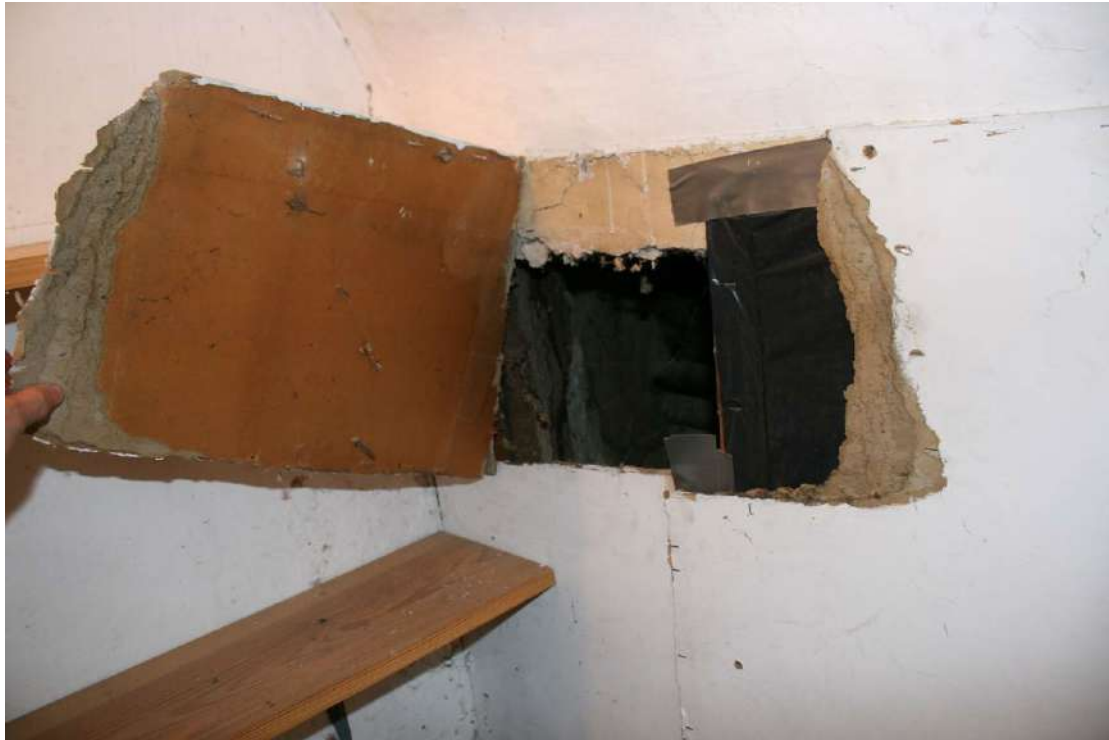
A section of hardboard panelling has been pulled back to get at the pipes.
