# Priory Heritage

## Condition Inspection Report

### Brickwork to Former Kitchen Garden Walls at Dower House - Preston

**Prepared by;** - D. Llewellyn Ba Arch, Dip Proj Man, MRICS, MCIOB  
**Date of Issue;** - April 2023

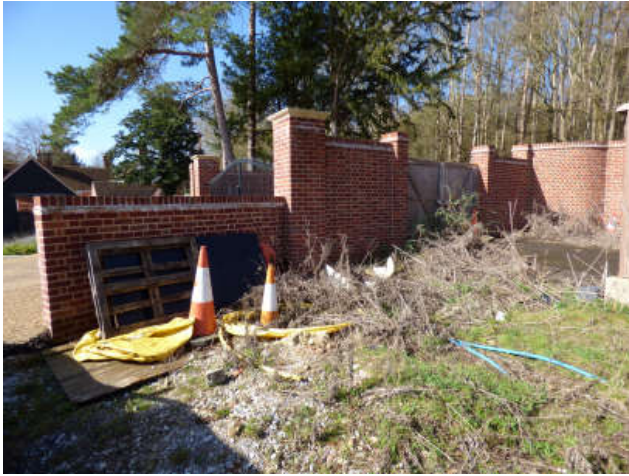
This length of wall starting at the entrance on the SW corner and continuing for 15-20M along the NW roadside elevation has been rebuilt in recent years. Although the exact mortar mix and brick type are unknown it remains in good order. It is erected in Flemish bond with recessed pointing, overall its character does not seem inappropriate to an historic setting. Lowest courses on inside face visible in concrete block. Ground levels require regrading. No significant defect was apparent in this section although it should be noted there was no provision for horizontal thermal movement. Depending on mortar strength and the maturity of the bricks when utilised omission of movement joints might later cause a defect

Section A1 - Wall rebuilt at entrance + electric sub-station

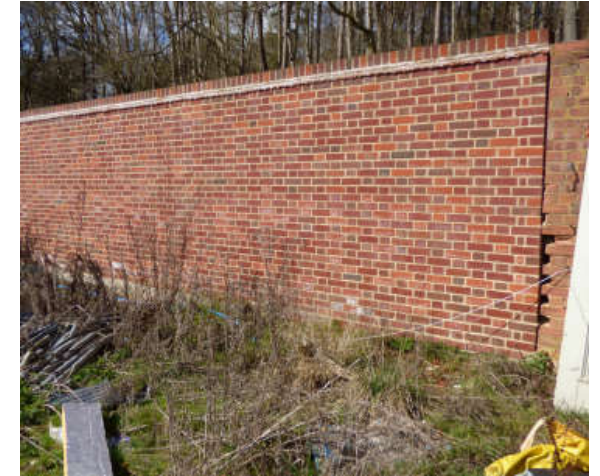
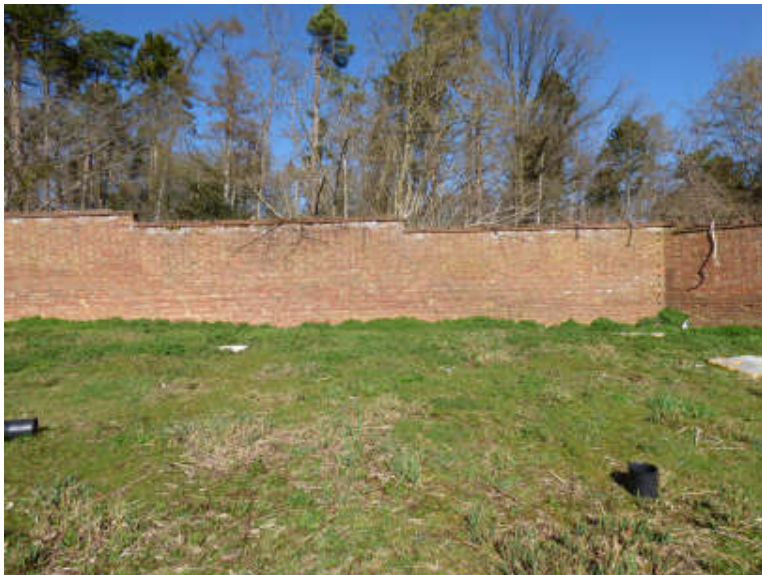
Continuation of North West side - Section A2

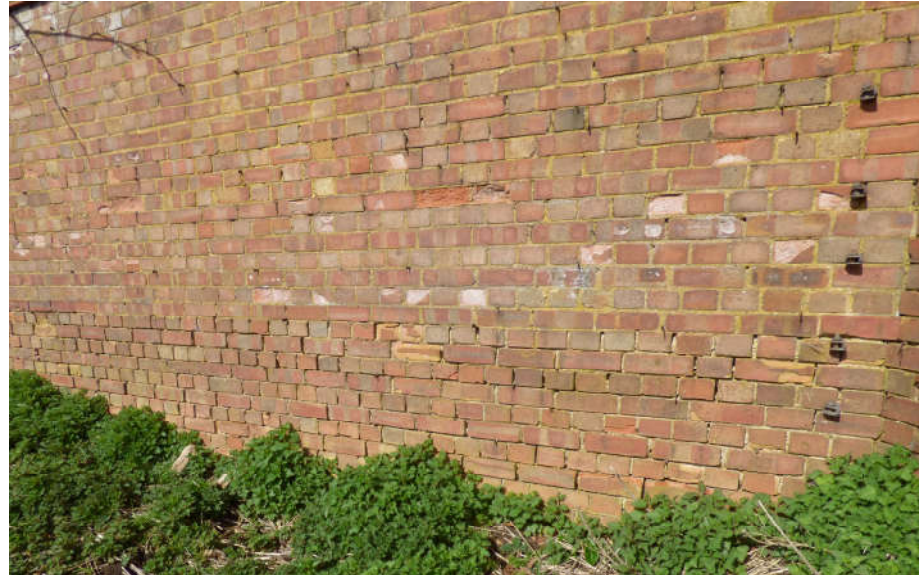
A2 also exhibits the visible change in construction at low level seen clearly along elevation B1-B2

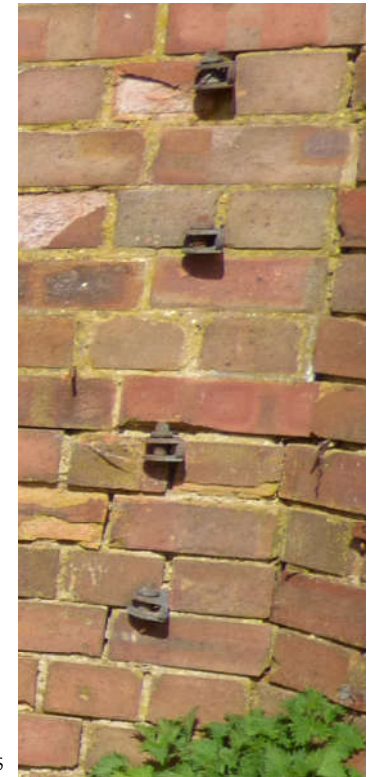
Surviving tension spools for vine wires

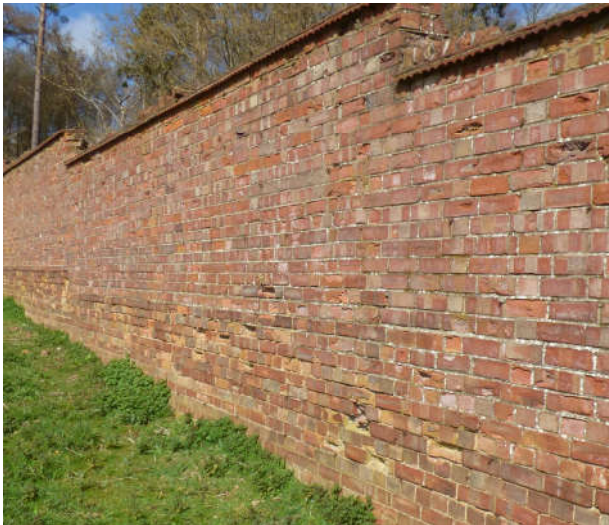
Sequence / construction break in brick type + jointing visible as increased erosion of lower 10-12 courses

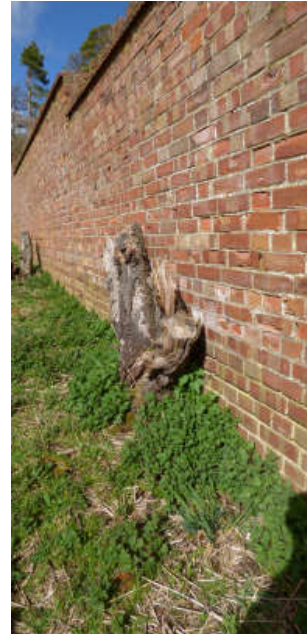
Fruit tree remnants

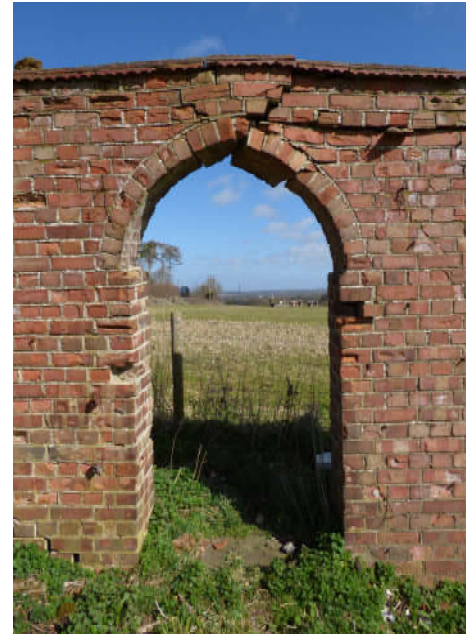
- 2.10** The arch over the doorway between (B1) and (B2) is structurally unstable and currently dangerous. The sections of wall panel along B1 as it approaches the doorway become progressively further out of vertical with a pronounced inward lean up to 6 degrees. The brickwork beyond the arch to (B2) has a less pronounced lean of 2 - 3 degrees. Consequently the wall / arch is no longer in line and has failed. Realistically this could only be repaired by rebuilding several panels of brickwork either side of the arch back to vertical such that the wall + arch can achieve a continuous line. The walls along both section B1 and B2 become less out of vertical as they approach the corner and are stiffened by buttressing effect from the adjacent wall.

Unstable brick arch to side gate

- 3.07** Several sections of wall whilst still upstanding at date of inspection such as arch + adjacent wall to section (B1/2) and the piers along section (C) are dangerously unstable and will have to be demolished to be made safe irrespective of decision to rebuild or otherwise.

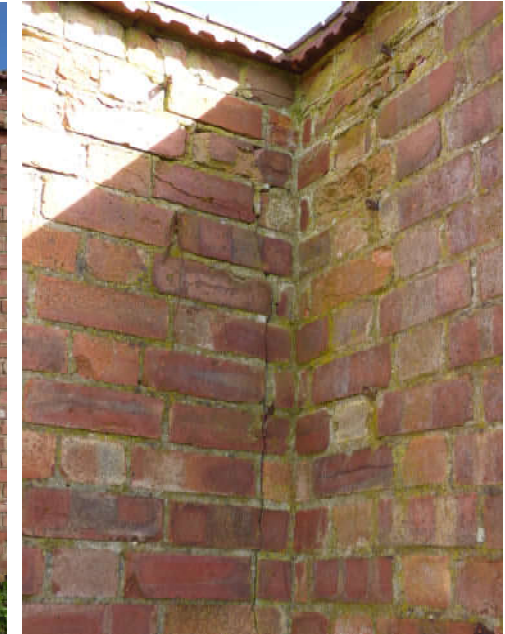
- 2.11** The NE wall section (B1/B2) exhibits several vertical cracks through brickwork along its length and in the corner with (B2 - C). Similar to section (A2) there is no provision for thermal movement joints along the wall and expansion likely concentrates at the door opening which is an inherently weak point, horizontal forces contributing to the tendency for the wall to become out of vertical.

One of several vertical cracks, section B1+B2

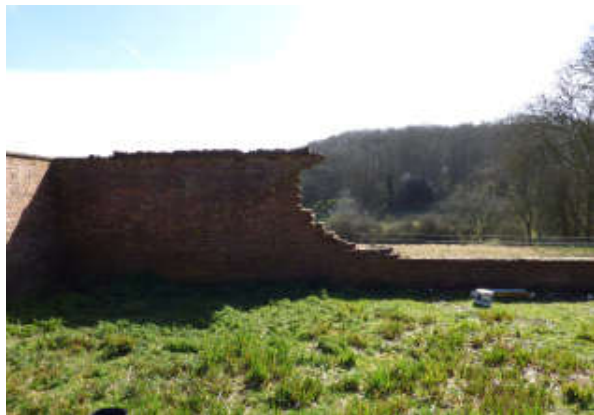
South East wall Section C I----- fallen section -----I

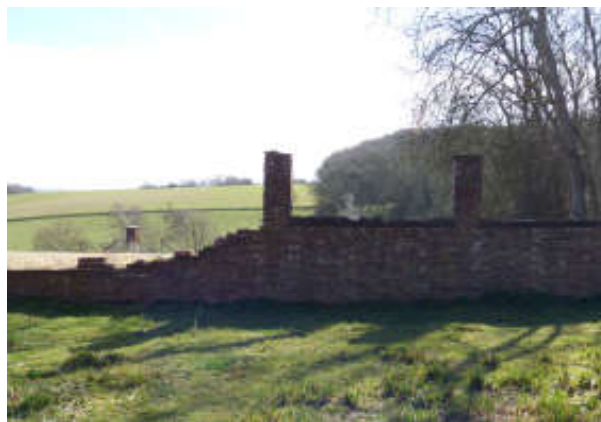
Lower wall along SE boundary with slender brick piers

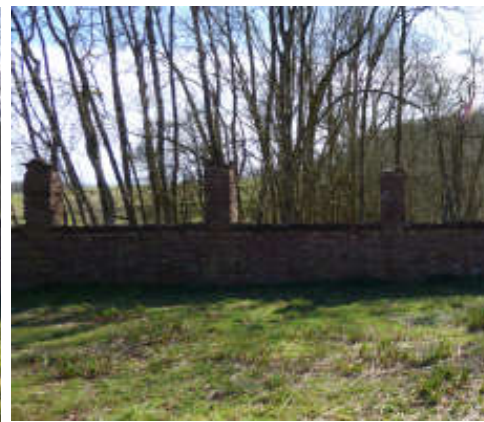
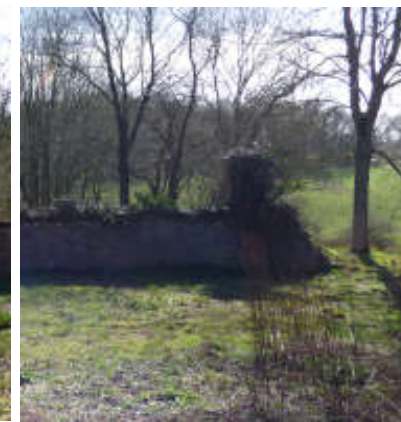
Truncated prior to return for (D)

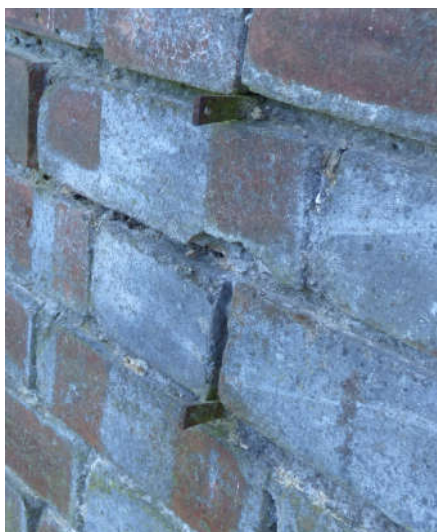
Surviving vine eyes (mild steel) and wire tension spools.

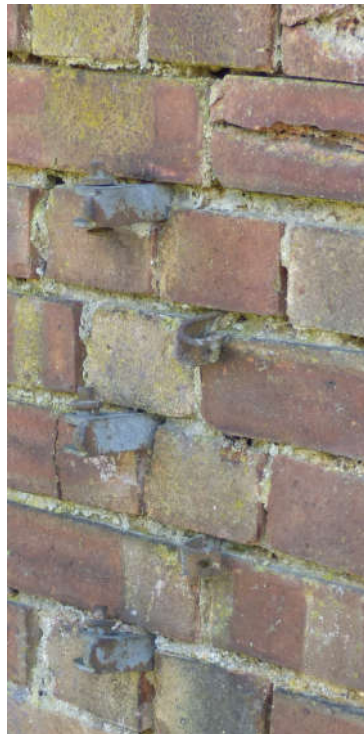
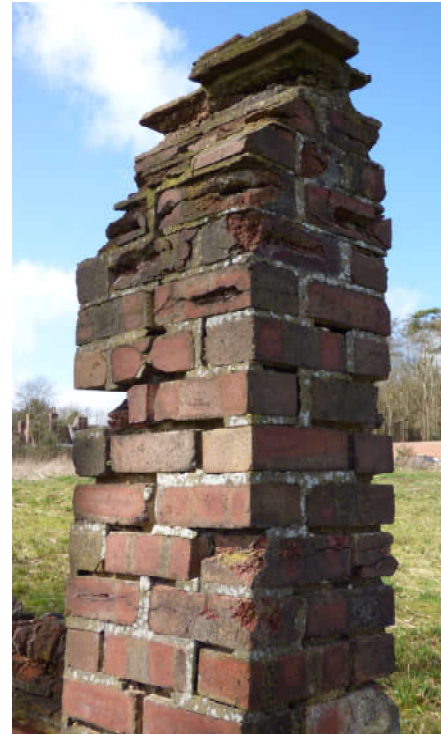
Example of extensively eroded and open jointed brickwork to piers along section (c)

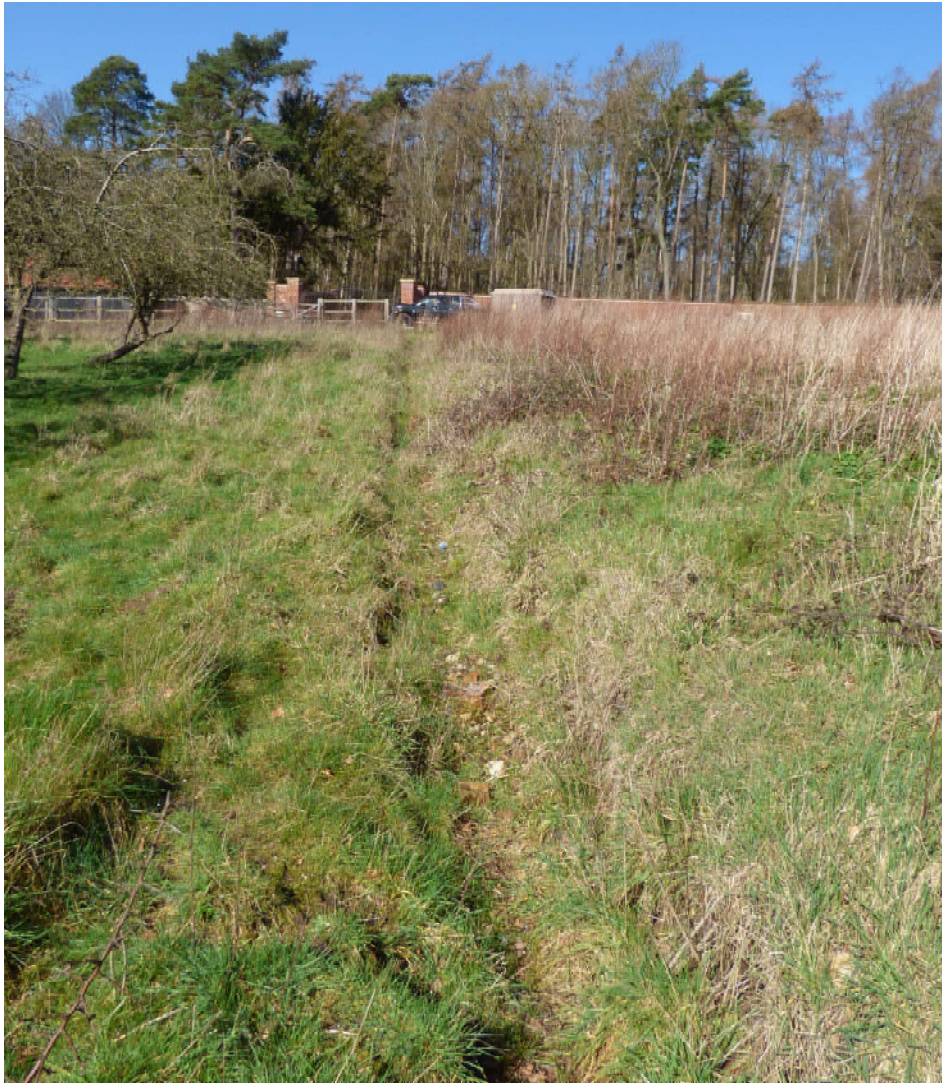
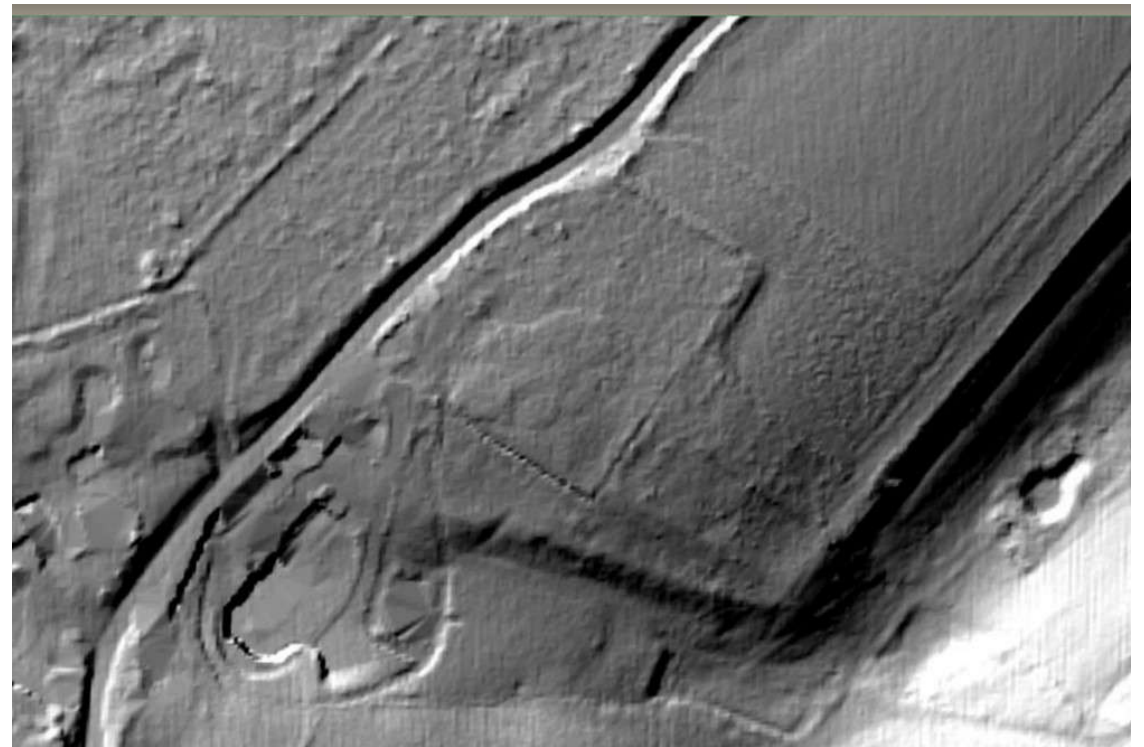
- Section (D)
- 2.17** The wall along the South West boundary section (D) and the short return immediately to the SE corner has collapsed or been demolished. All brickwork has been cleared including remnants of any foundation save for isolated bricks. There remains a shallow depression along the line of the former wall where the foundation brickwork has been removed. To regain the correct form and sense of enclosure for the kitchen garden along section (D) the wall ,or a similar boundary treatment, should be reinstated.

Former South West wall to kitchen garden now demolished and footings largely robbed out.

Line of wall apparent as a shallow depression on site and seen on LIDAR map above

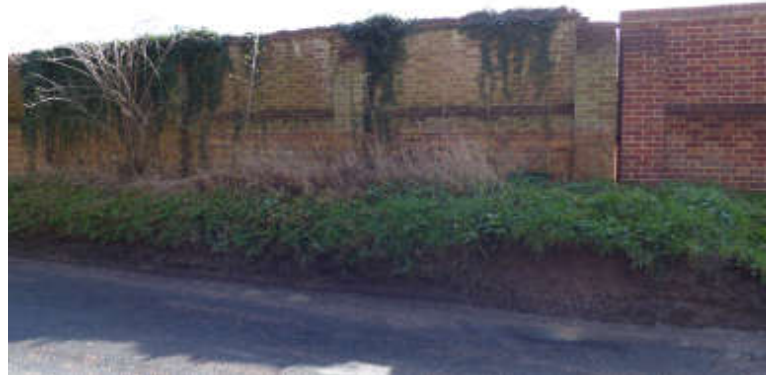
Original section A2 adjoins rebuilt section A1

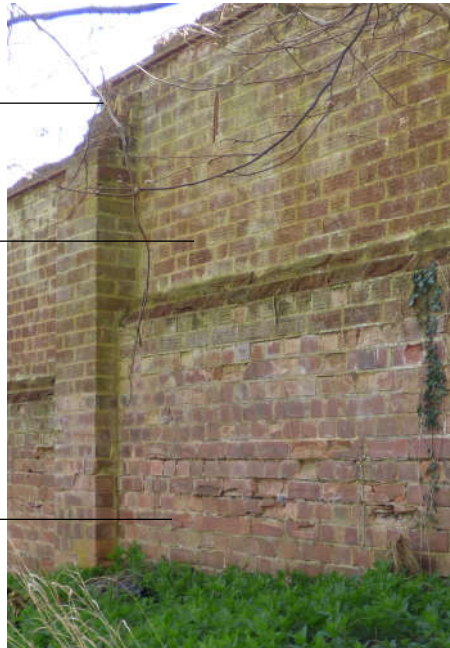
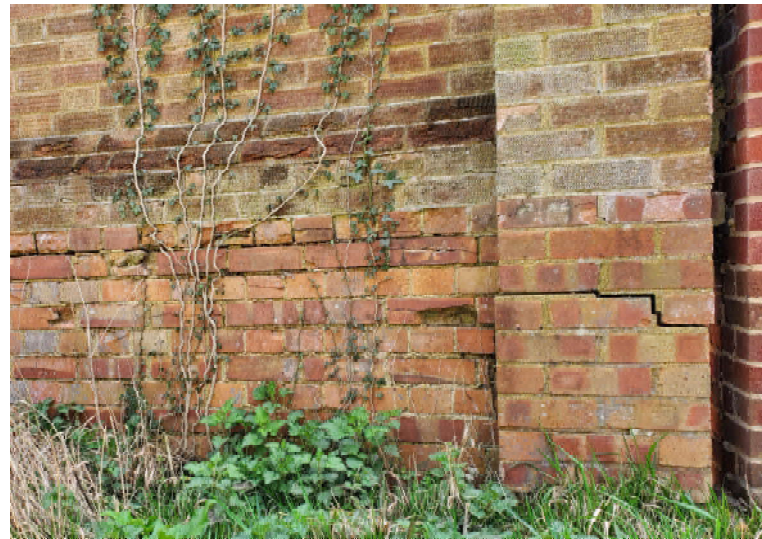
Typical detail to section A2.  
Upper brick capping to wall and  
pier tablings decayed

Upper level LBC rustic keyed  
face bricks fair condition but  
offset plinth stretchers  
universally decayed.

Lower course LBC Fletton  
unfaced brick, commonly used  
for more functional purposes.  
I.e. below DPC, non visible walls,  
economy outbuildings etc.

Above - low level brick decay and horizontal structural crack. Displacement of the brickwork is caused by insufficient allowance for thermal expansion in the wall.

- 2.06** The wall to (A2) will require extensive renewal of bricks at low level, complete reconstruction of plinth offset courses, upper pier structure, tablings, pier capping's and entire wall head capping detail. In addition the wall has no provision for thermal movement. There are several full height vertical cracks and a significant horizontal structural crack which propagates along the majority of wall length for (A2).  
The wall in general is reasonably vertical toward the corner at (B1) but further south has a general lean outward of 2 - 3 degrees. If wall is to be considered for repair consult structural engineer for repair of thermal movement crack and acceptability for extent of lean.

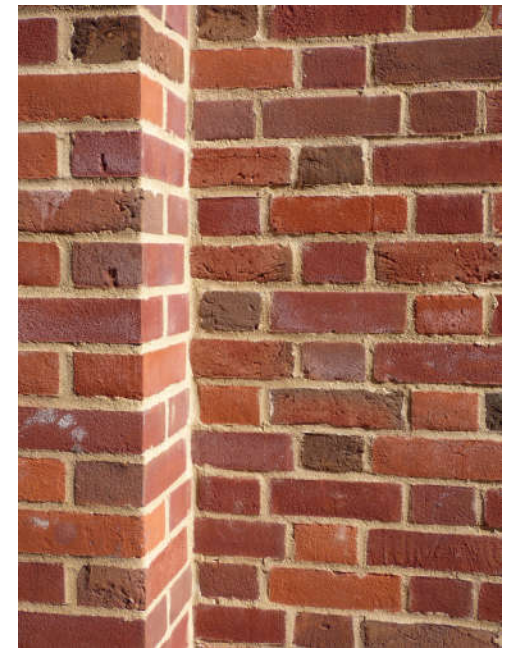
Right - example of rebuilt section of brickwork A1 adjacent to the main entrance + new electric substation.

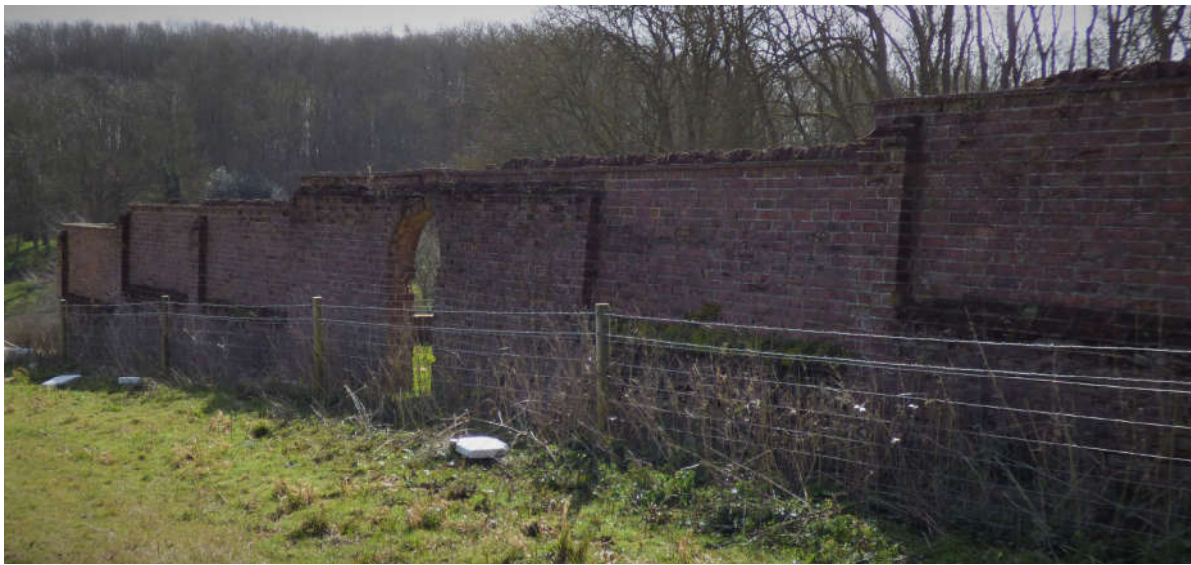
North east wall, Section B1 / B2, external face as visible from highway

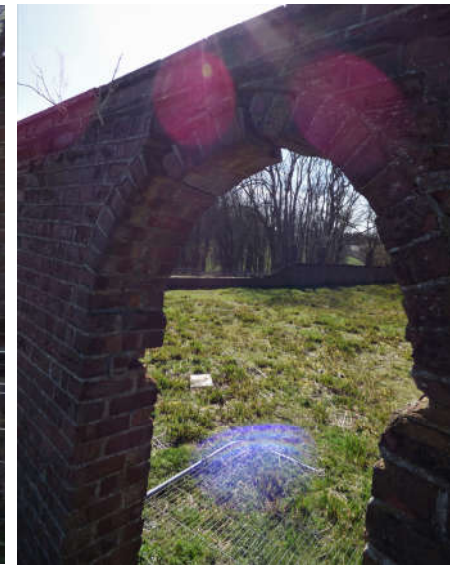
Structural failure / inward lean to arch

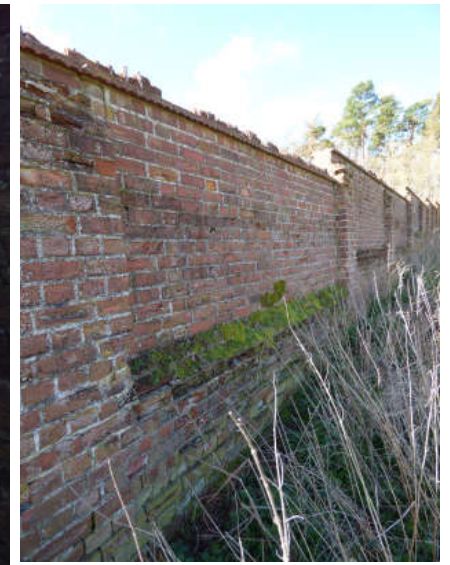
Typical brick panel to NE elevation

Almost complete failure of all plinth stretcher bricks and extensive spalling + structural lamination of bricks more generally

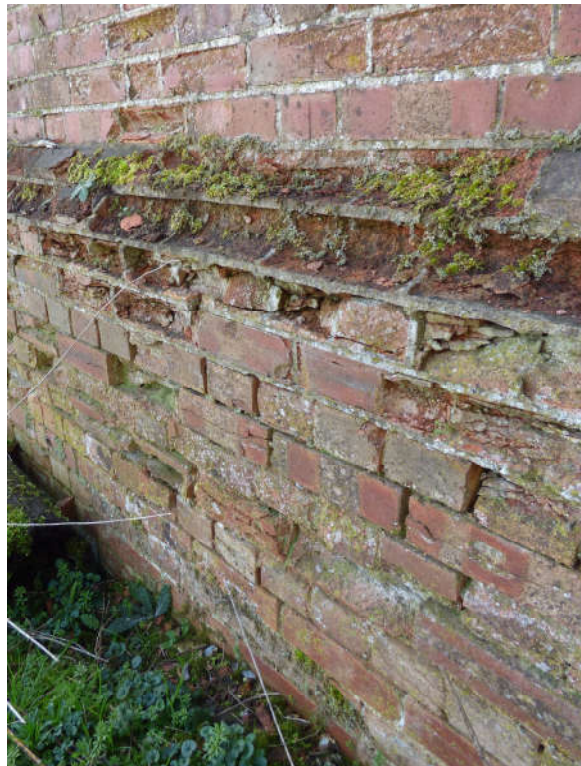
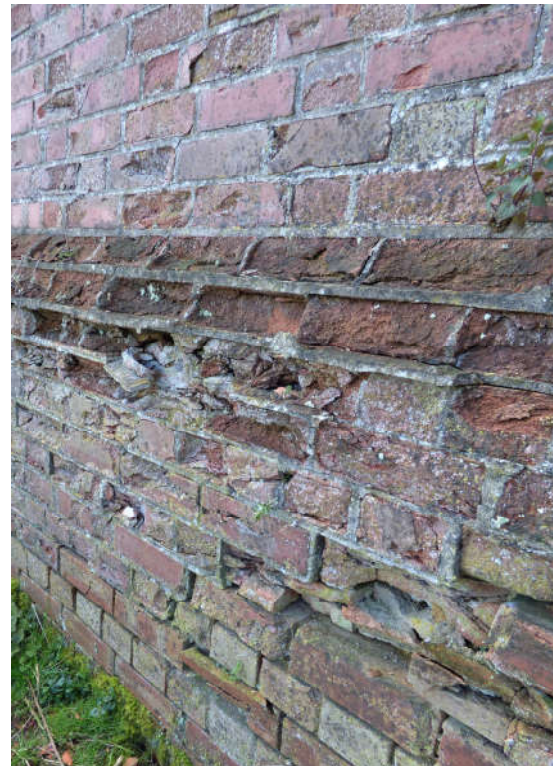
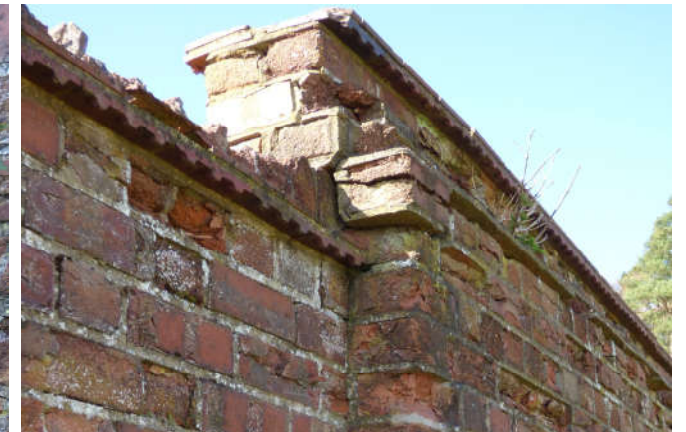
Above - clay tile capping, in places still functional but many tiles cracked / missing. Upper level frost decay to bricks over entire wall face but more prevalent in courses below capping's

Left - Extensive decay is accelerated by dense cement based mortar used in many areas, seen here as hard mortar surviving as projecting ledges causing the softer bricks to become a sacrificial route for damp leaving the wall.

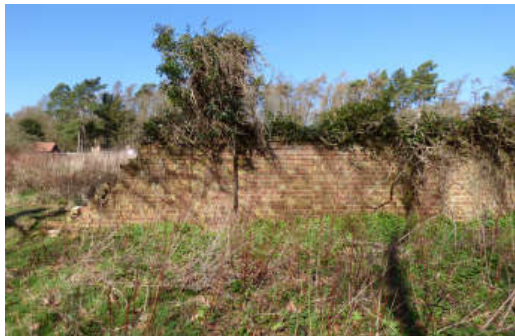
Southerly end of wall section (C) – low level without piers

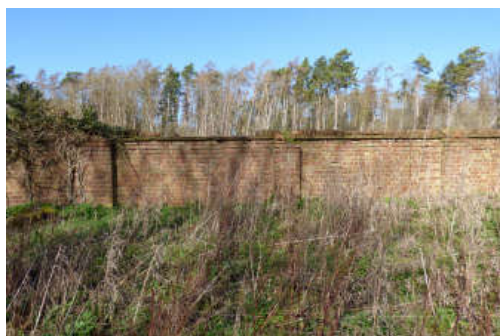
middle section of wall with slender piers

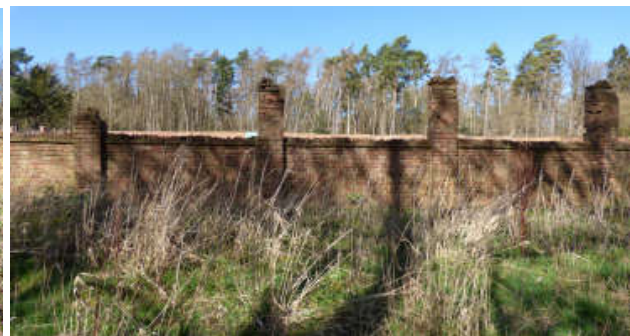
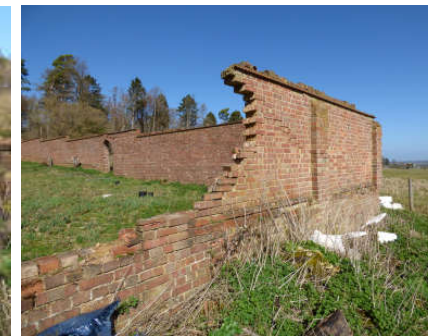
Northerly end, high wall partially collapsed

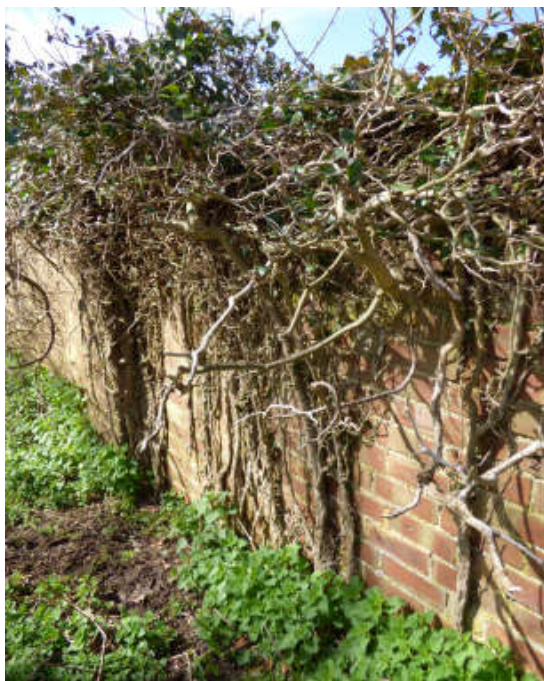
- 2.15** Both the wall and pier in this section are extensively overgrown with ivy. Ivy can on occasions form a protective layer over masonry but in this case where the brick jointing is loose and open the ivy can be expected to have rooted into the wall itself and be causing considerable (unseen) damage. Removal of the ivy will further destabilise the wall and likely require reconstruction.

Above, extensive ivy cover to south end wall (C)

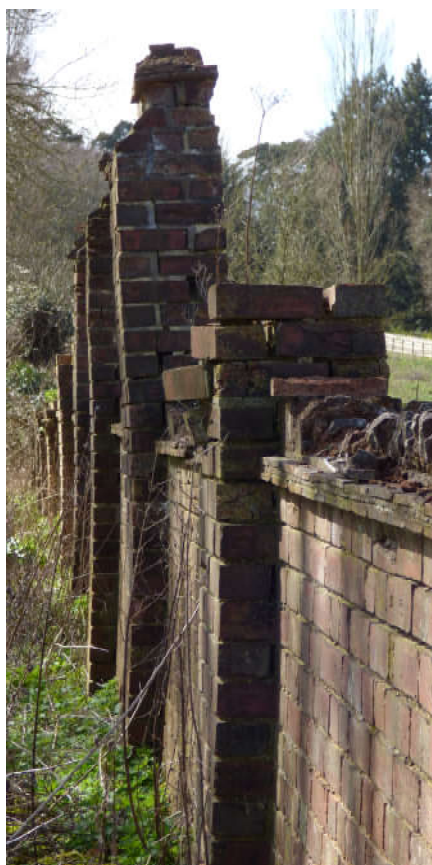
Right – Slender piers, open jointed and out of vertical.

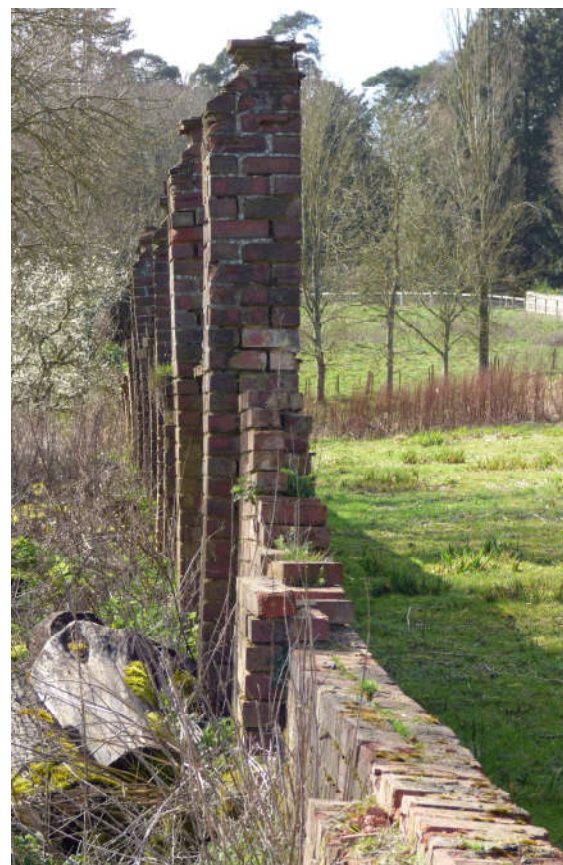
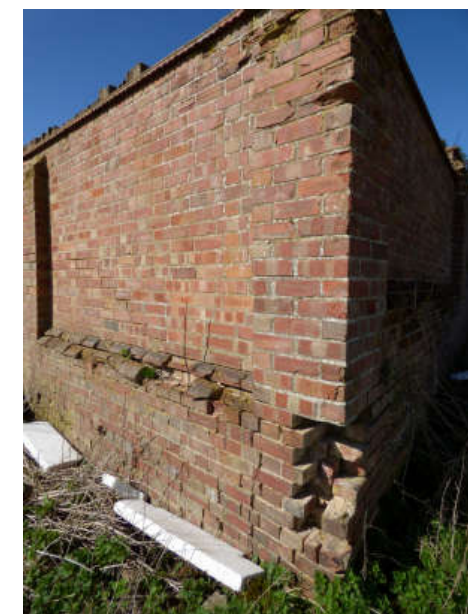
Above – Damaged brickwork at external corner of sections (C) – (B). Decayed plinth and low level brickwork continues.

Left – low level remnants of collapsed wall decayed and open jointed.

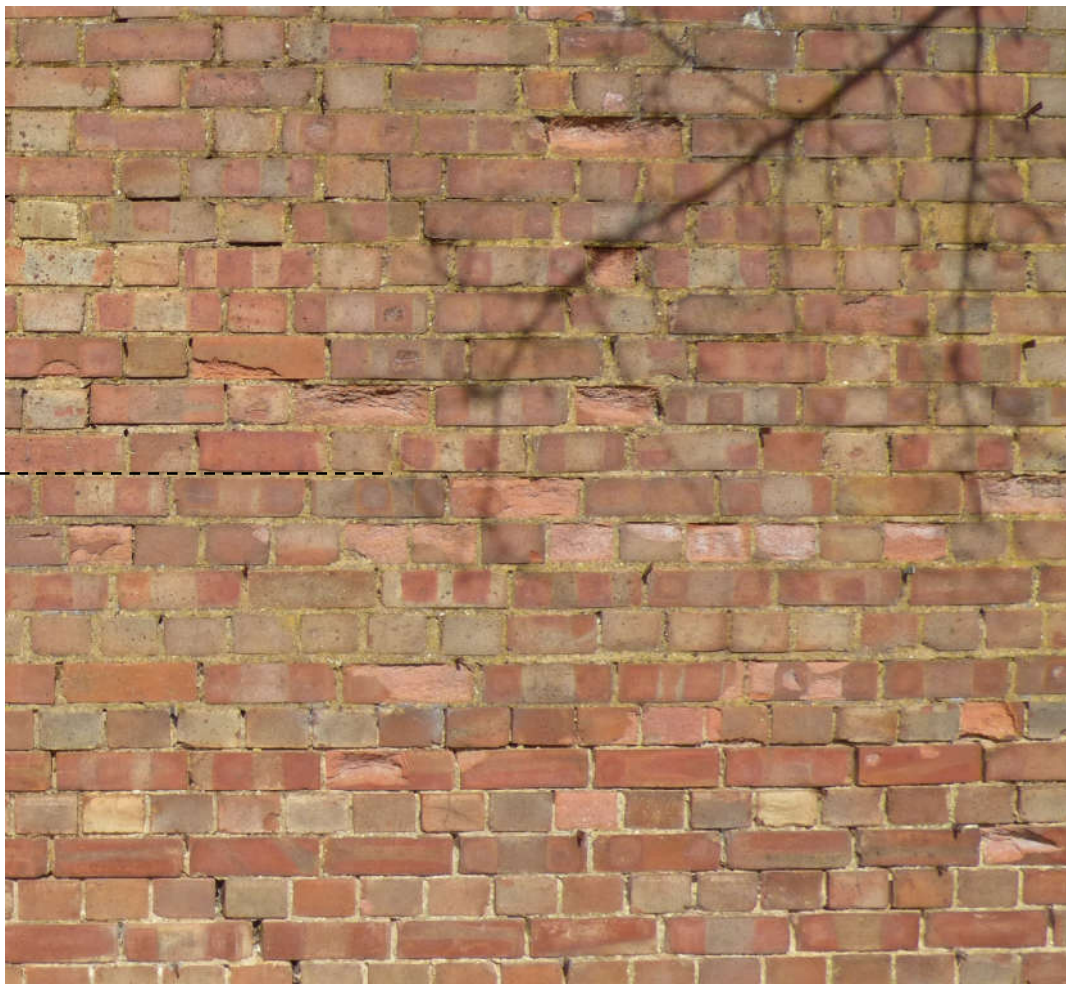
Above - Detail of brickwork, note clear change in bond from English Garden wall at low level to a version of Flemish bond above (X). Brick bond is generally irregular and of intermediary quality (Bed thickness is variable and perps visibly 'wander' out of vertical.)

Above right - decayed brick capping's  
Right - change in detail along wall (C) where wall thickness reduces and low level plinth was omitted during construction

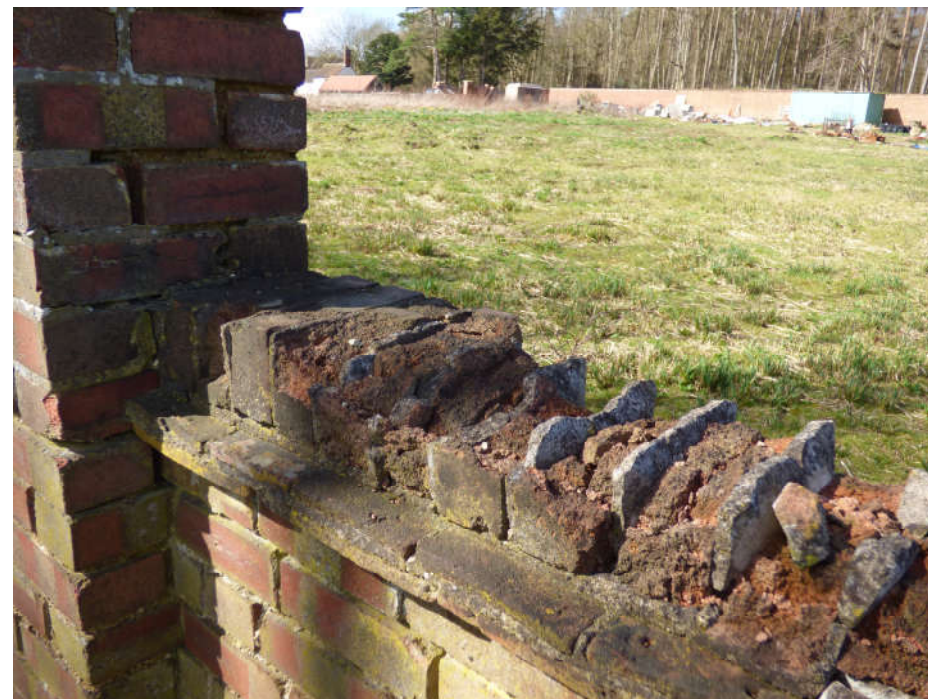
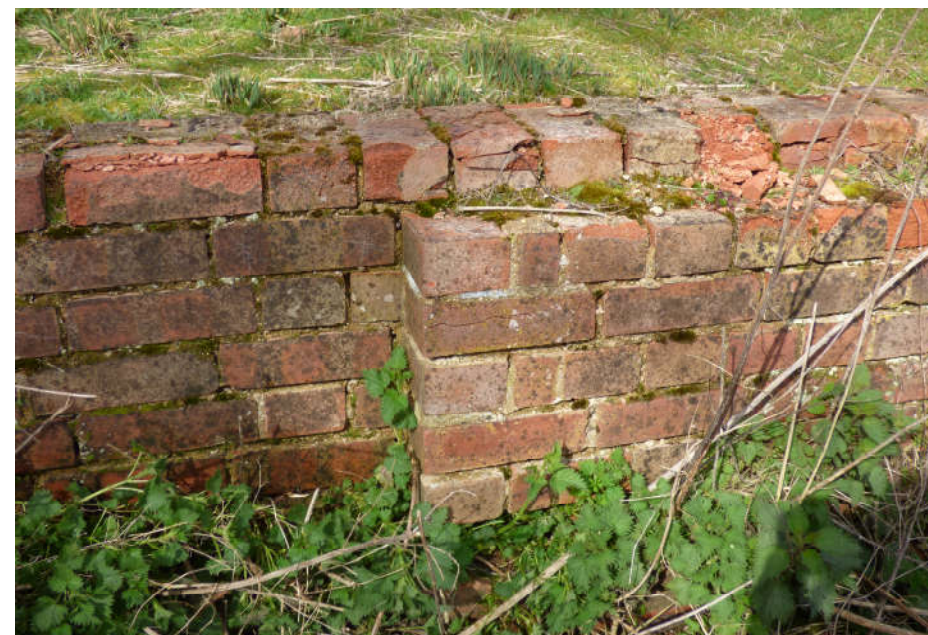
Above -  
Bricks used are of at least two types, NPB Co and Hicks & Co Flettons.
