# Arboricultural Appraisal

*Smith End Farm, Smiths End Lane, Barley, SG8 8LL*

*Report Reference: 002231682\_AA001*

*Date of inspection: 25-09-2026*

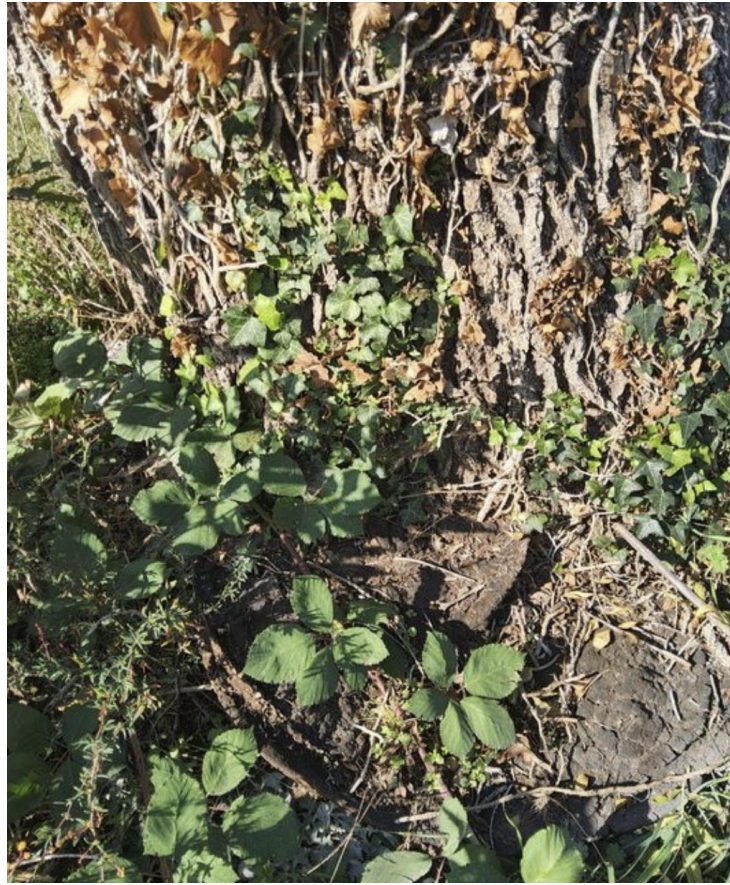
- 5.4 Four principal fungal brackets, identified in Appendix A as [Perenniporia fraxinea](#), were present around the cardinal points of the lower stem. [Ash dieback](#) and [bacterial canker](#) were also recorded. The combination of fungal fruiting, bacterial symptoms and reduced crown vitality is consistent with a tree experiencing both physiological decline and significant structural deterioration.

*Fig. 2: T001 Perenniporia bracket at the buttress.*

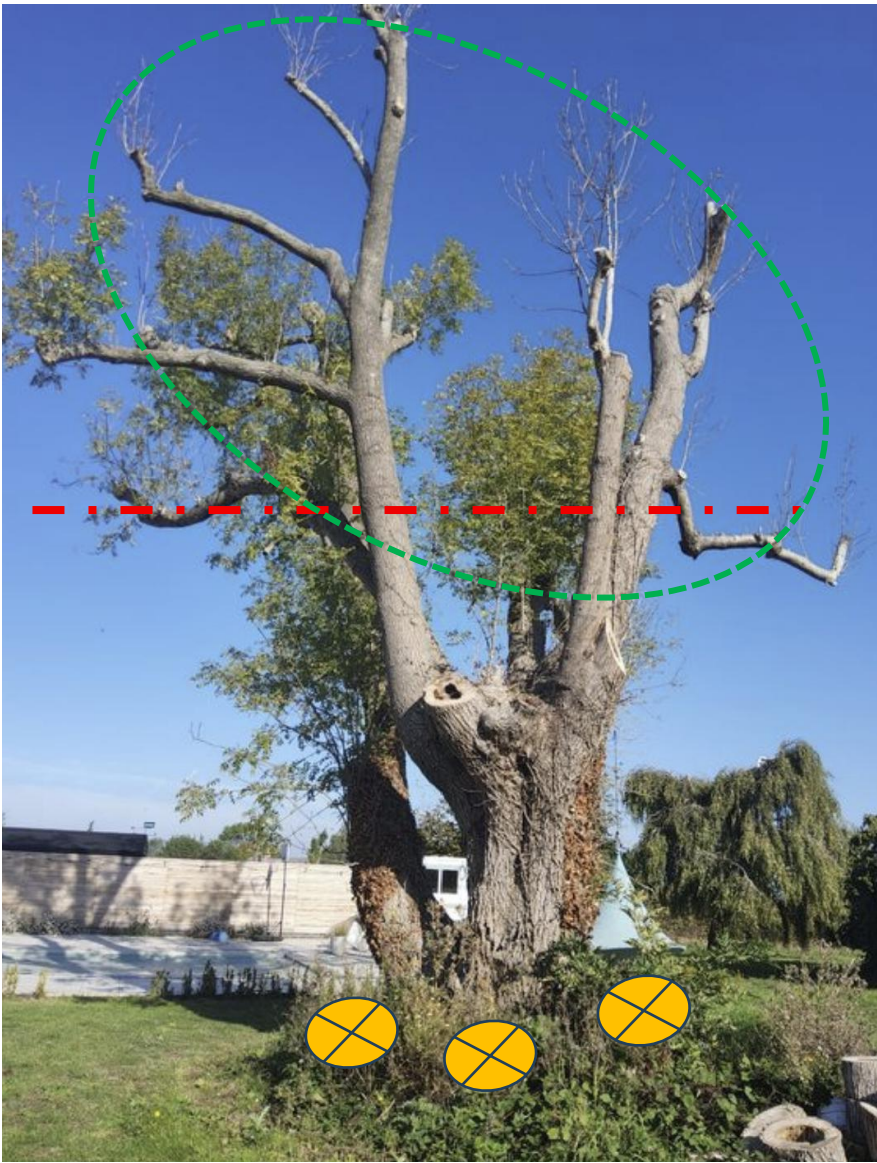
5m monolith line. Remove crown to below indicated level

Points of Prenniporia fraxinea infections

Ash die back - Hymenoscyphus fraxineus

- 9.1 Tree T001 should be reduced to a standing monolith of approximately 5 m in height within three months of the inspection, and no later than 25 December 2026. The reduction should remove the full crown and unstable upper stem sections while retaining the lower

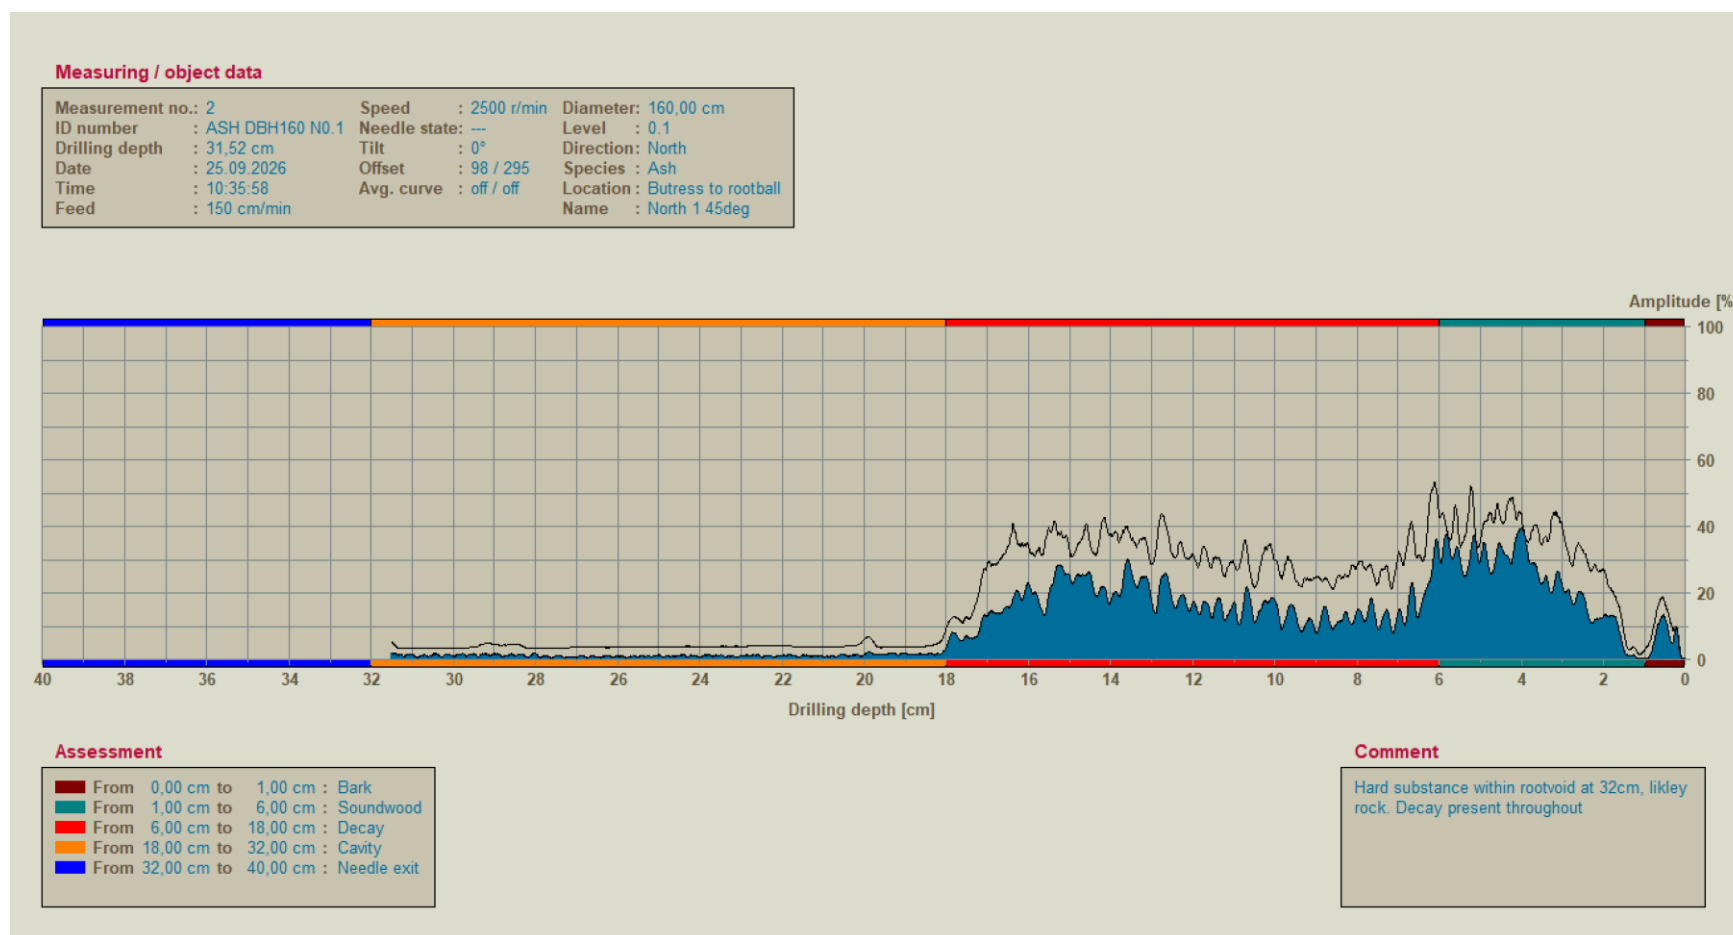
- 5.5 Resistance drilling on the north aspect recorded moderate structure between approximately 2 cm and 6 cm, followed by a marked reduction in integrity and pulpy wood leading to a central heartwood void. The principal cavity was recorded between approximately 18 cm and 32 cm. A second north-aspect calibration test similarly identified decayed wood from approximately 1 cm to 19 cm, a crack within the decayed zone and a cavity between approximately 18 cm and 32 cm.

Fig. 3: North cardinal aspect drilled to a depth of 40 cm. Moderate structure between 2 cm and 6 cm, then integrity starts to diminish sharply. Structural wood becomes pulpy and lacks consistency up to the central heartwood void at 18 cm. Heartwood decay has resulted in a cavity between 18 cm and 32 cm where a hard, non-woody structure forced the drill to recede. Drilling was undertaken above the fruiting bodies of *Perenniporia fraxinea*.

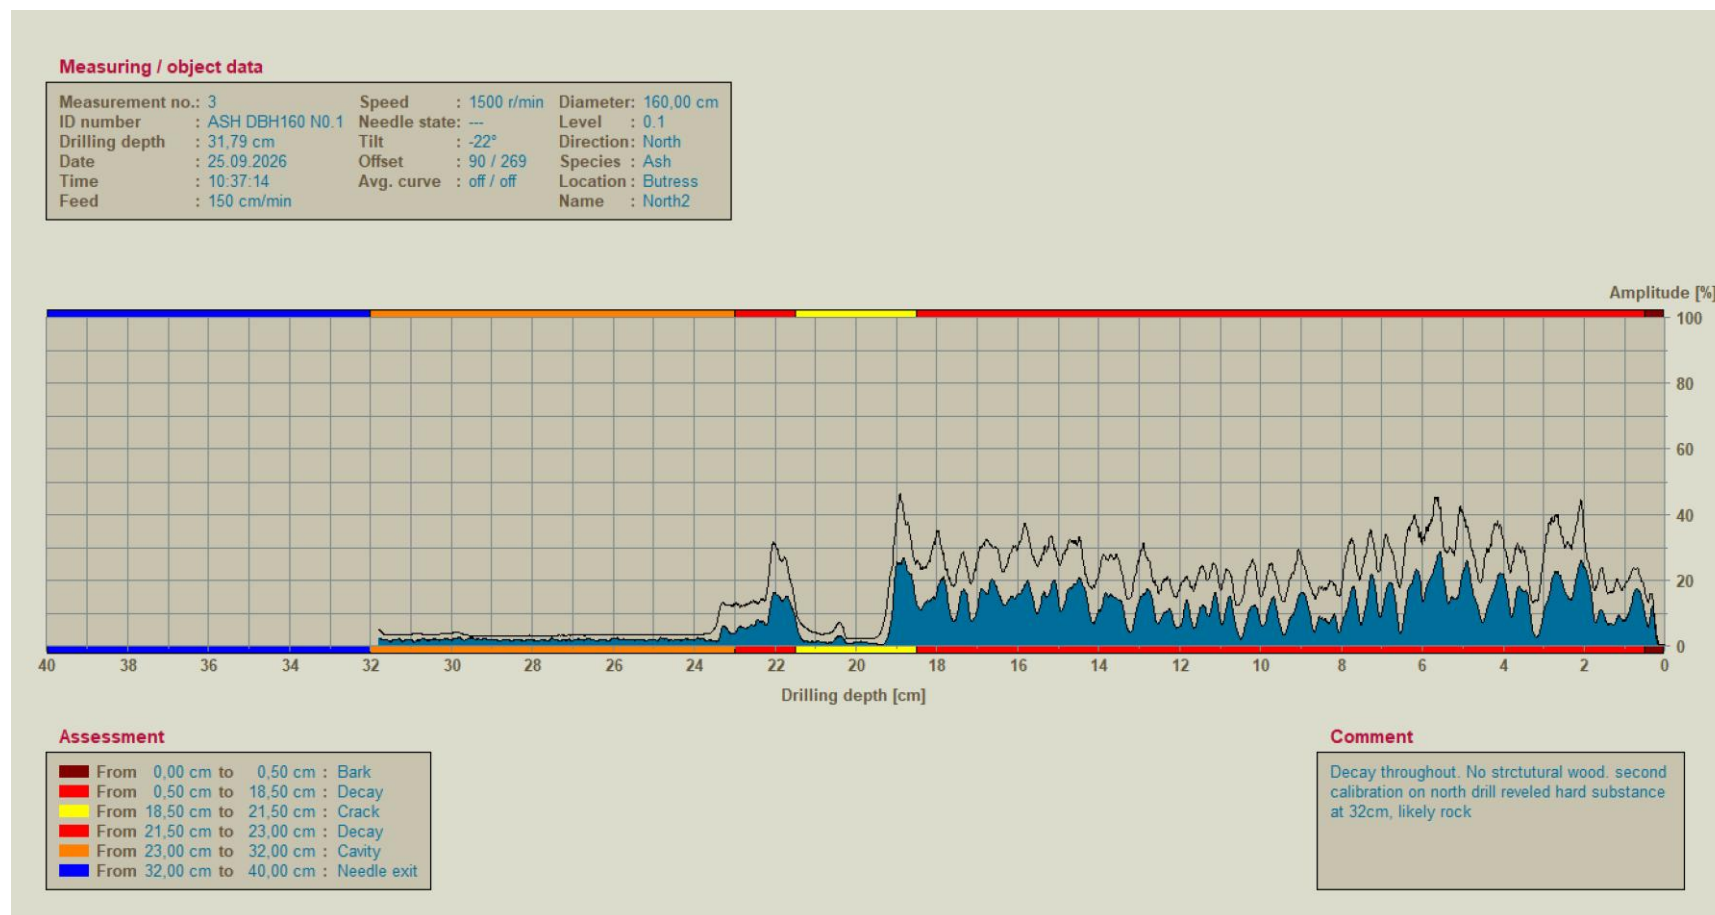
Fig. 4: North cardinal aspect drilled to a depth of 40 cm during the second calibration test. Decayed wood between 1 cm and 19 cm, after which integrity diminishes sharply, revealing a crack in the decayed wood. Heartwood decay has resulted in a cavity between 18 cm and 32 cm where a hard, non-woody structure again forced the drill to recede. Drilling was undertaken above the fruiting bodies of *Perenniporia fraxinea*.

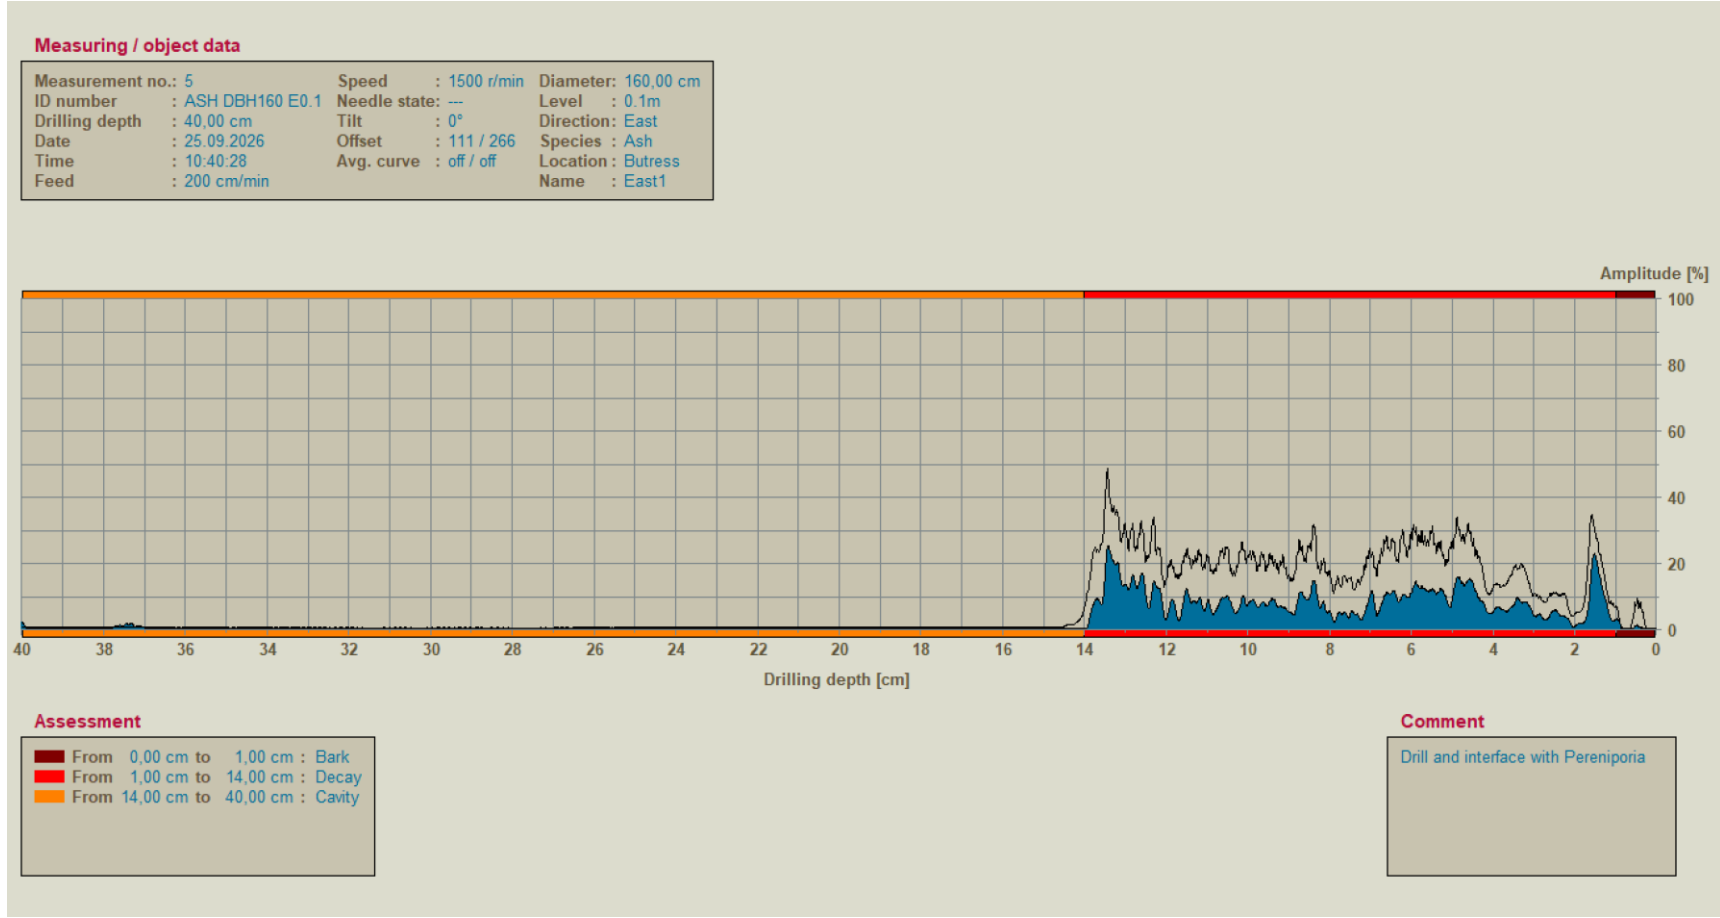
- 5.6 Testing on the east aspect recorded decayed wood between approximately 1 cm and 14 cm, with a heartwood cavity extending from approximately 14 cm to the full 40 cm drilling depth. On the south aspect, severely decayed wood was recorded between approximately 1 cm and 28 cm, beyond which a heartwood void extended to the 40 cm drilling depth.

Fig. 5: East cardinal aspect drilled to a depth of 40 cm. Decayed wood between 1 cm and 14 cm, after which integrity diminishes sharply, revealing a void in heartwood. Heartwood decay has resulted in a cavity between 14 cm and 40 cm. Drilling was undertaken above the fruiting bodies of *Perenniporia fraxinea*.

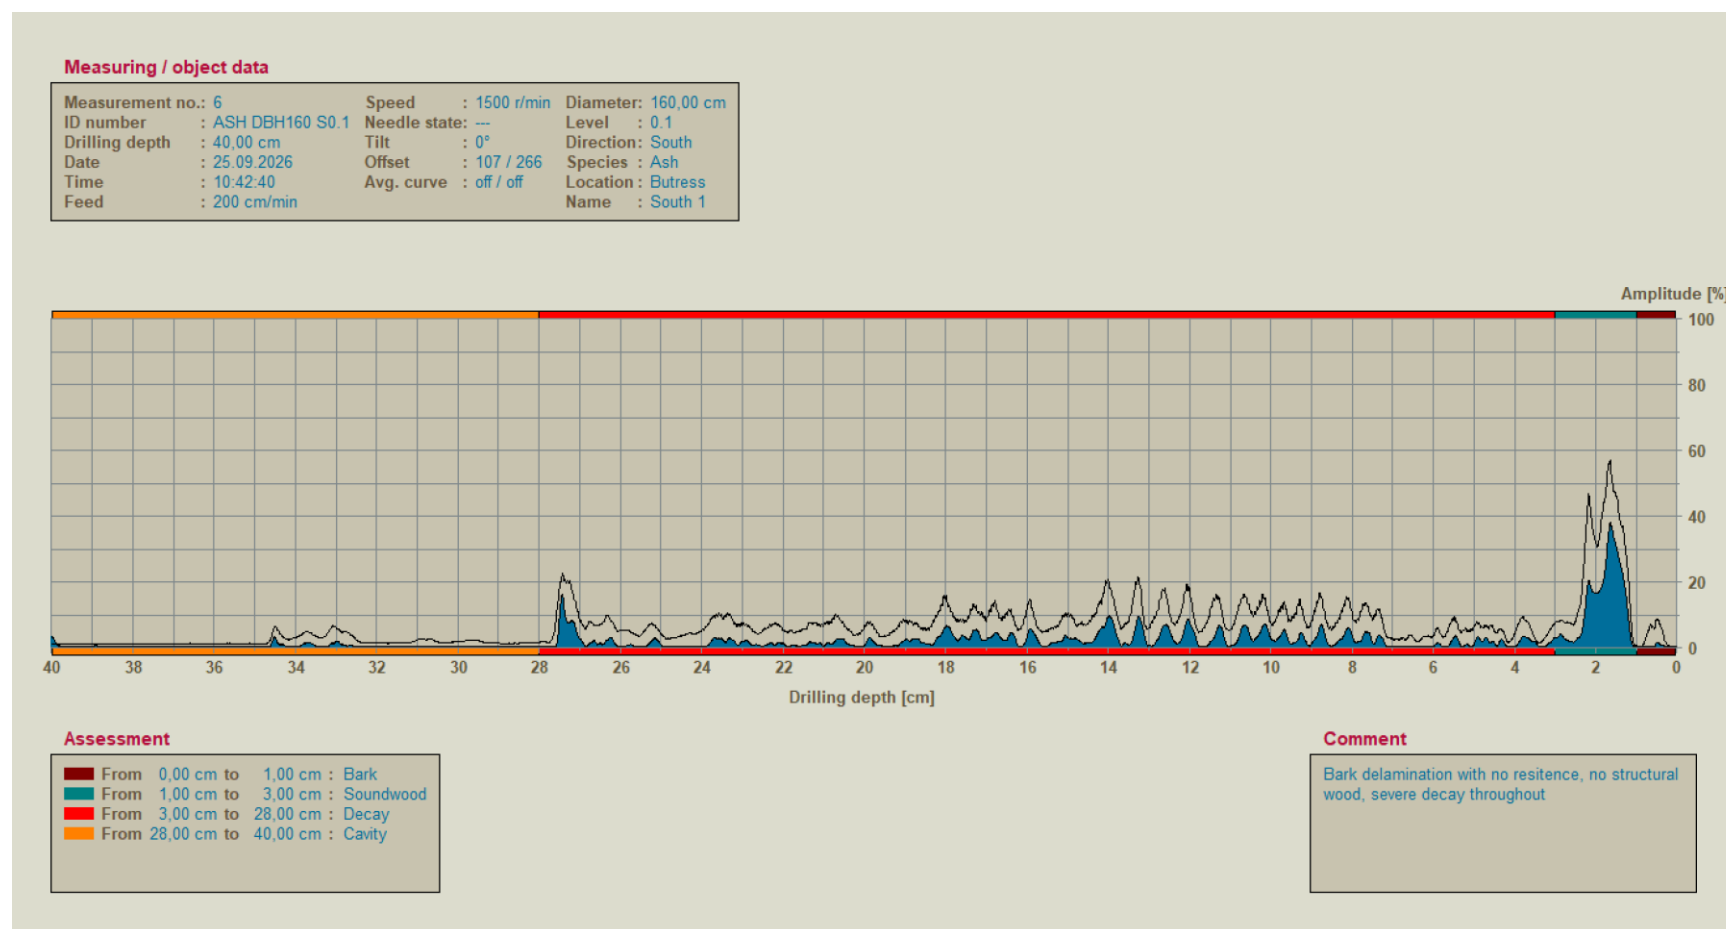
Fig. 6: South cardinal aspect drilled to a depth of 40 cm. Severely decayed wood between 1 cm and 28 cm, after which integrity diminishes sharply, revealing a void in heartwood. Heartwood decay has resulted in a cavity between 28 cm and 40 cm. Drilling was undertaken above the fruiting bodies of *Perenniporia fraxinea*.

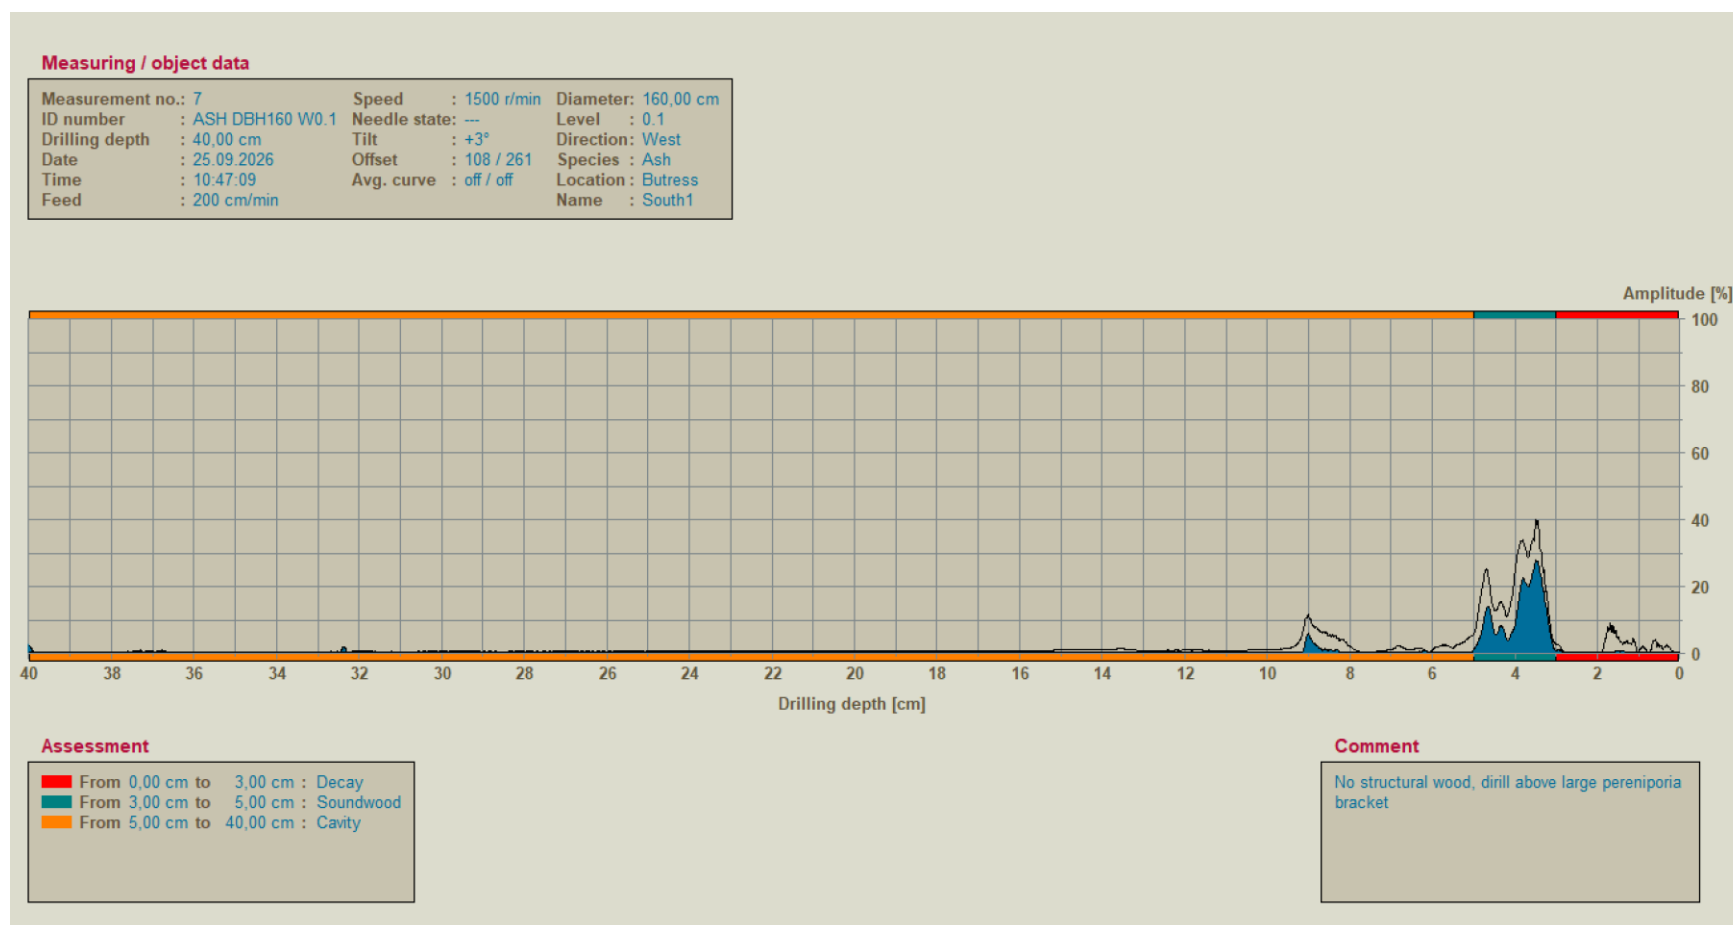
- 5.7 The west aspect produced the most extensive loss of resistance: severely decayed wood was recorded between approximately 1 cm and 5 cm, followed by a void affecting both live wood and heartwood from approximately 9 cm to the full 40 cm drilling depth. Considered collectively, the four drilling positions demonstrate extensive and

Fig. 7: West cardinal aspect drilled to a depth of 40 cm. Severely decayed wood between 1 cm and 5 cm, after which integrity diminishes sharply, revealing a void in the heartwood and live wood. Both live-wood and heartwood voids extended between 9 cm and 40 cm. Drilling was undertaken above the most significant fruiting bodies of *Perenniporia fraxinea*.
