## **Condition Survey**

**Threshing Barn at  
Highover Farm  
Highover Way  
Hitchin  
SG4 0RQ**

**Gill-Hudson Homes Limited**

**16<sup>th</sup> June 2025**

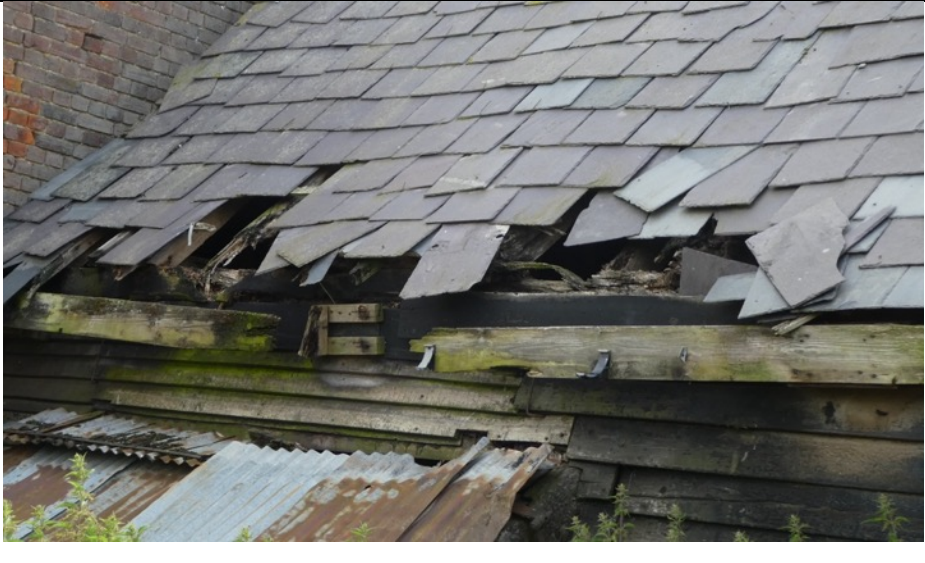
| | <p>North-west corner – large amount of missing slates resulting in water ingress and decay to the timber frame beneath.</p> |

At the north-west corner of the barn, the wall plate is significantly decayed, as are the ends of the rafter feet in this area. This is visible externally where a large number of slates are missing which is causing water ingress and subsequent decay.

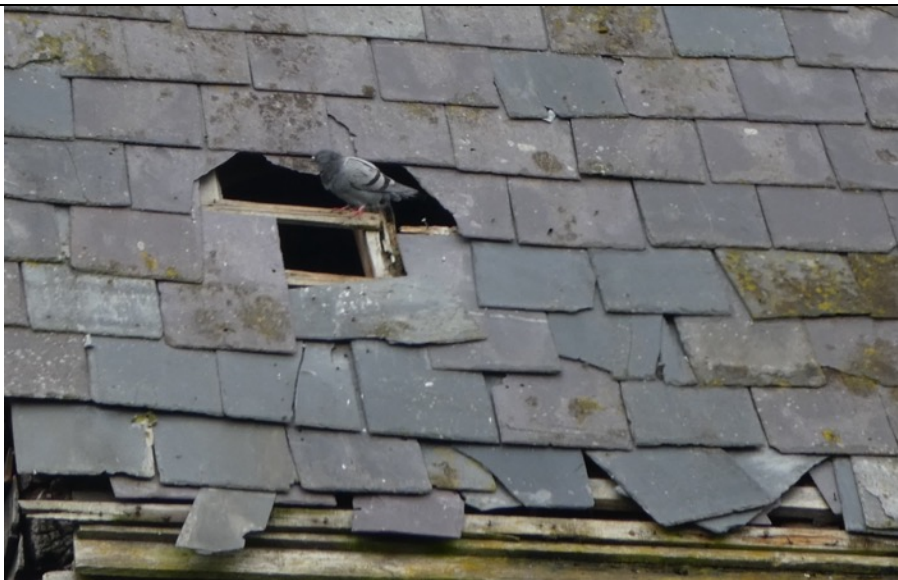
| | <p>Many holes in the roof allowing water ingress...and pigeons.</p> |

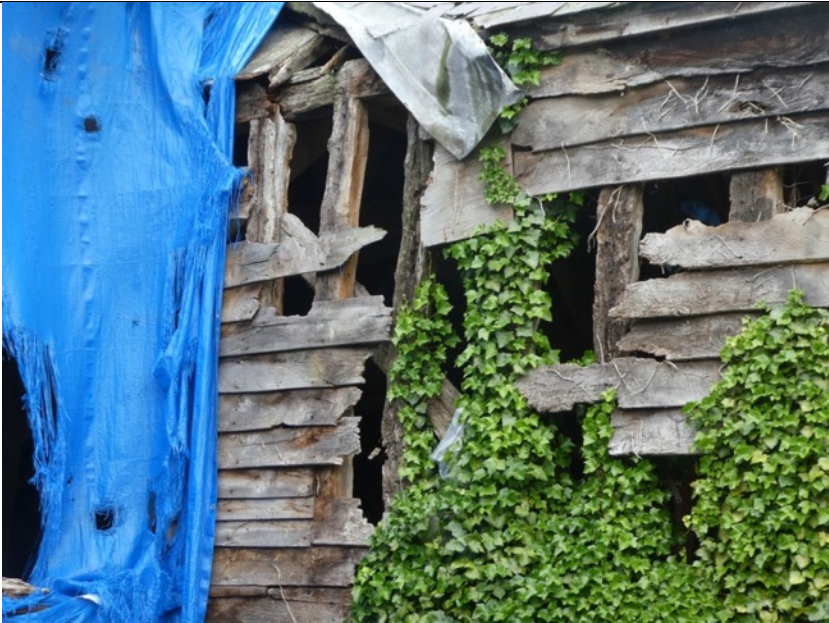
| | <p>Weatherboards in poor condition. vegetation growing up walls of the porch on the south side.</p> |

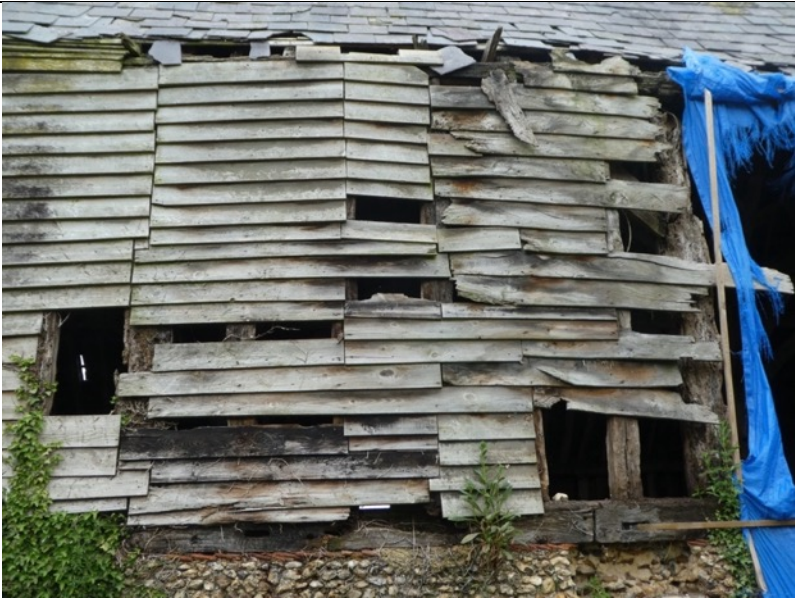
| | <p>South part of the south-east elevation has a visible bulge in the wall due to outward movement of the frame beneath the weatherboards.</p> |

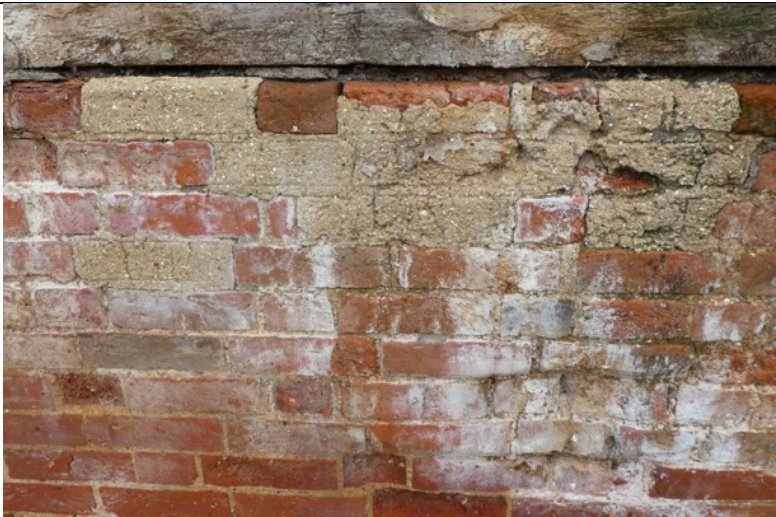
| | <p>Deteriorated bricks 'repaired' with cement – south-east corner.</p> |

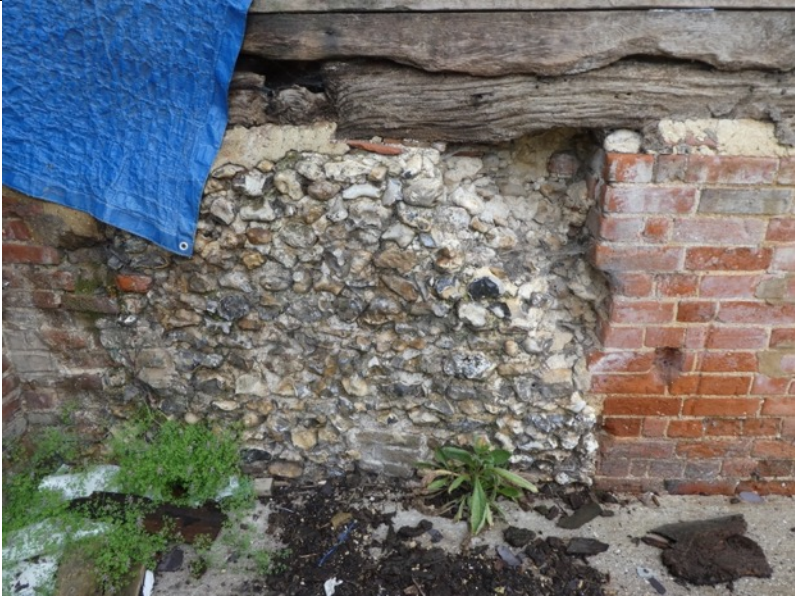
Also, on the northern part of the south-east elevation, adjacent to the porch, there is an area where a large amount of flint work has fallen out. A patch repair will be required in this location.

| | <p>Area of missing flintwork to south-east elevation.</p> |

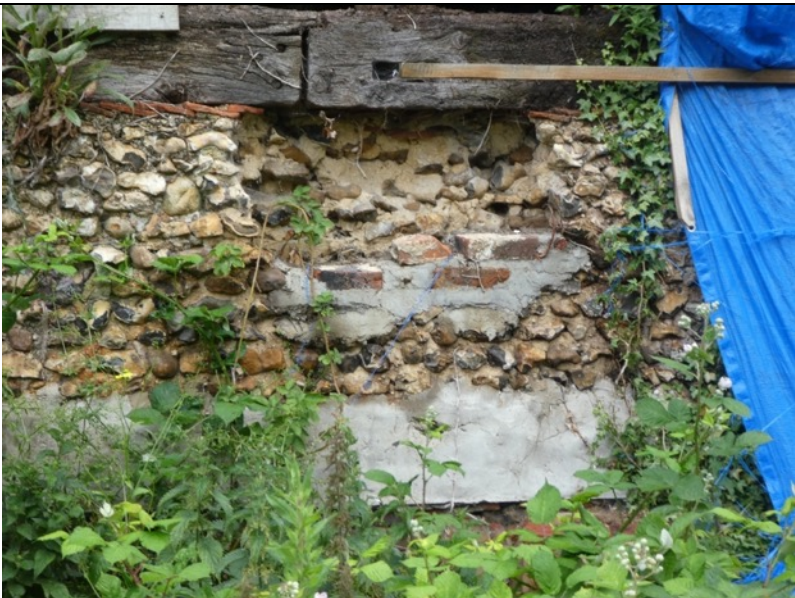
| | <p>Another area to same elevation, towards south end.</p> |

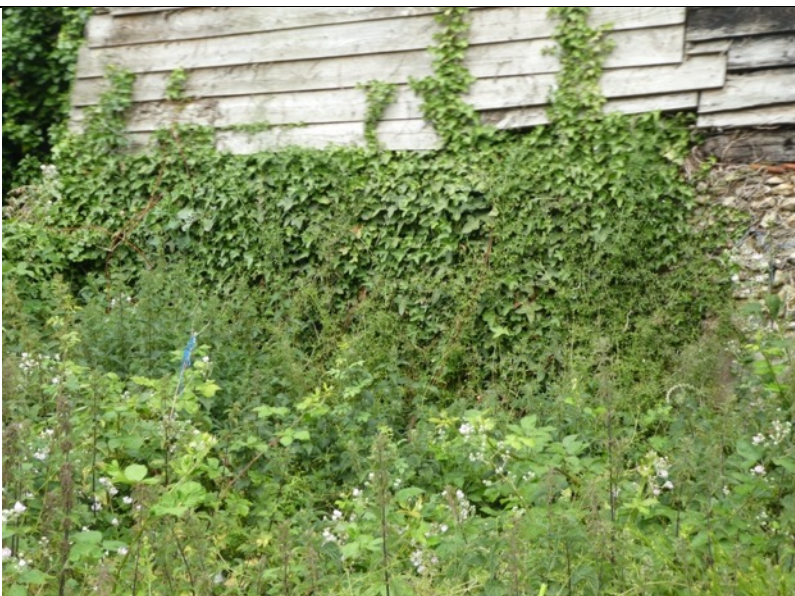
| | <p>Much elevation concealing the plinth to the southern half of the south-east elevation.</p> |

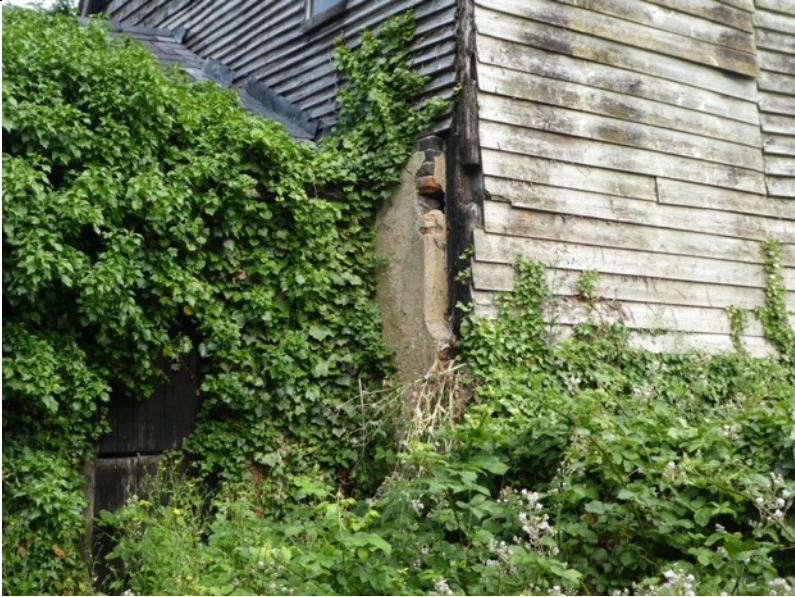
| | <p>Exterior side of the south-west wall is unknown as it is concealed by the single storey building attached to it, however, the small exposed section at the corner is covered with cement render which will need removing.</p> |

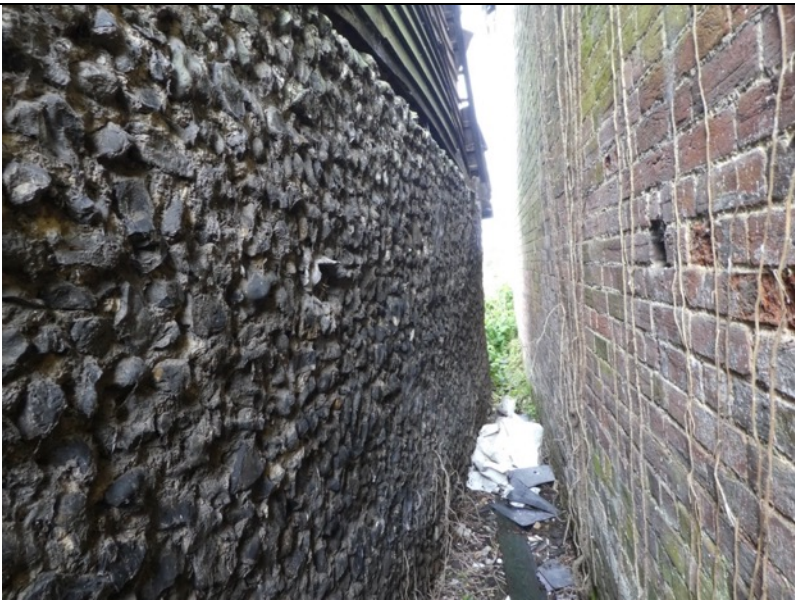
On the north-east elevation, there is a series of vertical cracks to the flintwork, but these do not show up internally. Additionally, there is a slight outward lean along the course of the top of the wall and some bulging in the north-west corner.

| | <p>North-east elevation – various cracks present to flintwork and some leaning to the top of the wall at the north-west corner.</p> |

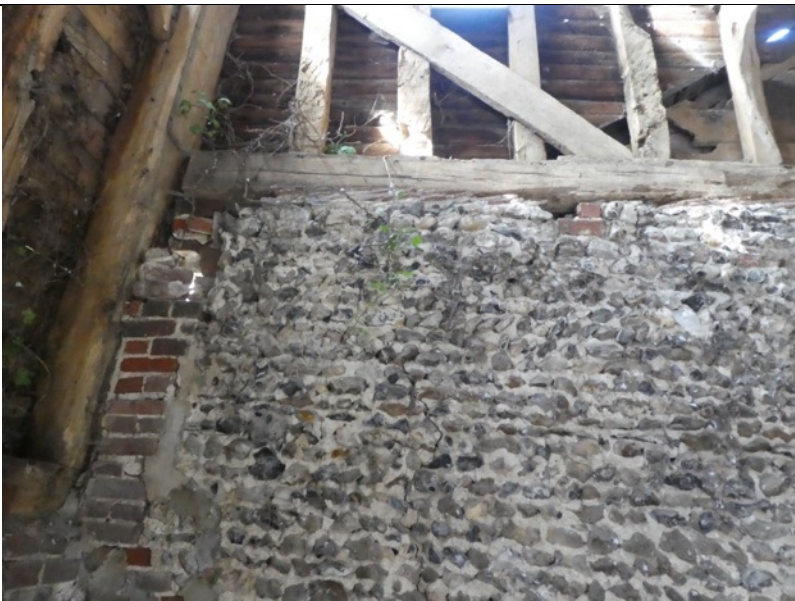
On the south-west wall, there is vertical cracking in several places in the south-east corner, where the wall has experienced movement. This is particularly evident between sections of flintwork and brickwork, which are not properly tied together. There are also a number of loose and missing bricks in this area. In addition, vertical cracking is present in the flintwork a short distance from this location, spanning almost from bottom to top, which may also be due to movement in this corner. This area will require repairs.

| | <p>South-west elevation has various cracking to flintwork and between brick corner pier, all of which will require repairs.</p> |

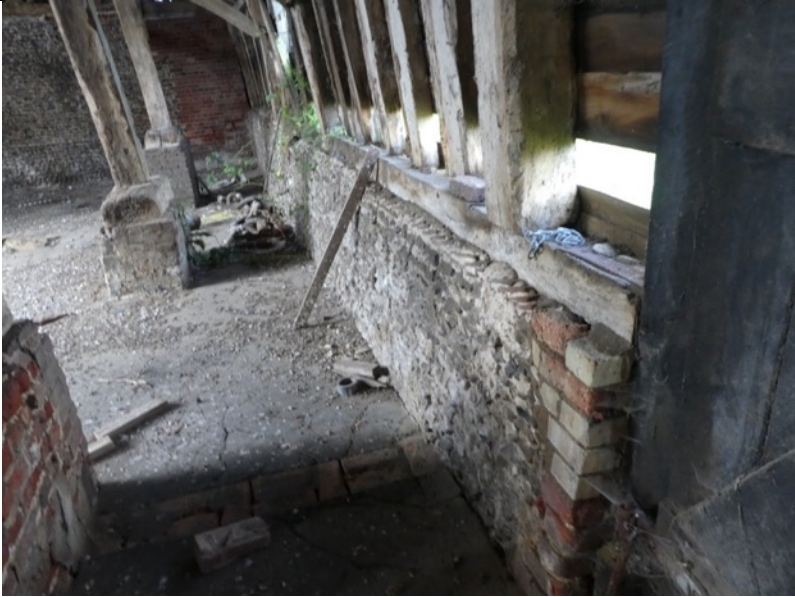
| | <p>North-west plinth has noticeable lean internally but not noticeable externally.</p> |

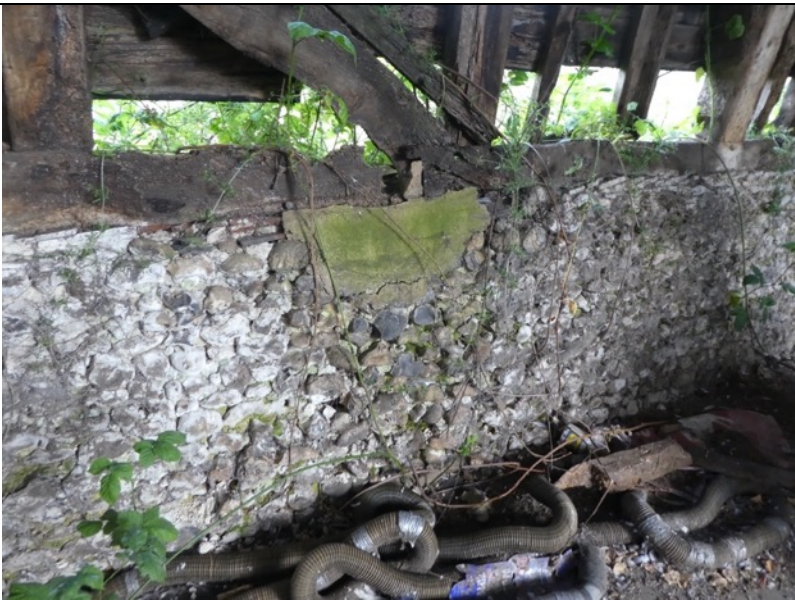
| | <p>Area of significant water ingress to north-west elevation has caused localised deterioration to plinth. An inappropriate patch repair with cement has been undertaken which will need removing.</p> |

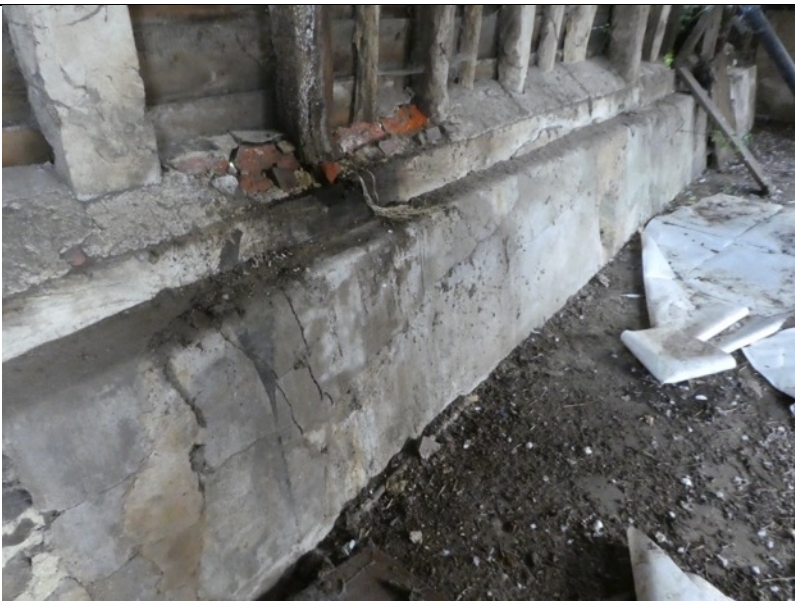
On the northern part of the north-west plinth, a non-vapour-permeable cement render has been applied. This render has cracked in many places and is likely trapping moisture, causing deterioration to the underlying flintwork. It is recommended that this render be removed. From the interior, the northern part of the plinth to the north-west wall also appears to lean forward.

| | <p>Cement render to northern half of the north-west elevation plinth needs removing.</p> |

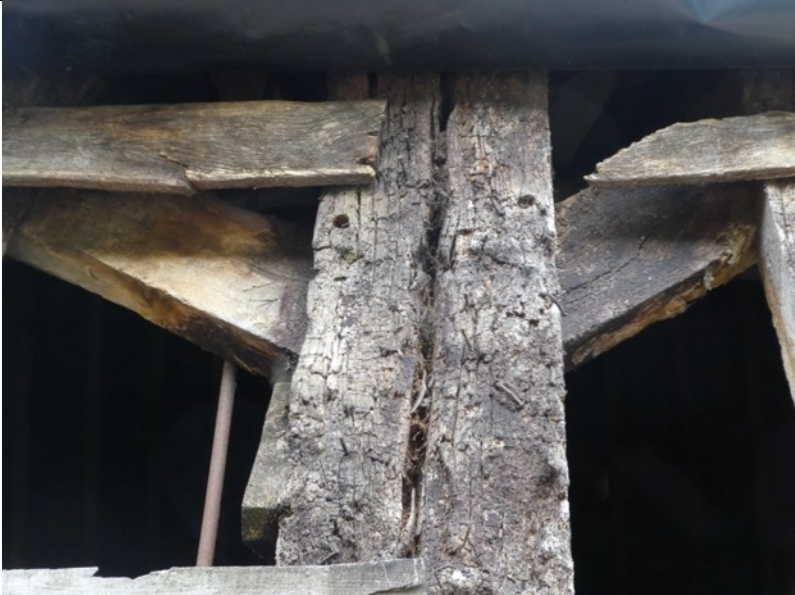
Part of the jowl post between bays 5 and 6 is exposed and is in poor condition. There is a large vertical split on the outer face. Internally, much more deterioration is evident. This post requires replacement.

| | <p>Vertical split to jowl post between bays 5 and 6 on the south-east elevation. This post is in poor condition and requires replacement.</p> |

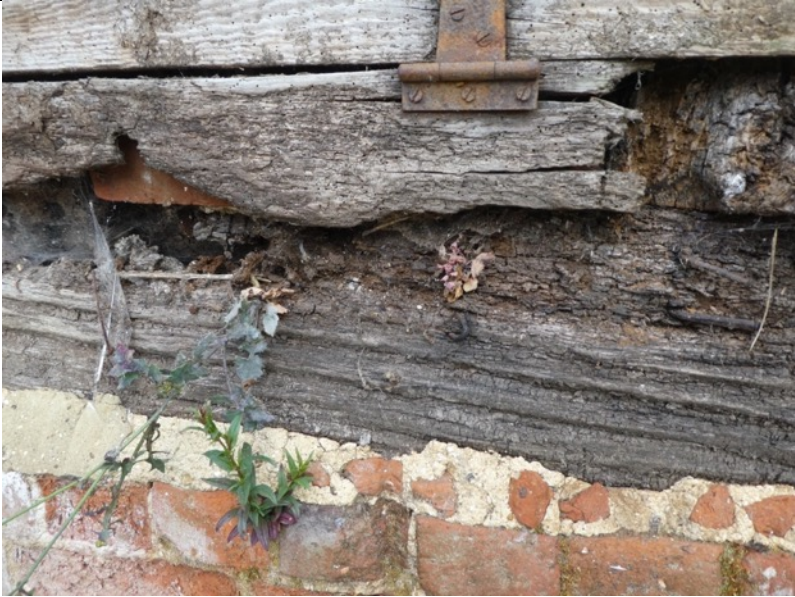
| | <p>Localised decay to sole plate to south-east elevation – bay 7.</p> |

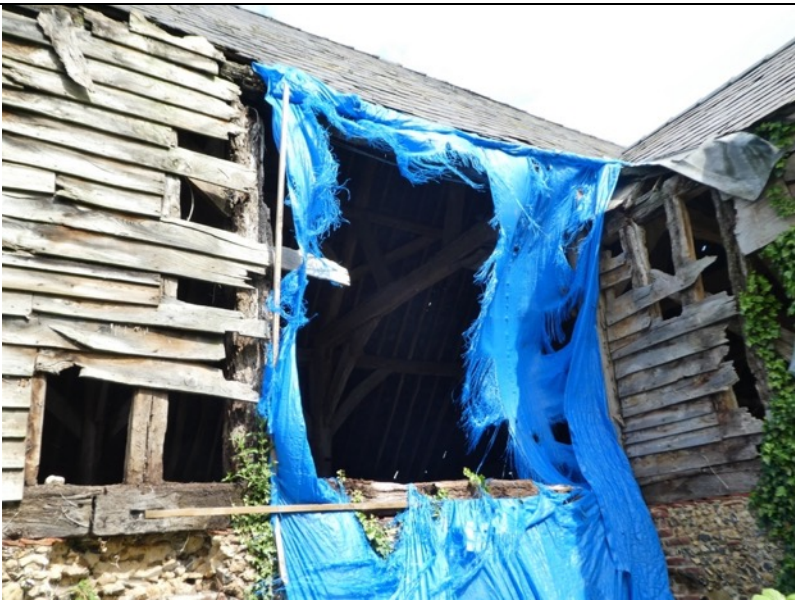
| | <p>Studs completely missing from south-east wall of bay 3.</p> |

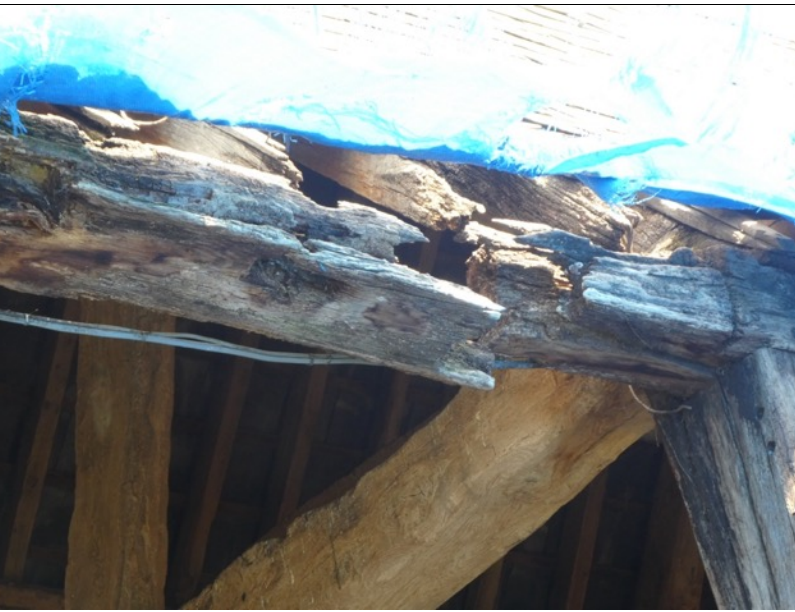
| | <p>Wall plate to south-east of bay 3 has completely snapped.</p> |

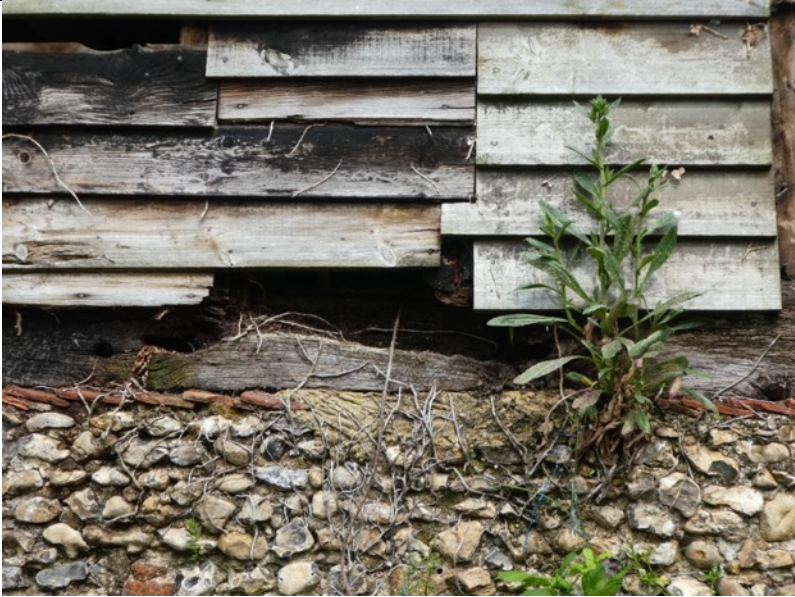
| | <p>Significant decay noted to sole plate to south-east wall of bay 2.</p> |

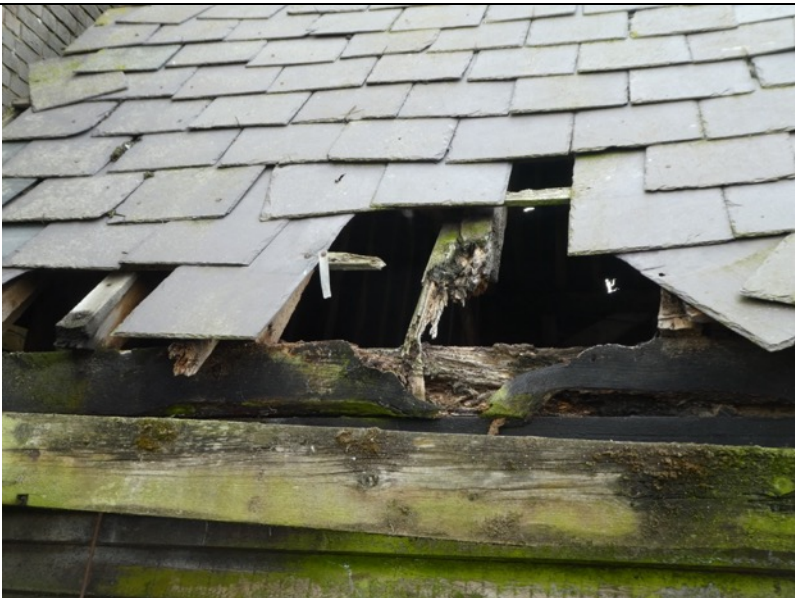
| | <p>Significant decay to wall plate and rafter feet – north-west of bay 7.</p> |

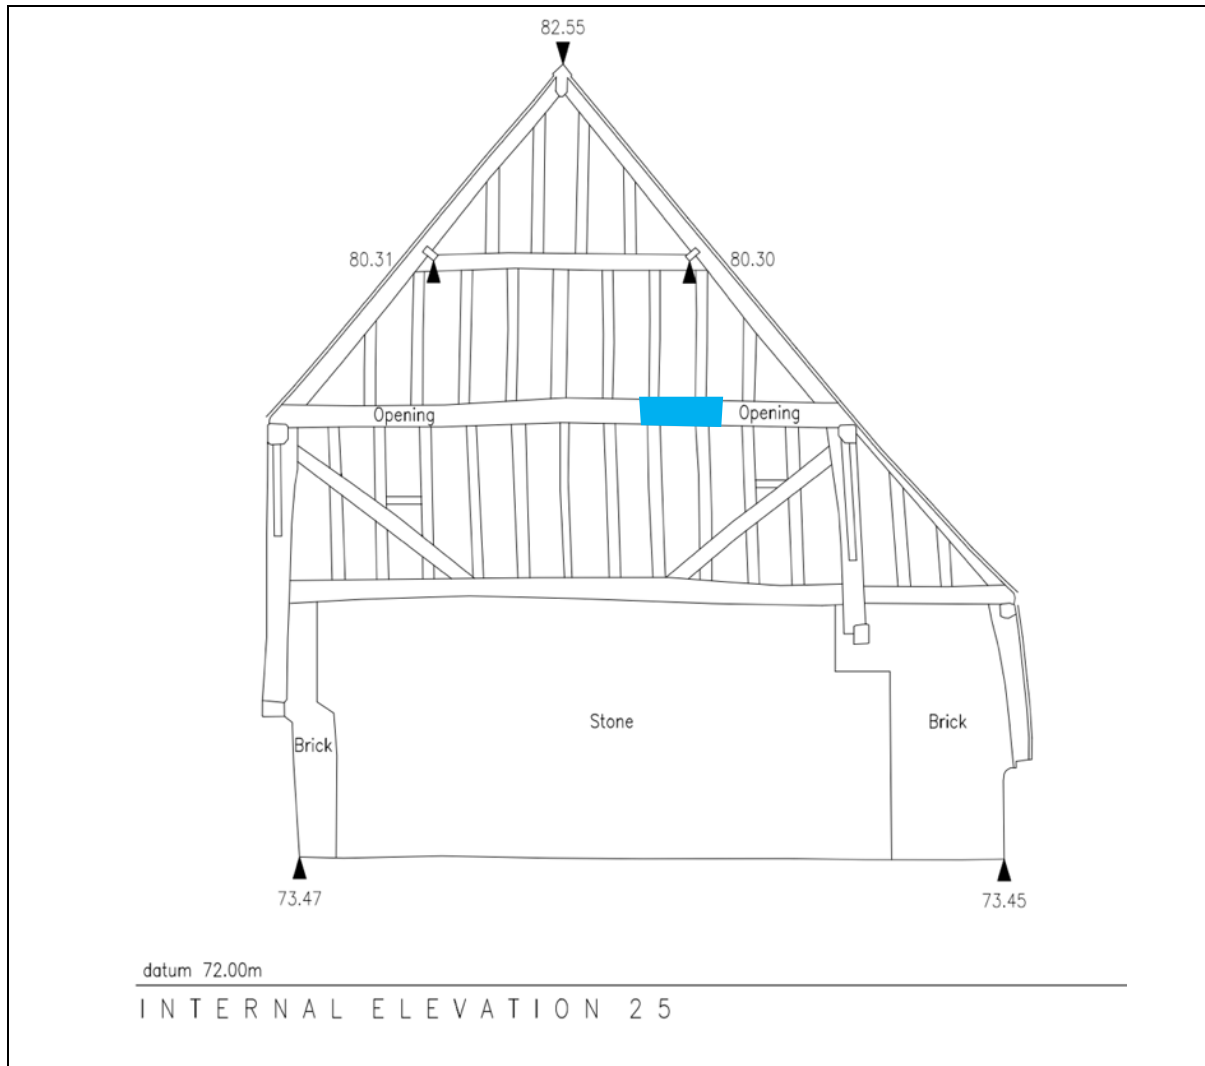
### 5.1.1 Internal Elevation 25

The timber frame to this elevation appears to be in reasonable order, with no areas of significant decay noted. However, a large stain was observed on the tie beam at the south-west corner. This is located directly beneath an area of missing slates on the roof, and it is likely that water ingress is occurring at this location. Due to the height, it was not possible to confirm the condition of the timber from ground level. The extent of any decay to the tie beam could not be determined, particularly to its upper surface, which was not visible. Further inspection will be required once safe access is available via scaffolding.

Aside from this area, no major issues were noted with the frame to this elevation.

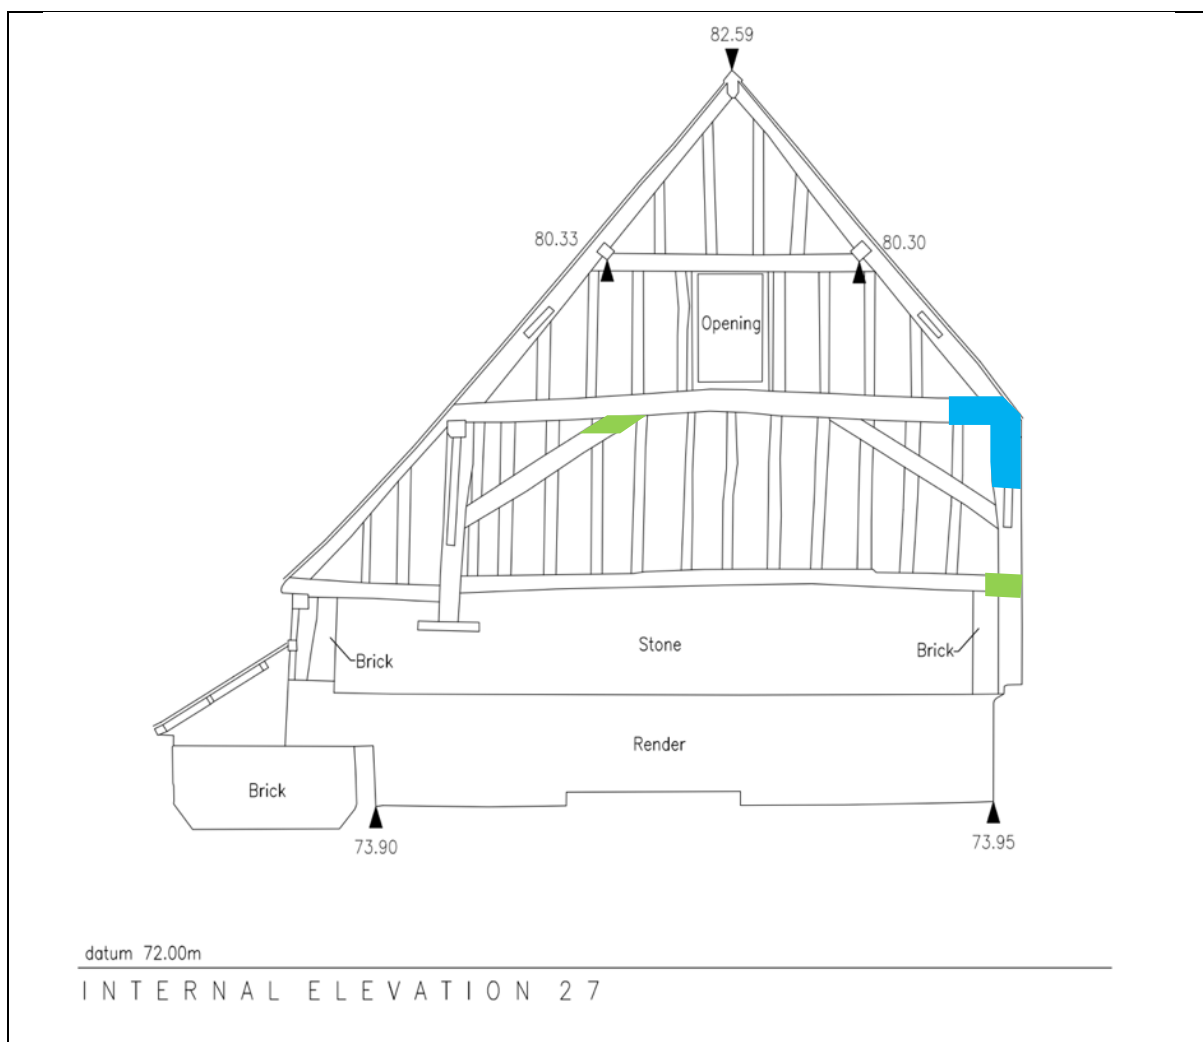
### 5.1.2 Internal Elevation 27

Visible decay and active water ingress were noted at the north-east corner of this elevation, due to roof leaks. As a result, the tie beam, jowl post, principal rafter, and adjacent wall plate (to internal elevation 26) are visibly wet. While the full extent of decay could not be determined at the time of inspection, it is likely that decay is present in these components, and repairs will be required.

It was also noted that the soleplate has pulled out of the mortise joint of the jowl post at the north-east corner. A metal strap will need to be installed to reconnect and secure these components.

Additionally, the left-hand diagonal brace has partially pulled out of the mortise joint beneath the tie beam. This area will require further assessment to determine whether the brace is loose and whether remedial action is needed, such as refitting the brace, re-pegging it, and possibly installing a new tenon.

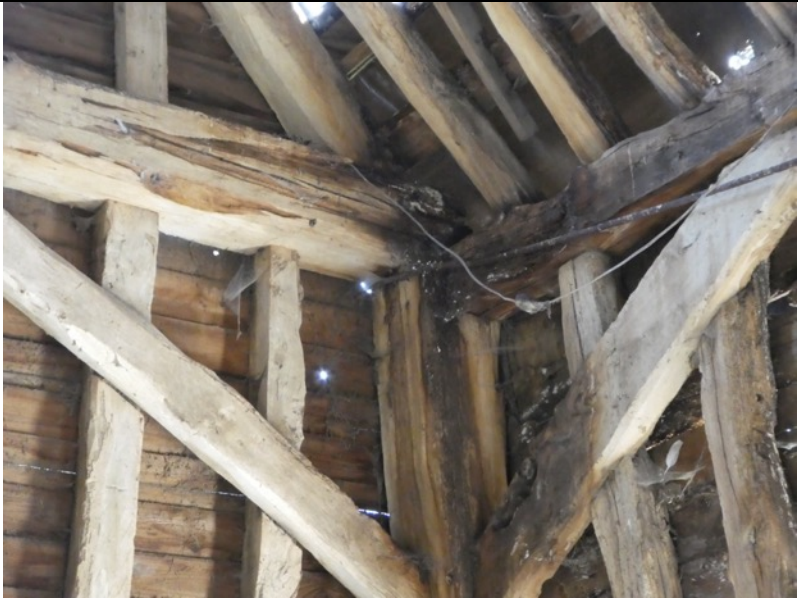
| | <p>Roof leaks in north-east corner have caused much staining, and probably localised decay.</p> |

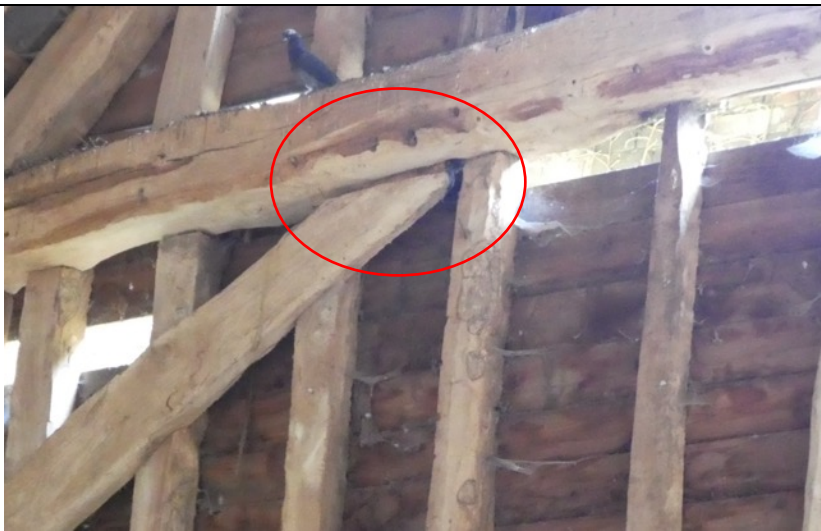
| | <p>Partially disconnected brace.</p> |

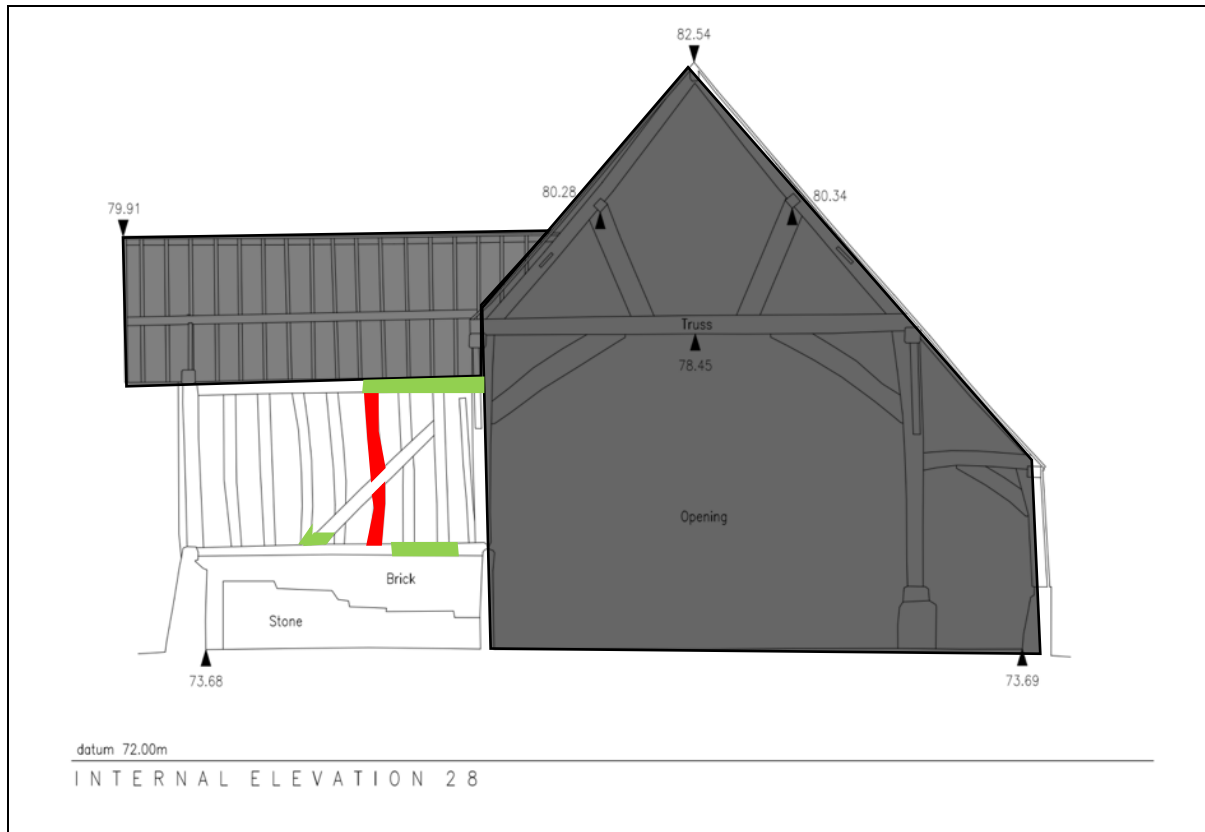
### 5.1.3 Internal Elevation 28

The wall plate has become completely disconnected from the jowl post of the main part of the barn. The wall plate also shows significant decay to its outer face and top section, caused by water ingress at the roof valley. As a result, several of the studs are no longer properly connected to the wall plate, and decay is present to a number of the studs as well as the diagonal brace.

The soleplate appears largely free of decay when viewed from the interior. However, a large amount of mortar has been applied to the base of the plate, possibly to fill voids. It will be necessary to remove this mortar to inspect the condition of the timber underneath and determine whether repairs are required. The soleplate was noted to be wet in multiple areas due to roof leaks, and while some decay is present, it did not appear to be extensive.

As noted, the base of the diagonal brace is decayed. Additionally, the jowl post at the south-east corner is split, and it is recommended that the gap be filled with timber inserts to restore proper integrity at this joint.

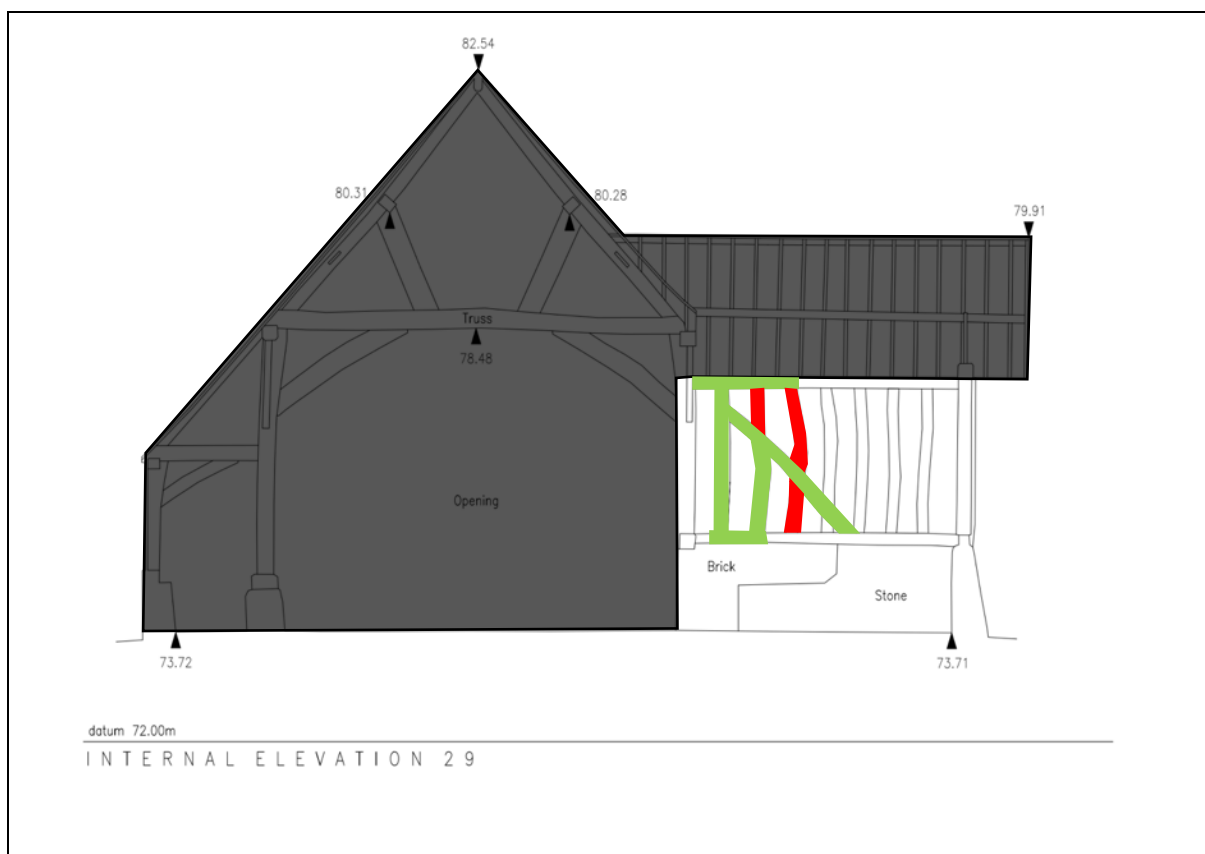
#### 5.1.4 Internal Elevation 29

There is localised decay to the inner face of the soleplate, as well as decay to the sides and outer faces of four studs. Decay is also present to the diagonal brace, and the top of the wall plate appears to be heavily decayed in one area.

All of this deterioration is attributed to ongoing water ingress from the roof above.

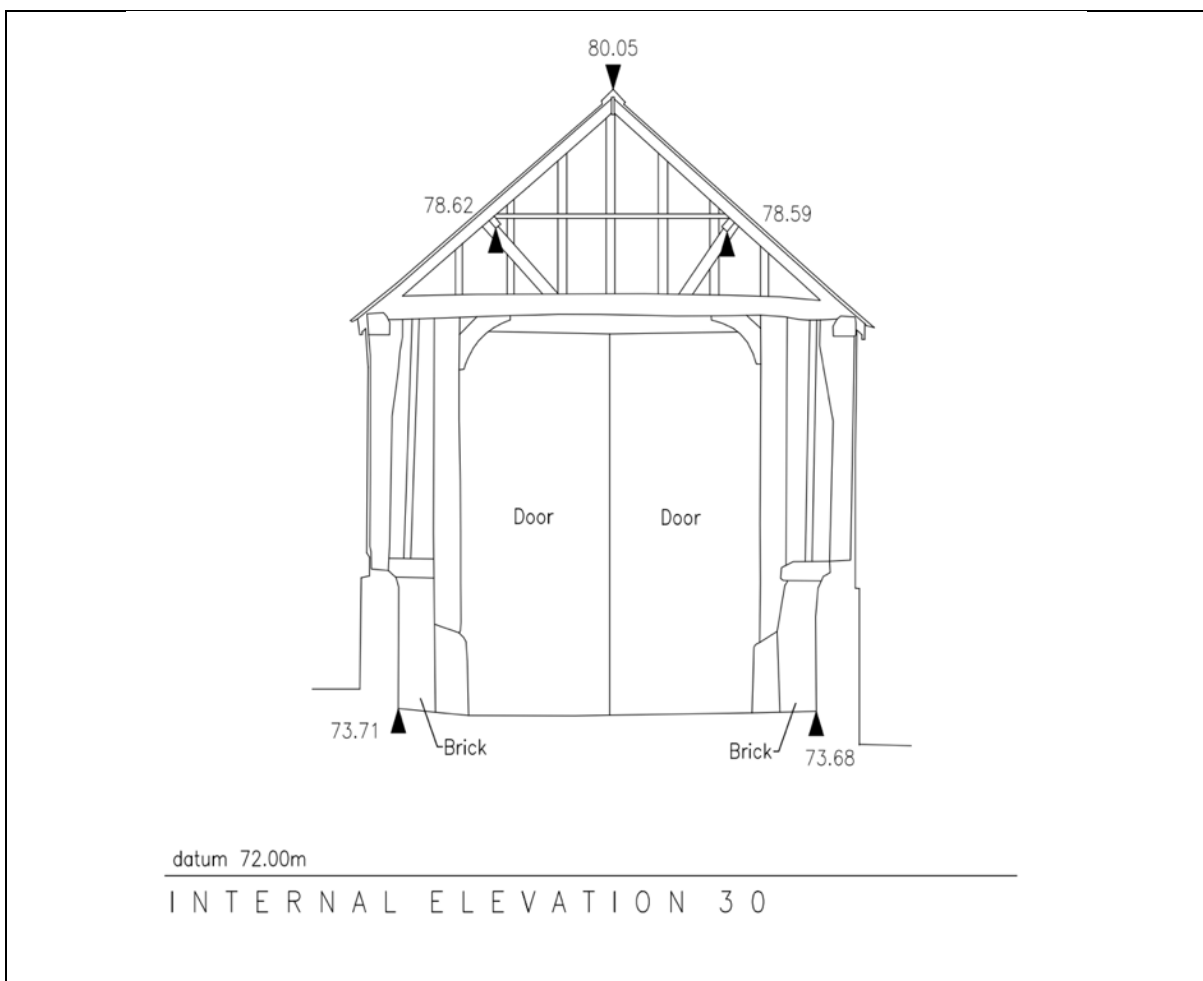
#### 5.1.5 Internal Elevation 30

The framing to this elevation is in reasonable condition, though it was noted that there is a split to the top of the jowl post adjacent to the south door. There is also gaps between the top of the jowl post and the tie beam and adjacent wall plate. As a precaution it is suggested that a metal strap be installed which laps onto all three components, providing additional restraint.

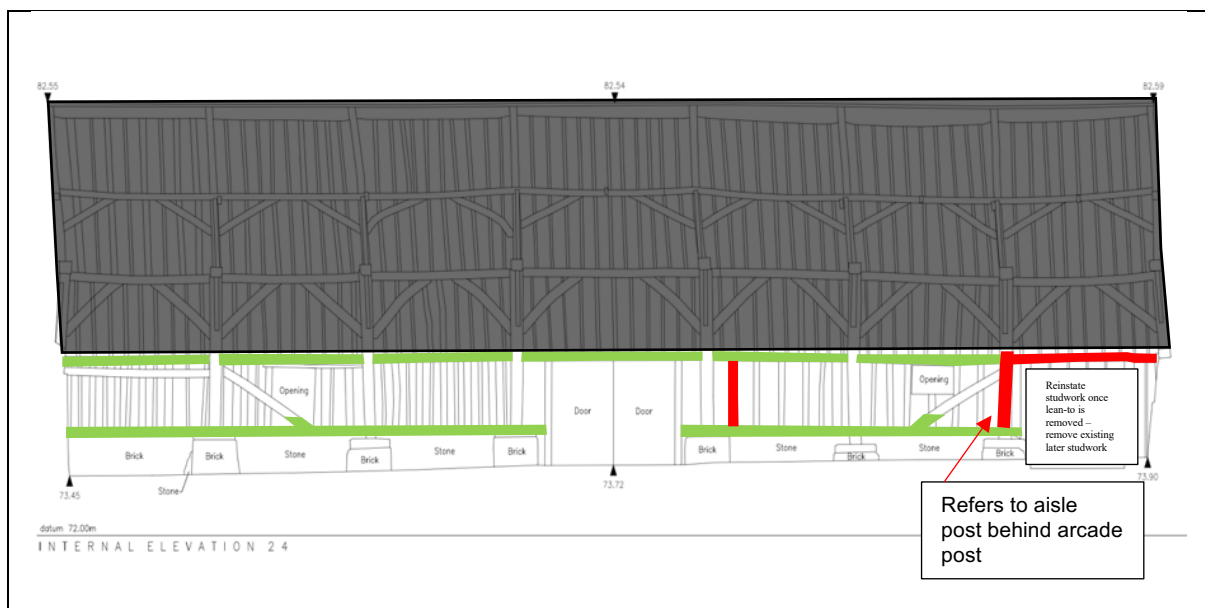
#### 5.1.6 Internal Elevation 24

On the southern part of this elevation, the soleplate is heavily decayed at mid-span and is almost entirely missing in one area. In many other areas along this elevation, the outer face of the soleplate has also significantly decayed. While some sections may be capable of being retained, a large proportion will need to be cut out, replaced, and scarfed into the existing sound sections. Although the full outer face of the soleplate could not be fully inspected, visible signs of decay suggest that face repairs are also likely to be required.

In the northern part of the elevation, there is an area that is significantly wet and decayed due to roof leaks. The soleplate in this location has rotated outwards, indicating likely decay to its outer face. At the north-west corner, another section of the soleplate is both significantly decayed and wet. This portion will also require cutting out and replacement.

The wall plate along this elevation is significantly rotten at various intervals and will require sectional replacement. The decay is due to water ingress from roof leaks, particularly in areas above the window openings.

The studs along this elevation require numerous repairs. In many cases, scarf repairs will be needed at the base where the timbers are decayed and no longer connected to the soleplate. In some areas, the studs are too short and do not reach the wall plate. While a few studs will require full replacement, it is thought that the majority can be retained with localised repairs. The primary issue is the loss of connection at the base where decay has occurred.

The aisle post between bay 6 and 7, in the north-west corner adjacent to the lean-to, is significantly decayed and requires full replacement. Water ingress from holes in the roof have caused this.

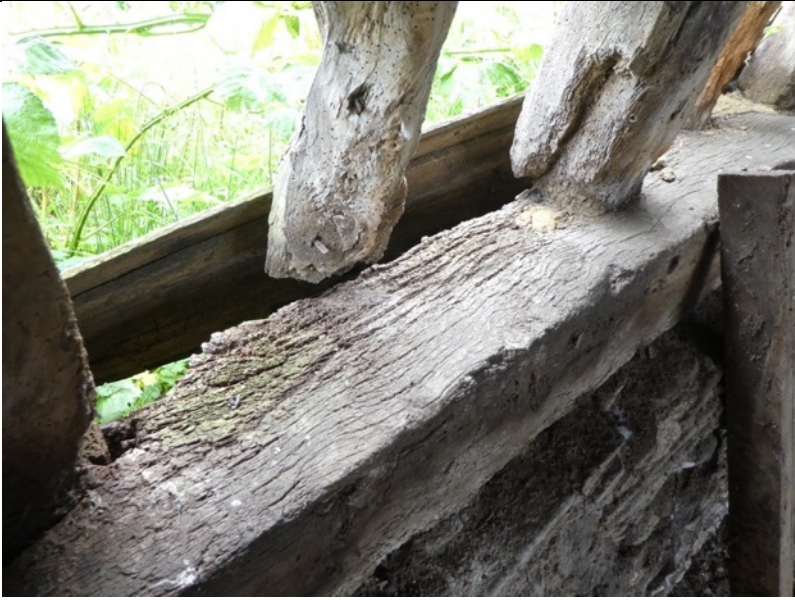
| | <p>Many of the studs no longer connected to the sole plate.</p> |

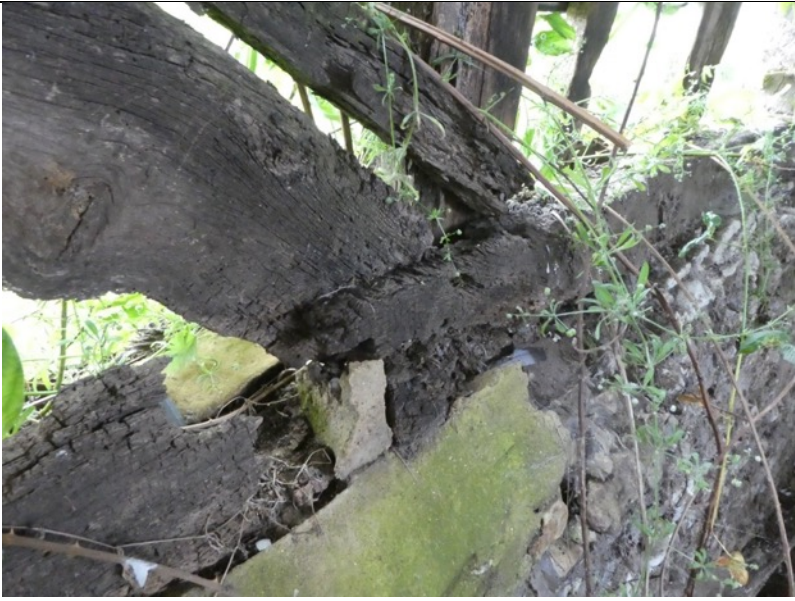
| | <p>Significant decay to sole plate – has resulted in one section becoming disconnected.</p> |

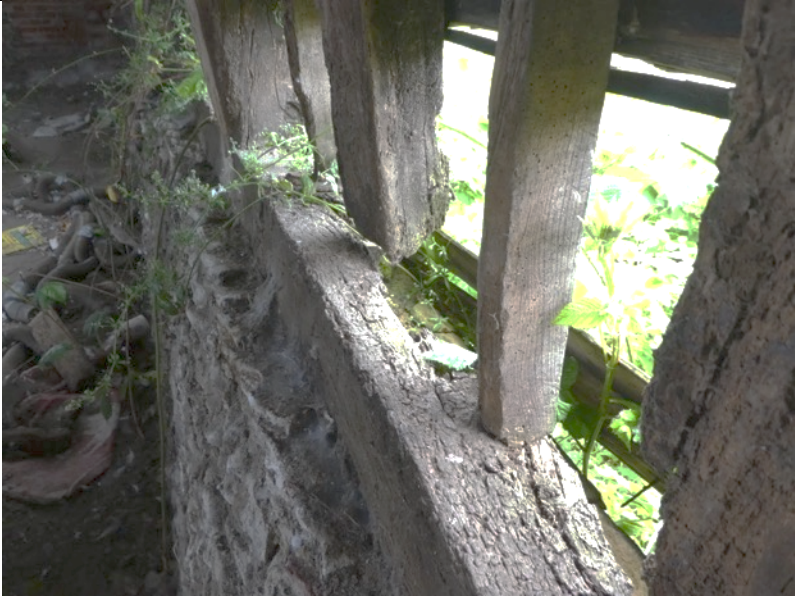
| | <p>Outer face of the sole plate has decayed in many places; as a result, the plate has rolled outwards, causing the studs to become disconnected.</p> |

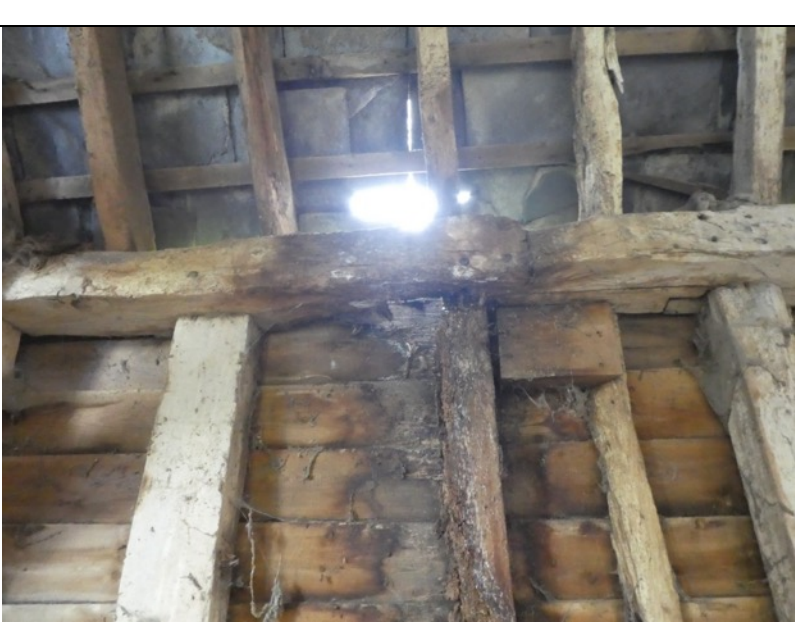
| | <p>Leaks from the roof causing localised decay to the wall plates and studs.</p> |

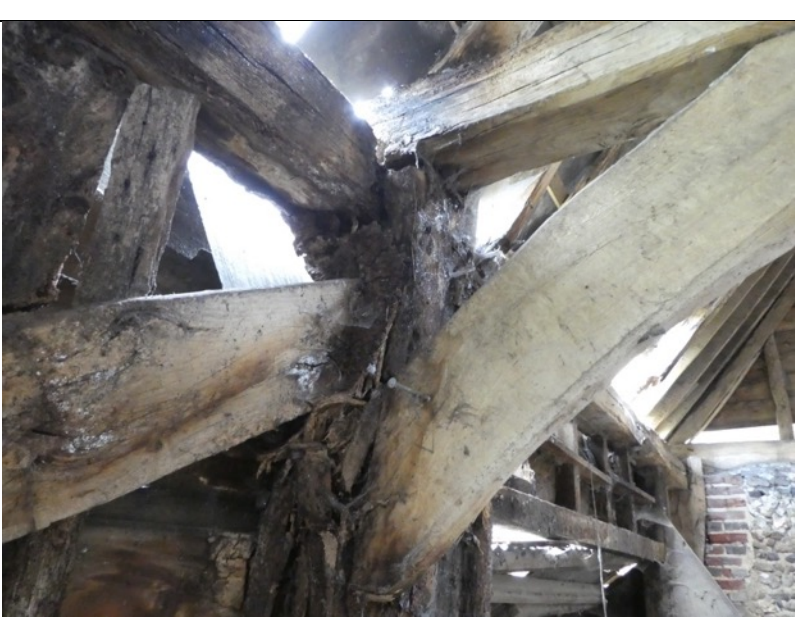
| | <p>Aisle post between bays 6 and 7 significantly decayed and requires full replacement. Adjacent timbers in this area also decayed and require repairs.</p> |

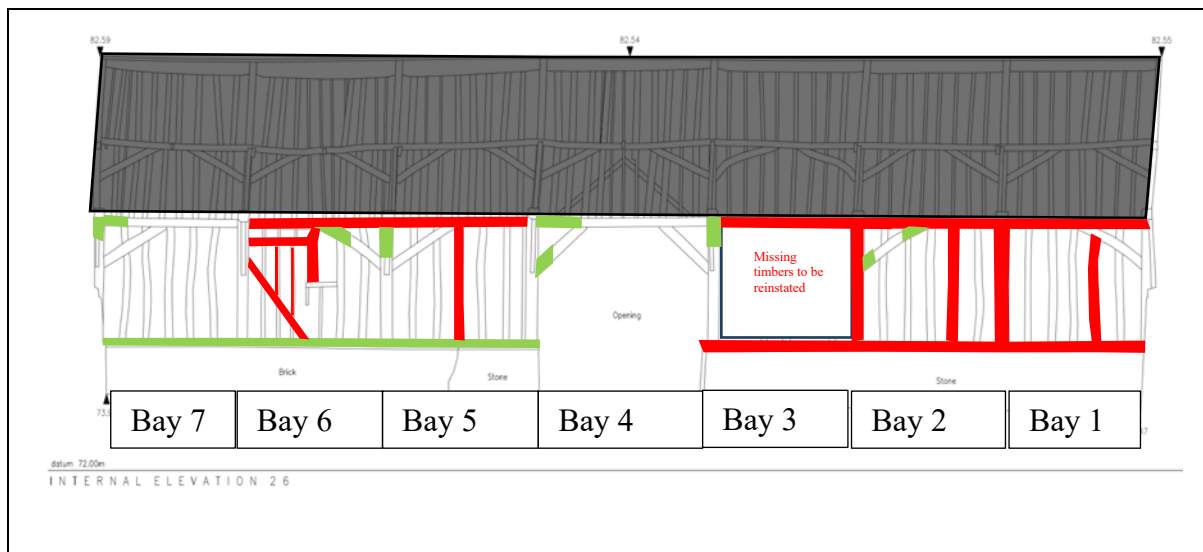
### 5.1.7 Internal Elevation 26

The jowl post between bays 1 and 2 is significantly decayed. The jowl post will require full replacement. The soleplate across bays 1, 2, and 3 is significantly decayed in numerous areas, and wholesale replacement is recommended along this stretch.
