## **Condition Survey**

**Threshing Barn at  
Highover Farm  
Highover Way  
Hitchin  
SG4 0RQ**

**Gill-Hudson Homes Limited**

**16<sup>th</sup> June 2025**

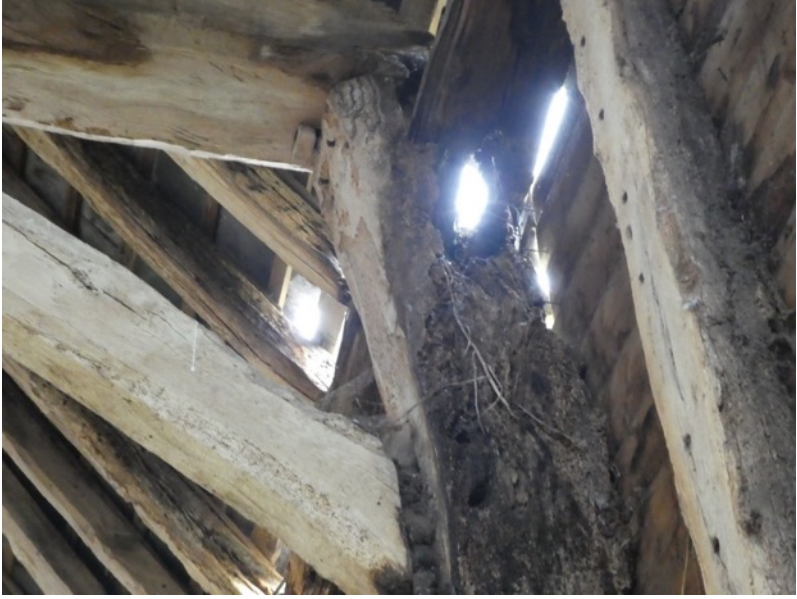
| | <p>Jowl post between bays 1 and 2 significantly decayed and requires replacement.</p> |

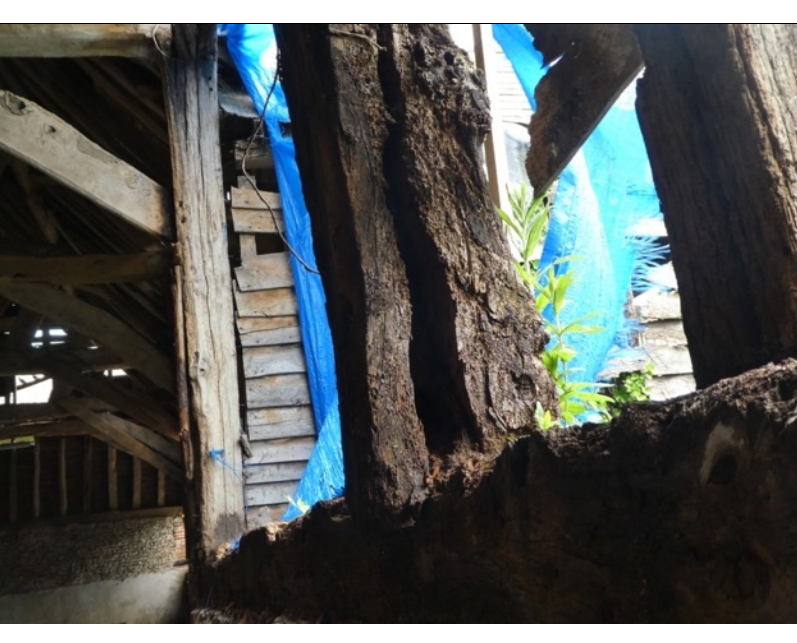
| | <p>The same also applies to the jowl post between bays 2 and 3.</p> |

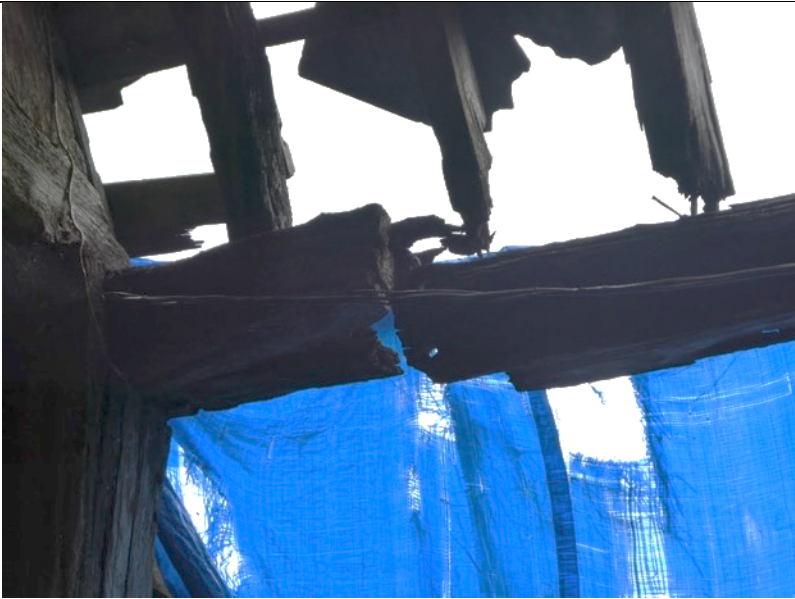
| | <p>Wall plate above bay 3 completely snapped due to extensive decay.</p> |

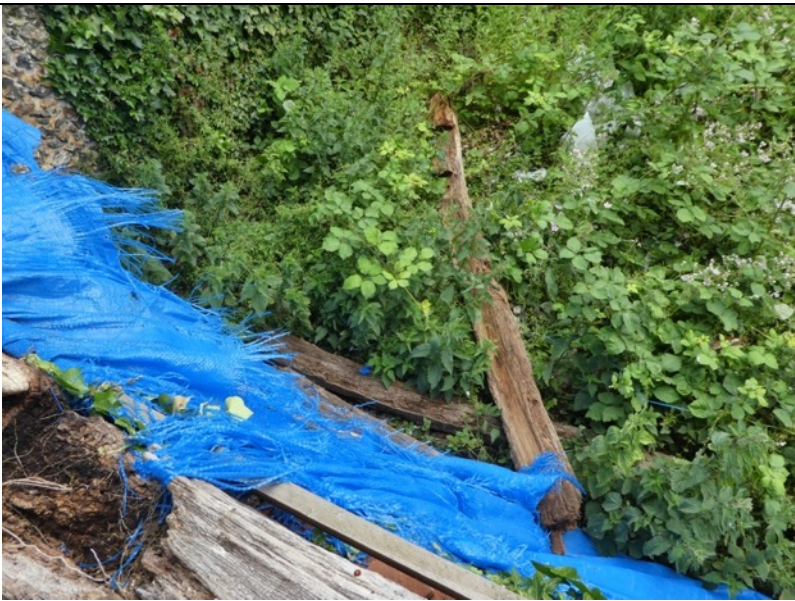
| | <p>Studs to bay 3 have fallen out and laying on the ground.</p> |

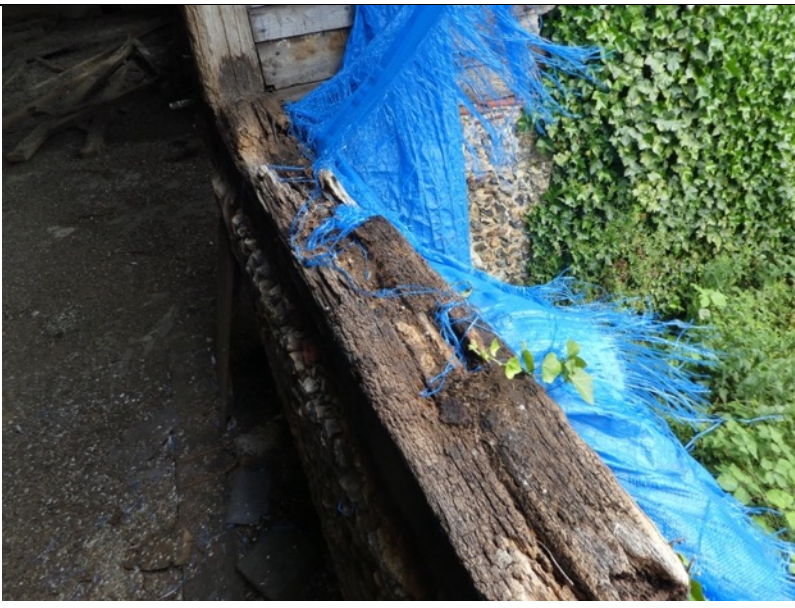
| | <p>Sole plate to bays 1-3 extensively decayed and beyond repair.</p> |

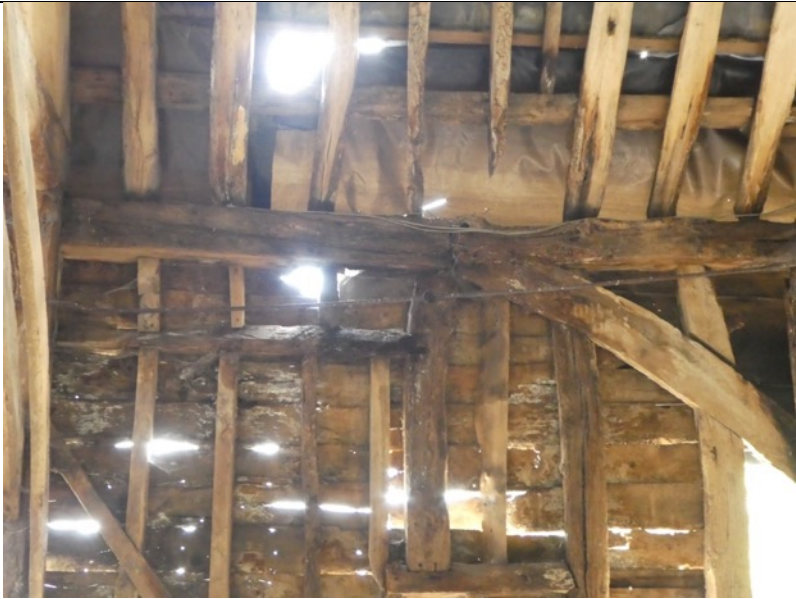
| | <p>Water ingress to bay 6 causing localised decay, particularly to the wall plate.</p> |

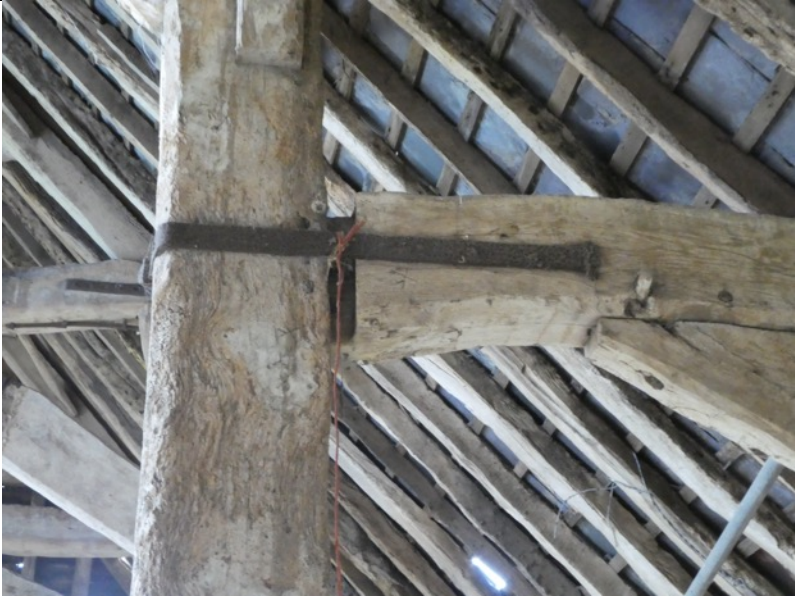
| | <p>Strapping between interrupted tie beams and arcade posts, thought to have been installed when the leaning of the arcade posts occurred. Note the tie beam has partially pulled out of the arcade post – bay 3.</p> |

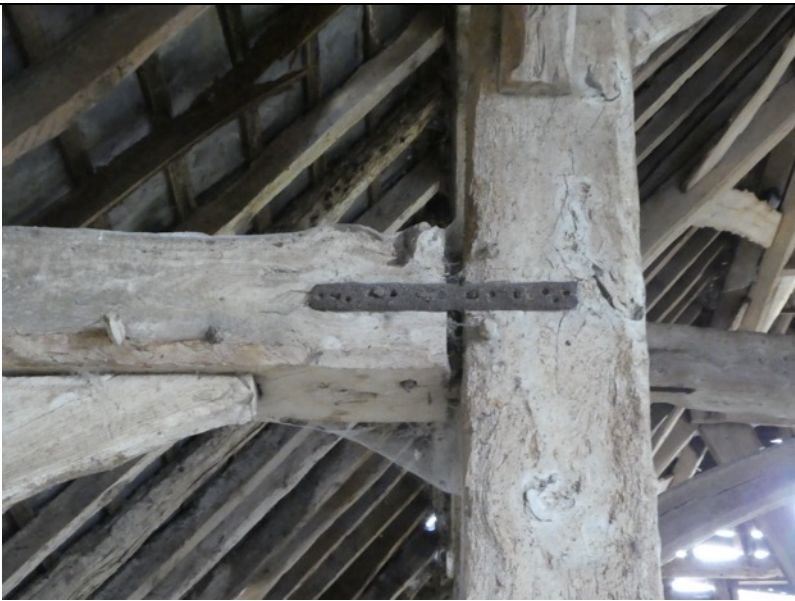
| | <p>As above but smaller strap which is not adequate – bay 4.</p> |

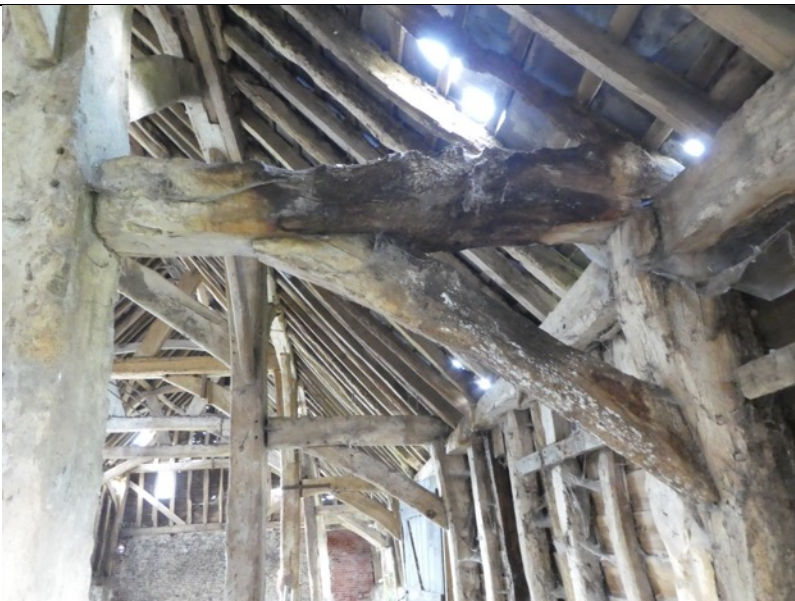
| | <p>Significant decay to interrupted tie beam and brace – bay 5. These are beyond repair and will require replacement.</p> |

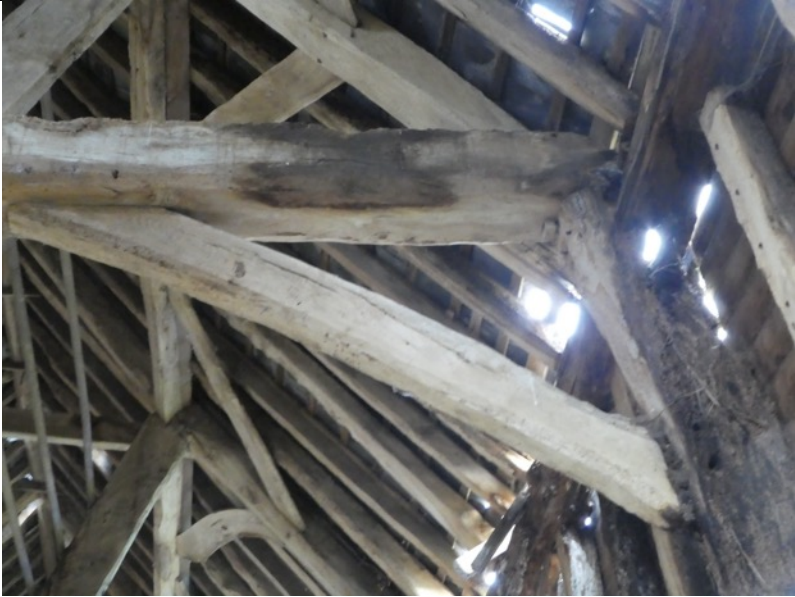
| | <p>Typical staining to main tie beams – requires close inspection to assess extent of decay.</p> |

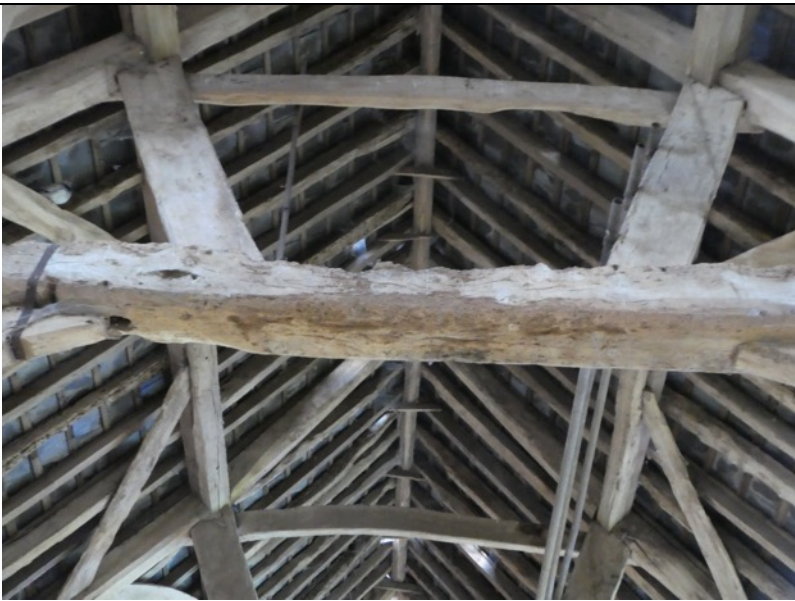
| | <p>Friable timber to underside of tie beam in bay 1.</p> |

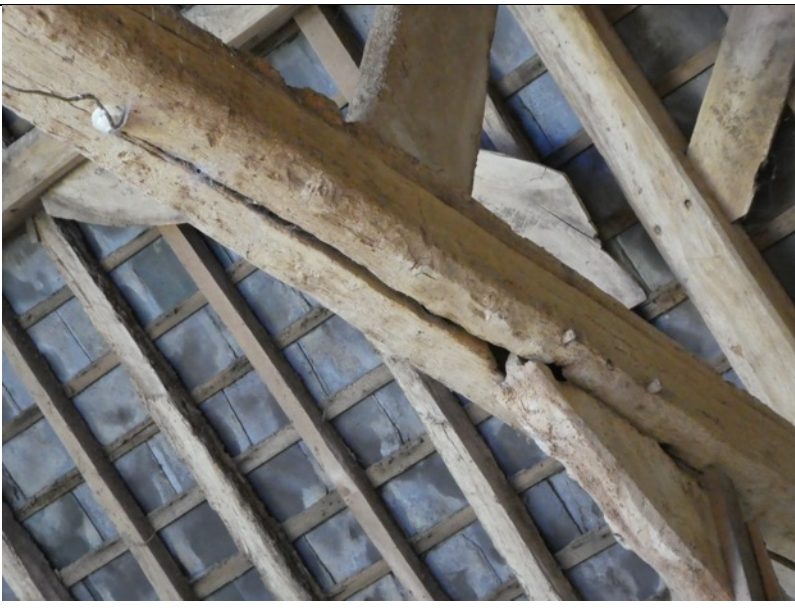
| | <p>Splitting to underside of tie beam – bay 4.</p> |

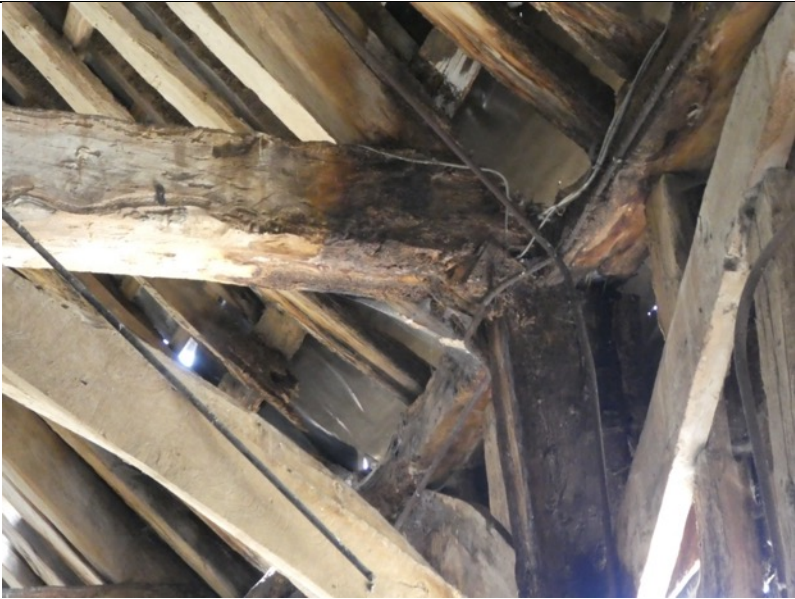
| | <p>Typical decay to tie beam ends.</p> |

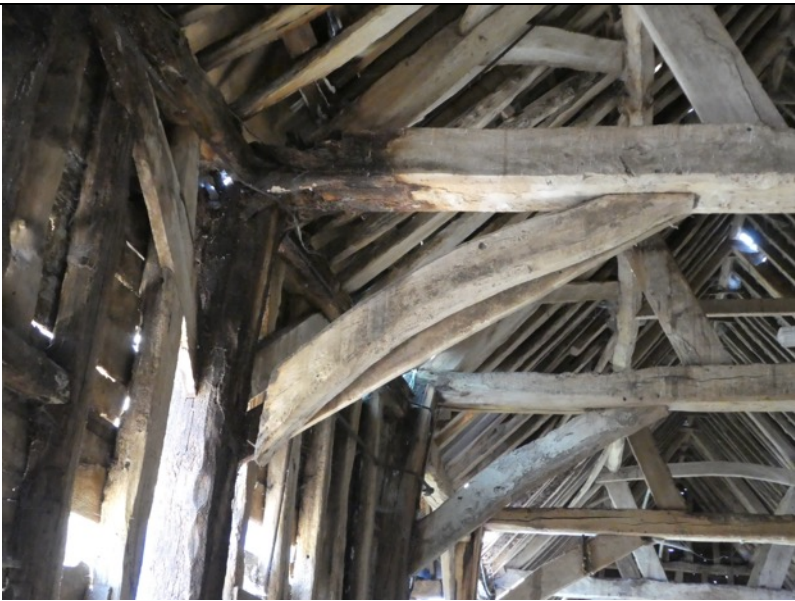
| | <p>As above.</p> |

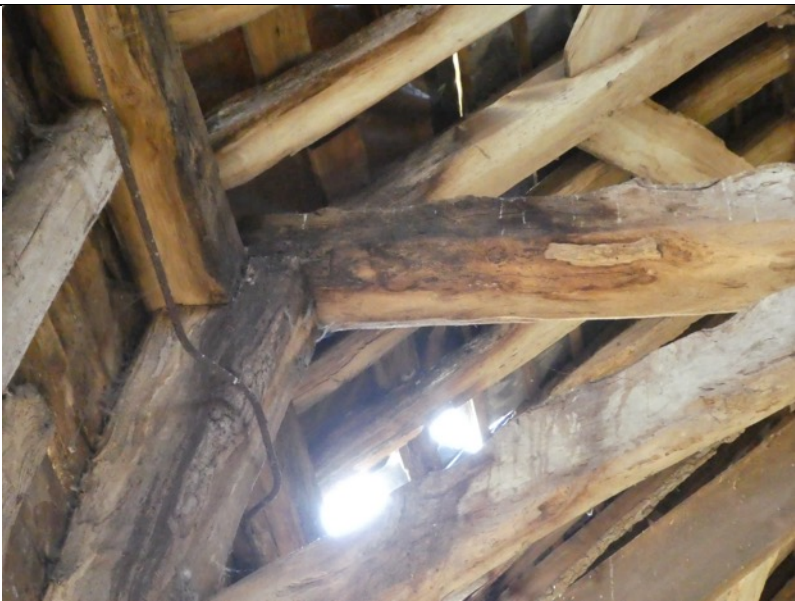
| | <p>Staining to tie beam ends in places and the extent of decay is unclear from ground level.</p> |

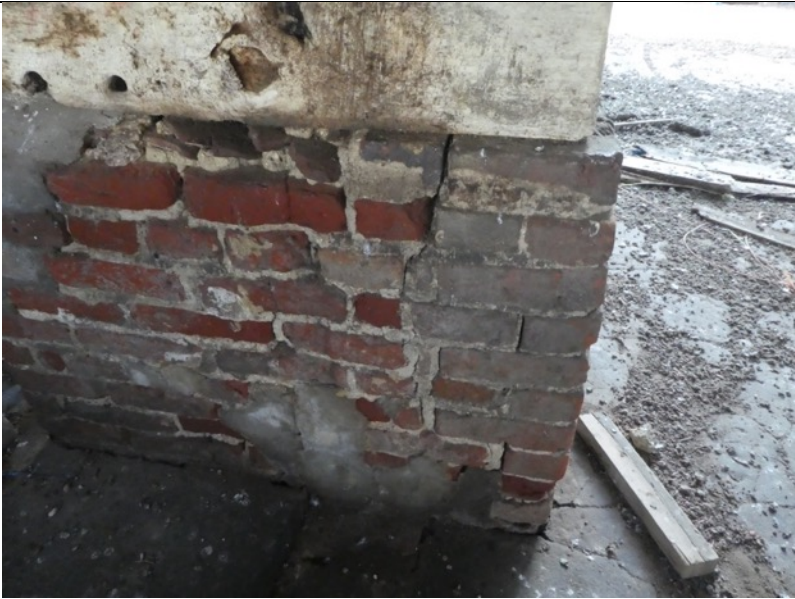
| | <p>Cracking to padstone 3.</p> |

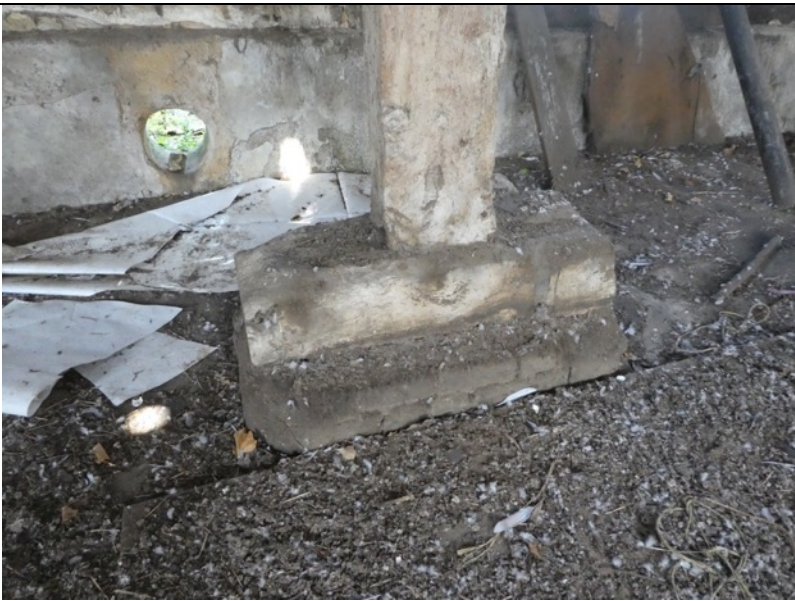
| | <p>Padstone 5 only a short padstone.</p> |

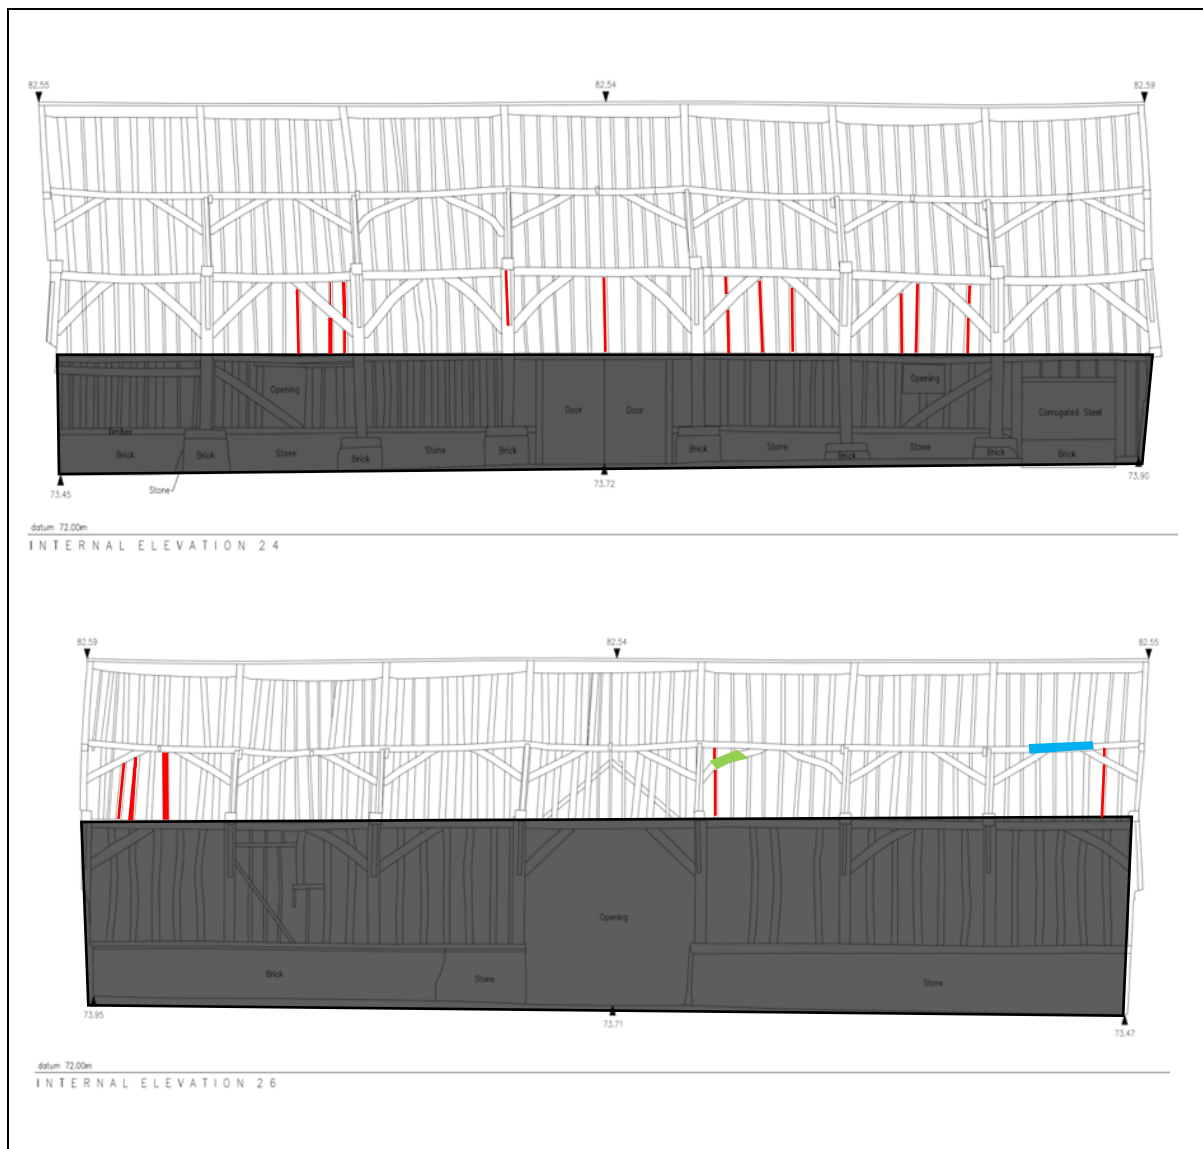
## 5.2 Roof Structure

The roof structure is in need of a number of repairs, primarily to the feet of the rafters. The majority of rafter feet appear to be decayed and will require cutting out and replacement. New rafter feet should be scarfed into the existing rafters and securely connected back to the wall plates.

In addition, some localised replacement of rafters will be required. The extent of this does not currently appear to be excessive and is mainly confined to areas where the roof is no longer watertight.

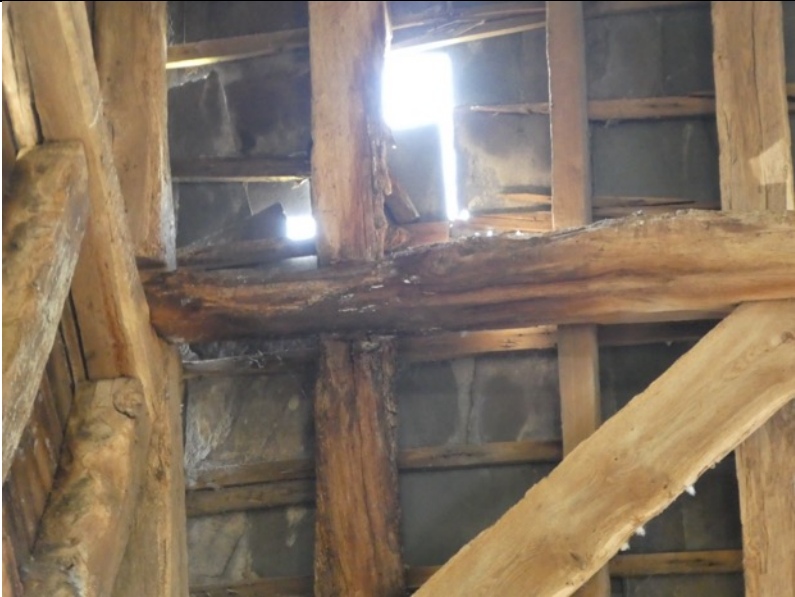
| | <p>Decay to purlin – bay 1, north-west elevation.</p> |

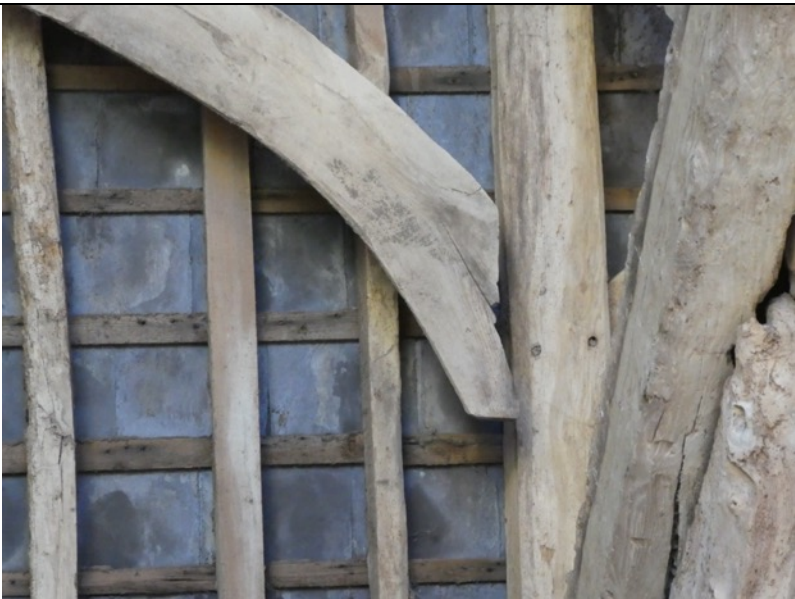
| | <p>Example of disconnected brace – north west elevation, bay 5.</p> |

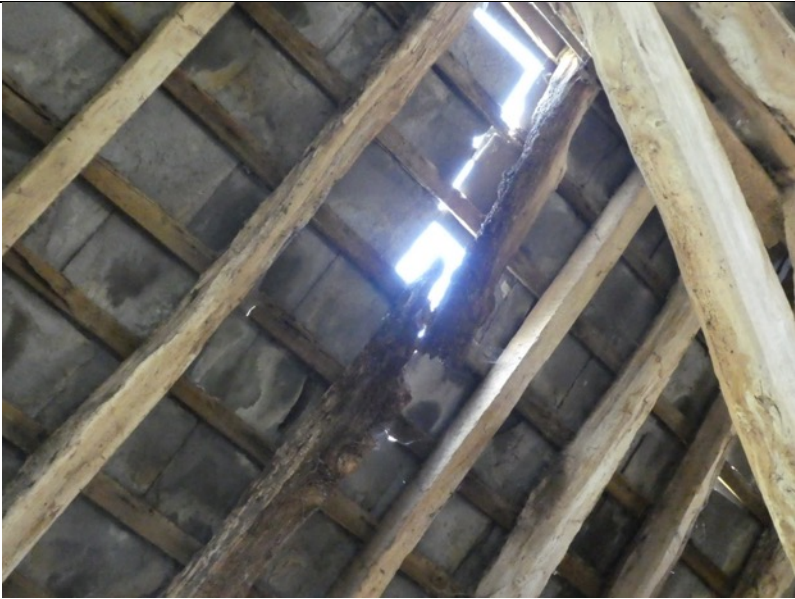
| | <p>Decayed rafter – south-east elevation, bay 5.</p> |

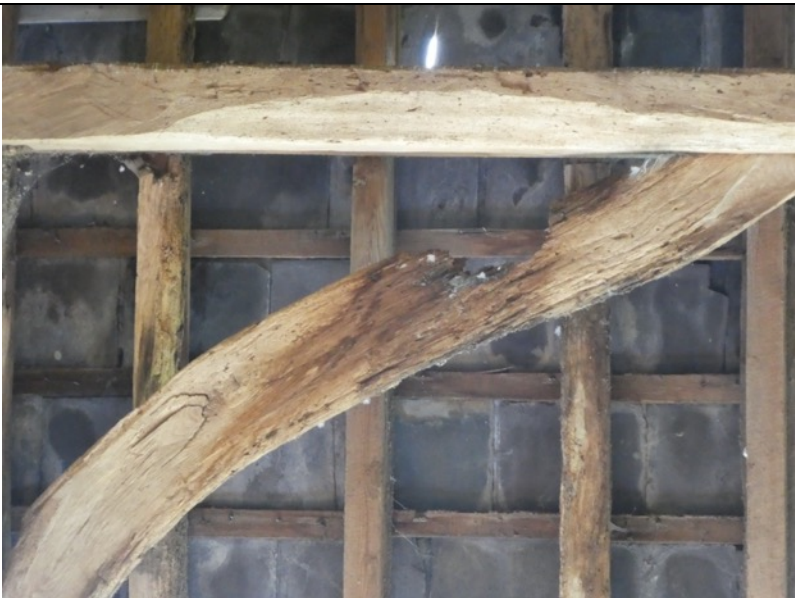
| | <p>Decayed brace – north-west elevation, bay 5.</p> |

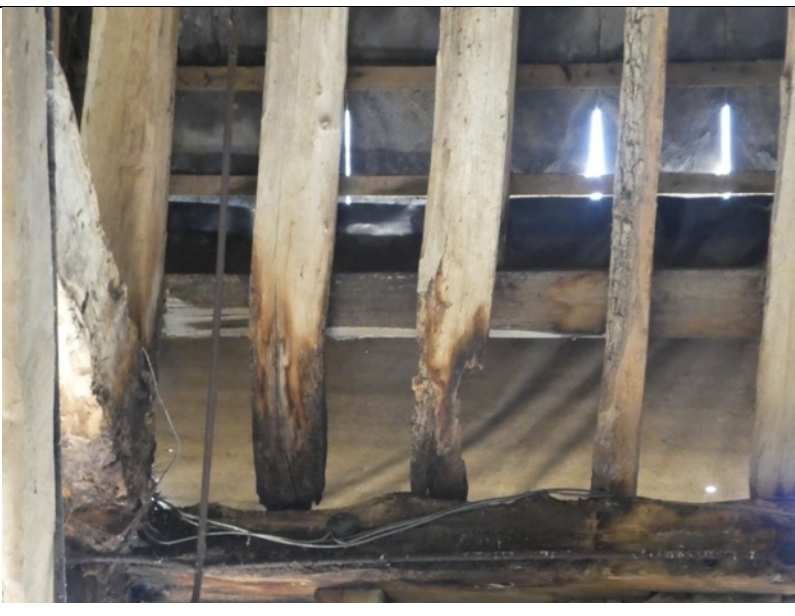
| | <p>Typical decay to rafter feet. The majority of the rafters require repairs at their base, and similar to the studs, these have not been individually marked on the drawings.</p> |
