**MILL BARNS, CHARLTON , HITCHIN**

**PRELIMINARY STRUCTURAL REPORT**

**MILL-BUR-ZZ-ZZ-RP-S-0001 – S2 – P01**

**DECEMBER 2023**

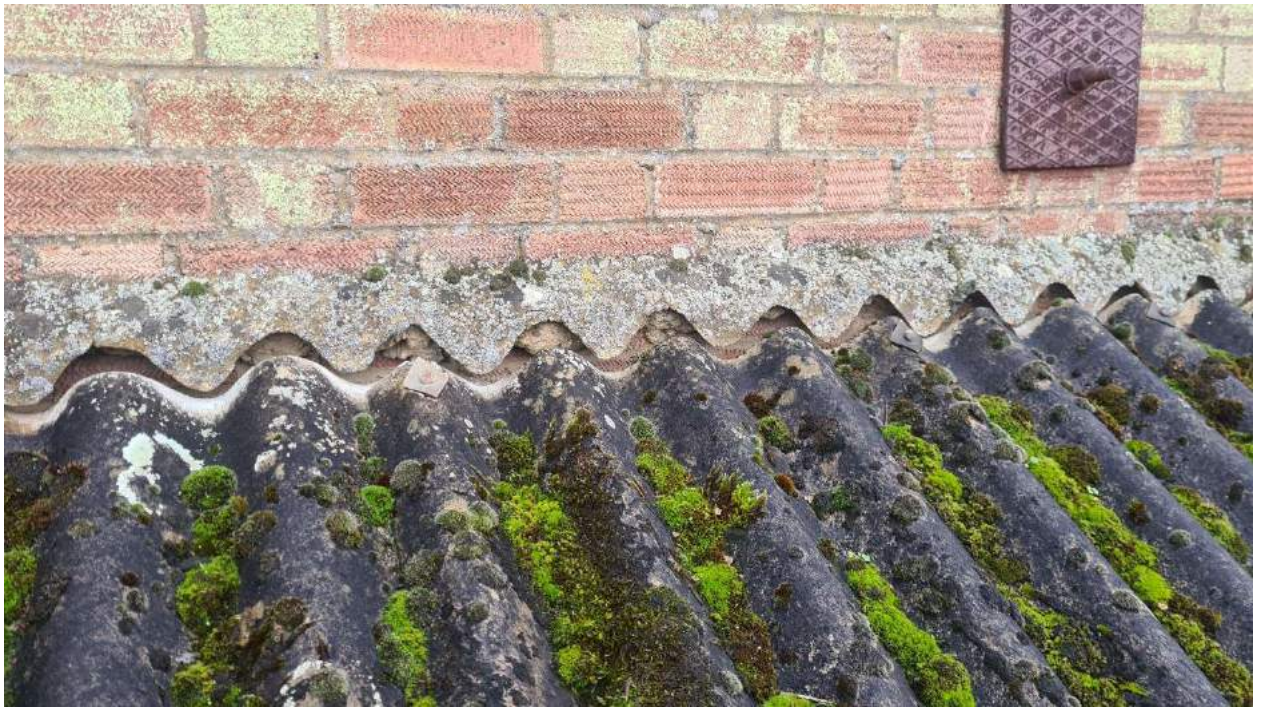
There is a small lean-to structure housing a service trench to the Western side of the barn with a more recently constructed concrete portal frame shed to the East of the barn. The small lean-to roof has failed and needs replacing while the guttering detail between the portal frame shed and Barn A has led to water ingress and weathering of an area of masonry.

*Photograph 5 – Failed lean to roof*

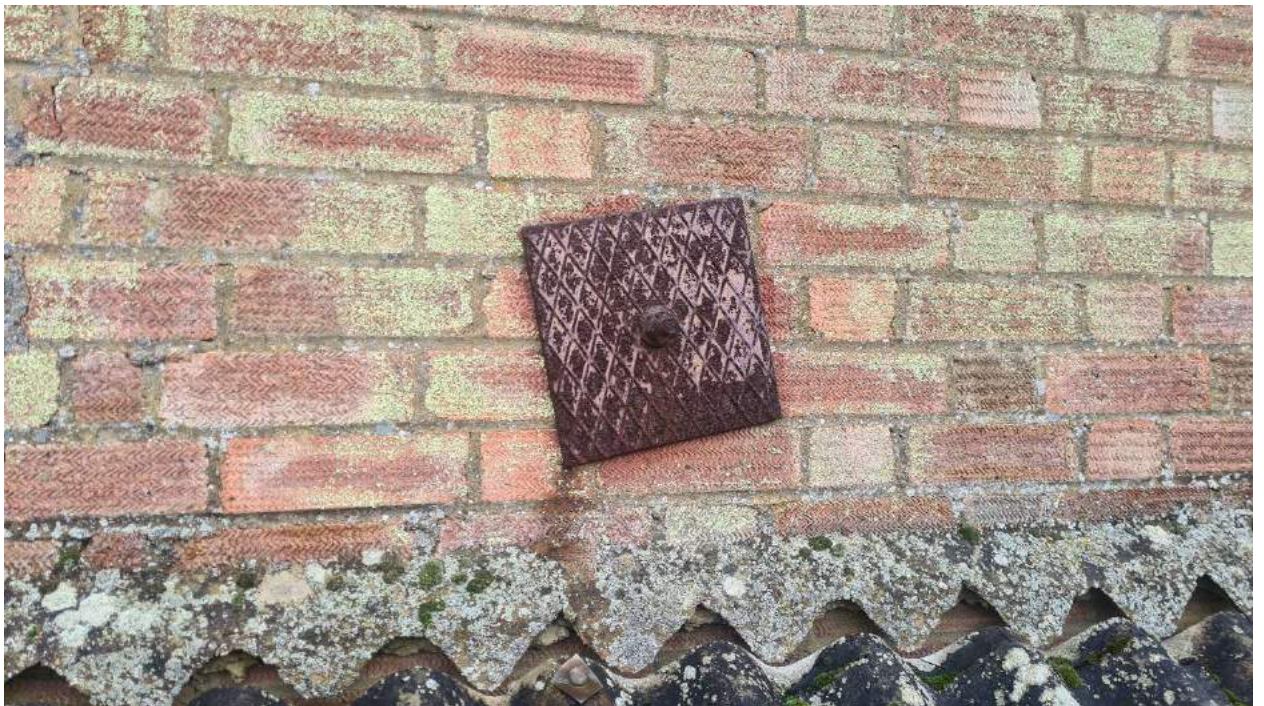
Two instances of historical cracking were observed within the same bay and have been remediated with steel ties and wall anchors. There were no visible signs of lateral bowing of the walls. The cracks were at high level only and assumed to be associated with historical storage of the the bay. As part of any new development the cracks would be stitched and cross walls tied into the external frame to ensure stability. The current layout offers significant lateral stability to the barn through the 5No. cross walls.

*Photograph 6 – Wall Plate Anchor*

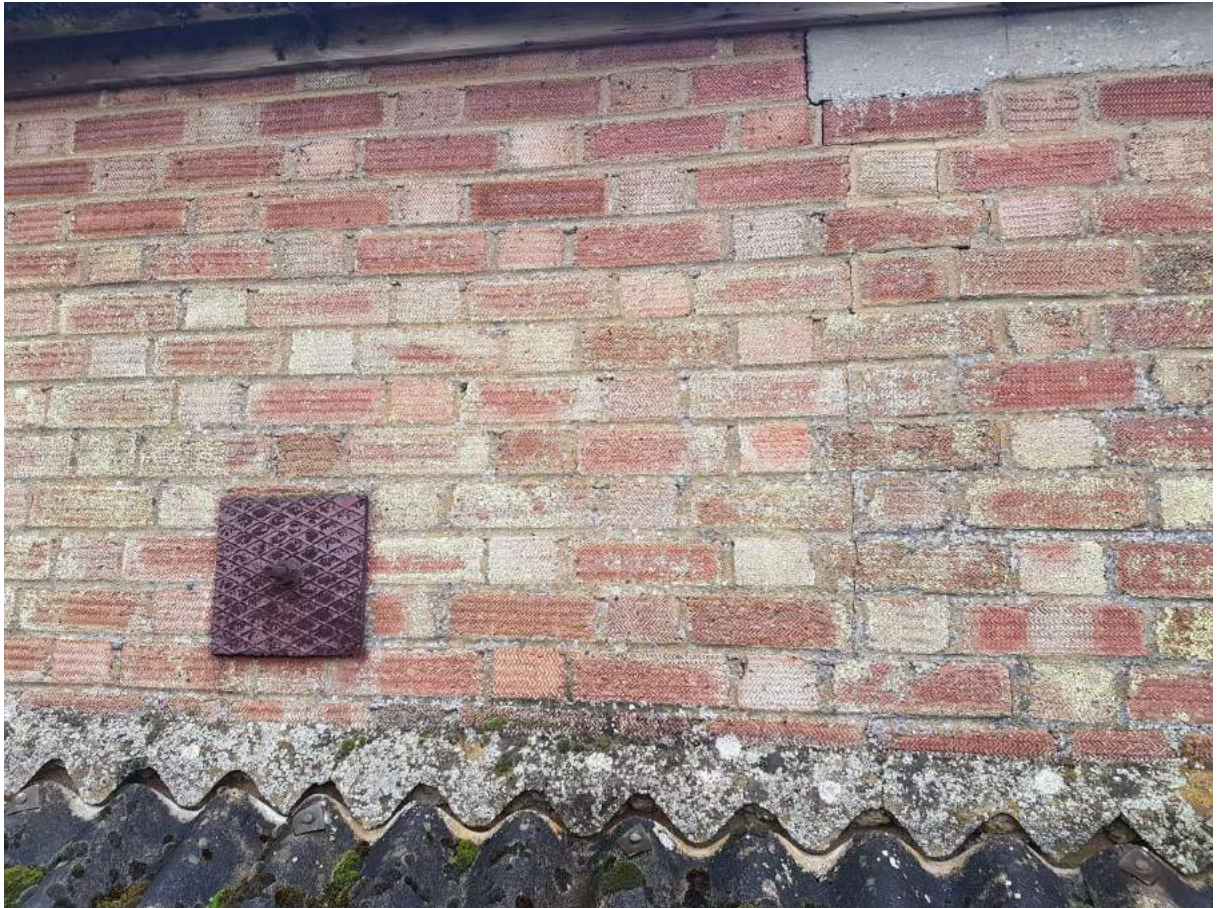
*Photograph 7 – Masonry cracking adjacent Wall Plate Anchor in Barn A*

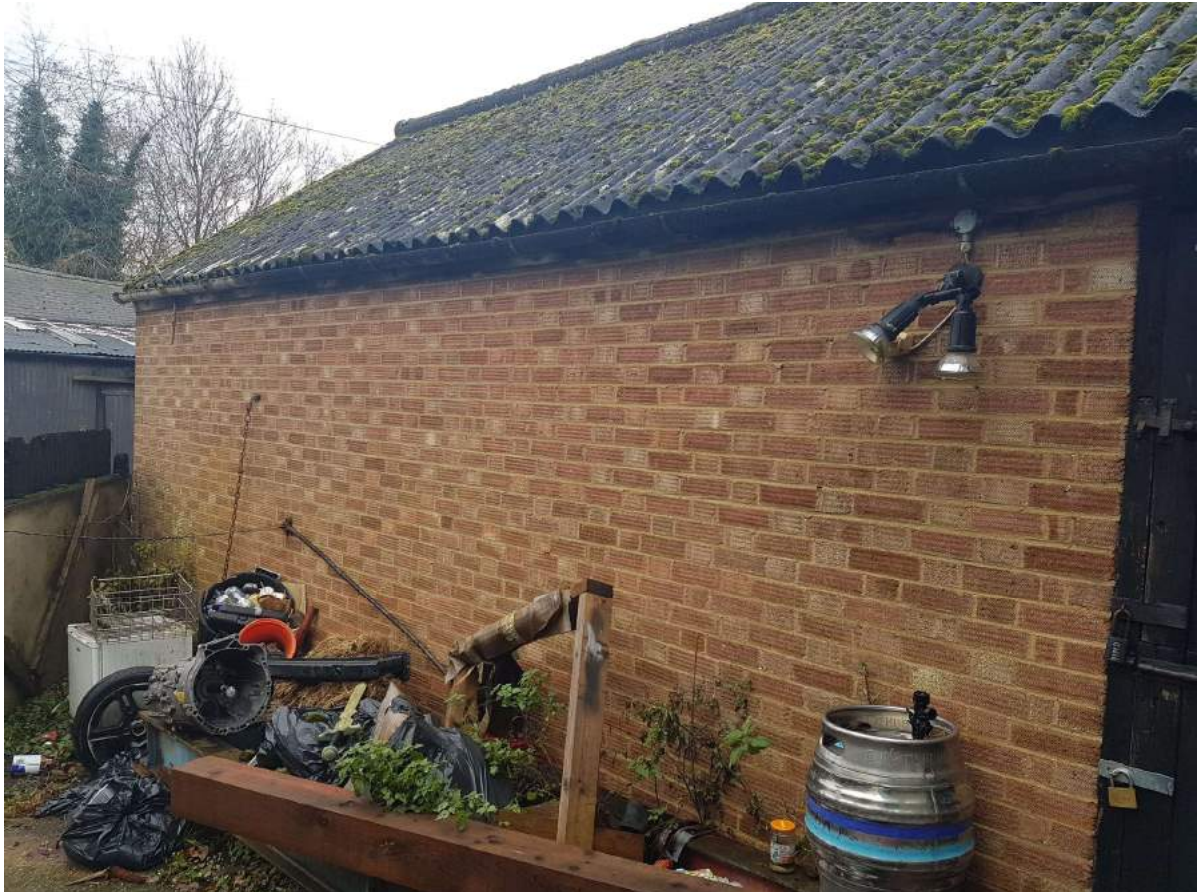
*Photograph 8 – Cement Based Roof Sheeting to Barn A*

It is expected that the new development will include the addition of insulation to the roof and walls and that the roof sheeting will be removed. It is therefore recommended that the roof covering be replaced in lightweight artificial slate.

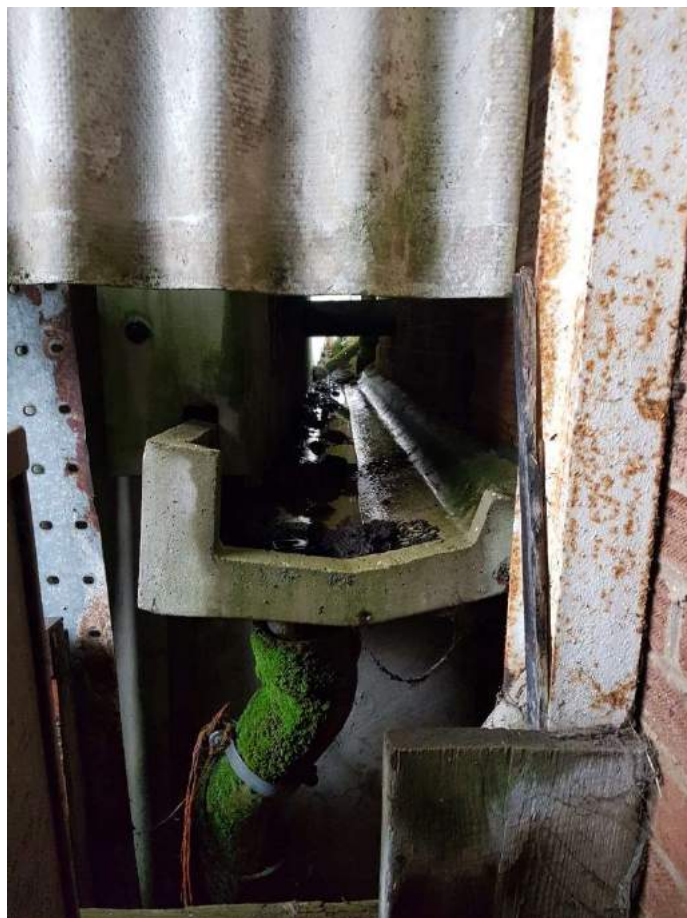
*Photograph 10 – Gutter detail between Barn A and concrete portal frame shed*

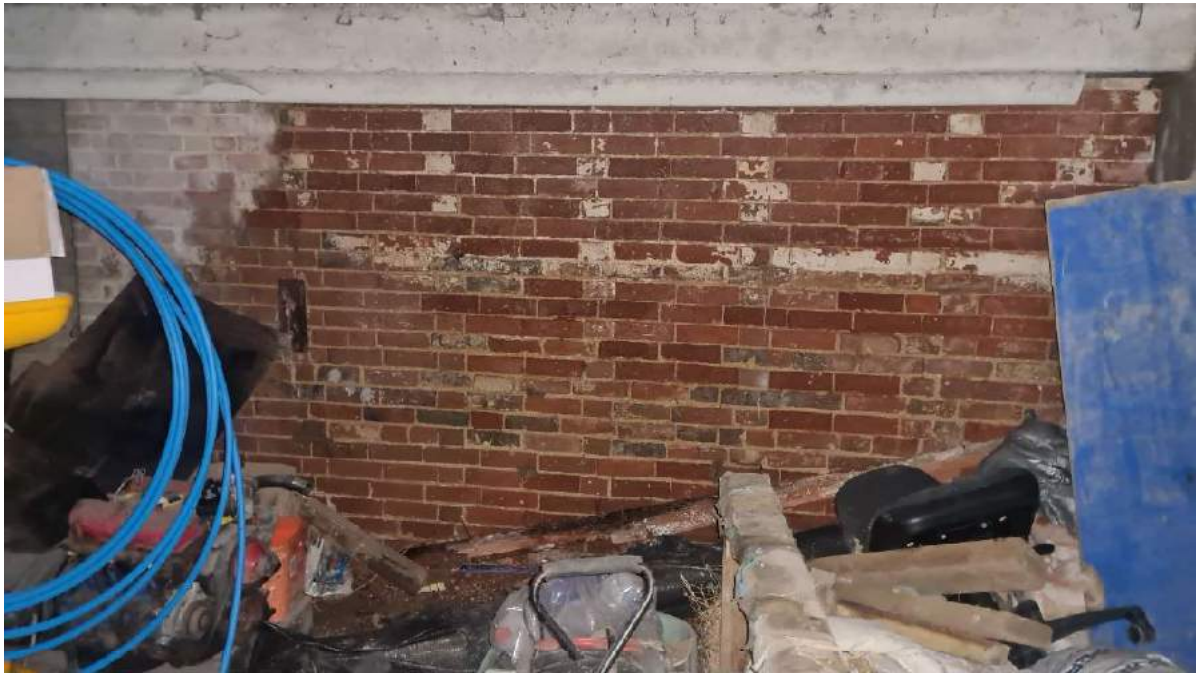
The masonry is in good condition with only a number of areas requiring repairs where water ingress has weathered the brickwork and repointing of the mortar is required. A slate DPC is visible and is in good condition.

*Photograph 11 – Area of water ingress under gutter between Barn A and portal frame shed*

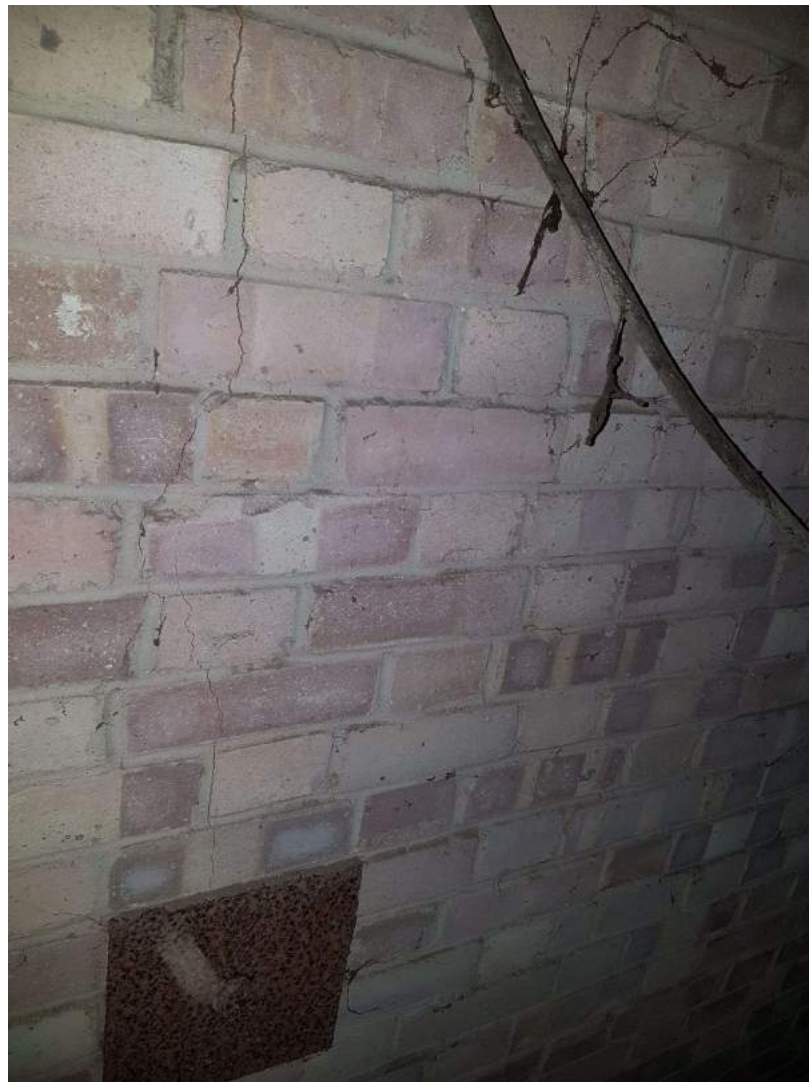
*Photograph 12 – Cracking above wall anchor plate in Barn A*

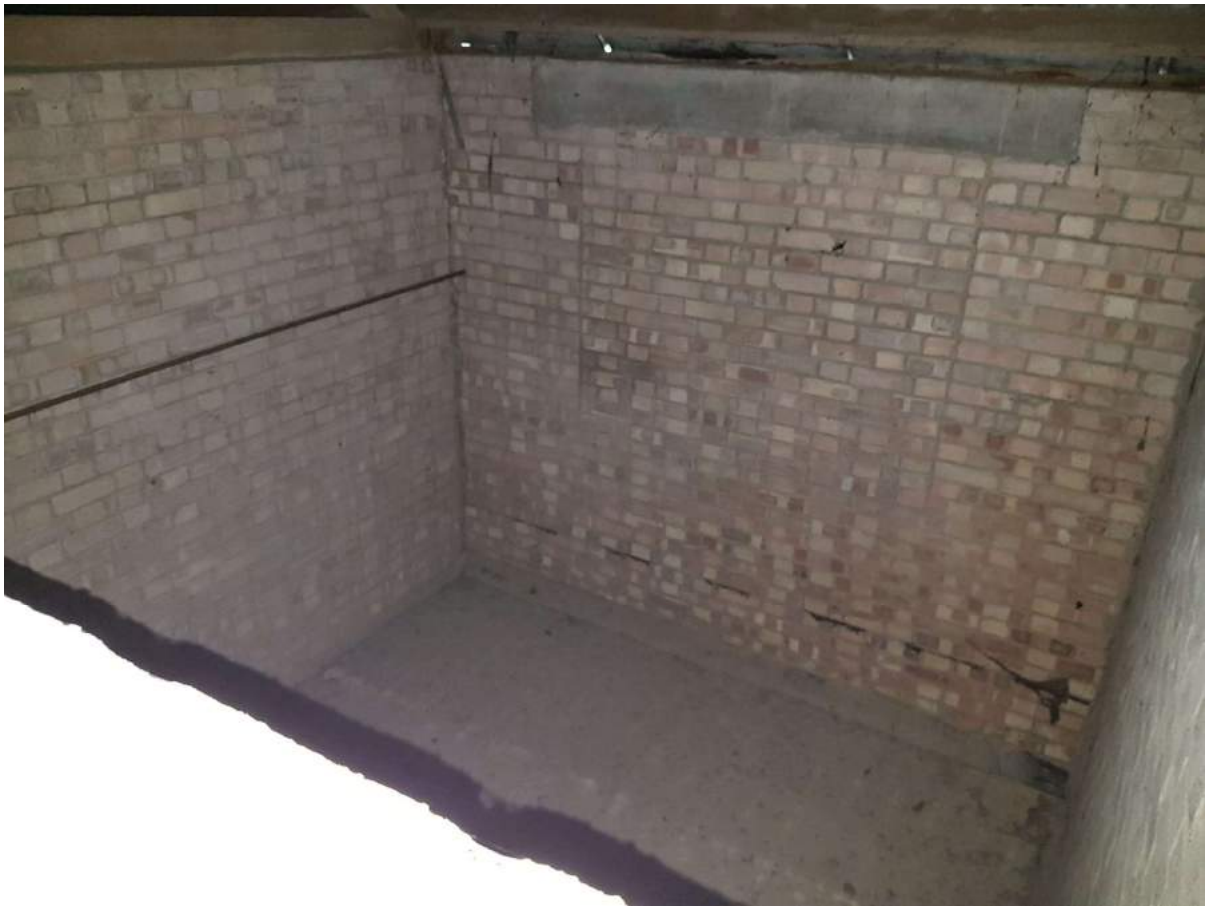
*Photograph 13 – Installed Steel Tie in Barn A*

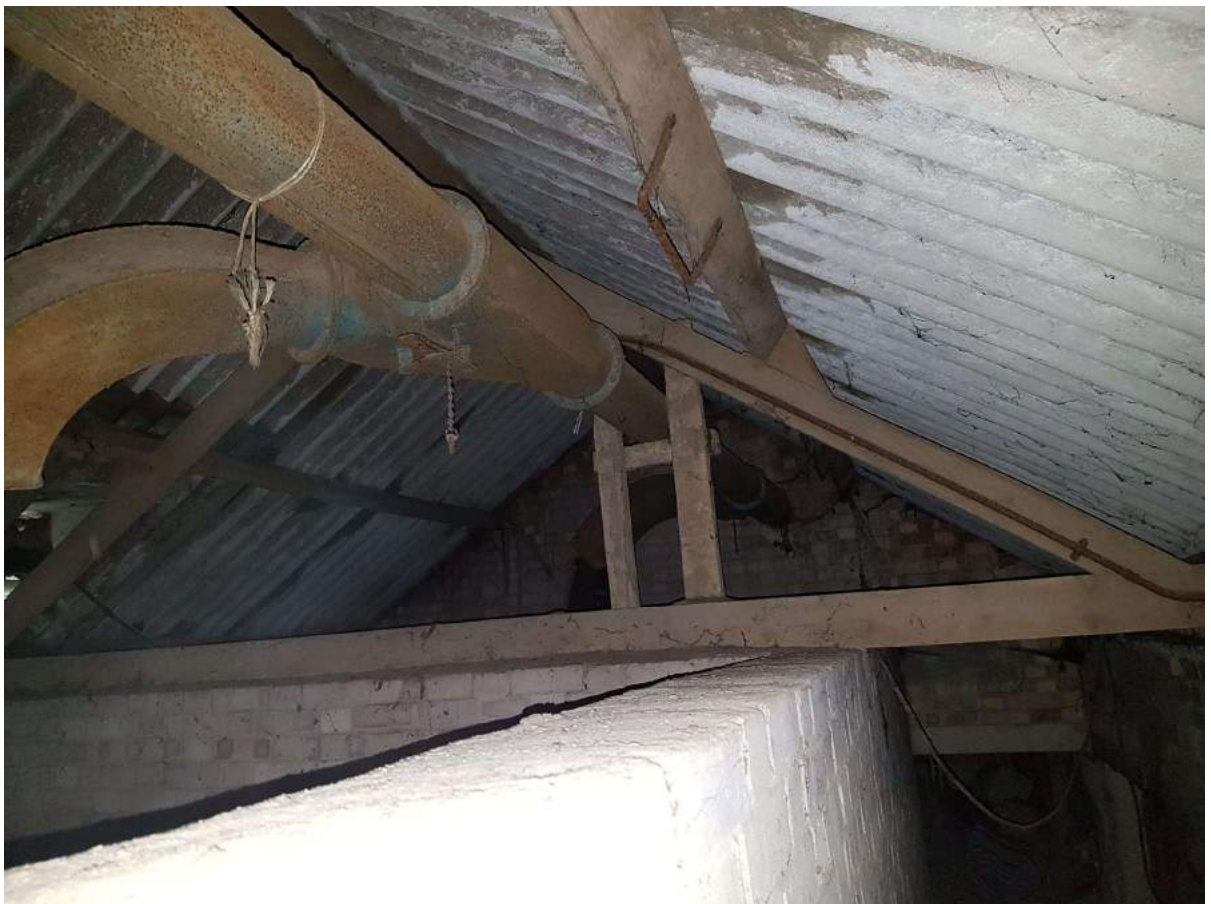
Barn A is a single storey long barn with a corrugated cement-based sheeting roof. The walls are of masonry construction and the roof is formed from timber trusses with timber purlins spanning between them. The roof trusses are in good condition but may need to be strengthened to accommodate the additional roof loads due to insulation/ ceiling installation.

*Photograph 14 – Timber Truss, Purlins and Roof Sheeting in Barn A*

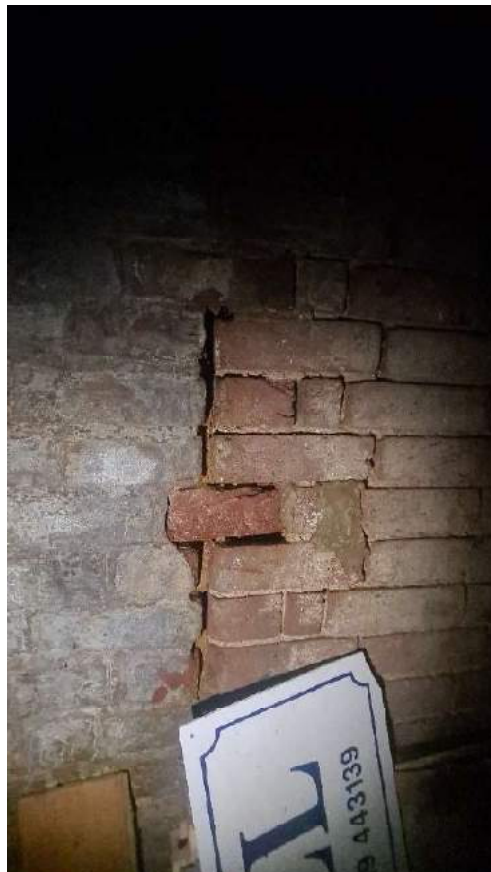
*Photograph 16 – Masonry infill junction to be repaired*

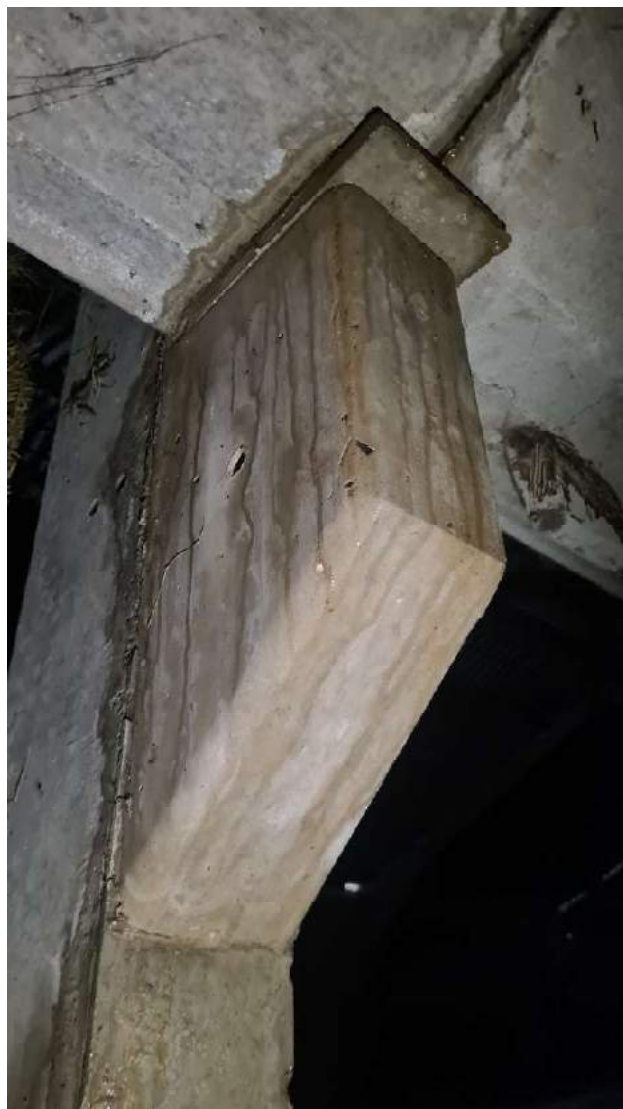
*Photograph 18 – Gutter junction with water ingress*

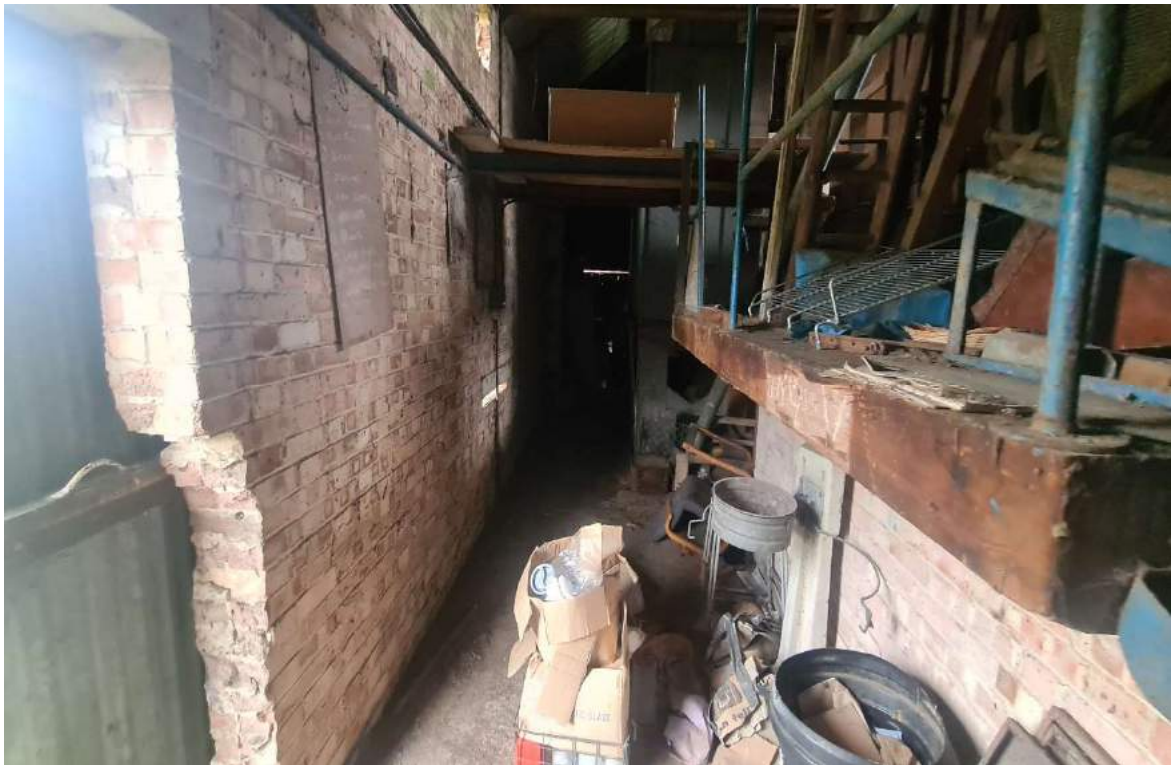
The masonry is in good condition and only a couple of areas require minor repairs where makeshift lintels have been installed to form openings.

*Photograph 24 – Removed brickwork at entrance door to Barn B*

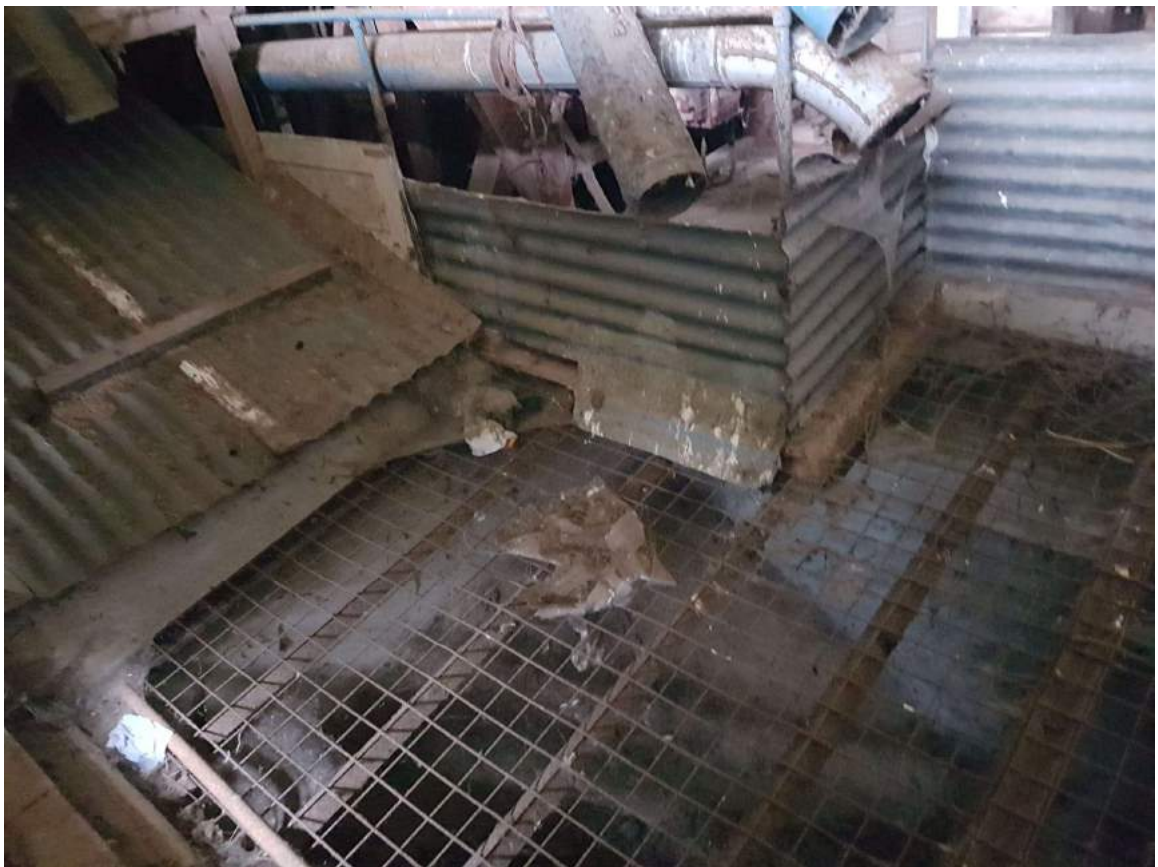
The floor hopper occupies approximately one third of the floor space of Barn B and it is assumed that the hopper will be infilled to provide a level floor across the entire barn.

*Photograph 30 – Floor Hopper Barn B*

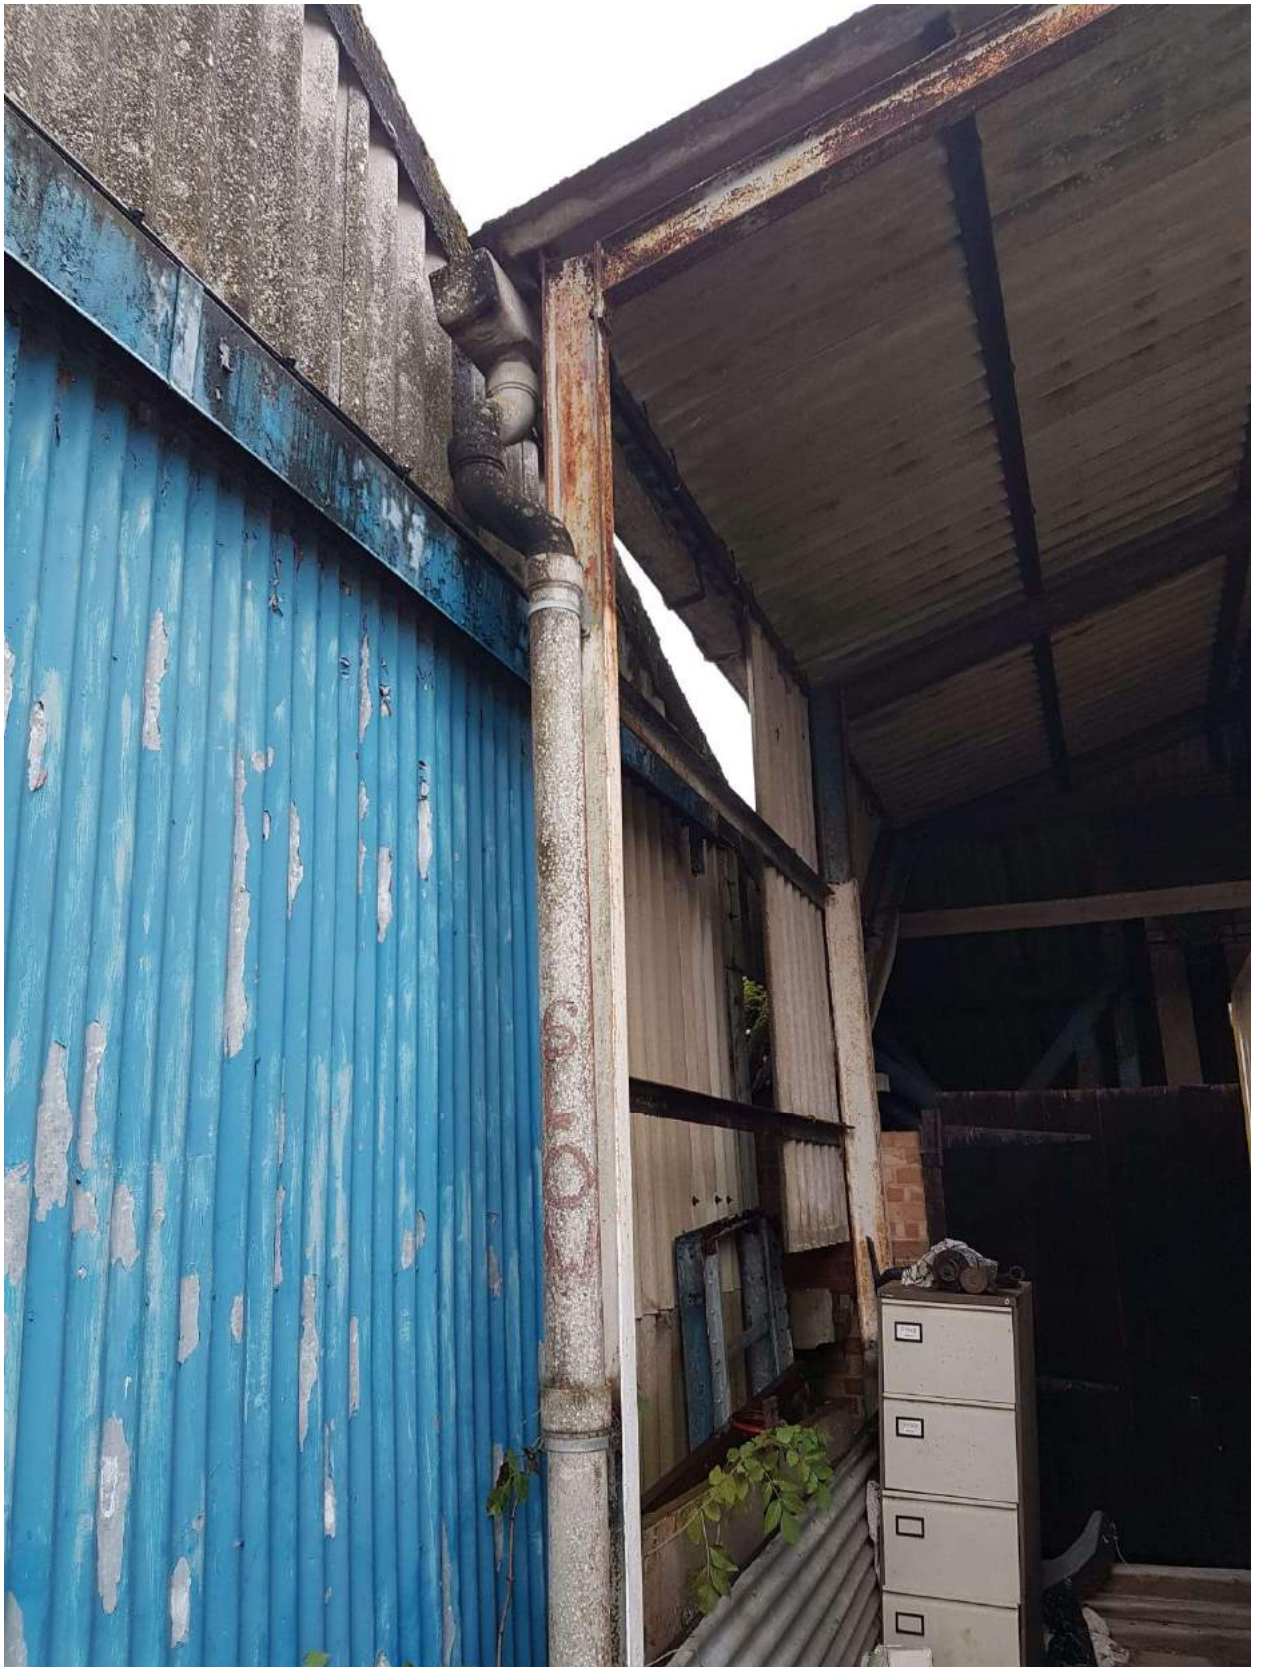
The lean to area comprises a steel frame with corrugated tin sheeting to the walls and roof. The steelwork frame and sheeting are in fair condition with visible rusting and will need replacing as part of any new development.

*Photograph 32 – Open front lean-to steel frame structure with corrugated tin walls and roof*

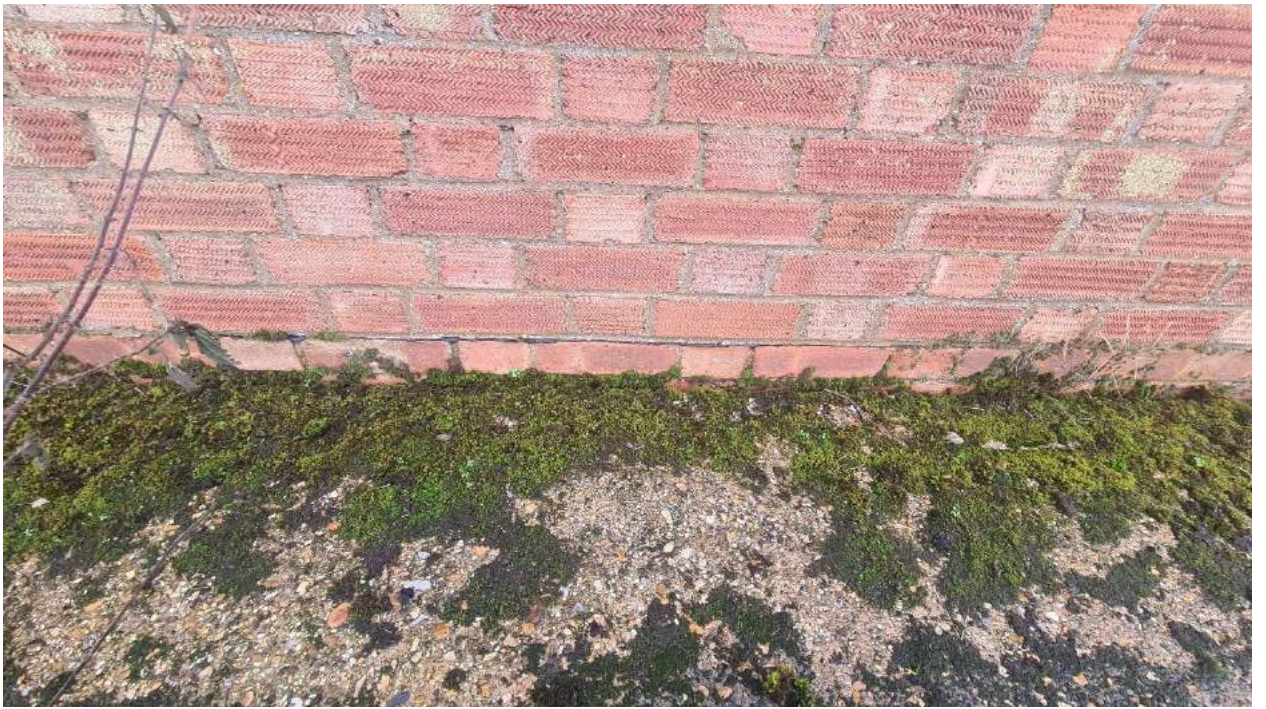
*Photograph 40 – Slate DPC*
