# Arboricultural Consultancy for Acromas Insurance Company Ltd

| Insured | Gail Dennehy | Address | 28 Rowan Crescent, Letchworth Garden City, SG6 4EY | | |

**Scope of Report:** To survey the property and determine significant vegetation contributing to subsidence damage, make recommendation for remedial action and assess initial mitigation and recovery prospects. The survey does not make an assessment for decay or hazard evaluation.

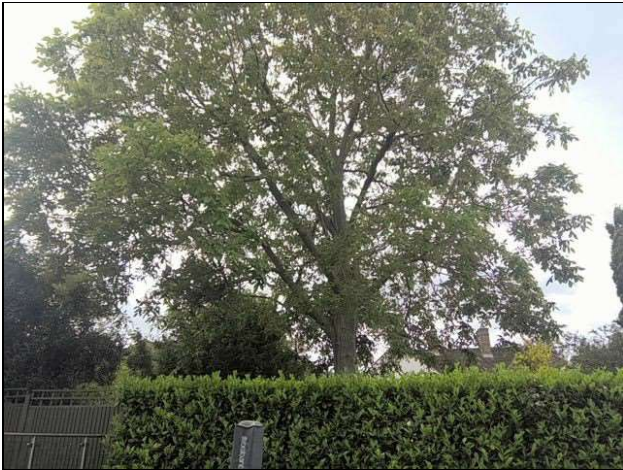
T1 - Walnut

With due regards to species profile, size and proximity, T1 (Walnut) is considered the dominant feature proximate to the focal area(s) of movement and accordingly, where vegetation is confirmed as being causal, we have identified it as the primary cause of the current subsidence damage.

| Tree No. | Species | Age Cat | Approx. Height (m) | Distance to Building (m) * | Ownership | Action | Requirement |
|---|---|---|---|---|---|---|---|
| T1 | Walnut | 3 | 16 | 8.1 | A - Third Party<br>29 Bedford Road | Remove | Remove close to ground level and treat stump(s) to inhibit regrowth. |

Consequently, we have advocated the complete removal of T1 & T2 as it will offer the most certain arboricultural solution likely to restore long-term stability.

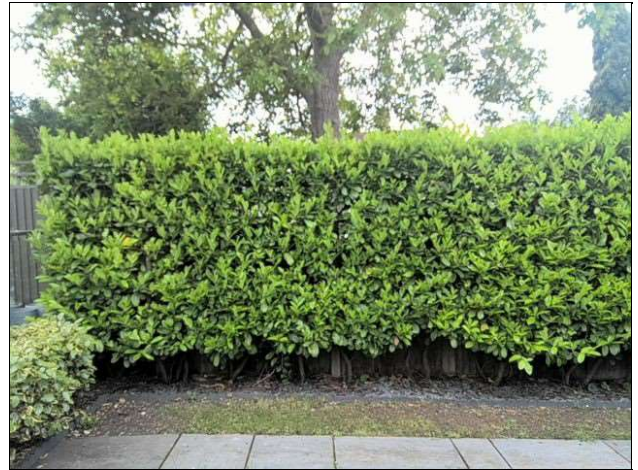
H1 - Laurel (Cherry)

| Tree No. | Species | Age Cat | Approx. Height (m) | Distance to Building (m) * | Ownership | Action | Requirement |
|---|---|---|---|---|---|---|---|
| H1 | Laurel (Cherry) | 1 | 2 | 4.1 | C - Insured | Action to avoid future risk | Maintain at, or below current dimensions by way of regular pruning. |

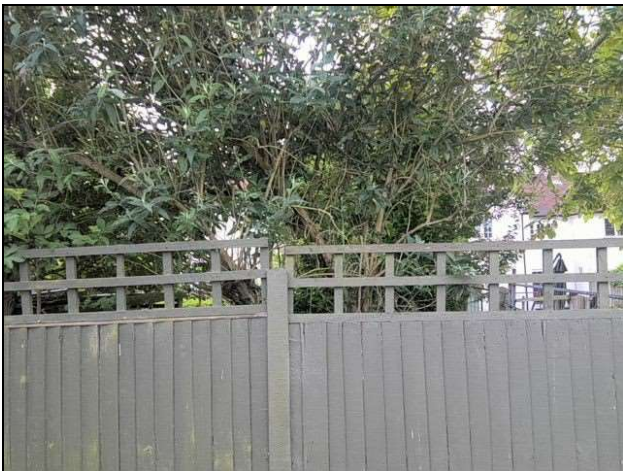
S1 - Buddleia

| Tree No. | Species | Age Cat | Approx. Height (m) | Distance to Building (m) * | Ownership | Action | Requirement |
|---|---|---|---|---|---|---|---|
| S1 | Buddleia | 1 | 4 | 2.8 | A - Third Party<br>27 Bedford Road | Action to avoid future risk | Maintain at, or below current dimensions by way of regular pruning. |

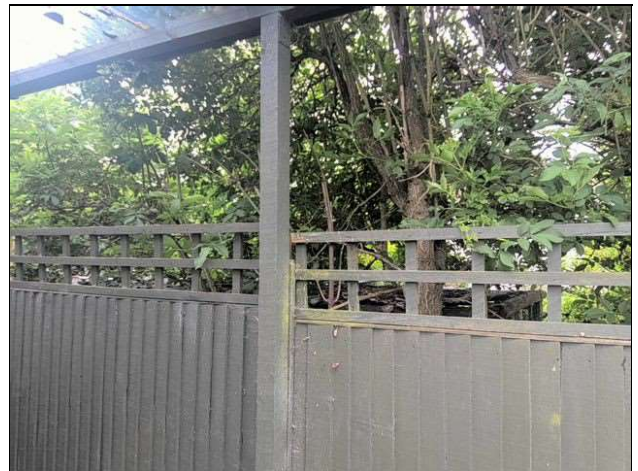
T2 - Elder

T2 (Elder) cannot be discounted as contributing to the overall level of soil drying proximate to the advised area of damage and is therefore also considered to be exerting a contributory influence, albeit in a limited / localised capacity when compared to T1.

| Tree No. | Species | Age Cat | Approx. Height (m) | Distance to Building (m) * | Ownership | Action | Requirement |
|---|---|---|---|---|---|---|---|
| T2 | Elder | 1 | 5 | 1.8 | A - Third Party<br>27 Bedford Road | Remove | Remove close to ground level and treat stump(s) to inhibit regrowth. |

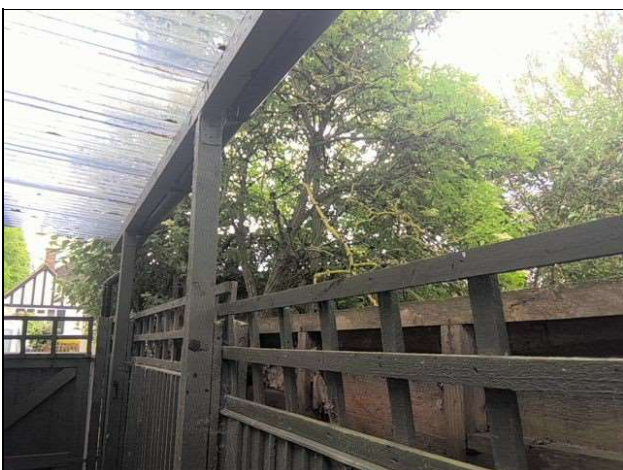
T3 - Elder

| Tree No. | Species | Age Cat | Approx. Height (m) | Distance to Building (m) * | Ownership | Action | Requirement |
|---|---|---|---|---|---|---|---|
| T3 | Elder | 1 | 4 | 1.4 | A - Third Party<br>27 Bedford Road | Action to avoid future risk | Maintain at, or below current dimensions by way of regular pruning. |

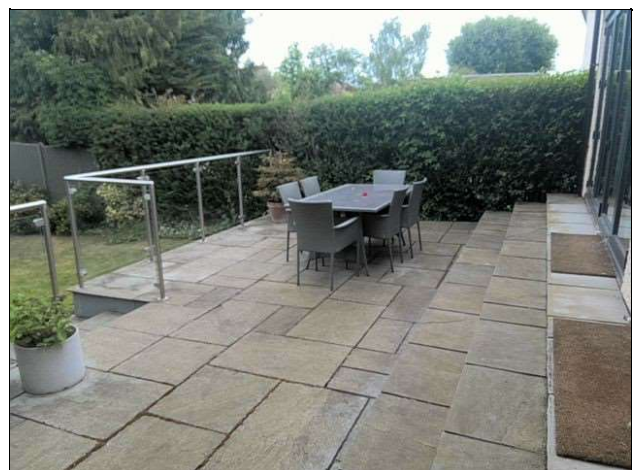
H2 - Mixed species hedge

| Tree No. | Species | Age Cat | Approx. Height (m) | Distance to Building (m) * | Ownership | Action | Requirement |
|---|---|---|---|---|---|---|---|
| H2 | Mixed species hedge | 1 | 2 | 0.3 | A - Third Party<br>26 | Action to avoid future risk | Maintain at, or below current dimensions by way of regular pruning. |

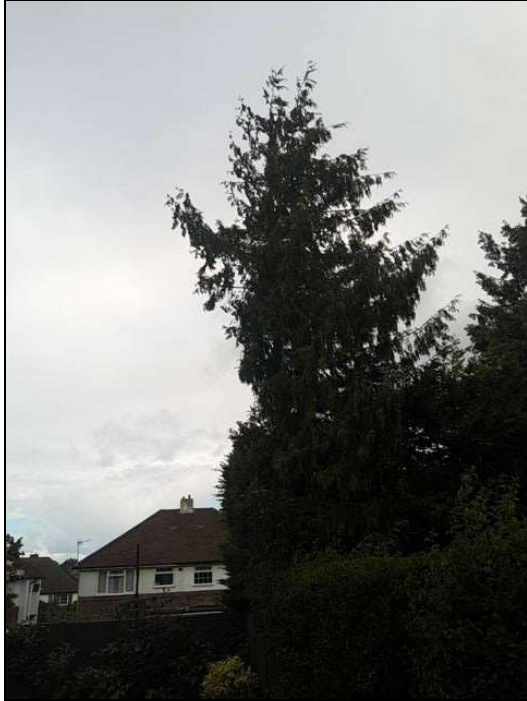
T4 - Cypress

| Tree No. | Species | Age Cat | Approx. Height (m) | Distance to Building (m) * | Ownership | Action | Requirement |
|---|---|---|---|---|---|---|---|
| T4 | Cypress | 1 | 12.5 | 11.5 | A - Third Party<br>26 | Action to avoid future risk | Maintain at, or below current dimensions by way of regular pruning. |

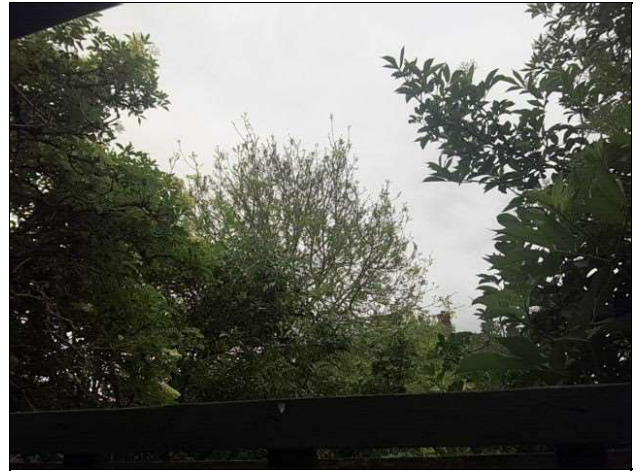
T5 - Ash

| Tree No. | Species | Age Cat | Approx. Height (m) | Distance to Building (m) * | Ownership | Action | Requirement |
|---|---|---|---|---|---|---|---|
| T5 | Ash | 1 | 9 | 11.0 | A - Third Party<br>27 Bedford Road | Action to avoid future risk | Maintain at, or below current dimensions by way of regular pruning. |

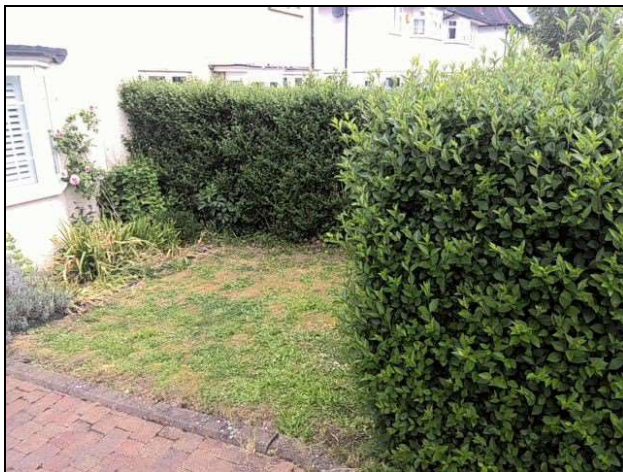
H3 - Privet

| Tree No. | Species | Age Cat | Approx. Height (m) | Distance to Building (m) * | Ownership | Action | Requirement |
|---|---|---|---|---|---|---|---|
| H3 | Privet | 1 | 2 | 0.5 | C - Insured | Action to avoid future risk | Maintain at, or below current dimensions by way of regular pruning. |
