# Arboricultural Consultancy for Lloyds Bank

| Insured | Mr Ramone Mclean Mrs Anisha Mclean | Address | 173 Jackmans Place, Letchworth, SG6 1RG | | |
| Client | Subsidence Management Services | Contact | Refer to iSubs | Claim No. | IFS-LBG-SUB-25-0124601 |

The insured structure is a 2 storey end-terrace house. The property occupies a level site with no adverse topographical features.

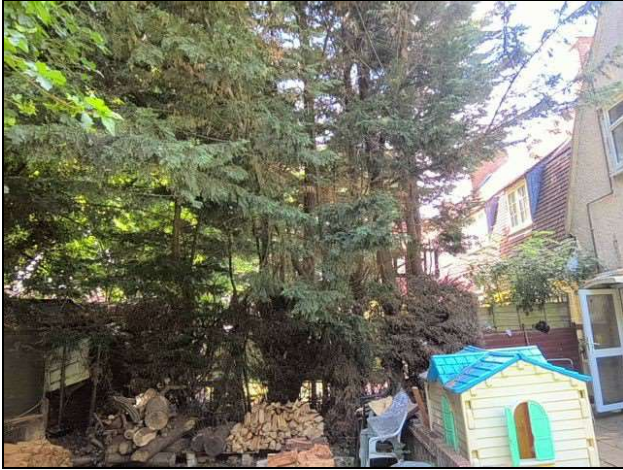
H1 - Cypress

With due regards to species profile, size and proximity, H1 (Cypress) and T1 (Hornbeam) are considered the dominant features proximate to the focal area(s) of movement and accordingly, where vegetation is confirmed as being causal, we have

The size and proximity of the above vegetation is consistent with the advised location(s) of damage and it is our opinion, on balance of probability, that roots from the above vegetation will be in proximity to the footings of the insured property.

Consequently, we have advocated the complete removal of H1 and T1 as it will offer the most certain arboricultural solution likely to restore long-term stability.

| Tree No. | Species | Age Cat | Approx. Height (m) | Distance to Building (m) * | Ownership | Action | Requirement |
|---|---|---|---|---|---|---|---|
| H1 | Cypress | 1 | 16 | 2.7 | C - Insured | Remove | Remove close to ground level. |

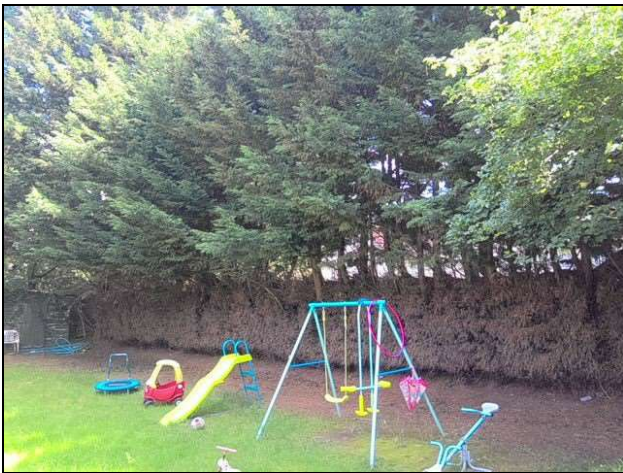
H2 - Cypress

Please note that the footings of the insured property fall within the anticipated rooting distance of additional vegetation which we believe presents a foreseeable risk of future damage and accordingly we have made recommendations in respect of this.

| Tree No. | Species | Age Cat | Approx. Height (m) | Distance to Building (m) * | Ownership | Action | Requirement |
|---|---|---|---|---|---|---|---|
| H2 | Cypress | 1 | 13 | 12.5 | C - Insured | Action to avoid future risk | Maintain at, or below current dimensions by way of regular pruning. |

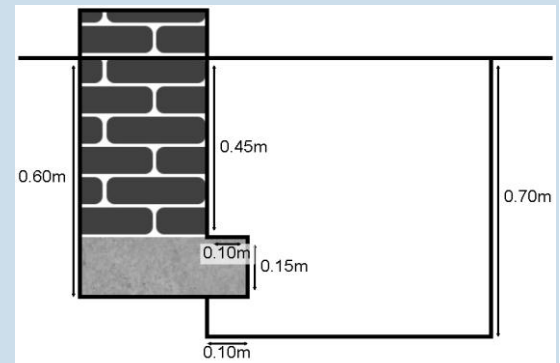
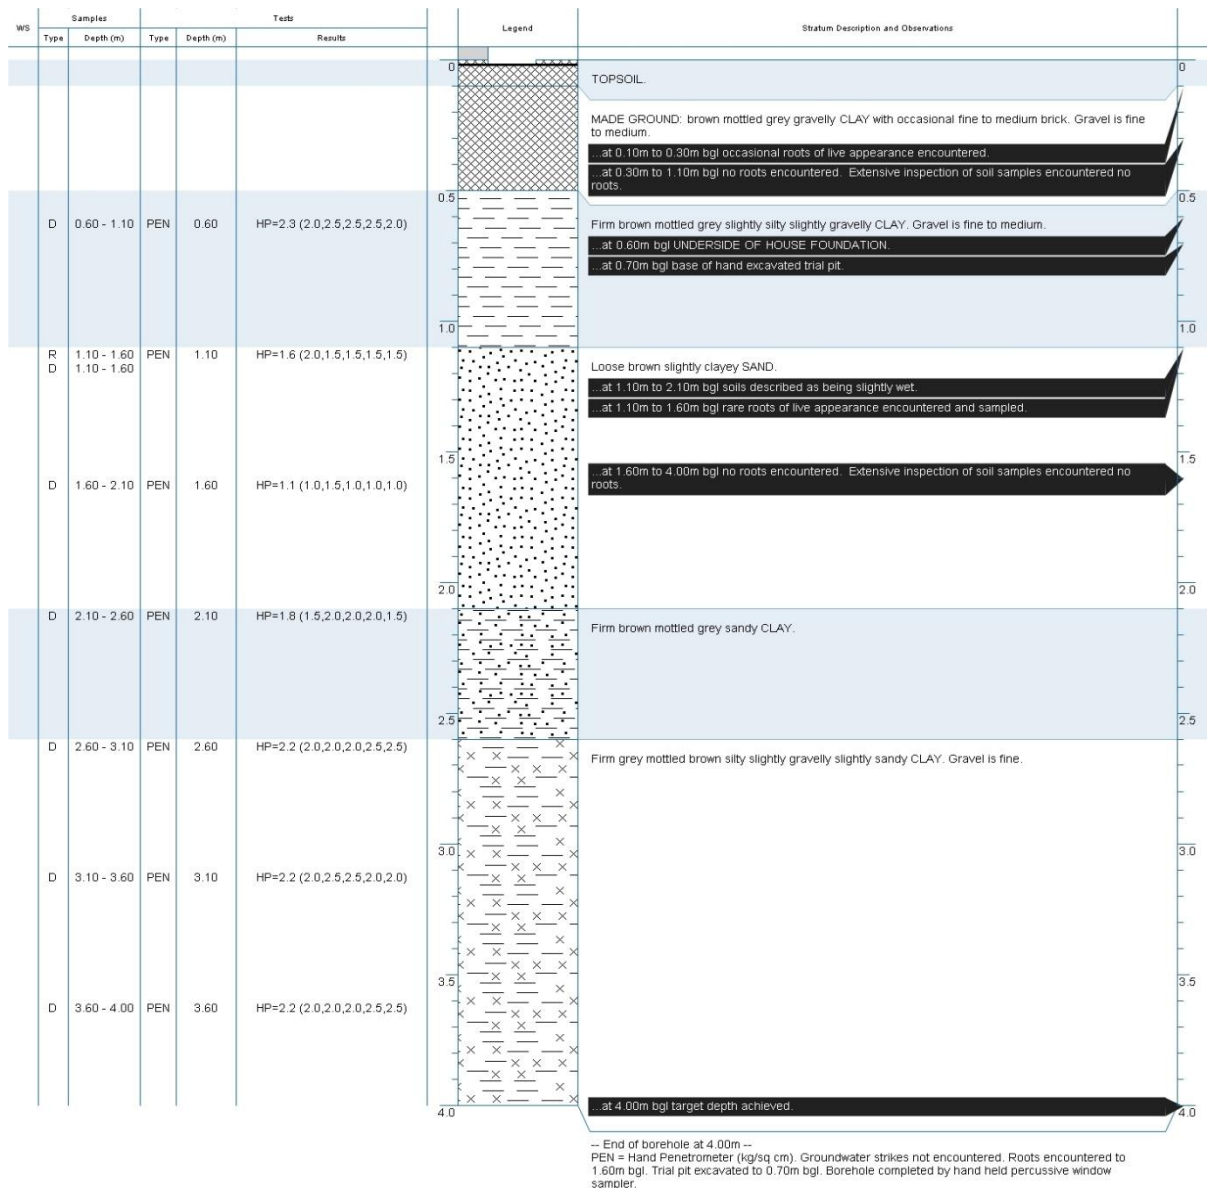
## TP/BH1 Foundation Detail and Borehole Log

House foundation comprised of brick wall to 450mm bgl, bearing on concrete to 600mm bgl, with a total projection of 100mm from the elevation. Underside of foundation (USF) was exposed to 100mm back from the face of the foundation and probed 400mm back from the face of the foundation.

At 0.60m bgl UNDERSIDE OF HOUSE FOUNDATION in TP/BH1.

At 0.10m to 0.30m bgl occasional roots of live appearance encountered in TP/BH1.

At 0.30m to 1.10m bgl no roots encountered. Extensive inspection of soil samples encountered no roots in TP/BH1.

At 1.10m to 1.60m bgl rare roots of live appearance encountered and sampled in TP/BH1.

At 1.60m to 4.00m bgl no roots encountered. Extensive inspection of soil samples encountered no roots in TP/BH1.
