**R & D for Asbestos containing materials at**

**Pumping Station  
Temple Dinsley  
School Lane  
Preston, Hitchin  
Hertfordshire, SG4 7RT**

SURVEY DATE; 14th August 2023

REFERENCE; ECB/5348

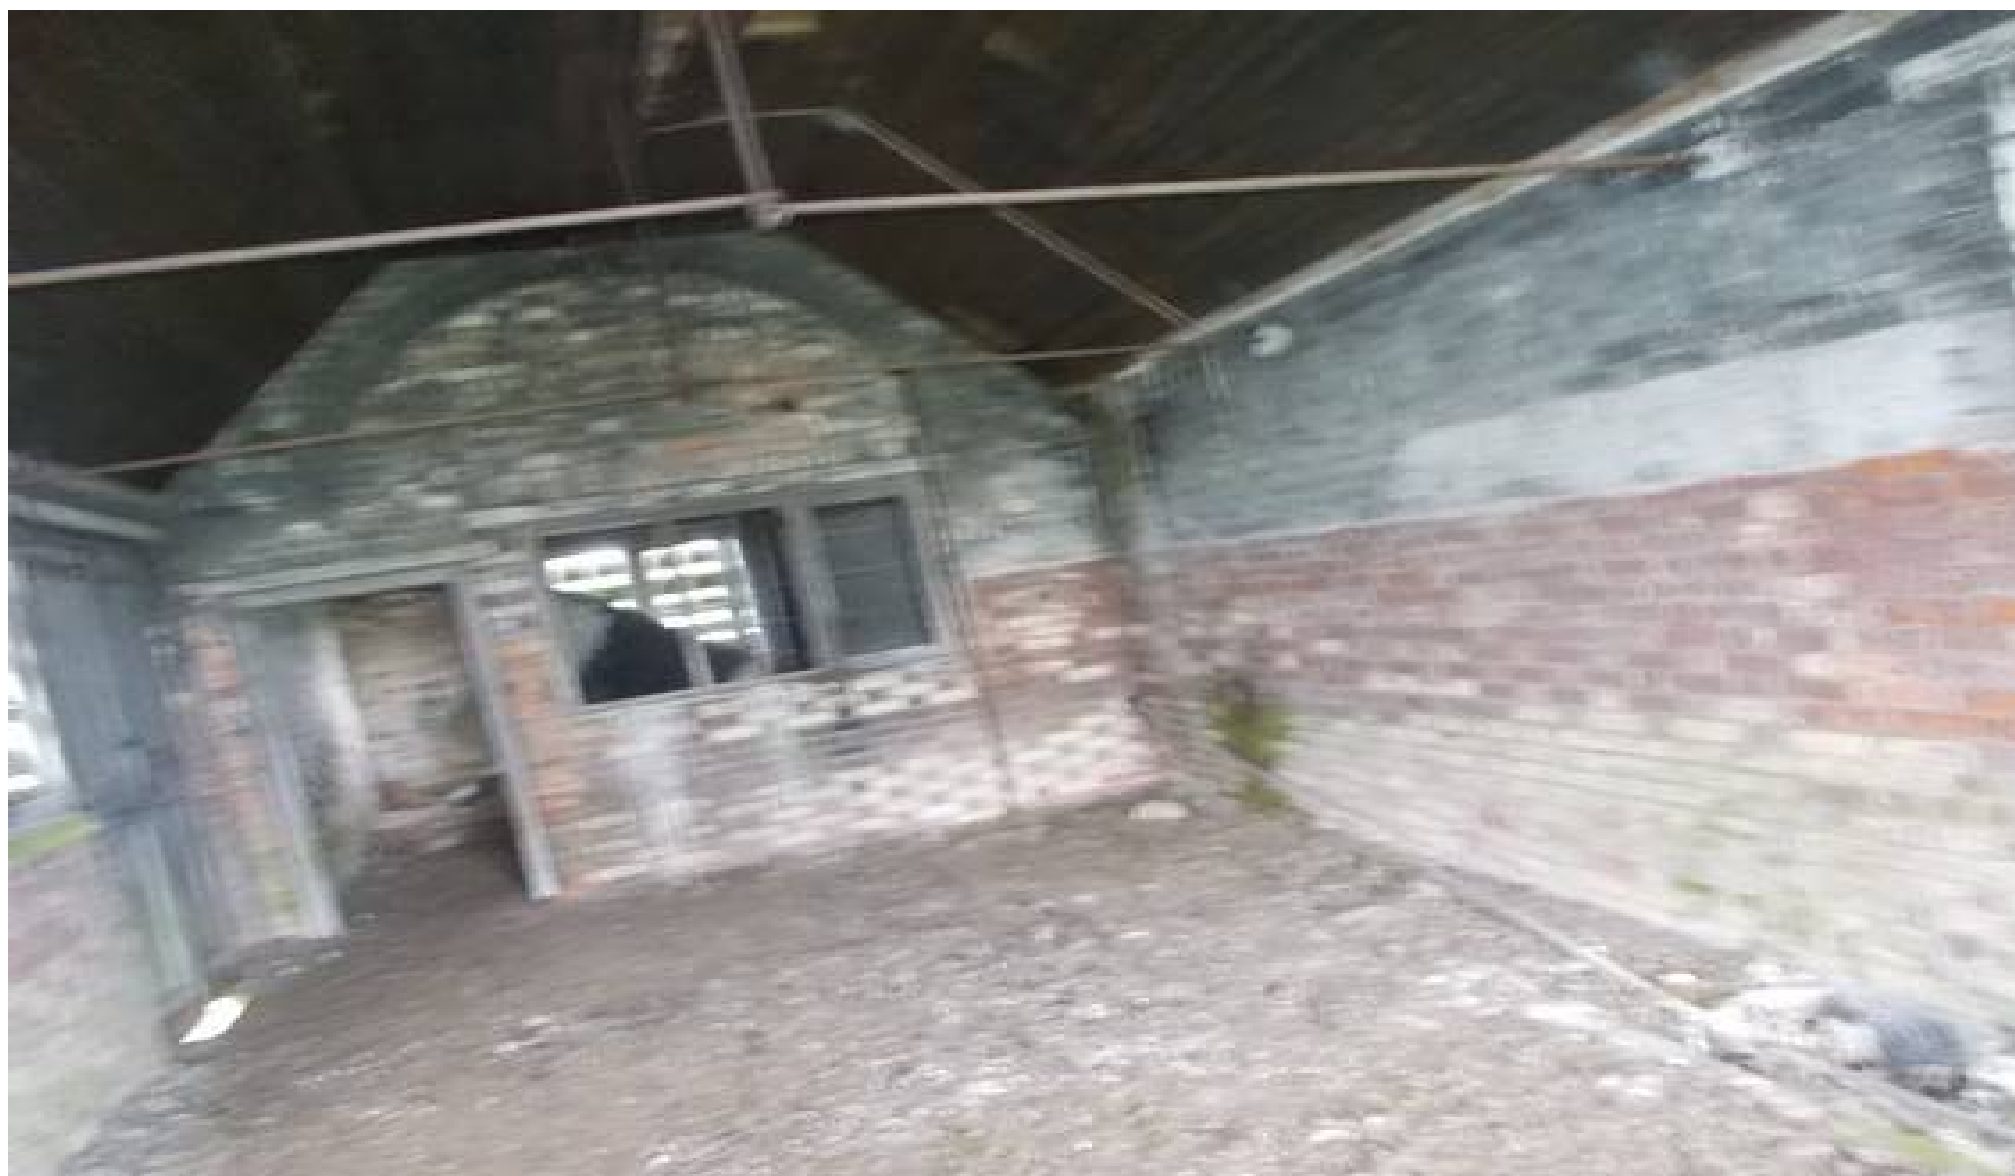
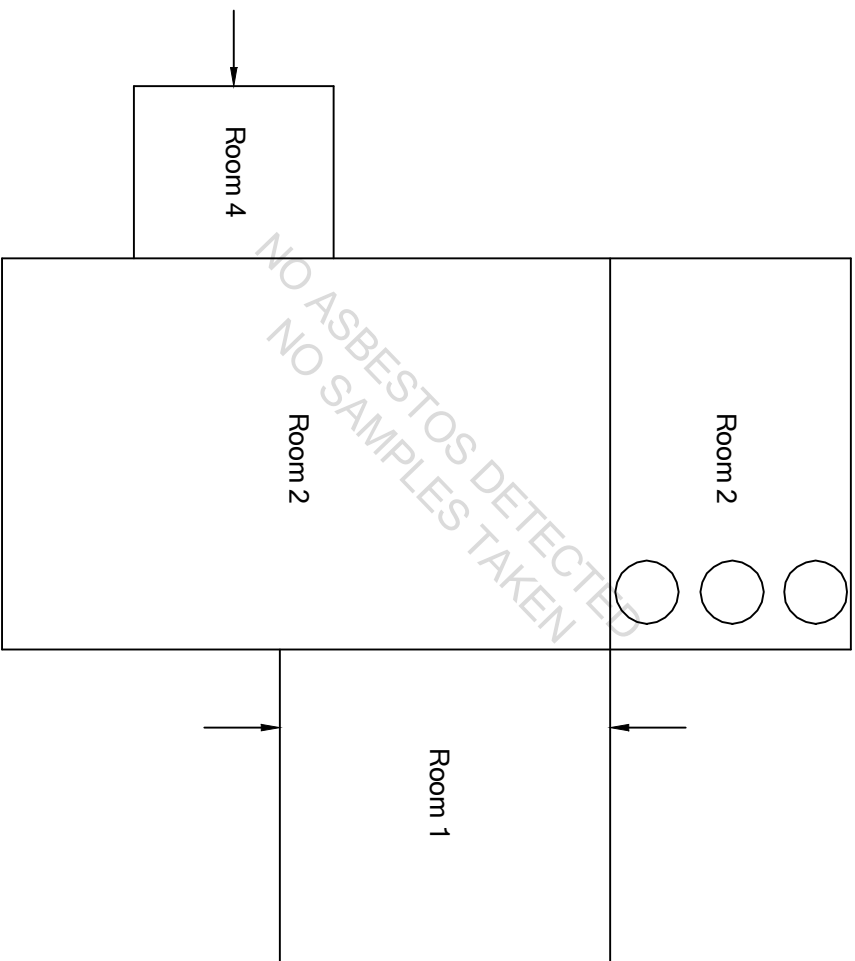
GROUND FLOOR

| Sample Date | Location Ref | Location ID | Drawing Reference | Area | Room | Asbestos Type | Product Name | Material Risk Score | Material Risk Band | Priority Risk Score | Comments | Action | Survey Type |
|---|---|---|---|---|---|---|---|---|---|---|---|---|---|
| 14/08/23 | Visual | 29435 | 1 | Main | All Areas | Not Applicable | N/A | 0 | Not Applicable | N/A | No asbestos was detected and no samples taken. | No Action Required | RDS |

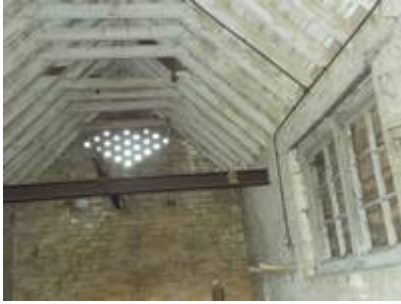
29435

Main: All Levels: All Areas: N/A

No asbestos was detected and no  
samples taken.

No Action Required
