**PLANNING REFERENCE 17/01955/1 Conditions 6 and 7**

ARBORICULTURAL IMPACT ASSESSMENT AND METHOD STATEMENT REPORT

Ickleford Mill, Arlesey Road, Ickleford

**OUR REF: SHA 1948**

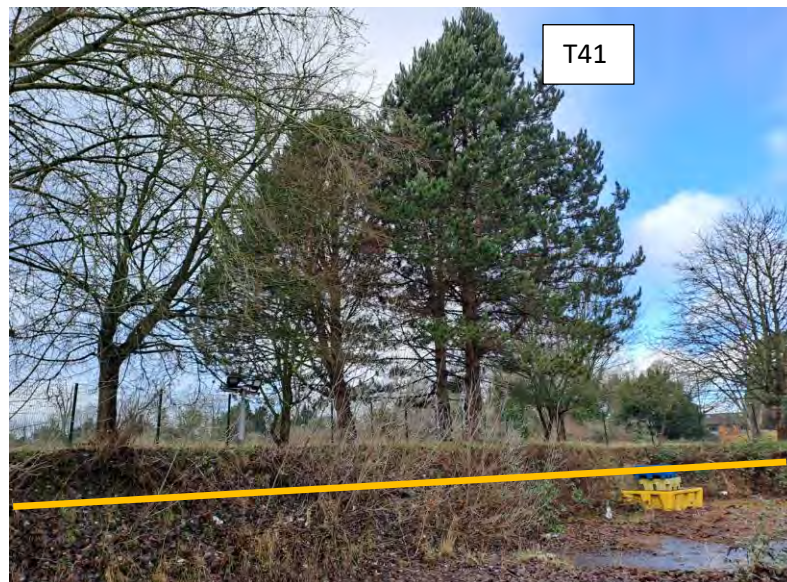
8.1 The trees on the northern and the western boundary (northern section) are on a raised bank. The bank is steep with a level change of 2m in some parts, and at the base the land is mostly laid to hard surface. Given the change in level, the facts that trees root generally in the top 600mm, raising the soil level up to the bank to reduce the steepness will not cause root asphyxiation or loss of physiological function. The tree protection fencing will be erected on the top of the bank to enable soil grading on, and up to, the bank. The raised areas will be planted with a native whip mix. The following photos and plans illustrate the proposed change.

*Photo 10 of north-western corner showing step bank and level change – annotated for proposed levels*

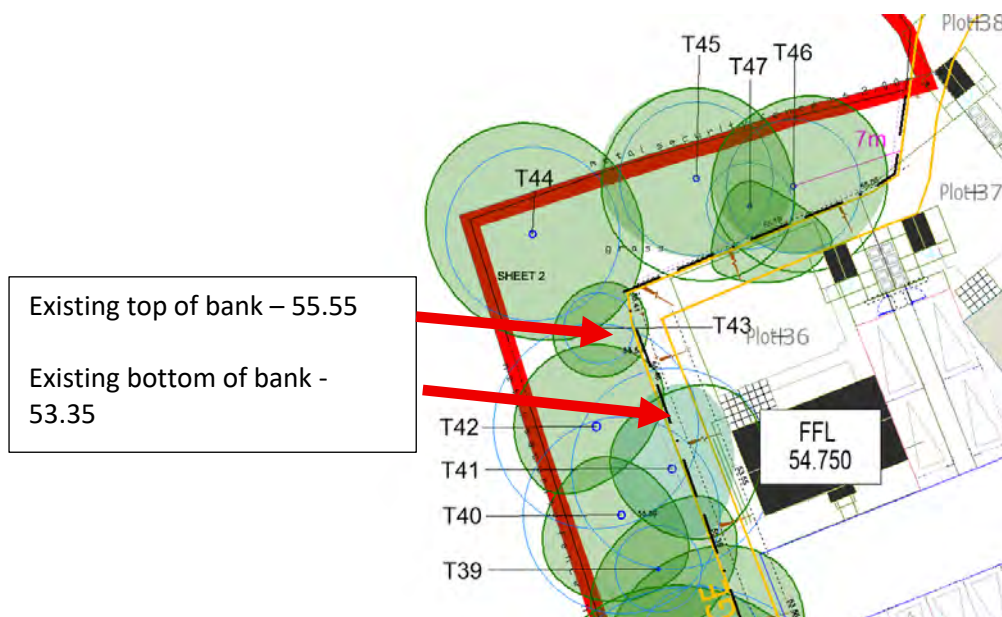
*Plan 6 – extract from SHA 1948 TPP2 – annotated.*

*Soil raising here will result in a bank of c.700mm height.*

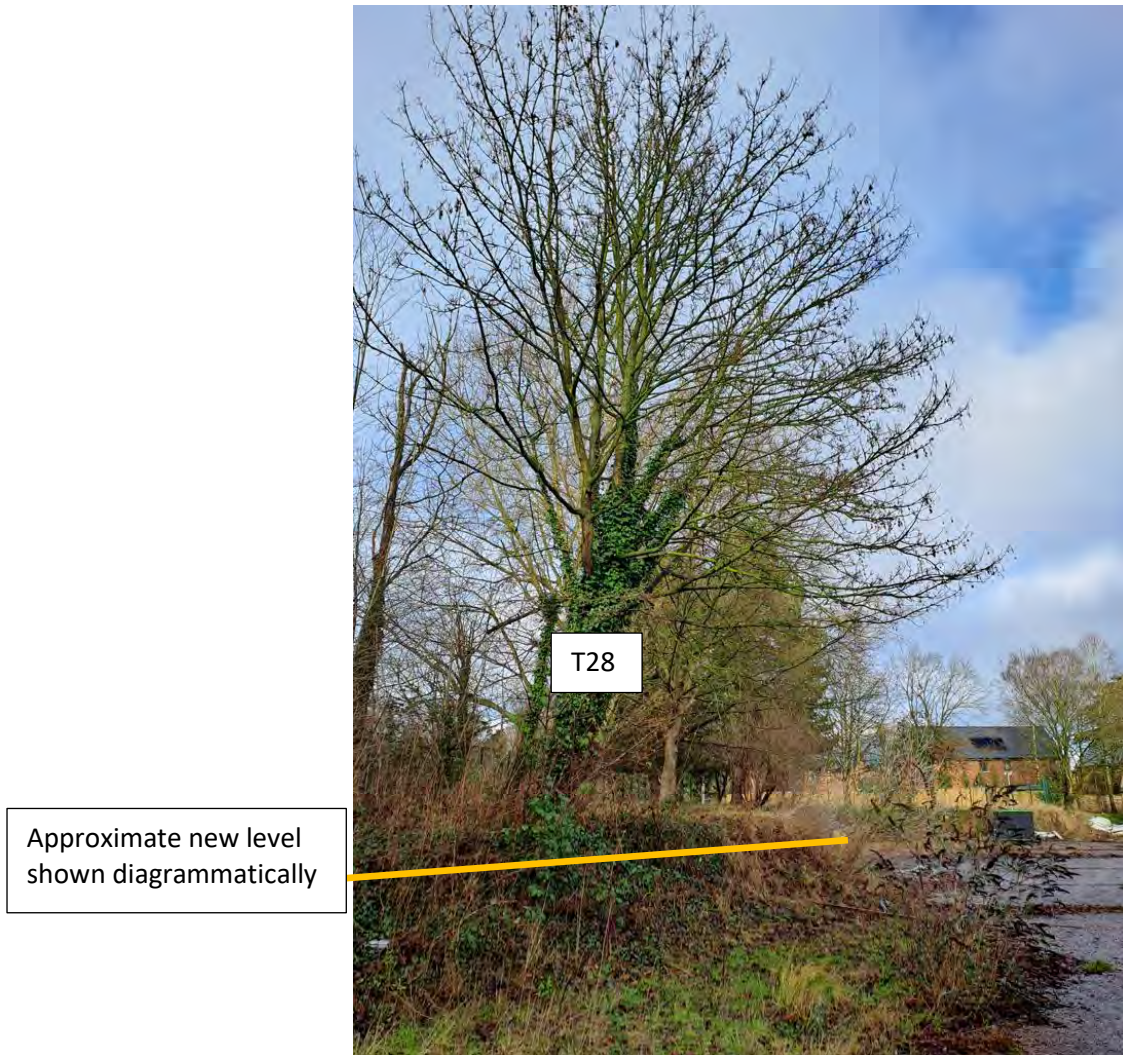
*Photo 11 of north-western edge showing step bank and level change – annotated for proposed levels at T28 looking north*

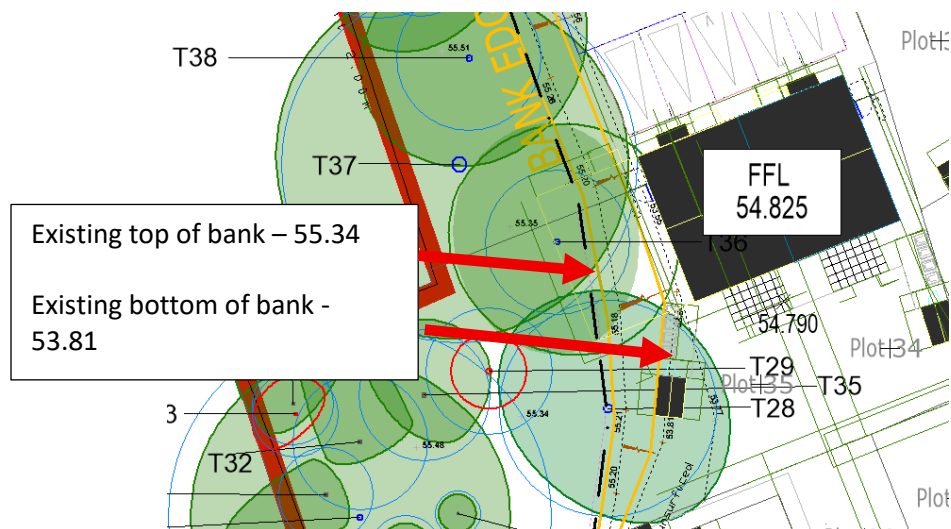
*Plan 7 – extract from SHA 1948 TPP2 – annotated. Soil raising here will result in a bank of c.500mm height.*

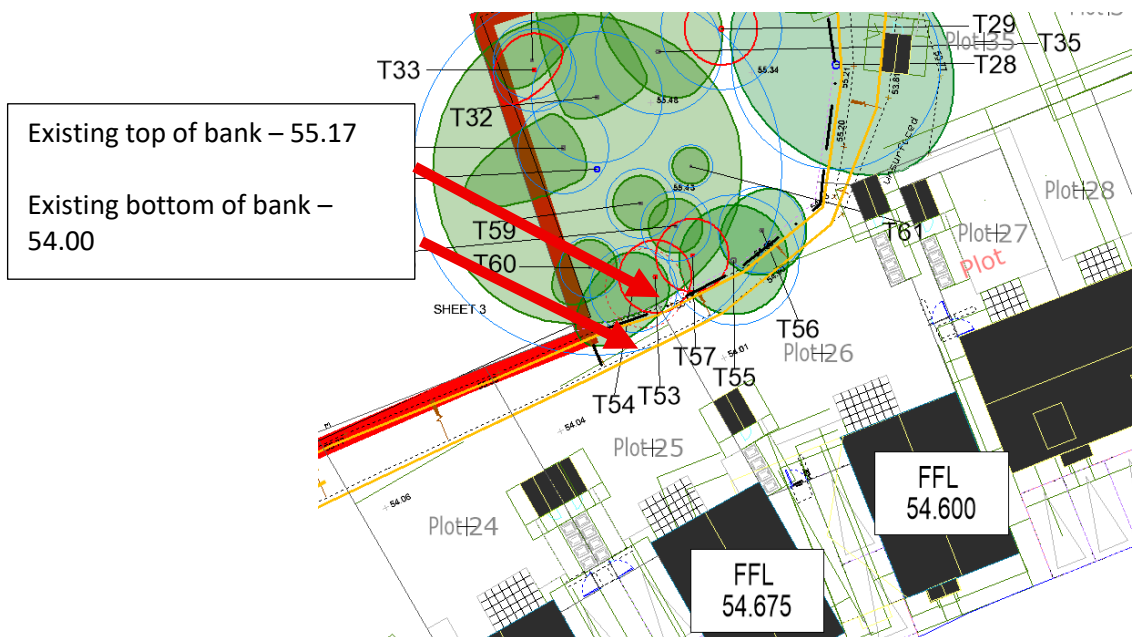
Plan 8 – extract from SHA 1948 TPP2 – annotated. Soil raising here will result in a bank of c.500mm height.

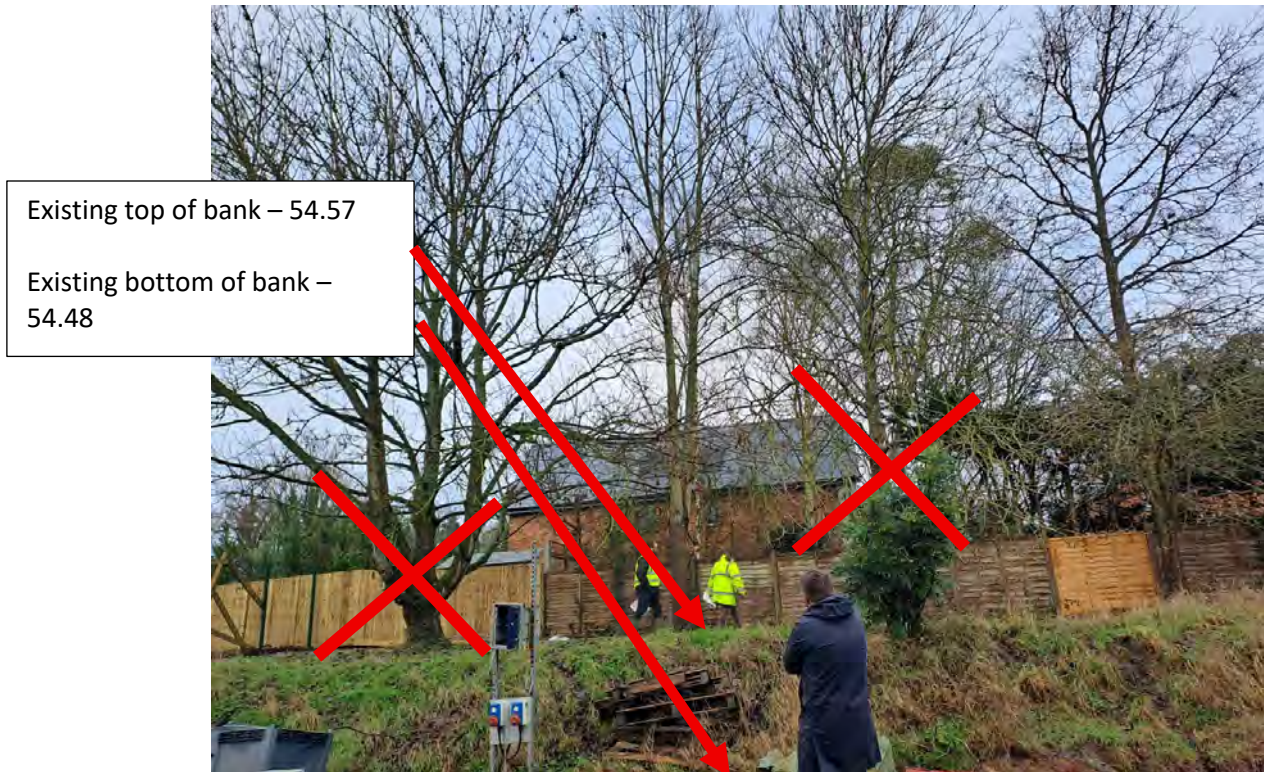
*Photo 13 of T49 and T51 looking north at the north-western part of the boundary.*

*Note trees with red X to be removed.*

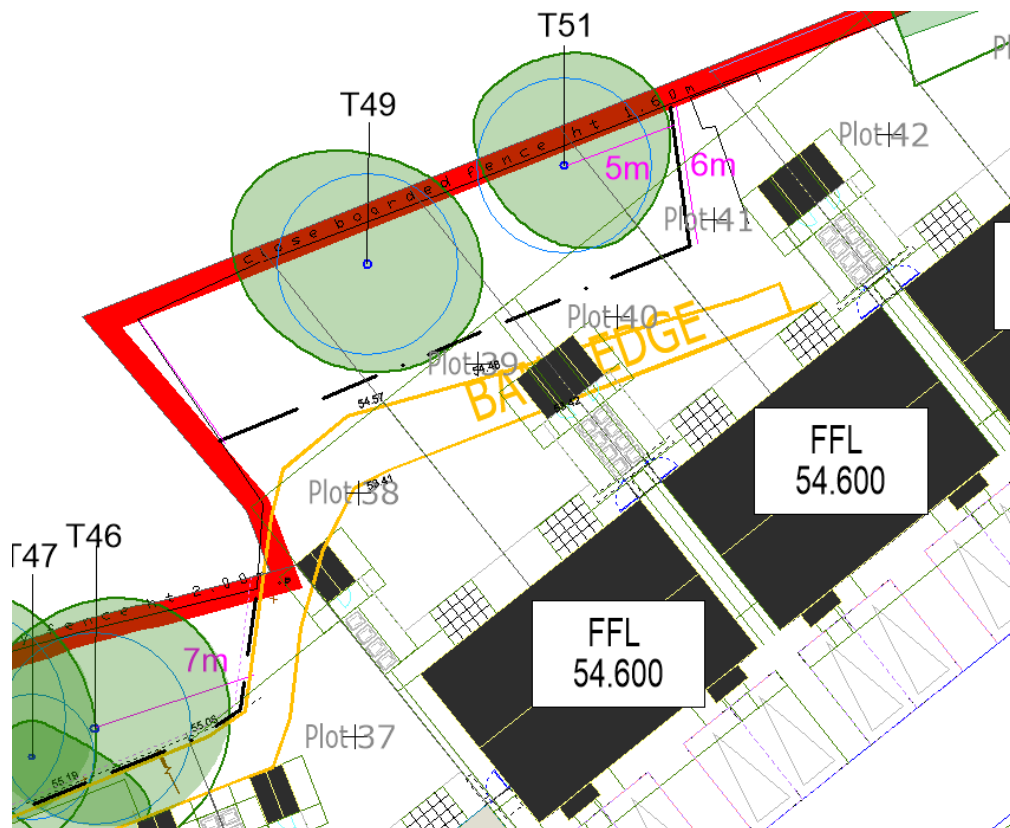
*Plan 9 – extract from SHA 1948 TPP2 – annotated. Soil raising here will result in raising of 112mm, which given the trees being removed are on the edge occupying root space near the change in level, has no arboricultural impact.*

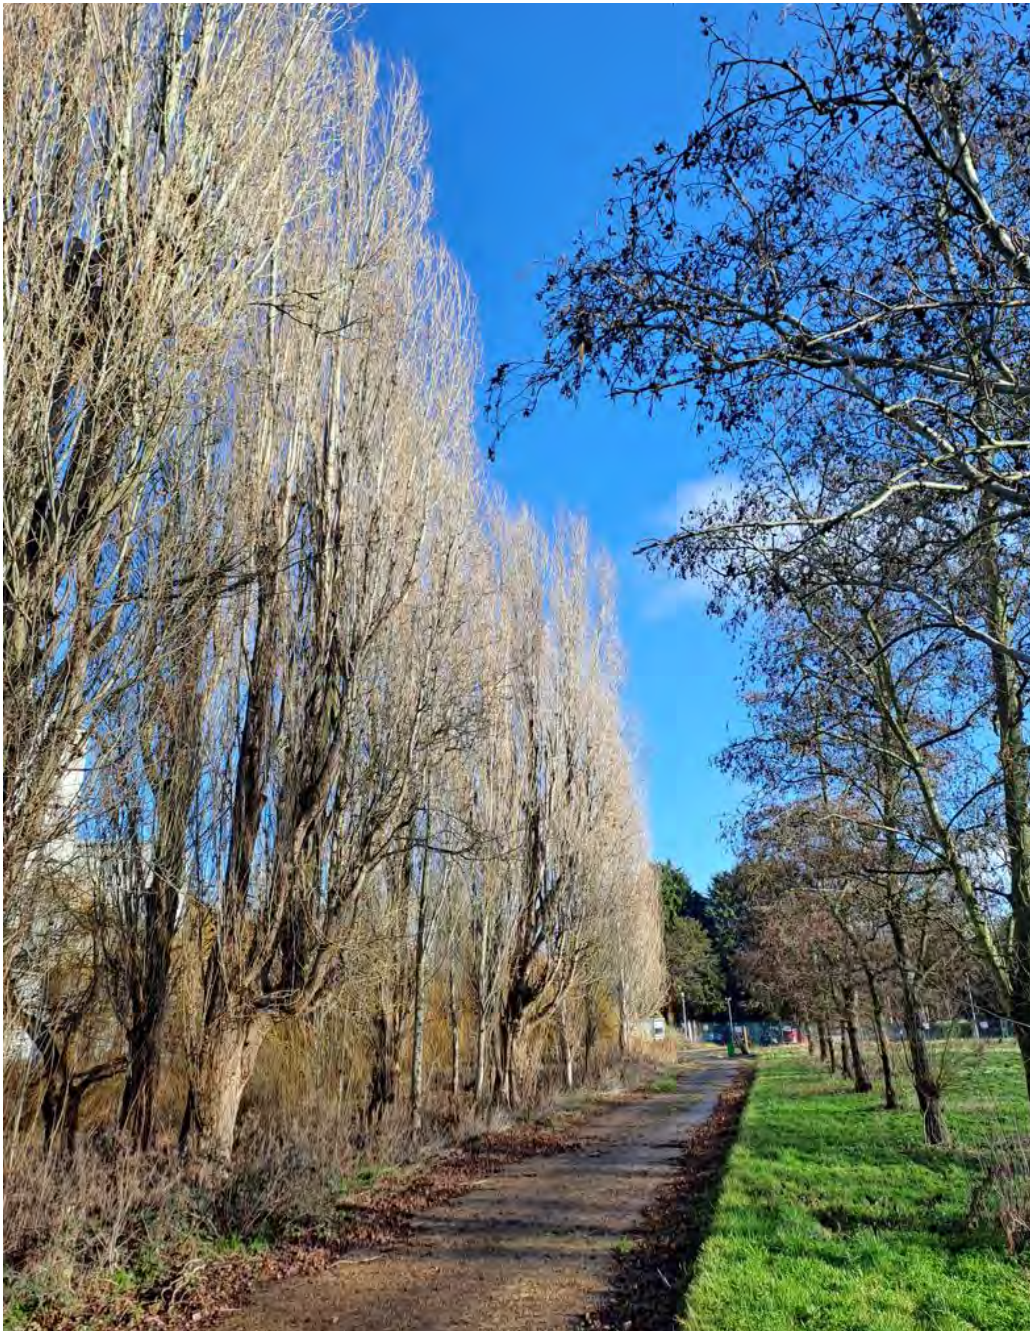
*Photo 14 of the poplars on the northern part of the existing path and alders on the southern side.*

*Looking east. Note that the removal of the path and replacement path with hoggins is beneficial as this surface is flexible and adjusts to tree root growth without causing cracking.*

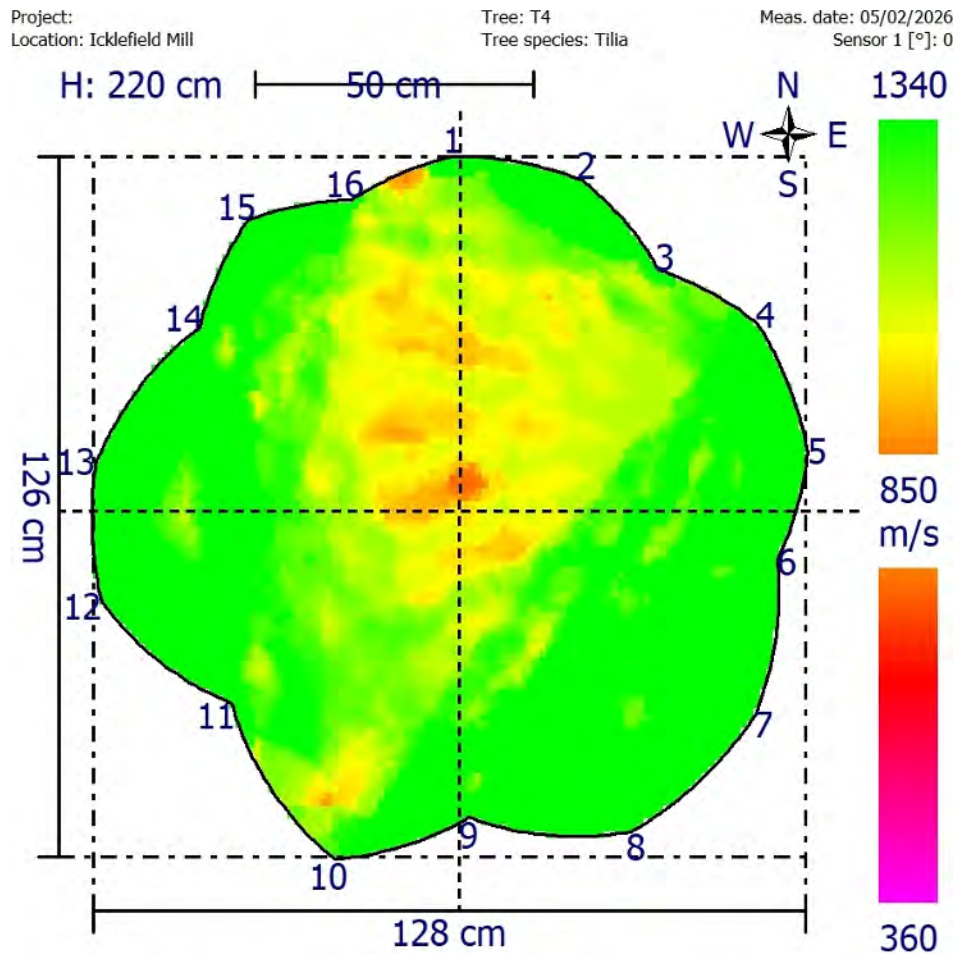
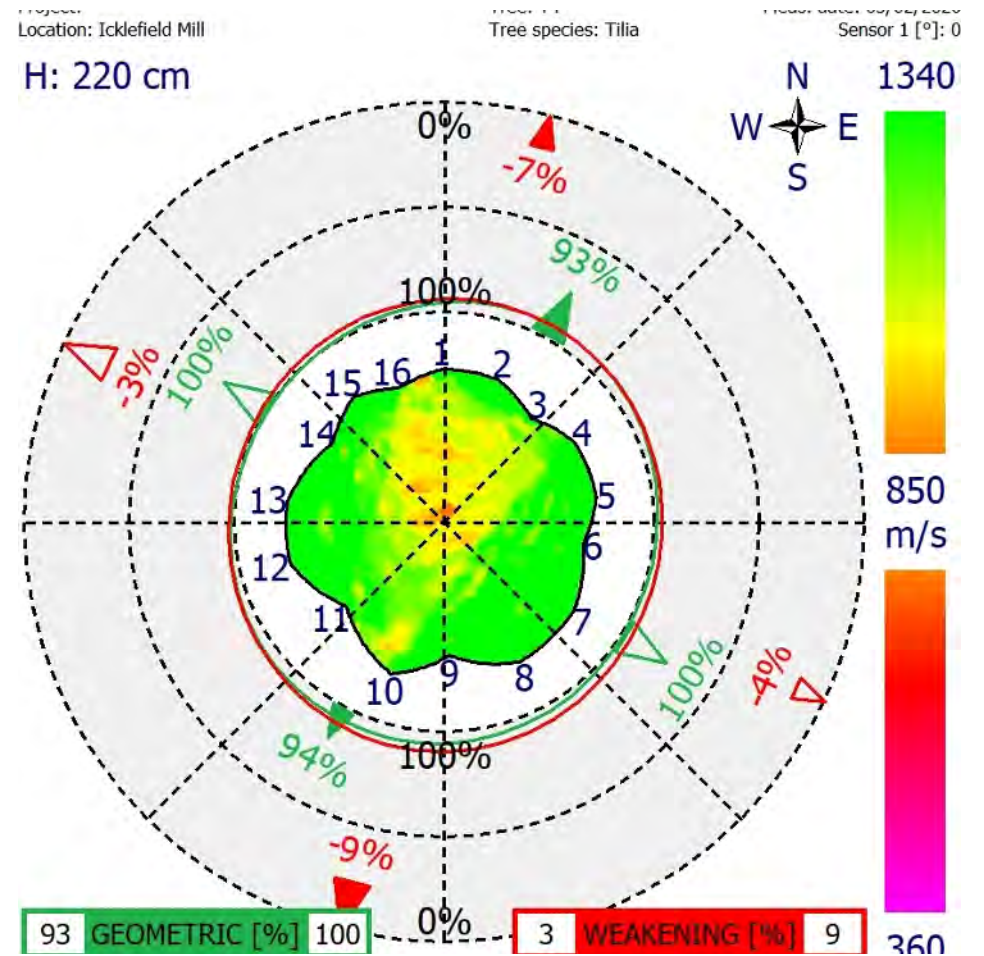
# Tomography - T4 at 220cm

Decay at 220cm above ground level is moderate. Impact on mechanical strength is low to moderate at 9%.

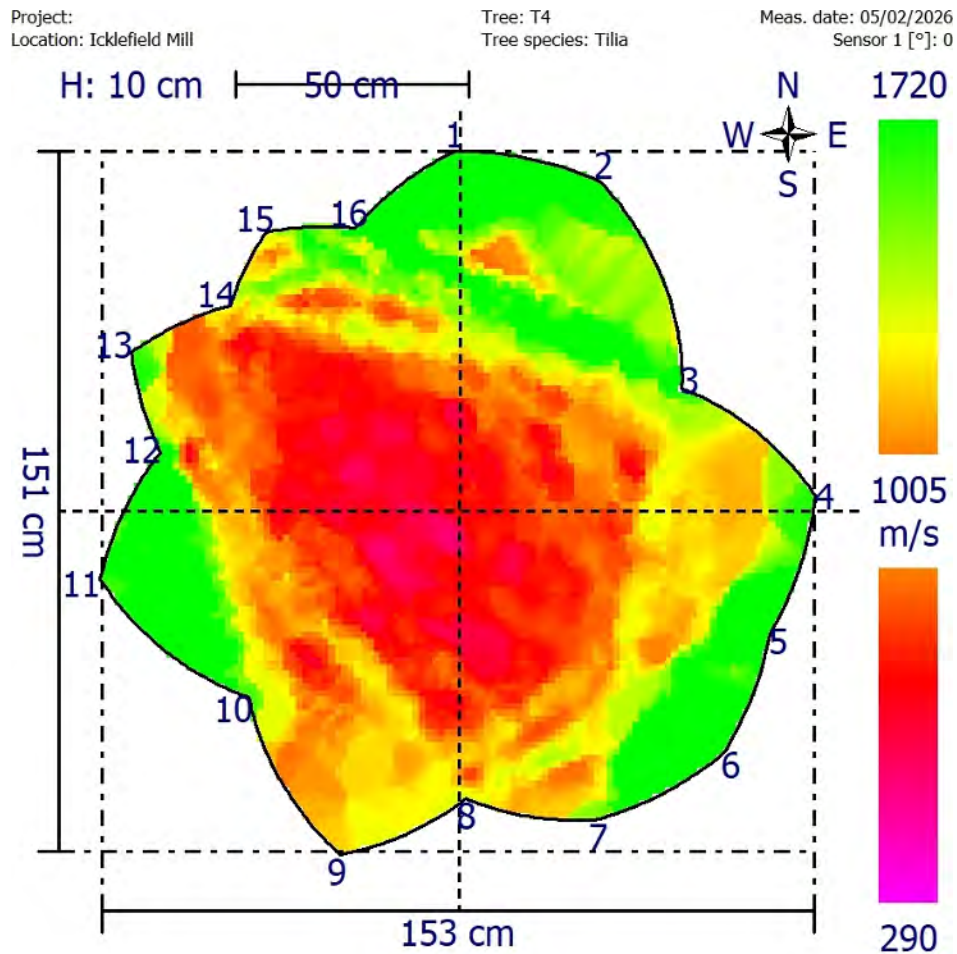
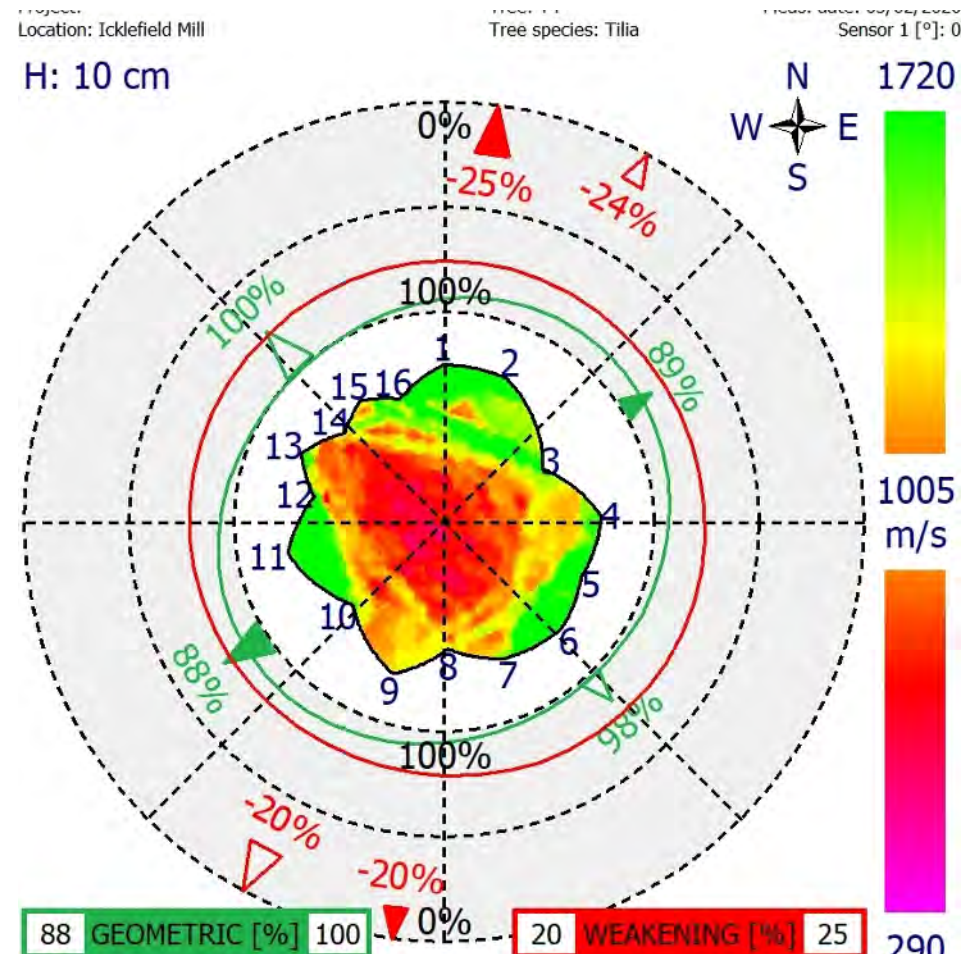
## Tomography - T4 at 10cm

| Tree number | BS category | Species | Comments |
|---|---|---|---|
| T4 | B2 (now C2) | Lime | Due to poor structural condition (refer to Appendix 12). Will be replaced with a semi-mature tree |

Decay at 10cm above ground level is extensive and impact on load bearing capacity significant.

Ganoderma australe bracket is located between sensors 13 and 14 - the tomogram shows the fungus has breached functional wood in this area.

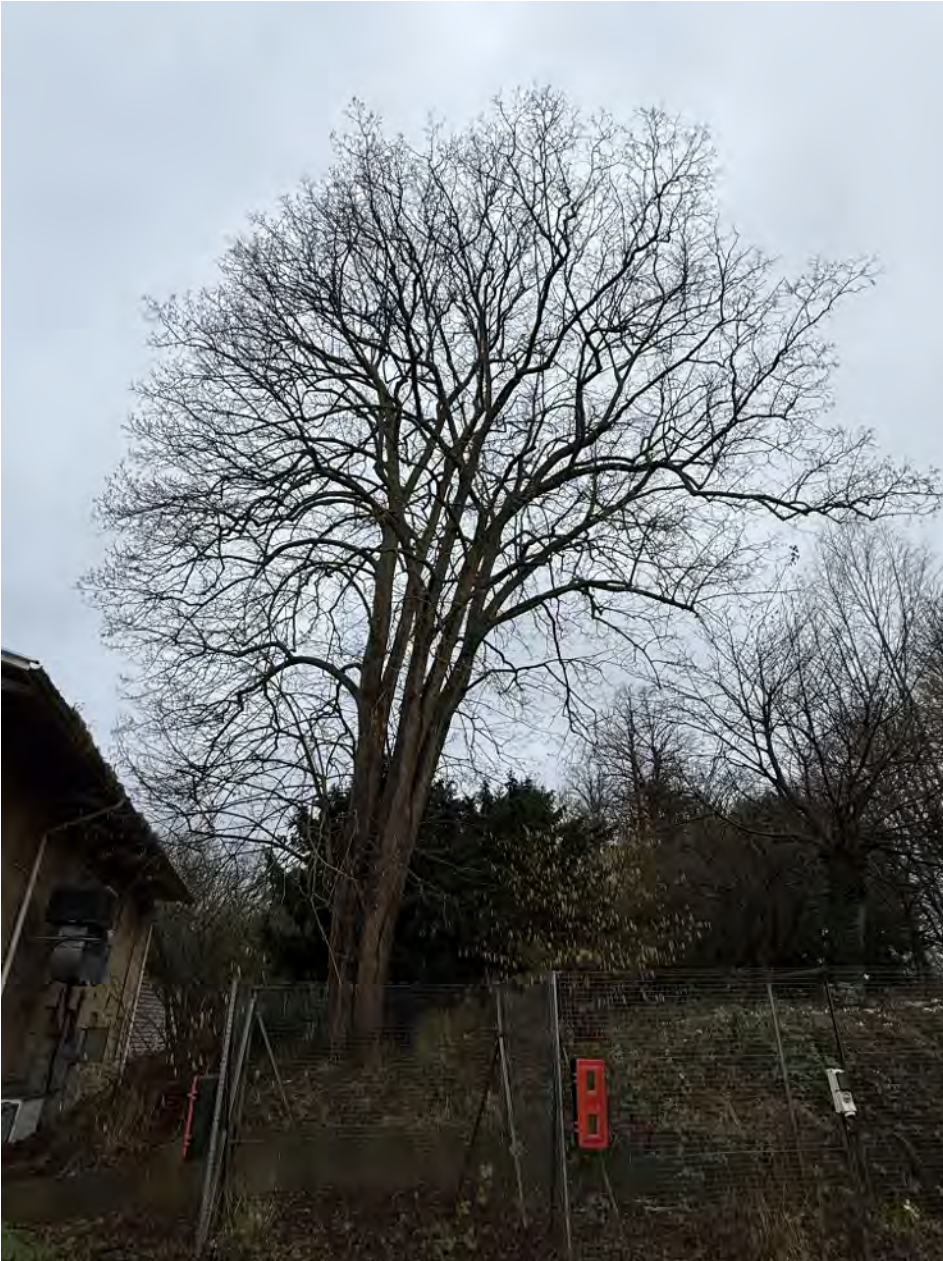
Image 1 - T4

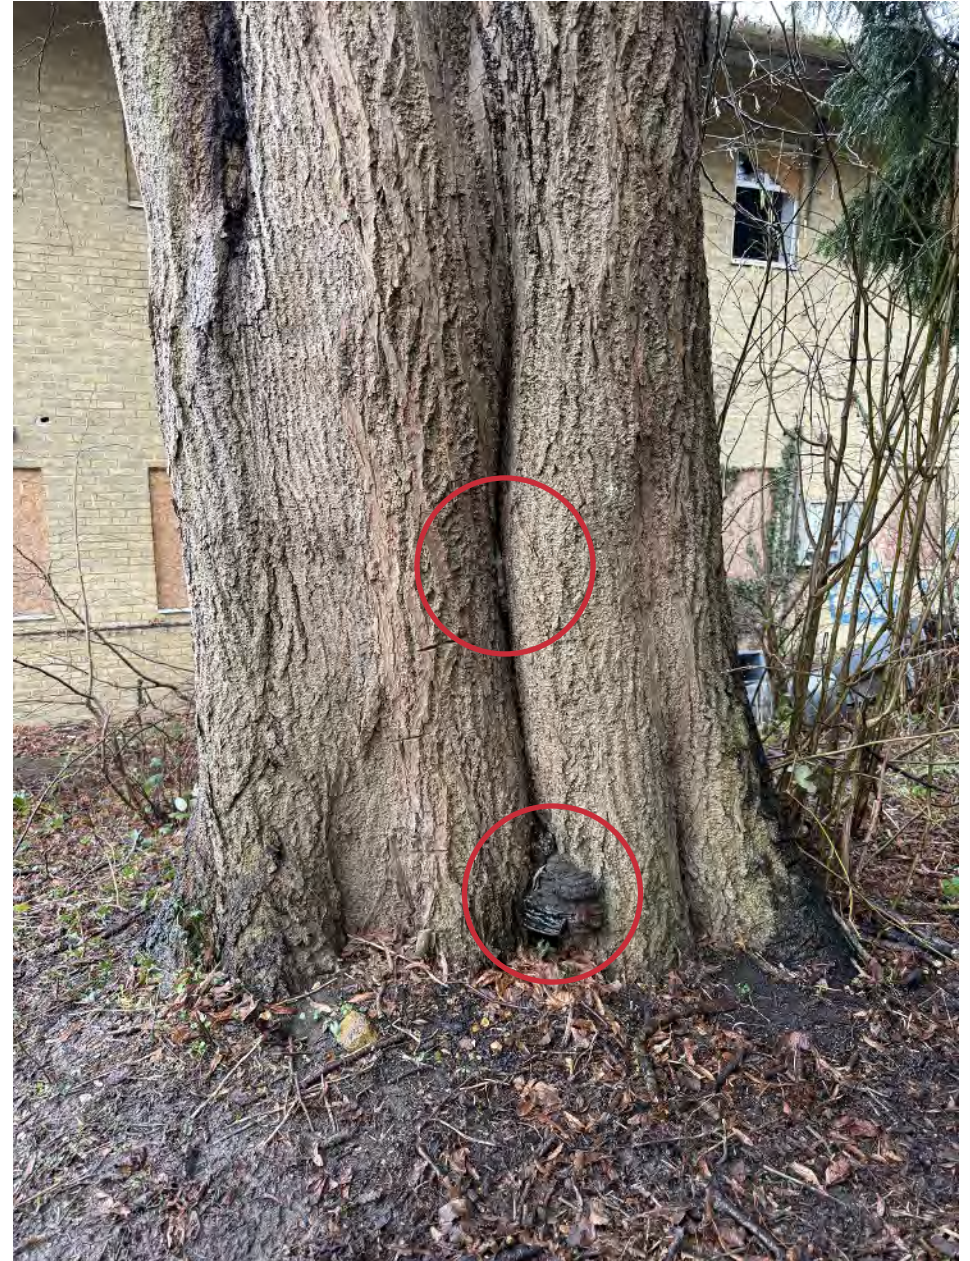
| Tree ID | Species | Height (m) | Stem diameter (cm) | No. of Stems | CROWN SPREAD (m) | | | | | | | | Crown clearance (m) | L.B. (m) | Life stage | Condition Notes | Survey date | RPA (m <sup>2</sup> ) | RPR (m) | Life expectancy (yrs) | BS Category |
|---|---|---|---|---|---|---|---|---|---|---|---|---|---|---|---|---|---|---|---|---|---|
| Tree T4 | Tilia x vulgaris (Common Lime) | 22.5 | 127 | 1 | | 12.0 | | 11.0 | | 11.0 | | 12.0 | 2.0 | | Late Mature | Structural condition Fair. Physiological condition Good. Fungal fruiting body - structural decay suspected. Fork - Weak with included bark. Stems - Co-dominant. Decay fungi - Ganoderma sp. brackets at base to the north and at 2.4 m to the northeast. Down graded to C due to further inspection by TCTC | 29/10/2025 | 706.9 | 15.0 | 40+ | C2 |

Image 2 - T4 - *Ganoderma australe* brackets lower stem
