# Decay Detection Investigation

Old Rectory

Hodwell, Ashwell

260786-TMA-XX-RP-AR-1600

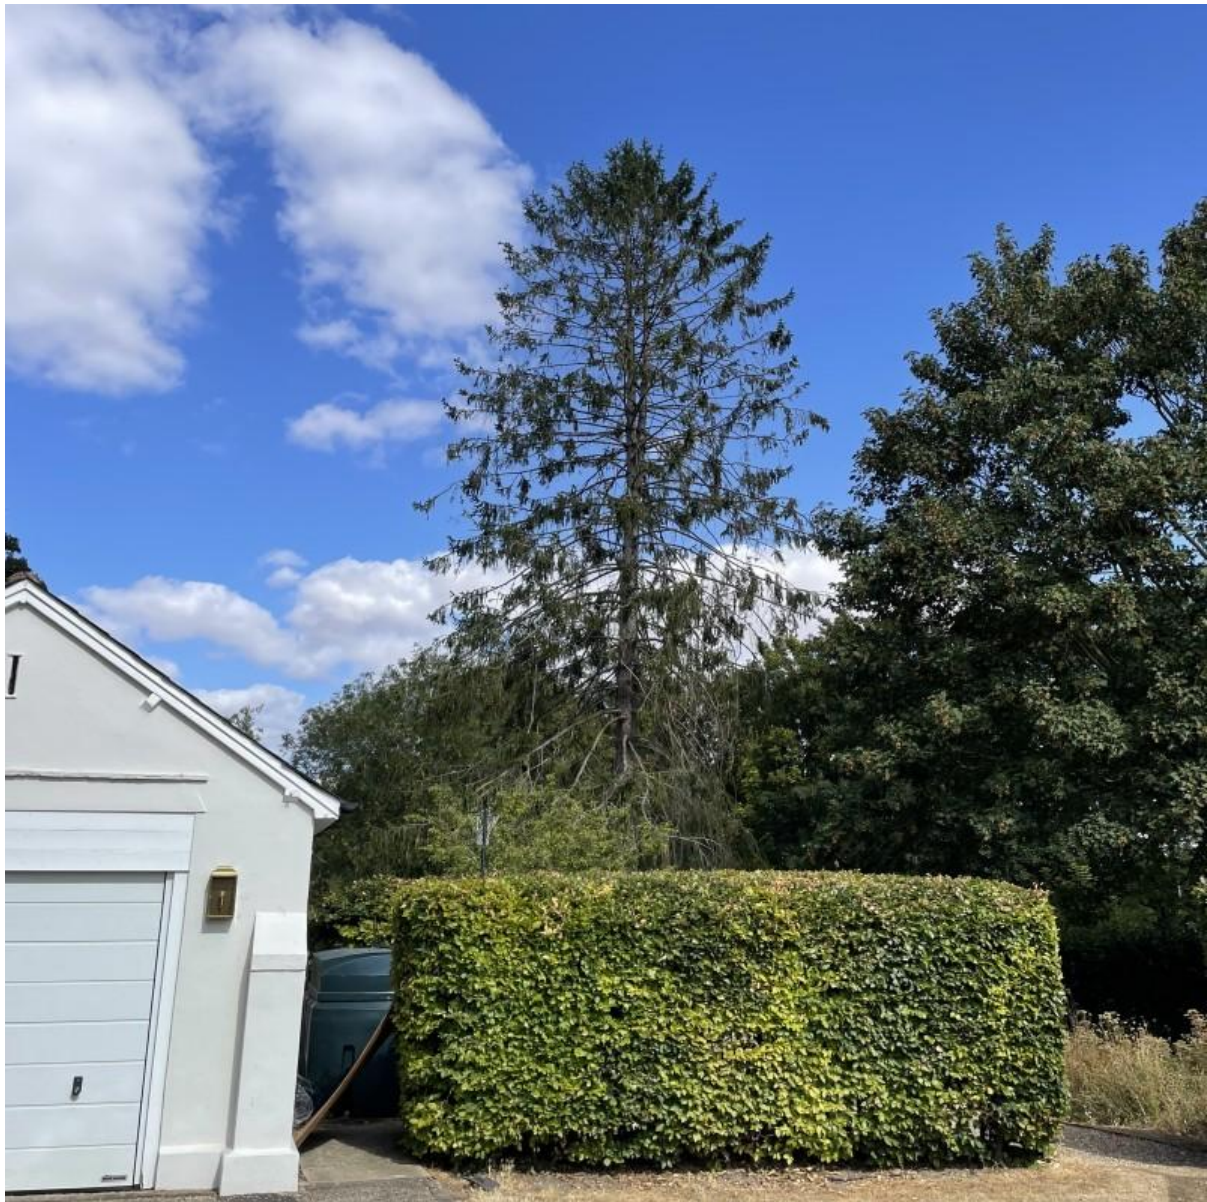
*T1 Norway spruce: tree shown within its setting*

- 4.1 An early mature Norway spruce (*Picea abies*), with pronounced root buttressing, in poor physiological condition, and exhibiting low vitality. The tree is located within the rear garden, and is surrounded by plant beds and lawns, constituting permeable ground. The tree is within falling distance of the house and the neighbouring property boundary.

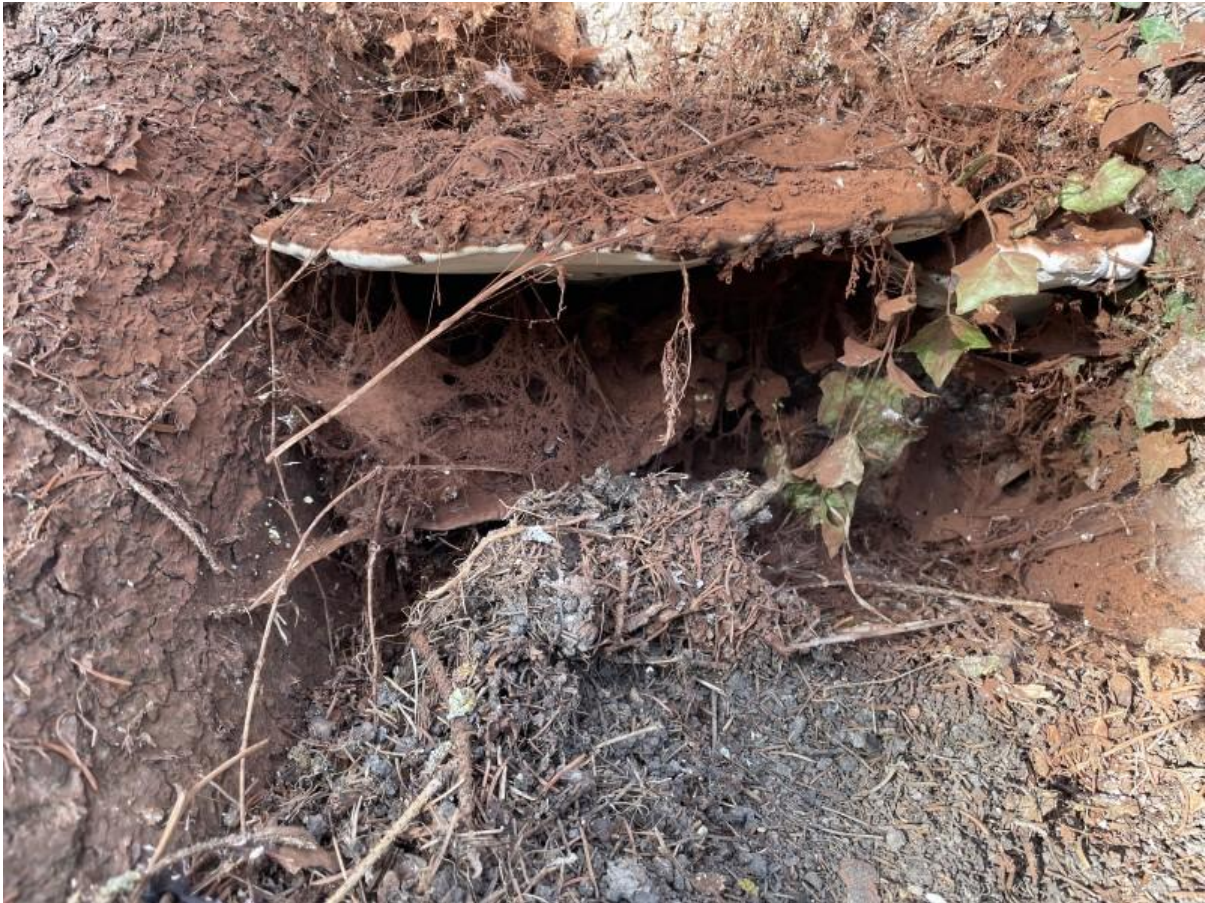
T1 Norway spruce: southern bracket (*Ganoderma australe*) fruiting bodies growing from the basal sinus on the eastern side

- 4.3 Fungal fruiting bodies of southern bracket (*Ganoderma australe*)<sup>6</sup> were observed growing from the lower stem and root buttresses to the east and west. Following visual inspection, tap testing indicated an area of decay and potential hollowing close to the fruiting bodies and in the eastern root buttress, ascending up the stem on the eastern side to around 2 m. This test was recommended to quantify the extent of decay and sound wood remaining.

6 - Southern bracket is parasitic and saprobic. Can breach reaction zones. Attributed to a selective white rot. Trees with poor compartmentalisation ability / lacking true heartwood are often quickly hollowed out. Prompts buttress development. Can cause structural failure via windthrow or collapse and stem fracture. Hollowness and stability investigations may be required where significant targets exist. Likely that all UK examples are *Ganoderma adspersum* – likely not a synonym of *G. applanatum*.

- **Tree removal due to extensive basal decay resulting from southern bracket (*Ganoderma australe*) colonisation, to prevent stem failure causing injury or property damage - necessary**
- **Stump grinding (removal) following the removal of the tree to facilitate replanting - landscape improvement**
- **Replacement planting (of suitable species) during the first planting season (September to April) following tree removal - landscape improvement**

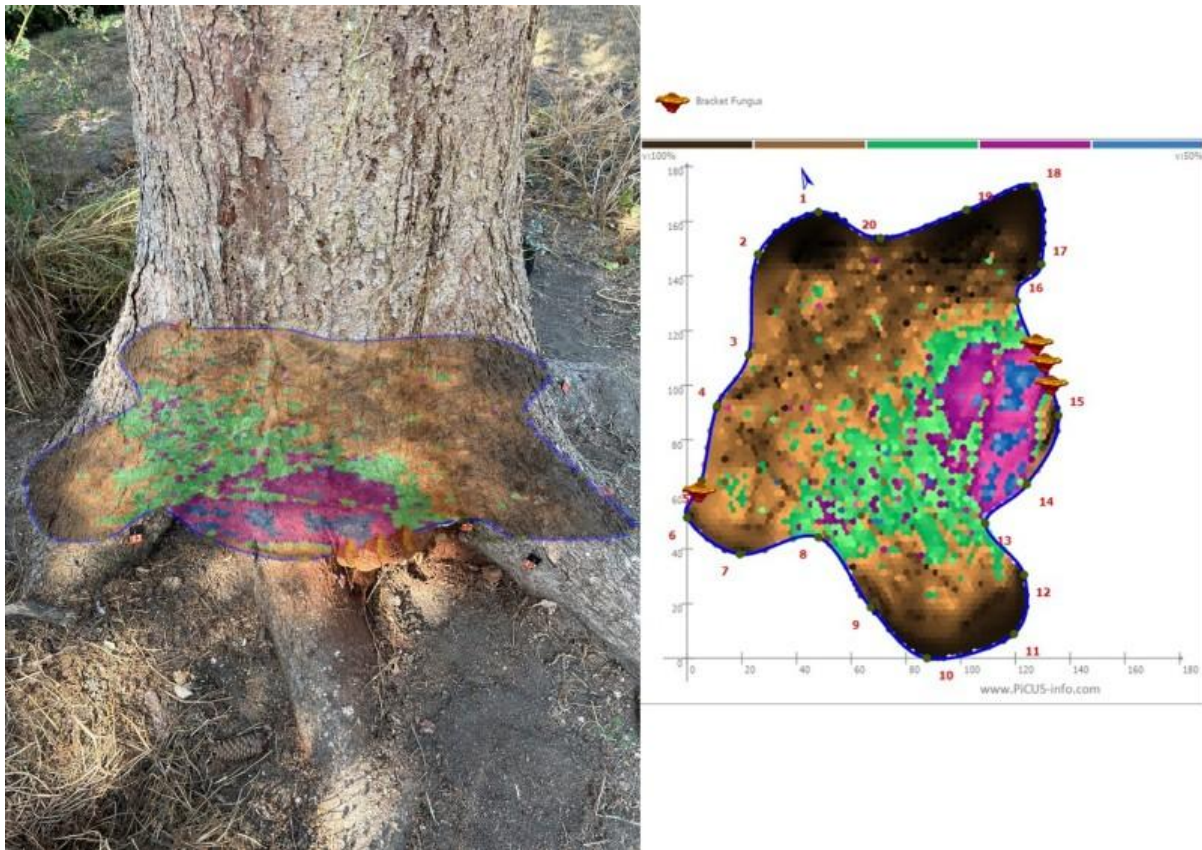
*T1 Norway spruce: tomogram (right), tomogram superimposed in the approximate test position over the stem (left)*

- 4.4 The sonic tomography test was undertaken at approximately 19 cm (at measuring point (mp) 1) above ground level (agl). This height was selected to encompass the most prominent cluster of fungal fruiting bodies and the area producing the most significant audible indications of decay, using a sounding mallet; where decay was suspected to be most developed.

- 4.5 The tomogram reveals low velocities, represented by blue and pink, indicating decay and/or hollowing, within the stem to the east and southeast. Intermediate velocities, represented by green, indicating incipient (early stage) decay can be seen throughout most of the central stem, with further mottled patches of blue and pink, indicating some more advanced intermediate decay developing. Additionally, high velocities represented by light and dark brown, indicating intact wood can be seen throughout most of the remaining stem, with the darkest areas, representing the densest wood, located in the outer circumference of the most protruding root buttresses to the north, northeast, and south.

- 4.10 The tomogram indicates extensive decay within the stem, surrounded by incipient developing decay. It is suspected that the tree has so far been unable to compartmentalise the decay due to the arrangement of different wood densities indicated.

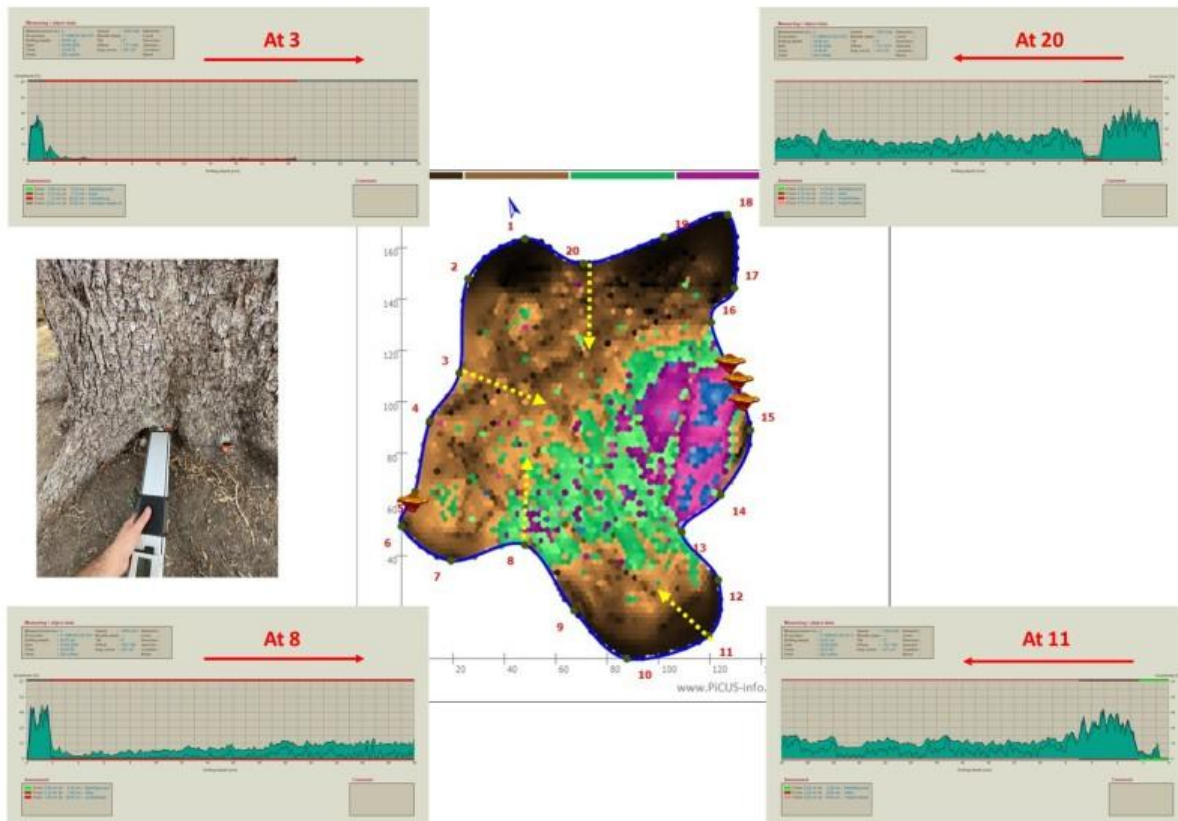
*T1 Norway spruce: RESI PD drill traces shown positioned around the tomogram with the drill direction indicated using a red arrow and the approximate test location indicated using a yellow arrow*

- 4.8 The stem was tested using the RESI PD at MP3, MP8, MP11, and MP20, and the results are as follows:
- The test at MP3 shows a high resistance, indicating intact wood to a depth of 1.15 cm, beyond which there is a very low resistance indicating decay and hollowing to a depth of 20.65 cm, where the drill automatically retracted the needle, a feature of the equipment to avoid damage following an extended passage through a cavity.
  - The test at MP8 shows a high resistance, indicating intact wood to a depth of 1.9 cm, beyond which there is a low resistance indicating decayed wood to a depth of 30 cm.
  - The test at MP11 shows a high resistance, indicating intact wood to a depth of 6.9 cm, where the resistance lowers and the graph pattern alters, indicating incipient decay to a depth of 30 cm.

- The test at MP20 shows a high resistance, indicating intact wood to a depth of 4.7 cm, where the resistance lowers indicating a localised cavity, before increasing to a moderate amplitude exhibiting an altered graph pattern, indicating incipient decay to a depth of 30 cm.

- 4.11 The extent of decay identified by the RESI PD confirms the presence of a significant volume of developed, and incipient decay, within the stem. It also suggests that some areas of incipient decay may be more advanced than indicated in the tomogram.
