# Arboricultural Report

Great Offley House

Kings Walden Road,  
Offley, Hitchin,  
SG5 3EA

*MH10757*

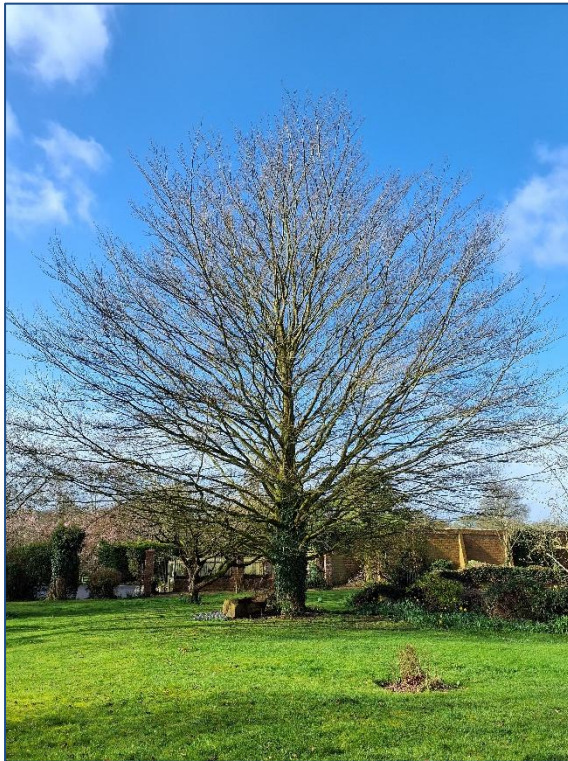
The proposed works to T109 comprise crown lifting to approximately 2.5 metres above ground level to allow improved access to the swimming pool area and to provide appropriate clearance beneath the canopy. T109 is a mature beech in good structural and physiological condition and is considered suitable for retention. The tree is positioned close to the entrance to the swimming pool area, where low branches currently impede movement beneath the crown. The proposed works are limited in extent and are intended to improve functional clearance whilst retaining the tree's overall form and contribution to the site. The works are considered proportionate and consistent with good arboricultural management.

Figure 3: **T109**, Beech tree identified for crown lifting

| Tree Ref | Tree Tag | Species | Scientific Name | Age Class | Height (m) | Stems | Stem Ø (mm) | Average Radial Crown spread (m) | Condition | | Category | General Observations | Recommendations |
|---|---|---|---|---|---|---|---|---|---|---|---|---|---|
| T109 | 6600 | Common beech | <i>Fagus sylvatica</i> | Mature | 13 | 1 | 870 | 9 | Good | Good | Reasonable | Tree is located 4 m southeast of entrance to swimming pool, with low hanging branches impeding access; Small amount of ivy on the stem; Good overall condition. | Lift crown to 2.5 m to allow for access to swimming pool area and for mower to operate under canopy |

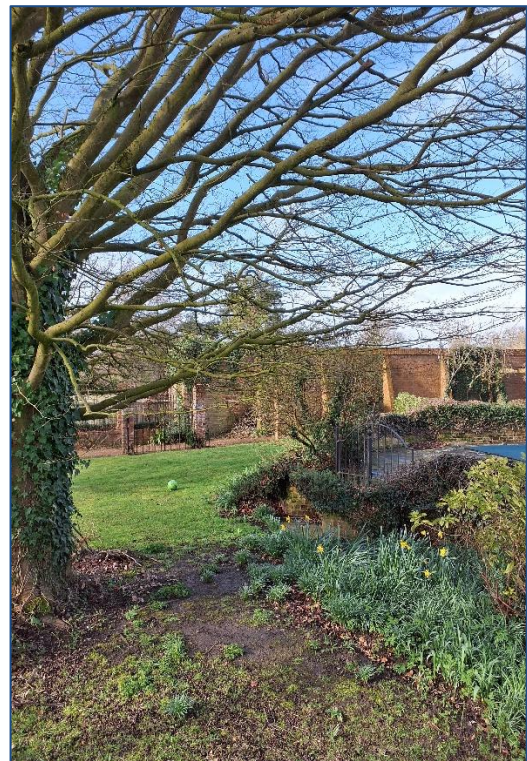
Figure 4: **T109**, Low branches

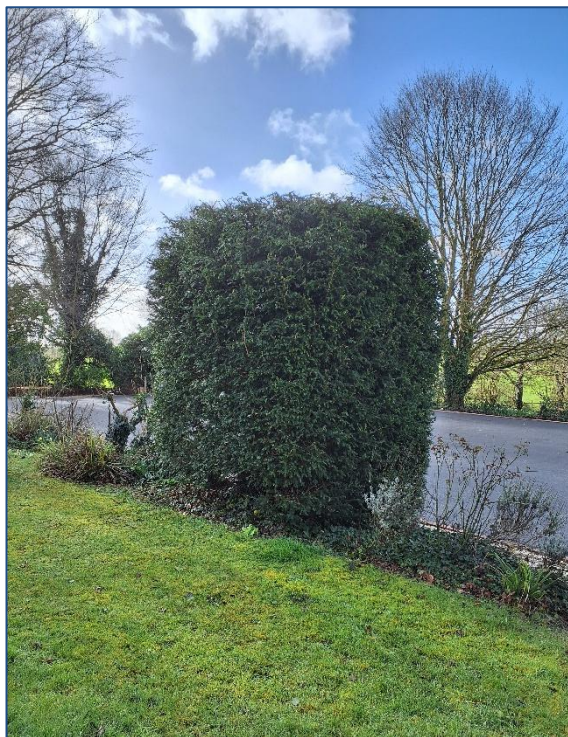
Removal of T2 is proposed based on its limited arboricultural merit and constrained relationship with the surrounding site. The tree is a small, semi-mature specimen with a twin stem arising from ground level and is located immediately adjacent to maintained lawn and recently reinstated tennis courts. In this position it makes only a limited contribution in landscape and amenity terms. Whilst recorded as being in fair structural and physiological condition, the tree is of modest scale and has restricted presence within the wider setting. Having regard to its size, form and limited public visibility or wider landscape contribution, its removal is considered reasonable in the context of the proposed management of the site.

Figure 5: **T2**, Yew identified for removal

| Tree Ref | Tree Tag | Species | Scientific Name | Age Class | Height (m) | Stems | Stem Ø (mm) | Average Radial Crown spread (m) | Condition | | Category | General Observations | Recommendations |
|---|---|---|---|---|---|---|---|---|---|---|---|---|---|
| T2 | 6599 | Common yew | <i>Taxus baccata</i> | Semi-mature | 3.5 | 2 | 240 | 0.5 | Fair | Fair | Reasonable | Located 0.1 m west of maintained lawn and 1 m east of recently reinstated tennis courts; Twin stemmed from ground level. | Remove tree to ground level |

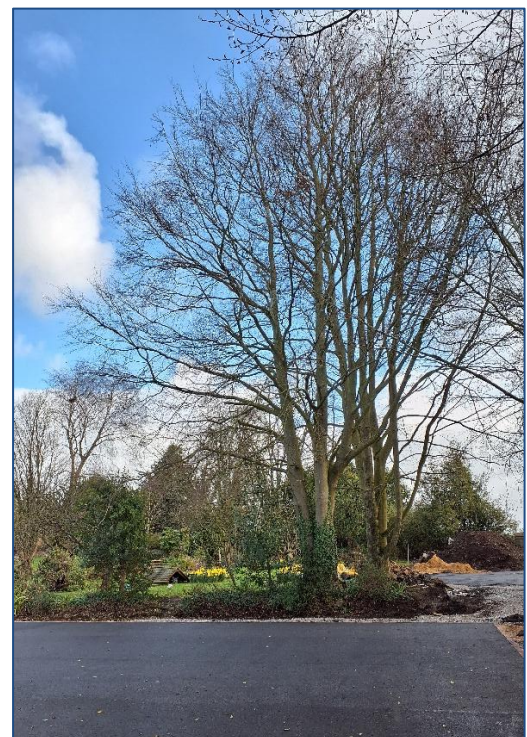
Removal of T96 is proposed due to its poor relationship with the adjacent tennis court and the constraints arising from its existing form and position. The tree is an early-mature beech located close to the eastern boundary of the reinstated tennis court, growing from the top of a raised bank. It has a trifurcated stem with included unions and compression forks between the western stems, giving rise to an adverse structural feature within the main framework. In addition, low hanging branches extend directly over the tennis court and the crown is one-sided, with canopy biased to the east of the stem. Although the tree was recorded as being in fair condition overall, its structural form is not ideal, and its position is increasingly incompatible with the adjoining recreational use. On balance, removal is considered justified in arboricultural and site management terms.

Figure 6: **T96**, Beech identified for removal

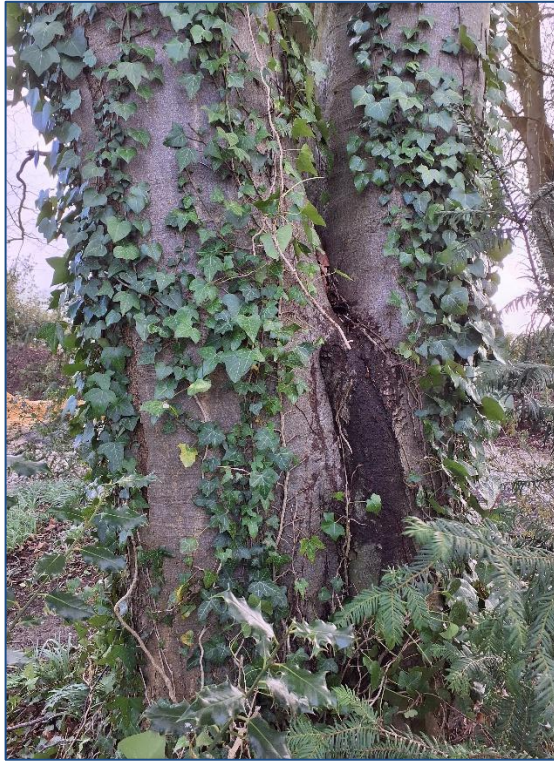
Figure 7: **T96**, included union of west side

| Tree Ref | Tree Tag | Species | Scientific Name | Age Class | Height (m) | Stems | Stem Ø (mm) | Average Radial Crown spread (m) | Condition | | Category | General Observations | Recommendations |
|---|---|---|---|---|---|---|---|---|---|---|---|---|---|
| T96 | 6597 | Common beech | <i>Fagus sylvatica</i> | Early-mature | 19 | 3 | 840 | 7 | Fair | Fair | Reasonable | Located 2 m east of newly reinstated tennis court, growing on top of 0.5 m high bank; Trifurcated stem with included union and compression fork between western stems; Low hanging branches directly over tennis court; Cohesive crown with neighbouring beech to the east of stem. | Remove tree to ground level |

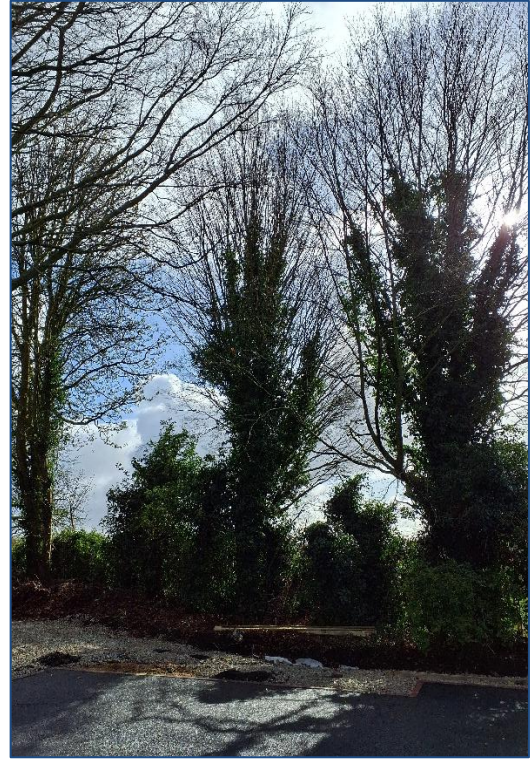
The proposed works to T143 comprise a crown reduction of approximately 2 metres from the crown height and radial spread. T143 is a semi-mature beech located on the southern boundary of the site, immediately north of the fence and footpath. The tree is recorded as having a dense crown and stem growth, and in this boundary position a modest reduction is considered appropriate to contain the crown and improve its relationship with the adjacent footpath and boundary. The proposed reduction is relatively minor in relation to the size of the tree and would retain the specimen as a boundary feature whilst allowing for more appropriate ongoing management.

Figure 8: **T143**, Beech identified for 2 m reduction

| Tree Ref | Tree Tag | Species | Scientific Name | Age Class | Height (m) | Stems | Stem Ø (mm) | Average Radial Crown spread (m) | Condition | | Category | General Observations | Recommendations |
|---|---|---|---|---|---|---|---|---|---|---|---|---|---|
| T143 | 6598 | Common beech | <i>Fagus sylvatica</i> | Semi-mature | 11 | 1 | 480 | 3.5 | Ivy | Fair | Reasonable | Located on the south boundary of site 0.5 m north of fence and 2 m south of footpath; Dense ivy clad stem and crown. | Carefully sever ivy at base of tree and strip all ivy from tree; Reduce crown by 2 m |

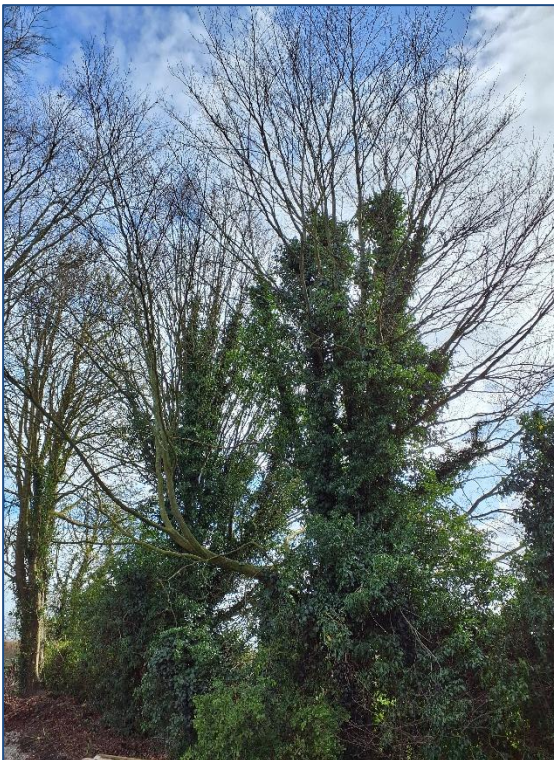
The proposed works to T144 comprise removal of a lower lateral limb and reduction of the overextended crown back toward the main stem. T144 is a semi-mature beech situated on the southern boundary of the site close to the footpath and tennis court. The survey records an overextended lateral limb on the north-east side extending directly over the tennis court and footpath. The proposed works are therefore justified to reduce encroachment into these actively used areas and to improve the tree's spatial relationship with its surroundings. The works are localised and targeted and would allow the tree to be retained in a more suitable form for its position.

Figure 9: **T144**, 2 m reduction & limb removal

| Tree Ref | Tree Tag | Species | Scientific Name | Age Class | Height (m) | Stems | Stem Ø (mm) | Average Radial Crown spread (m) | Condition | | Category | General Observations | Recommendations |
|---|---|---|---|---|---|---|---|---|---|---|---|---|---|
| T144 | 6596 | Common beech | <i>Fagus sylvatica</i> | Semi-mature | 11 | 1 | 460 | 3.5 | Ivy | Fair | Reasonable | Located on the south boundary of site 0.5 m north of fence and 1 m south of footpath; Dense ivy clad stem and crown; Overextending lateral limb on northwest side of crown directly over tennis court and footpath. | Carefully sever ivy at base of tree and strip all ivy from tree; Remove lowest lateral limb directly over tennis court back to the main stem. |

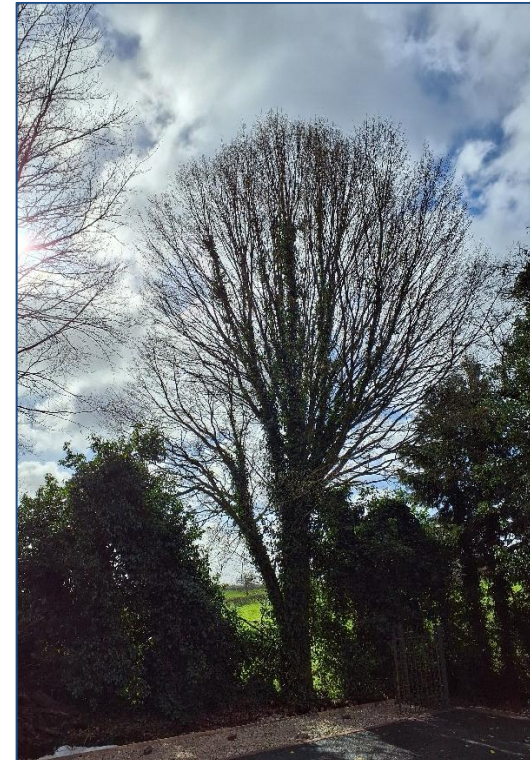
The proposed works to T147 comprise crown lifting to approximately 2.5 metres above ground level together with a crown reduction of approximately 2 metres from the crown height and radial spread. T147 is a semi-mature beech located on the southern boundary of the site adjacent to the footpath. In this position, the proposed lifting and reduction are considered appropriate to improve clearance and to contain the canopy within its immediate setting. The works are modest in scale and would maintain the

Moderate deadwood is present within the west side of the crown. Removal of significant deadwood is proposed as a routine maintenance operation in the interests of both health and safety and good arboricultural management.

Figure 10: **T147**, Beech identified for 2 m reduction

| Tree Ref | Tree Tag | Species | Scientific Name | Age Class | Height (m) | Stems | Stem Ø (mm) | Average Radial Crown spread (m) | Condition | | Category | General Observations | Recommendations |
|---|---|---|---|---|---|---|---|---|---|---|---|---|---|
| T147 | 6595 | Common beech | <i>Fagus sylvatica</i> | Semi-mature | 11 | 1 | 510 | 3.5 | Ivy | Fair | Reasonable | Located on the south boundary of site 0.5 m north of fence and 0.5 m south of footpath; Dense ivy clad stem and crown; Occluding wounds on stem at 2 m height (not significant); Moderate deadwood present in west side of crown over footpath. | Carefully sever ivy at base of tree and strip all ivy from tree; Remove deadwood (over 25mm diameter); Lift crown on north side to 2.5 m; Reduce crown by 2 m. |

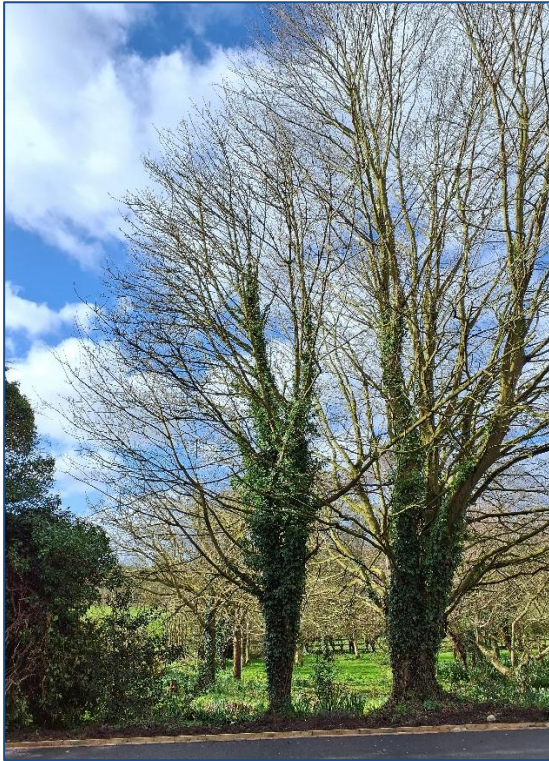
Removal of T134 is proposed as the tree is of only moderate quality and displays a poor relationship with neighbouring trees and the adjacent tennis court. The tree is a semi-mature specimen positioned close to the western side of the newly reinstated court. The crown is described as asymmetric and formed in mid-level association with neighbouring beech, which limits its individual form and long-term suitability. Minor deadwood is also present within the crown. Whilst the tree is in fair structural and physiological condition, it offers only a moderate contribution and is not especially notable as an individual specimen. Taking account of its form, limited separation from adjacent trees and its position immediately beside the tennis court, removal is considered to be a reasonable management proposal.

Figure 11: **T134**, maple Identified for removal (left)

| Tree Ref | Tree Tag | Species | Scientific Name | Age Class | Height (m) | Stems | Stem Ø (mm) | Average Radial Crown spread (m) | Condition | | Category | General Observations | Recommendations |
|---|---|---|---|---|---|---|---|---|---|---|---|---|---|
| T134 | 6594 | Norway maple | <i>Acer platanoides</i> | Semi-mature | 10 | 1 | 450 | 6 | Fair | Fair | Reasonable | Located 2 m west of newly reinstated tennis court; Ivy on stem and into middle crown; Asymmetric crown form with cohesive crown with neighbouring beech; Minor deadwood present in crown. | Remove tree to ground level |

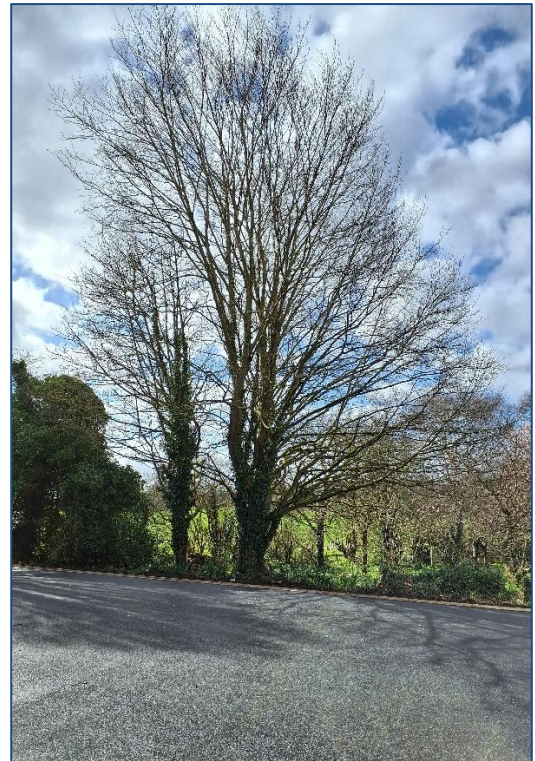
Removal of T135 is proposed owing to its constrained form, existing defects and close relationship with the reinstated tennis court. The tree is an early-mature beech with an asymmetric crown formed in association with neighbouring maple. Minor deadwood is present within the crown, and the east side of the crown extends directly over the newly reinstated tennis court, with lower branches occurring at approximately 2 metres above ground level. The tree also has multiple stems arising from the crown break at around 1.5 metres, which further affects its overall form and management suitability in this position. Although the tree is recorded as being in fair condition, it is not an especially well-formed specimen and its crown spread and structural arrangement are

Figure 12: **T135**, Beech identified for removal (right)

| Tree Ref | Tree Tag | Species | Scientific Name | Age Class | Height (m) | Stems | Stem Ø (mm) | Average Radial Crown spread (m) | Condition | | Category | General Observations | Recommendations |
|---|---|---|---|---|---|---|---|---|---|---|---|---|---|
| T135 | 6593 | Common beech | <i>Fagus sylvatica</i> | Early-mature | 15 | 1 | 830 | 9 | Fair | Fair | Reasonable | Located 2 m west of newly reinstated tennis court; Ivy on stem and into lower crown; Asymmetric crown form with cohesive crown with neighbouring maple; Minor deadwood present in crown; East side of crown is located directly over newly reinstated tennis court; with lower branches at 2 m height; Multiple stems have fused at crown break at 1.5 m. | Remove tree to ground level |

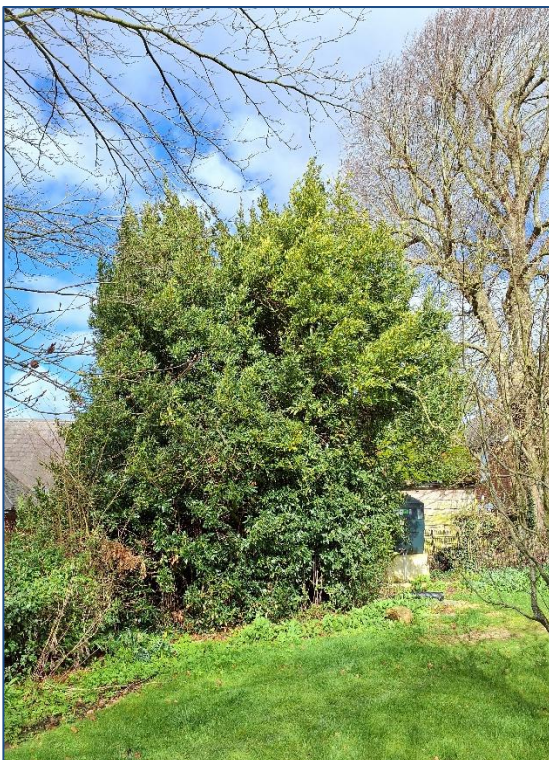
Removal of T9 is proposed due to its poor form, heavy epicormic growth and unsatisfactory relationship with adjacent built structures. The tree is a semi-mature bay comprising multiple stems and is located close to the southern side of a building and immediately east of a brick wall. It has un-managed growth within the understorey, extensive epicormic growth throughout, and a crown spread extending over a sloping oil tank and adjacent brick wall. The crown is also noted to lie within less than 0.2 metres of contact with chimneys on the adjoining building. Whilst recorded as being in fair condition, the specimen is of limited individual merit and appears to have developed in a constrained manner within a confined built setting. Given its form, proximity to structures and limited wider amenity contribution, removal is considered appropriate.

Figure 13: **T9**, Bay encroaching on oil tank

| Tree Ref | Tree Tag | Species | Scientific Name | Age Class | Height (m) | Stems | Stem Ø (mm) | Average Radial Crown spread (m) | Condition | | Category | General Observations | Recommendations |
|---|---|---|---|---|---|---|---|---|---|---|---|---|---|
| T9 | 6592 | Bay | <i>Laurus nobilis</i> | Semi-mature | 6 | 25 | 150 | 3 | Fair | Fair | Reasonable | Located 1 m west of oil storage tank, 3 m south of building and 0.1 m east of brick wall; Unmanaged with significant epicormic growth throughout understory; Crown encroaching on storage oil tank and adjacent brick wall; Crown is less than 0.2 m from contacting chimney on adjacent building. | Remove tree to ground level |

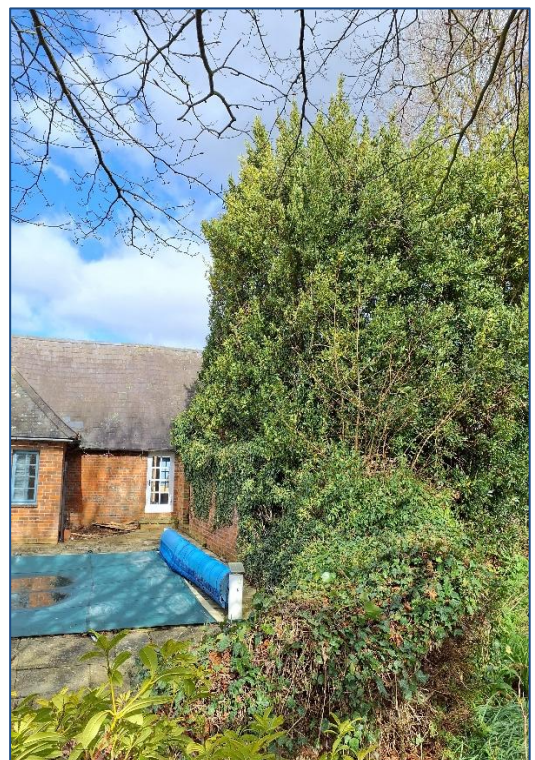
Figure 14: **T9**, Bay encroaching on wall
