## A Refurbishment Survey Report for Asbestos-Containing Materials at:

**Kimpton Players Playhouse, Hall  
Lane, Kimpton, Hitchin, SG4 8RD**

**SURVEYED ON: 17TH NOV 2023**

**SURVEY REF: AGG 711**

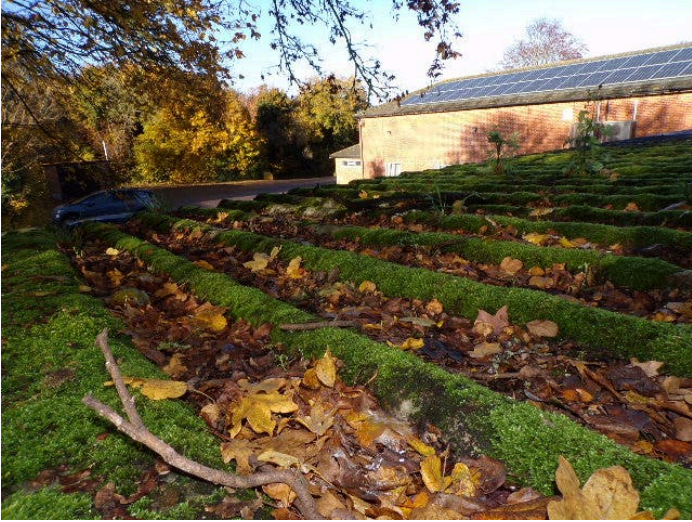
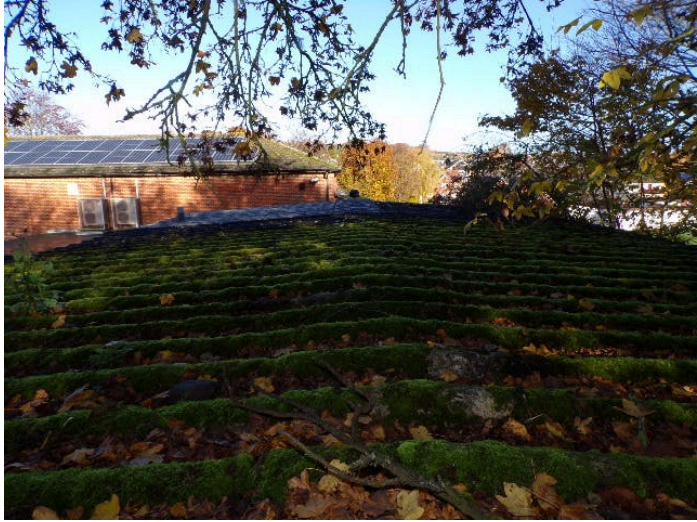
## The Playhouse > external > roof area > roof sheets

| Location | roof area | Item | roof sheets |
| Material | asbestos cement | Extent | 50 square metres |
| Strategy / Sample Id | Sample / S3 | Fibre Type | Chrysotile |

| Material Score | 4 / Very Low | | |

External, roof area - 50 square metres of asbestos cement roof sheets. Remove and dispose of as asbestos waste.

| Recommendation | Non-licensable material. Remove and dispose of as asbestos waste. | | |

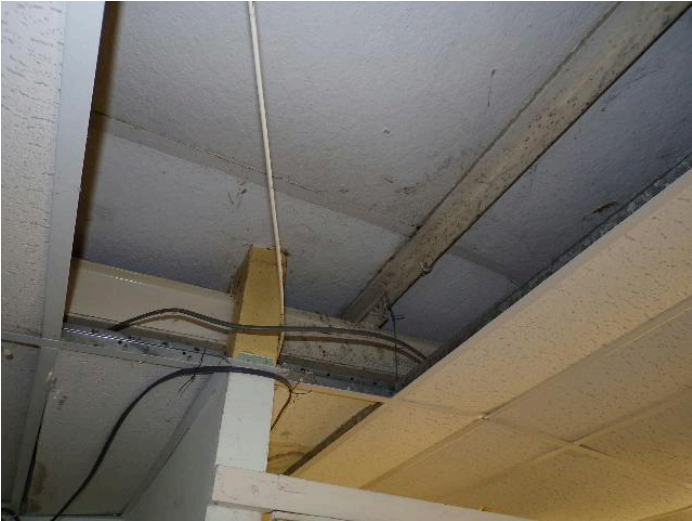
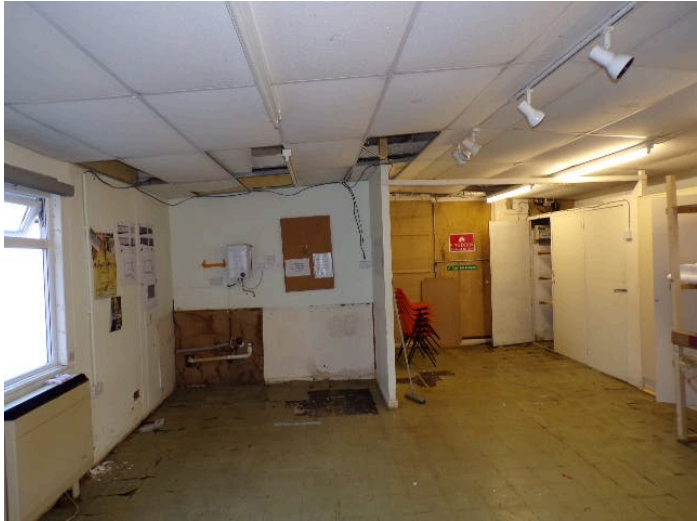
## The Playhouse > ground floor > rehearsal room > ceiling panels and boards covering walls

| Location | rehearsal room | Item | ceiling panels and boards covering walls |
| Material | fibreboard | Extent | |
| Strategy / Sample Id | Sample / S1 | Fibre Type | NADIS |

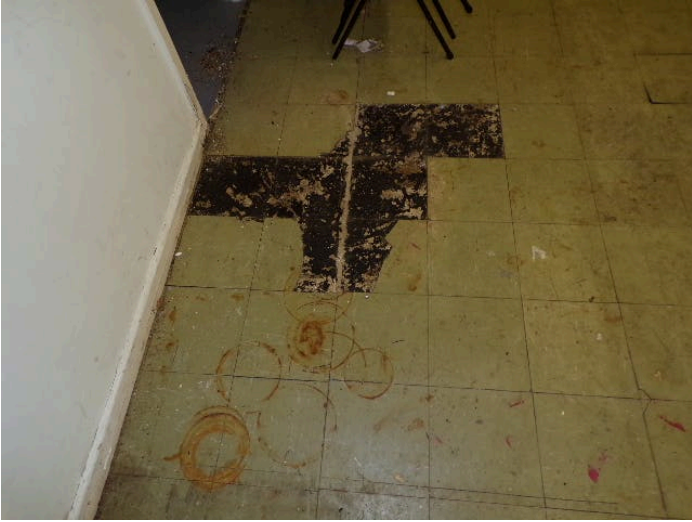
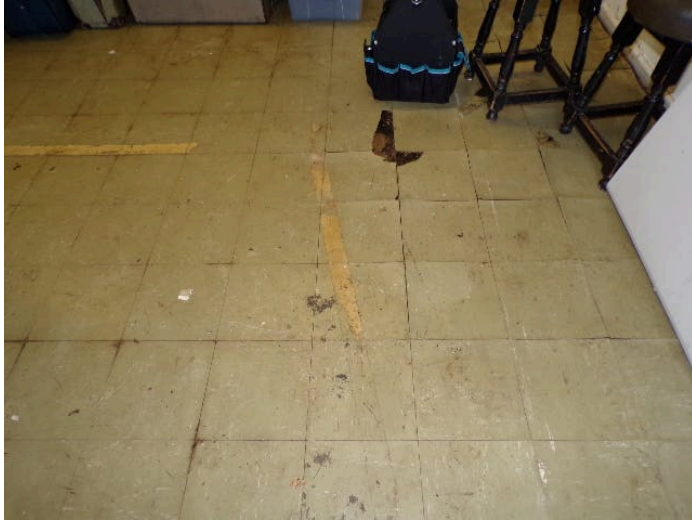
## The Playhouse > ground floor > rehearsal room > floor tiles and adhesive

| Location | rehearsal room | Item | floor tiles and adhesive |
| Material | vinyl and bitumen | Extent | 48 square metres |
| Strategy / Sample Id | Sample / S2 | Fibre Type | Chrysotile |

| Material Score | 3 / Very Low | | |

The rehearsal room - 48 square metres of vinyl floor tiles and bitumen adhesive. The floor tiles need to be removed and disposed of as asbestos waste, The bitumen adhesive can remain in situ and be encapsulated with floor levelling compound, laytex, etc.

| Recommendation | Non-licensable material. Remove and dispose of as asbestos waste. Encapsulate adhesive with laytex. | | |
