Our Ref: 17446/JAE/KL

24 November 2023

**Kimpton Players Playhouse by the Memorial Hall, Hall Lane, Kimpton, CG4 8RD**  
**Structural Inspection**

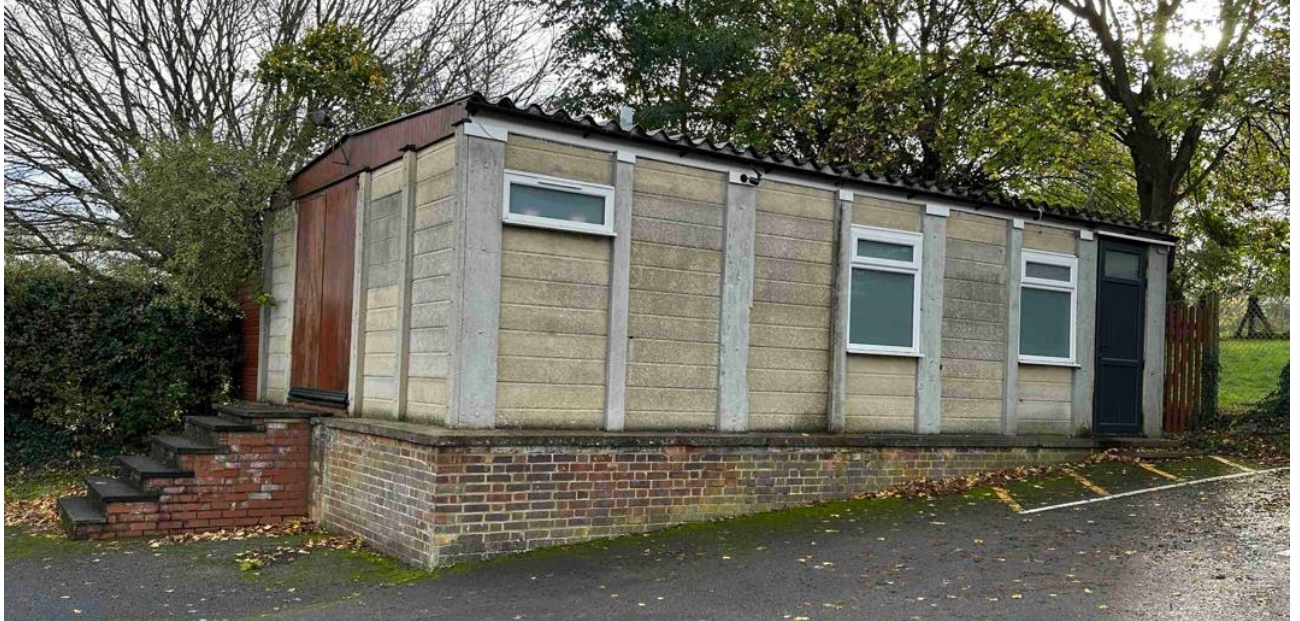
6. The property is a single storey detached prefabricated building built in about 1970.
7. It is built on a site sloping from the rear to the front and is built on a brick plinth which is built off strip foundations stepped to allow for the slope of the site.
8. The walls are constructed of precast concrete posts supporting precast concrete panels slotted into the posts. There is a concrete slab and the roof is formed from asbestos cement sheets supporting on lightweight steel sections.

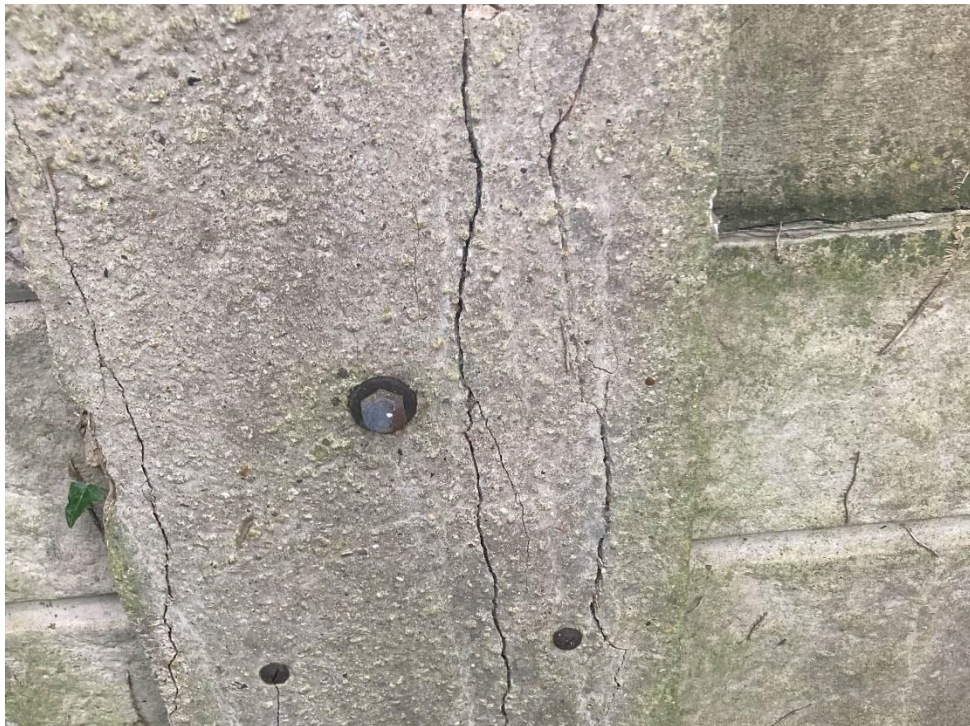
9. Most of the concrete posts are cracked, with the cracks typically running vertically up the posts.

39. The main issue is the deterioration of the concrete posts.
40. The cracking and spalling of the concrete is probably due to carbonation of the concrete.

45. The cracking and spalling seen to the posts is typical of rusting steel causing spalling due to carbonation issues.
46. The test for carbonation is quite a simple, cheap test. A small core or a section of dislodged concrete is sprayed with an indicator such as phenolphthalein and the concrete remains colourless on carbonated concrete and turns pink on alkaline concrete.

49. Often all that has to be done is to hack off the spalled or loose areas. The steel can then have the rust removed and can be treated against further corrosion and then the area repaired with an epoxy render. It is also possible to apply an anti-carbonation coating which can then extend the life of the concrete.

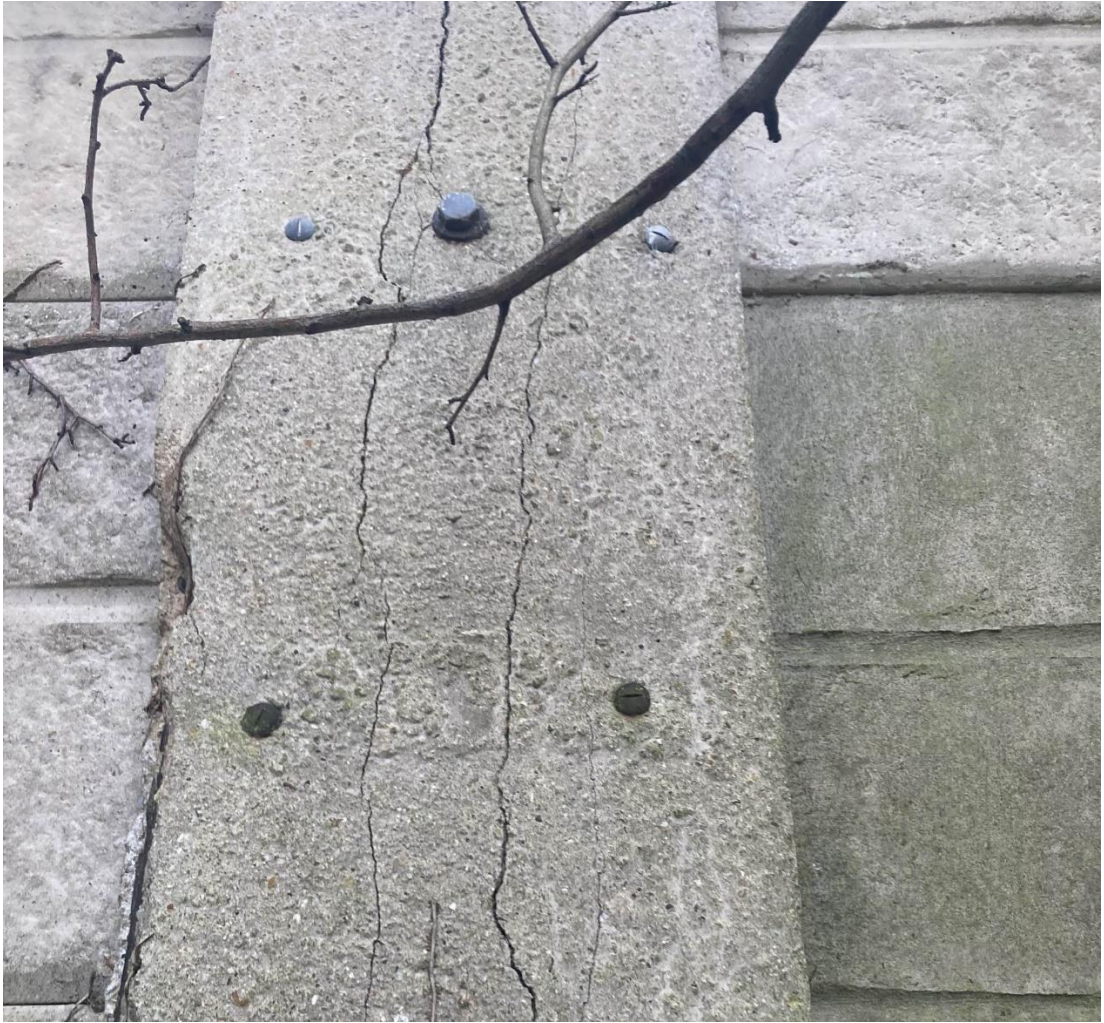
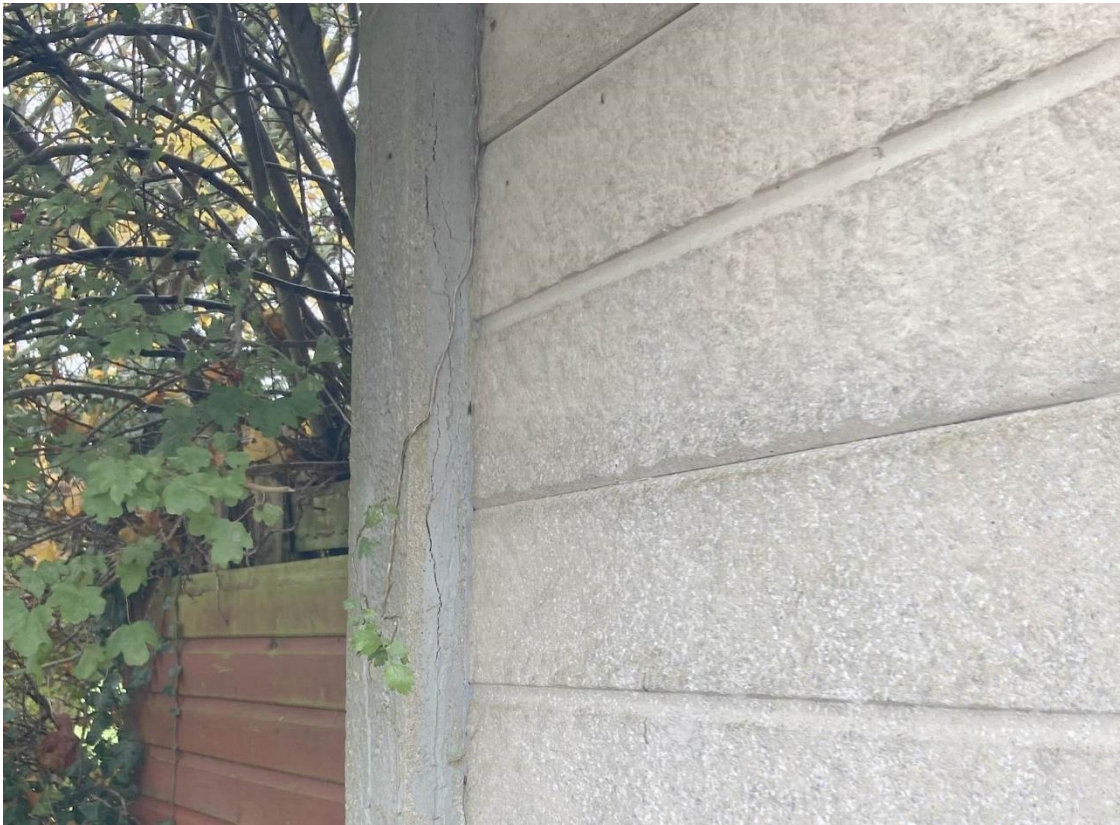
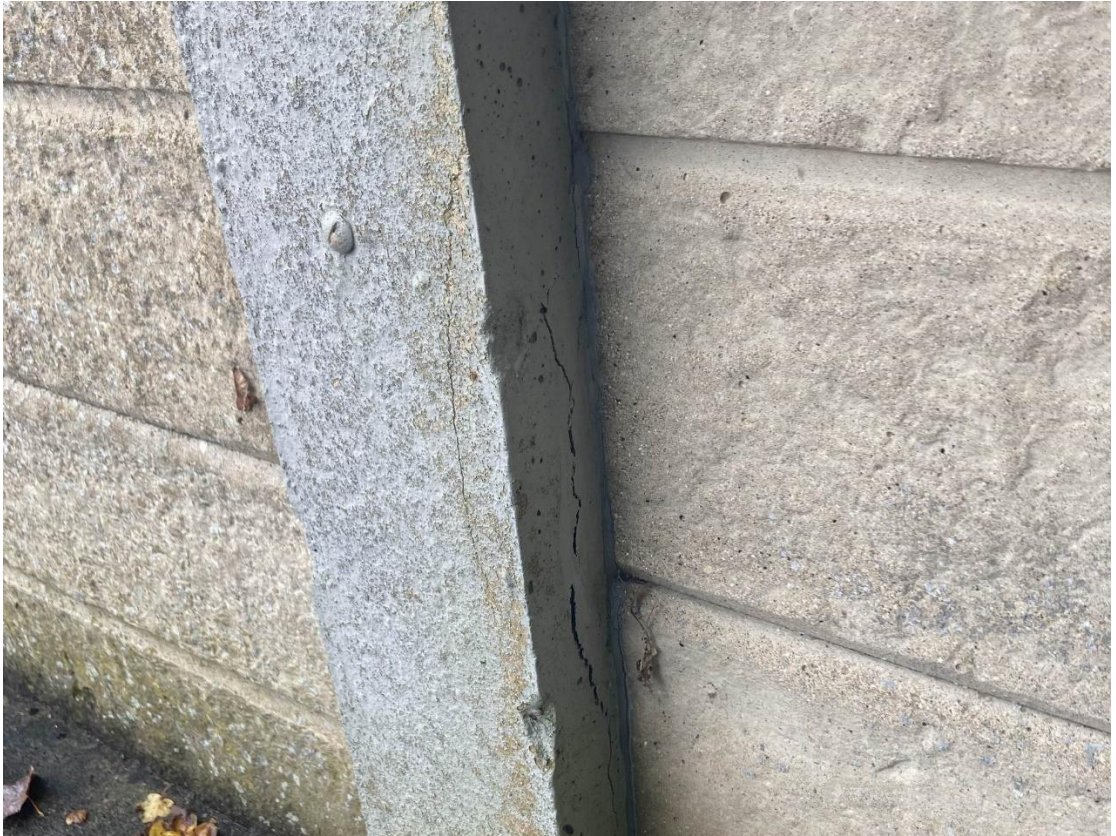
10. Some of the cracking was relatively minor.

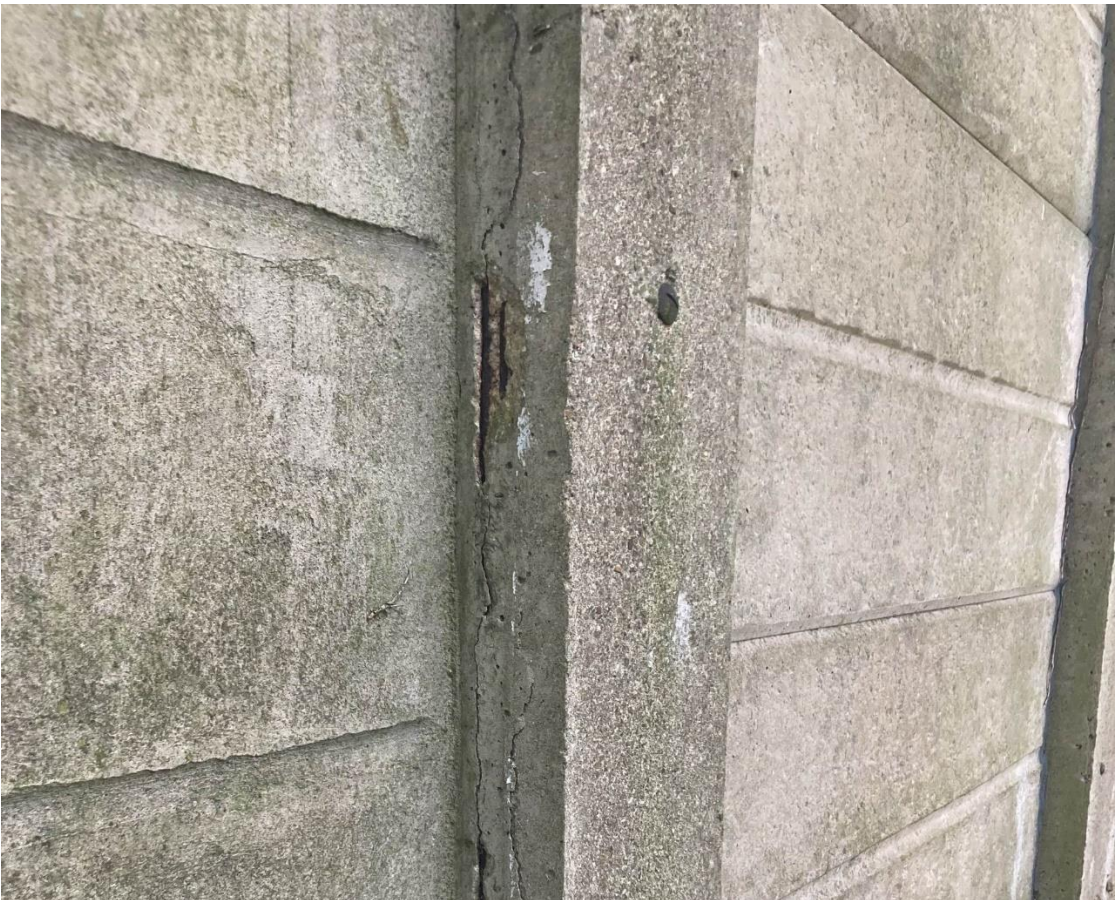
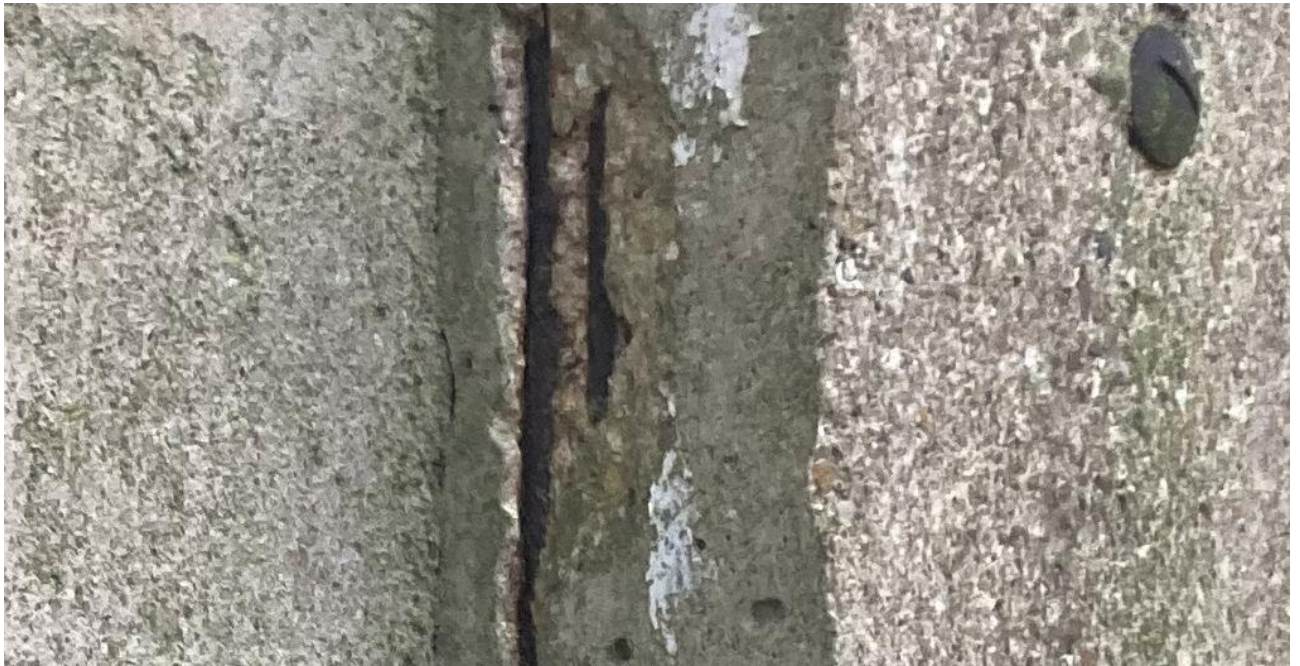
11. In some areas, the reinforcement was exposed and was rusted. The cover was noted to be minimal.

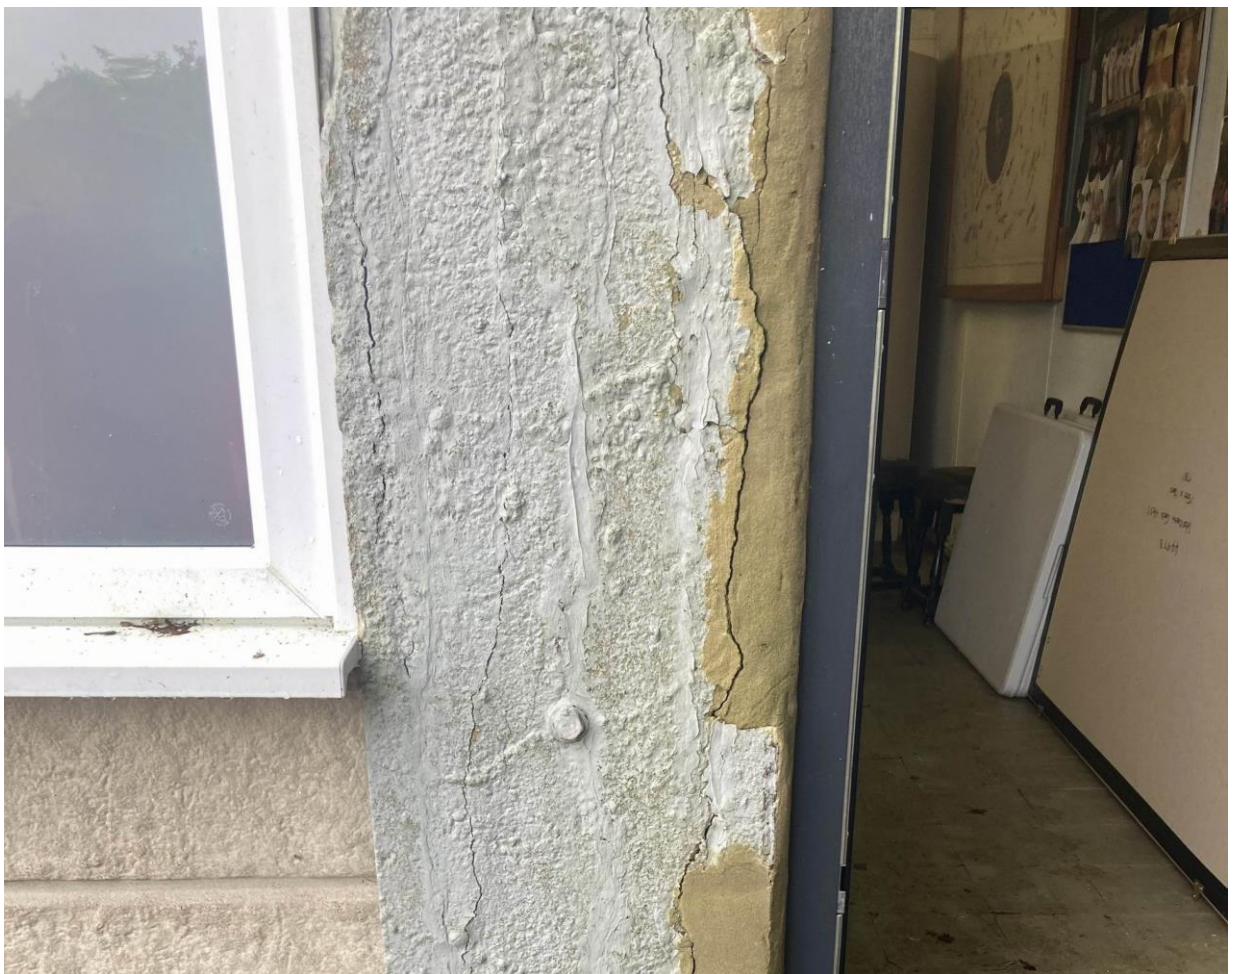
12. Several of the posts have been repaired. Some of the repair appeared to be just normal mortar and this has cracked again. Some appears to be some form of painted on coating which has also cracked.

52. If you repair using normal mortar this will not give a long-term solution and will tend to spall as has happened on some of the repairs here.
53. Ideally, repairs should be carried out by a specialist contractor, but they tend to be expensive. As stated above, all that has to be done is to hack off the spalled or loose areas, remove the rust from the rebar, treat the steel against further corrosion and then the area repaired with an epoxy render. If you can keep the post sheltered from the weather, then these repairs are not so critical, and a general builder could probably do the repairs.

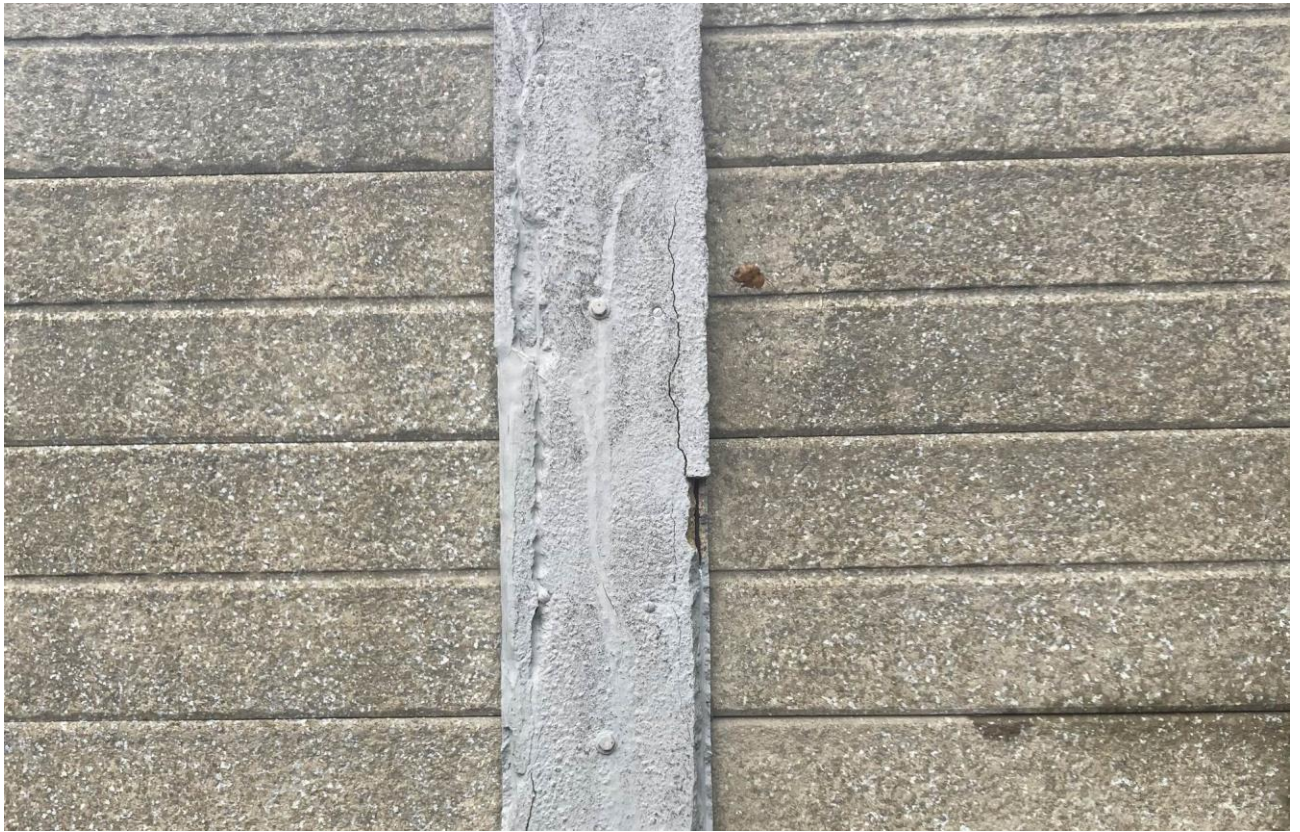
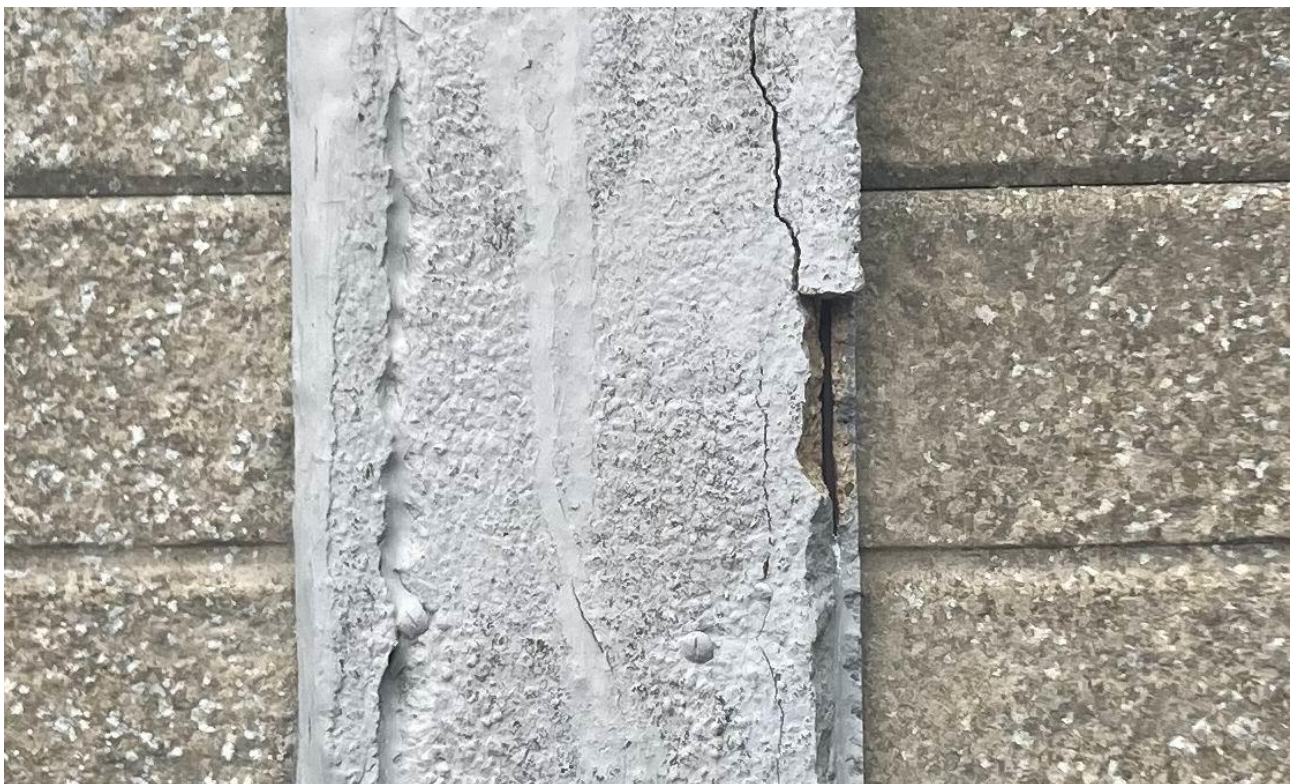
13. Some of the cracks have been filled with mastic. Also, where the concrete has spalled some areas appear to have been painted over with a coating material.

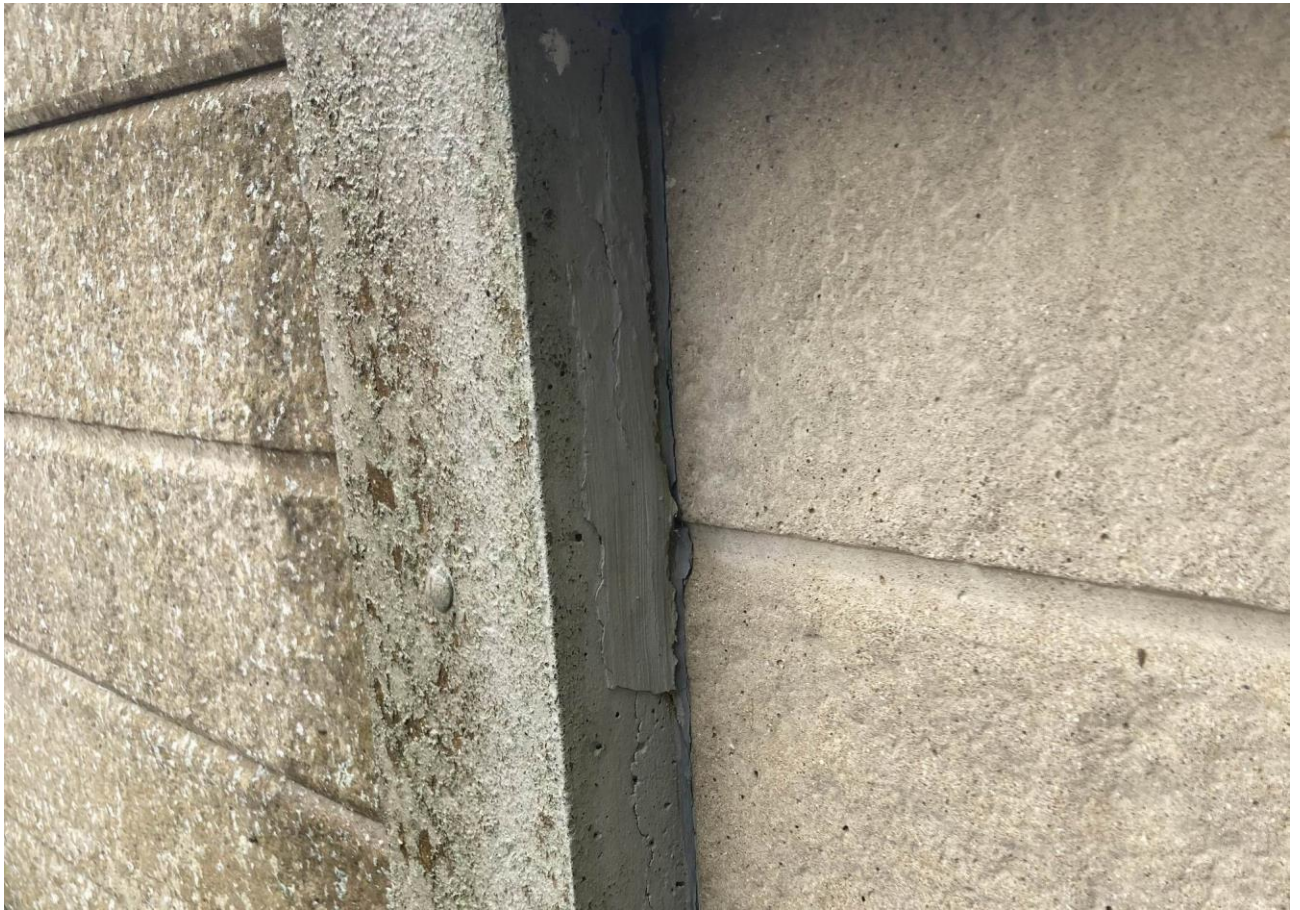
14. Where patch repairs have been carried out, the repair is being pushed out of position.

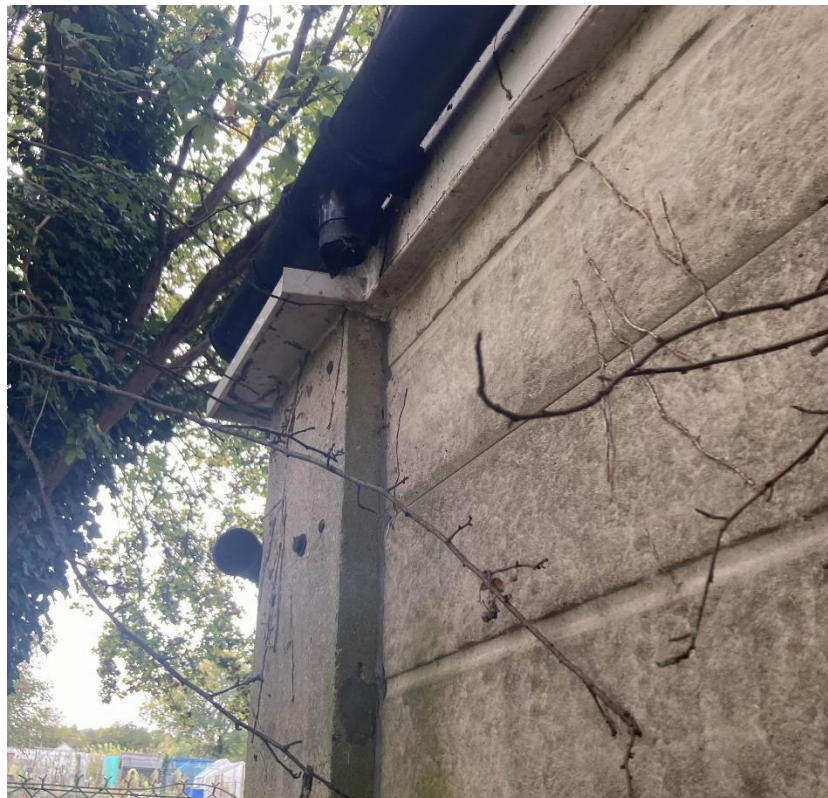
15. The gutters have missing downpipes and several areas do not drain away from the structure.

38. The gutters and down pipes need to be adjusted and/or replaced to drain the water from the building and to discharge it away from the building, ideally taken into a soakaway away from the building. Good practice is for the soakaway to be located a minimum of 5.0m from any structure.

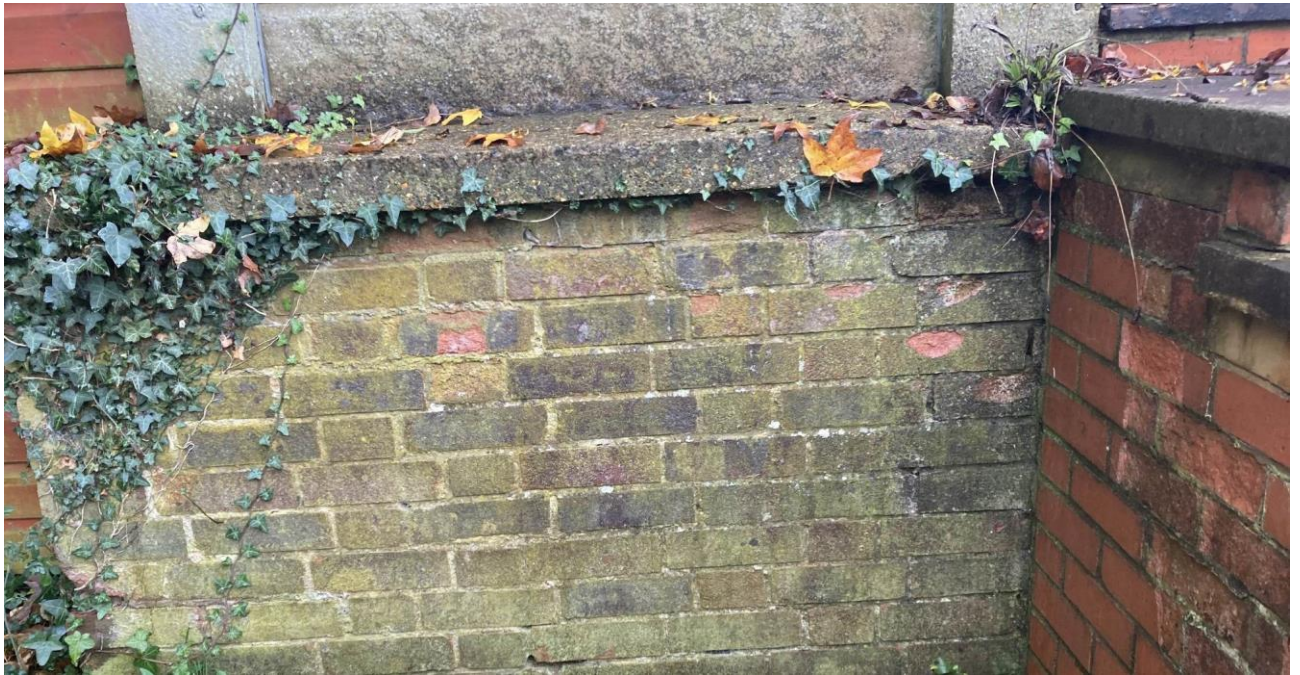
16. The brick plinth has a number of bricks with spalled faces.

30. A depth of hardcore fill has been called up below a thin mesh reinforced slab.
31. There were a number of bricks with eroded faces. Normally bricks form a very durable outer finish to an external wall however in some cases the faces begin to erode. There are two main causes of erosion of the face of the brickwork.

- Frost damage
  - Dissolved salts.
32. Frost damage is caused when there is excessive water ingress into the brick which then retains the water.
33. In cold weather this water can freeze and expand, causing the brick to spall and the face flakes away. Once the face has spalled, it makes the brick more susceptible to absorbing water and the process accelerates the degrading of the brick.

35. You can also get a combination of both of these issues occurring.
36. There is no simple solution to dealing with eroded brickwork. The only real option is to cut out the damaged bricks and stitch in new bricks.

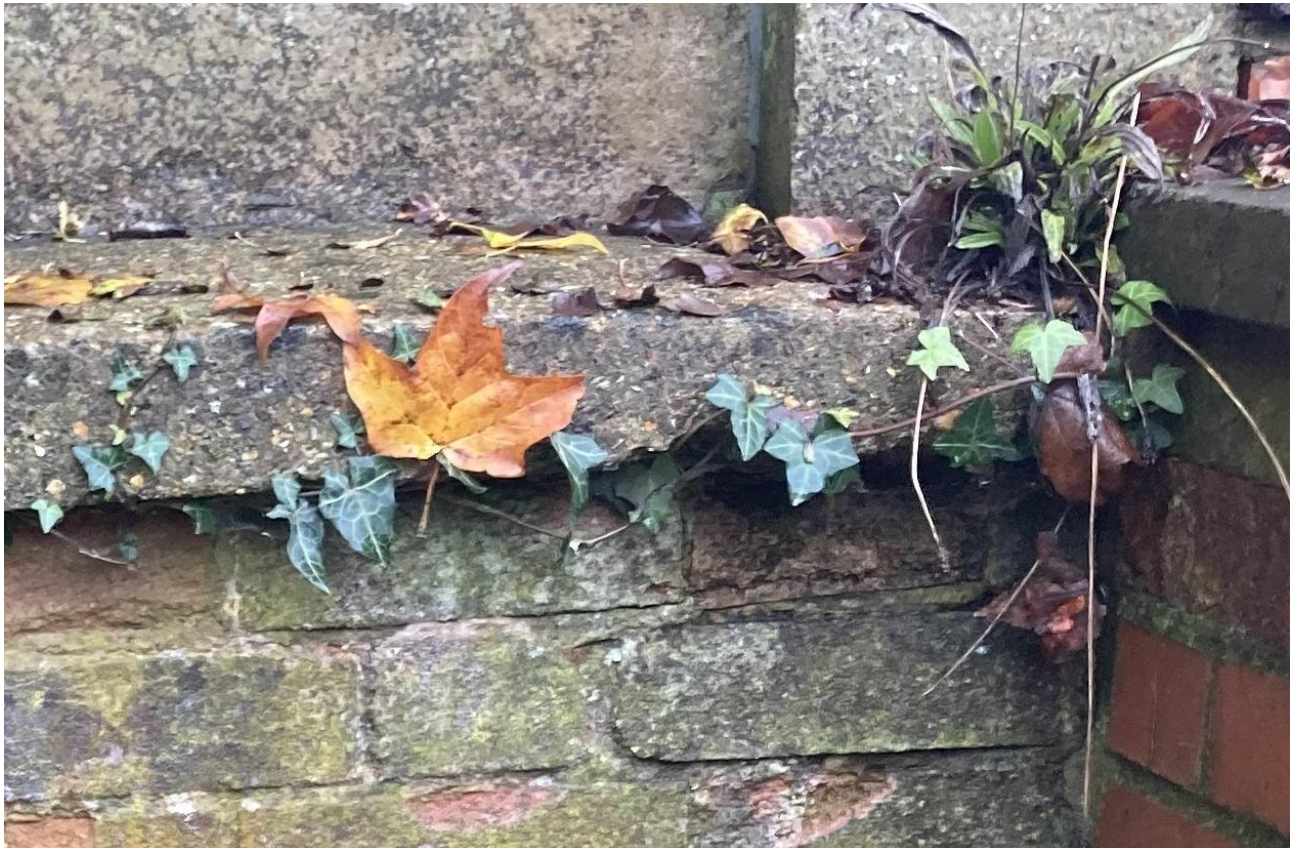
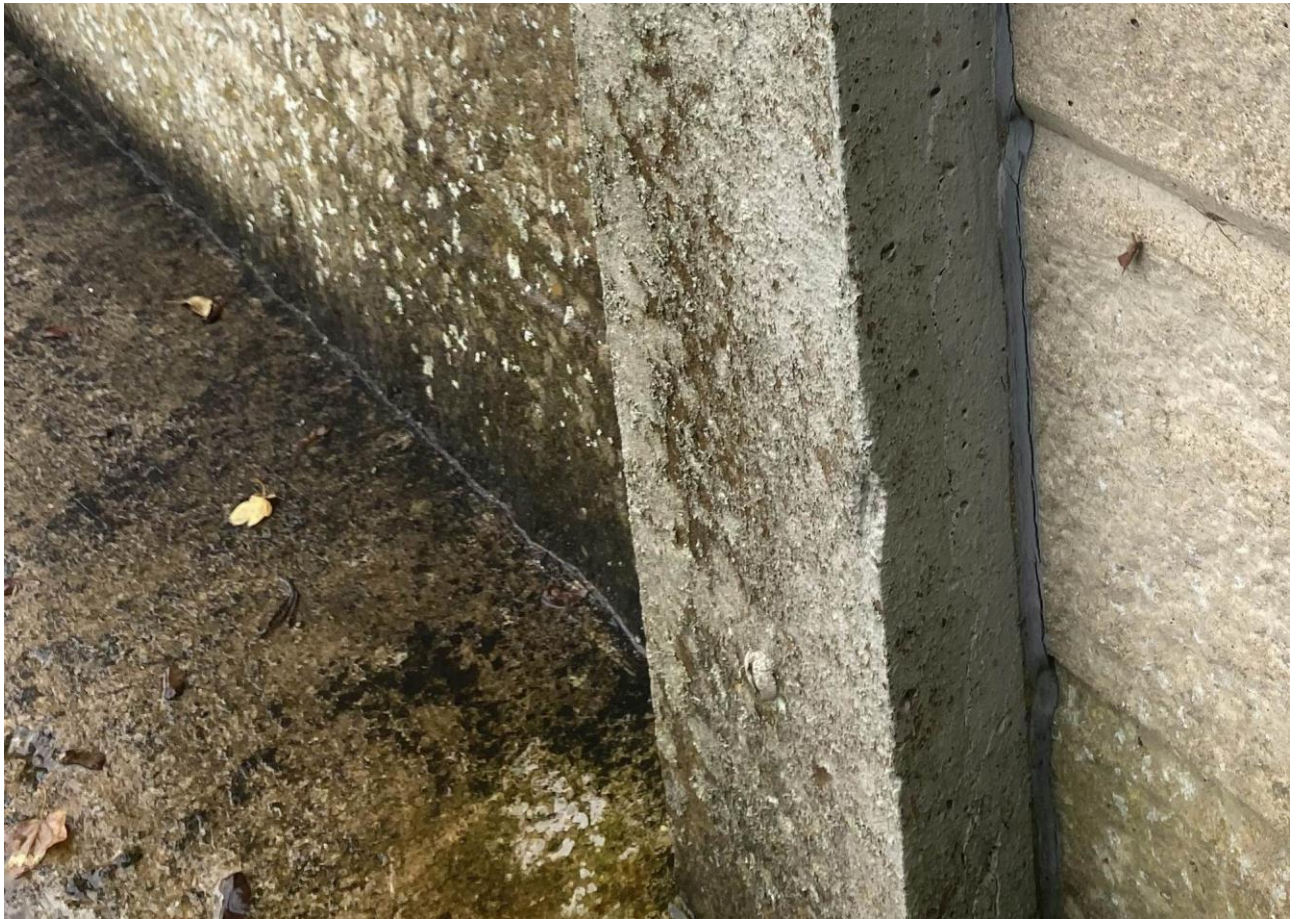
17. The raised plinth has a concrete slab and it can be seen that there was a lot of water landing on the slab and splashing the walls.

37. With the way this building has been sat on a raised concrete plinth and the poor rainwater provision, there is a lot of water getting onto the slab and around the base of the building. Ideally the topping should be removed and laid to better falls away from the building.

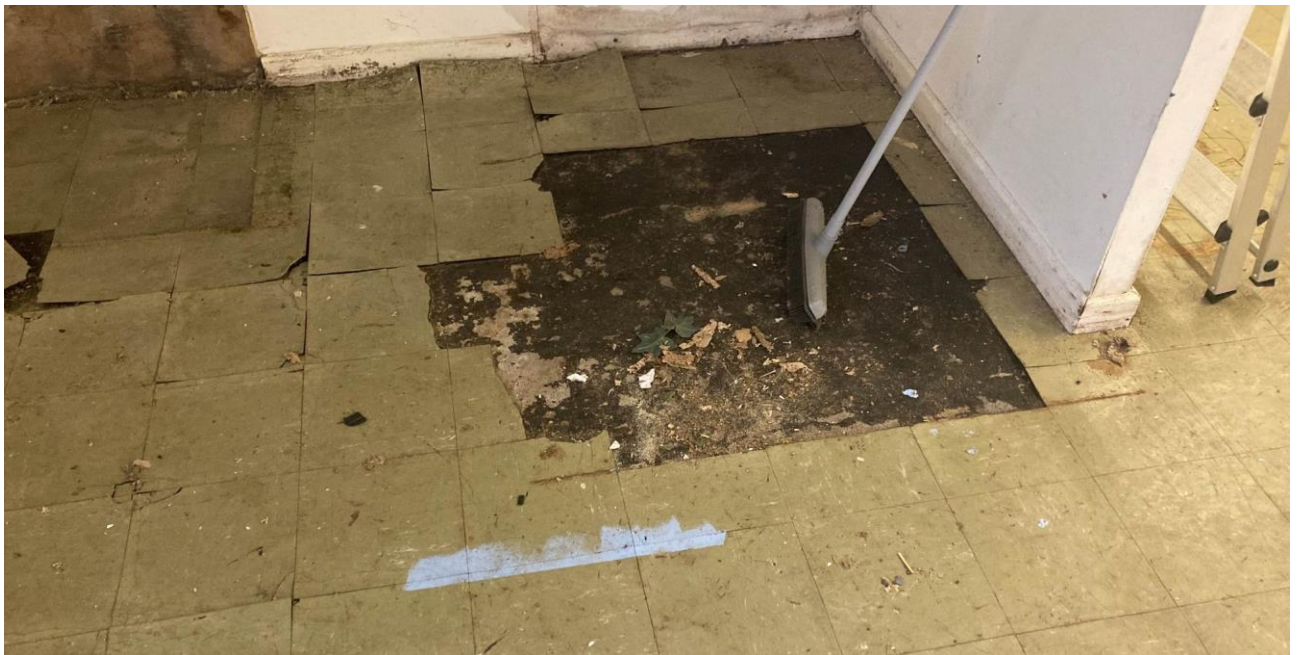
18. The floor has been covered with thermoplastic tiles with areas of this lifting.

61. On the floor there are thermoplastic tiles. Older thermoplastic tiles contained asbestos, and you should get C. Wood to check these if they have not already been checked.

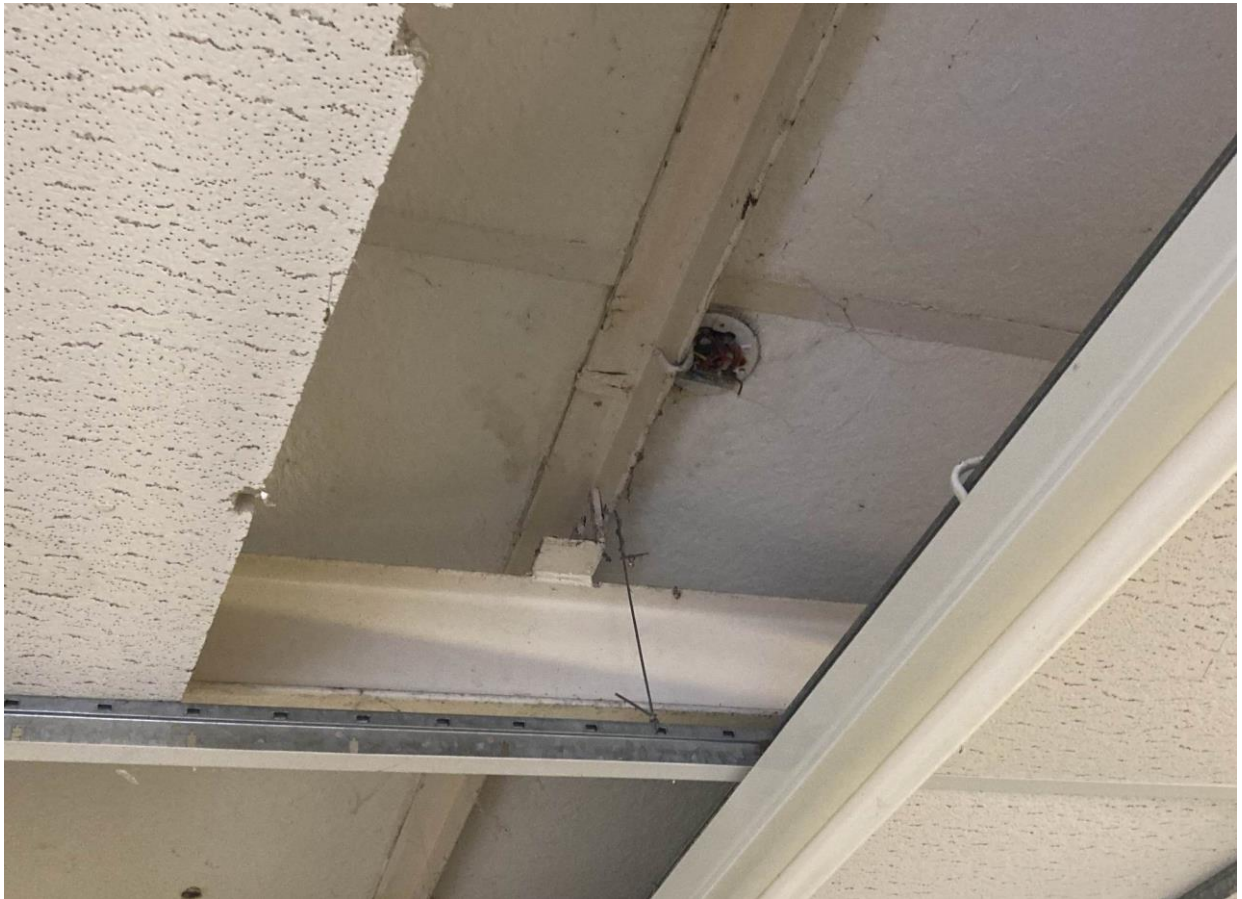
19. The roof structure is formed with a small steel 'I' beam supporting a rolled steel angle purlin which in turn carries the roof sheeting.
20. There is a fibre board suspended ceiling below the sheeting with a second similar ceiling installed below.

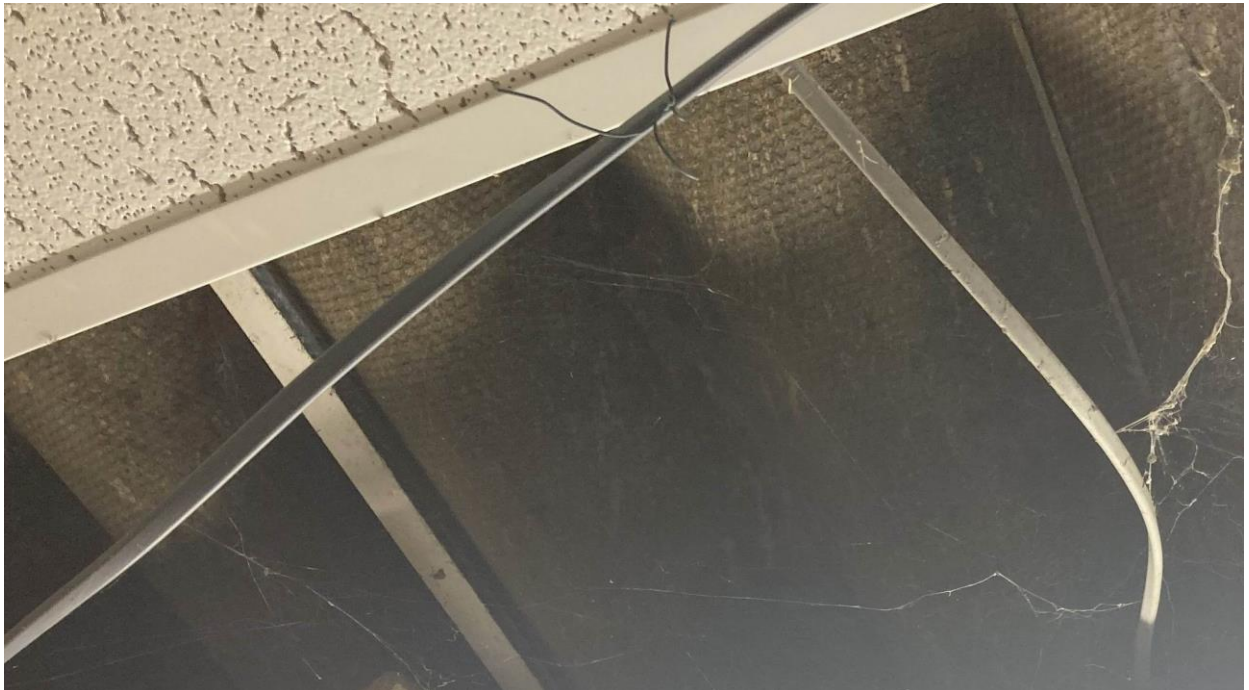
21. The roof has a suspended ceiling and the roof itself is formed with asbestos cement corrugated sheeting.

56. The roof has asbestos cement sheets. These are safe if left totally alone but if any work is required to them then this may require special precautions depending on the type of asbestos.

59. If you are spending money to upgrade the building, I would recommend that you have the asbestos roof removed. You can then install a new roof which can be insulated.

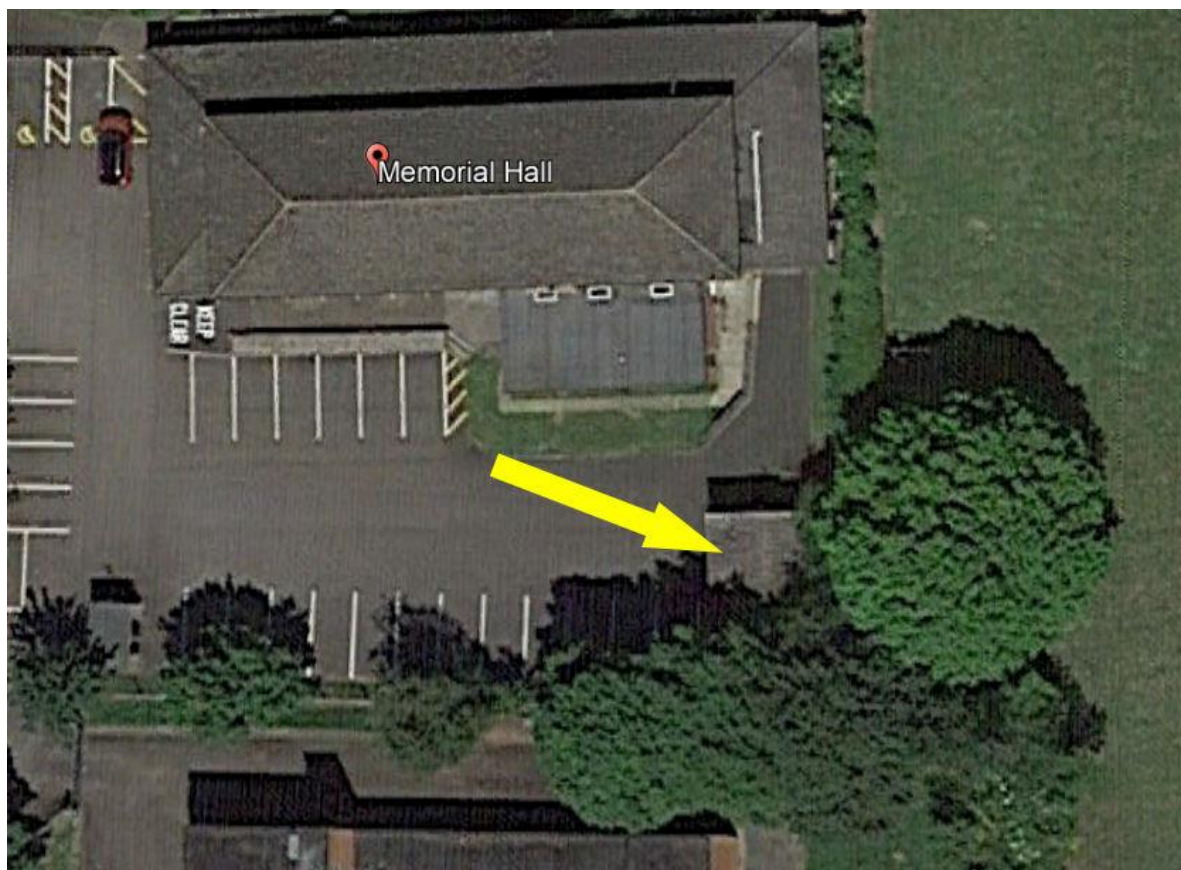
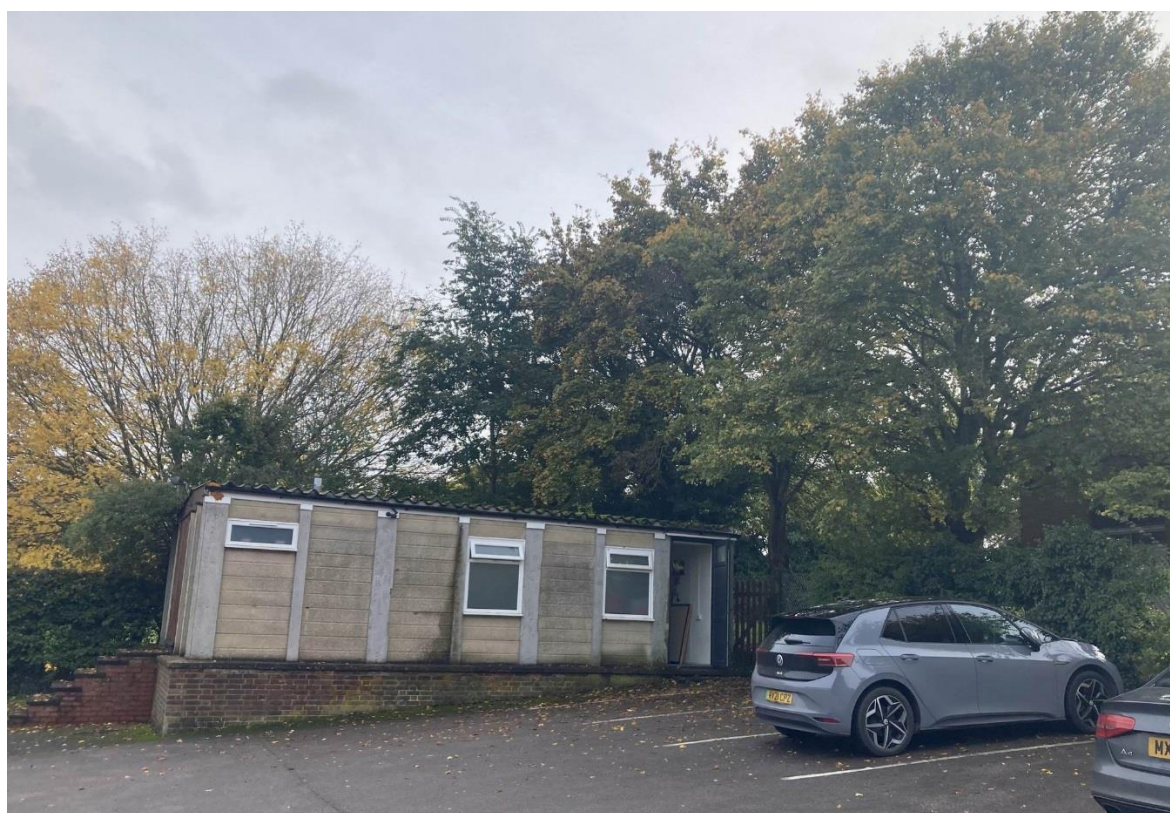
23.1. There is a bank of mixed trees up to about 10 metres high located around the corner of the site close to the building in question.

26. There are no superficial deposits at this location.
27. With the expected subsoil, means that there is a low risk of subsidence at this property and the trees located close to the property should have no effect on the building. There was nothing I saw to suggest there was any historic or on-going subsidence movement and no action is required.
