Please see below a selection of photographs taken from our property on the 9<sup>th</sup> and 19<sup>th</sup> August 2025.

**Photograph 'A' 9 August 2025 , Photograph 'B' and Photograph 'C' both dated 19 August 2025 (below).**

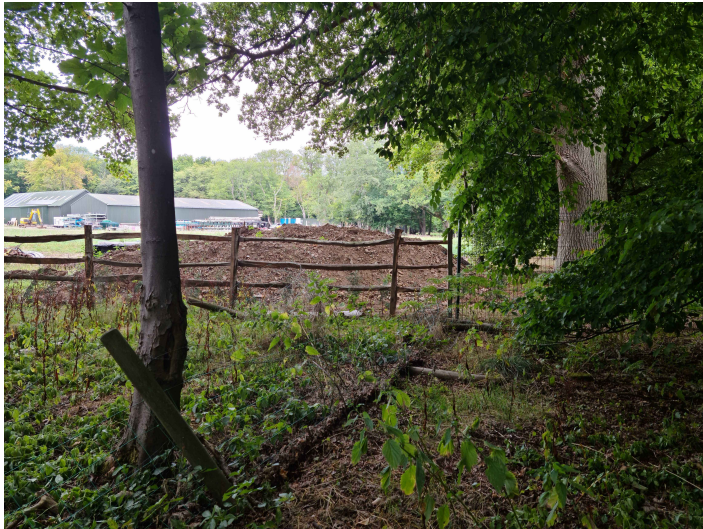
**PHOTOGRAPH 'A' 9 August 2025.**

Show a large amount of earth spoil deposited beneath the canopy of the oak tree in Church Wood (protected by the TPO). This is located within the Root Protection Zone of the tree and it is contrary to BS: 5837: 2012 Trees in relation to design, demolition and construction. Recommendations.

A mature oak like this tree will have at least a 15m Root Protection Zone (RPZ) and this will be increased to at least 20m if it's a veteran tree in an ancient woodland.

Storing materials within the RPZ is contrary to the BS. Storing materials on the bare ground, without any ground protection, is also contrary to BS 5837: 2012. The top 150mm of the soil contains the dense area of fine tree roots that supply the tree with its nutrients. Damage to these roots (or the bark) by machinery, ground excavations/leaching of materials (from tarmac waste??) is an additional threat to the trees.

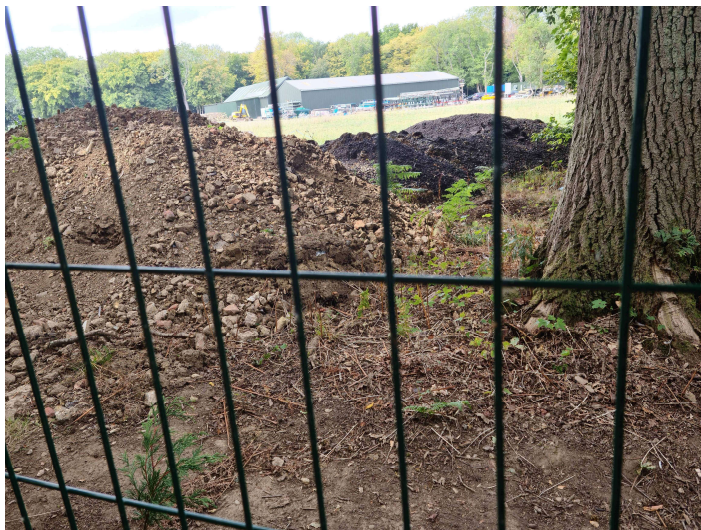
**PHOTOGRAPH 'B' 19 August 2025.**

Shows how the bark at the base of the mature oak tree trunk has been damaged.

Shows the same large spoil heap plus a heap of tarmac debris deposited beneath the canopy of the tree in Church Wood (protected by the TPO). The bark on the trunk of the tree has been damaged it appears in two places.

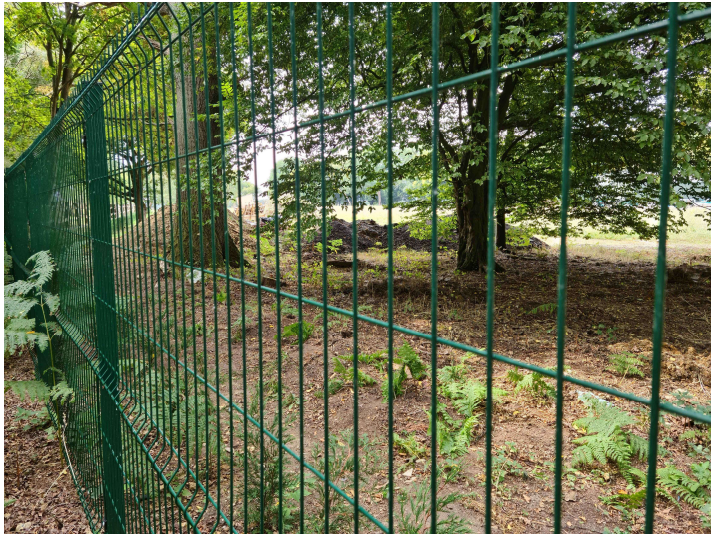
**PHOTOGRAPH 'C' dated 19 August 2025**

Shows the two heaps of spoil within the RPZ of the oak tree and nearby hornbeam trees.

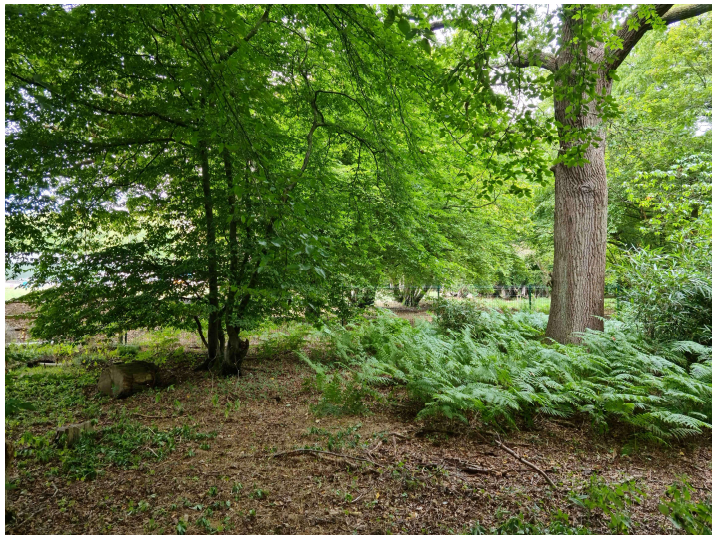
**PHOTOGRAPH 'D' dated 9 August 2025 (below)**

Show the above oak tree plus a mature oak tree, possibly a veteran tree (located on our property, also within Church Wood).

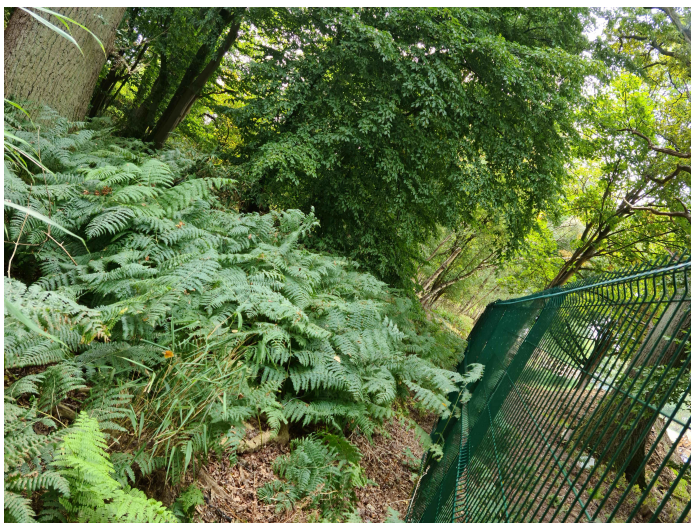
**PHOTOGRAPH 'E' dated 19 August 2025 (below)**

Shows how the two oak trees are approximately 8m apart. The earth spoil and tarmac waste therefore fall well within the RPZ of both mature trees.
