| Prepared by: | Letchworth Garden City Heritage Foundation (Property and Estates Team) |

## Summary

| Road: | WILLIAN CHURCH ROAD |

| Species: | Crataegus laevigata (Hawthorn) |

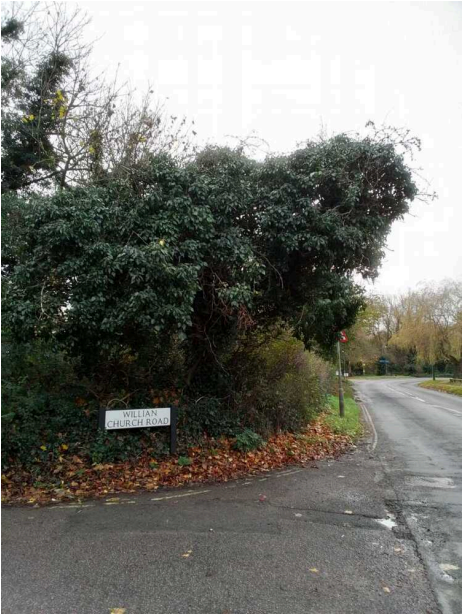
Inspection with Work Request: 18 Nov 2024 14:14:35

| No | Species | Height (m) | Age Class | Next Inspection | Work Priority | Est. Duration |
|---|---|---|---|---|---|---|
| | GENERAL OBSERVATIONS Heavily ivy clad impeding inspection. Broken hanging branch. Overhanging road. Very sparse crown. Measurements estimated due to ivy. CATEGORY U; PHYSICAL_CONDITION Poor; STRUCTURAL_CONDITION Poor; LIFE EXPECTANCY <10 years; TREE/GROUP TAG Unable to tag due to ivy ; KT ASSET ID 1090001241; STEM DIAMETERS 30cm, 15cm; COMMENT Unable to tag; CAVAT FUNCTIONAL VALUE 25%; CAVAT CASH VALUE £471; LAST INSPECTED 18-11-2024 UPRN P1/22/06 ( Willian Village Green & Amenity adj Manor Farmhouse) | | OPERATIONS CARRIED OUT<br>Inspect<br>PRELIMINARY RECOMMENDATIONS<br>Fell Tree (Due to within falling distance of road and heavily ivy clad with very little live growth.) | | | |

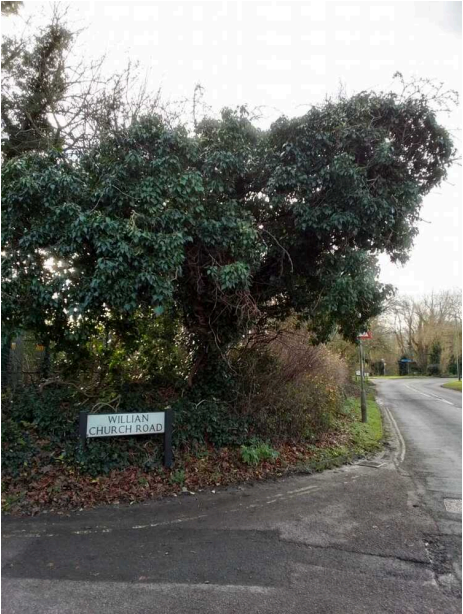
Inspection: 16 Dec 2024 12:40:50

| No | Species | Height (m) | Age Class | Next Inspection | Work Priority | Est. Duration |
|---|---|---|---|---|---|---|
| GENERAL OBSERVATIONS Heavily ivy clad impeding inspection. Broken hanging branch. Overhanging road. Very sparse crown. Measurements estimated due to ivy. CATEGORY U; PHYSICAL_CONDITION Poor; STRUCTURAL_CONDITION Poor; LIFE EXPECTANCY <10 years; TREE/GROUP TAG Unable to tag due to ivy ; KT ASSET ID 1090001241; STEM DIAMETERS 30cm, 15cm; COMMENT Unable to tag; CAVAT FUNCTIONAL VALUE 25%; CAVAT CASH VALUE £471; LAST INSPECTED 16-12-2024 UPRN P1/22/06 ( Willian Village Green & Amenity adj Manor Farmhouse) | | | OPERATIONS CARRIED OUT<br>Inspect<br>NO WORKS REQUIRED AT THE TIME OF INSPECTION | | | |
