**Supporting Information for Listed Building Consent  
Application  
Survey and Method Statement**

Doc ID: ING/YNG/LBC/002

Youngloves Farm, Southern Green, Hertfordshire, SG9 0SP

Date: 10<sup>th</sup> April 2025

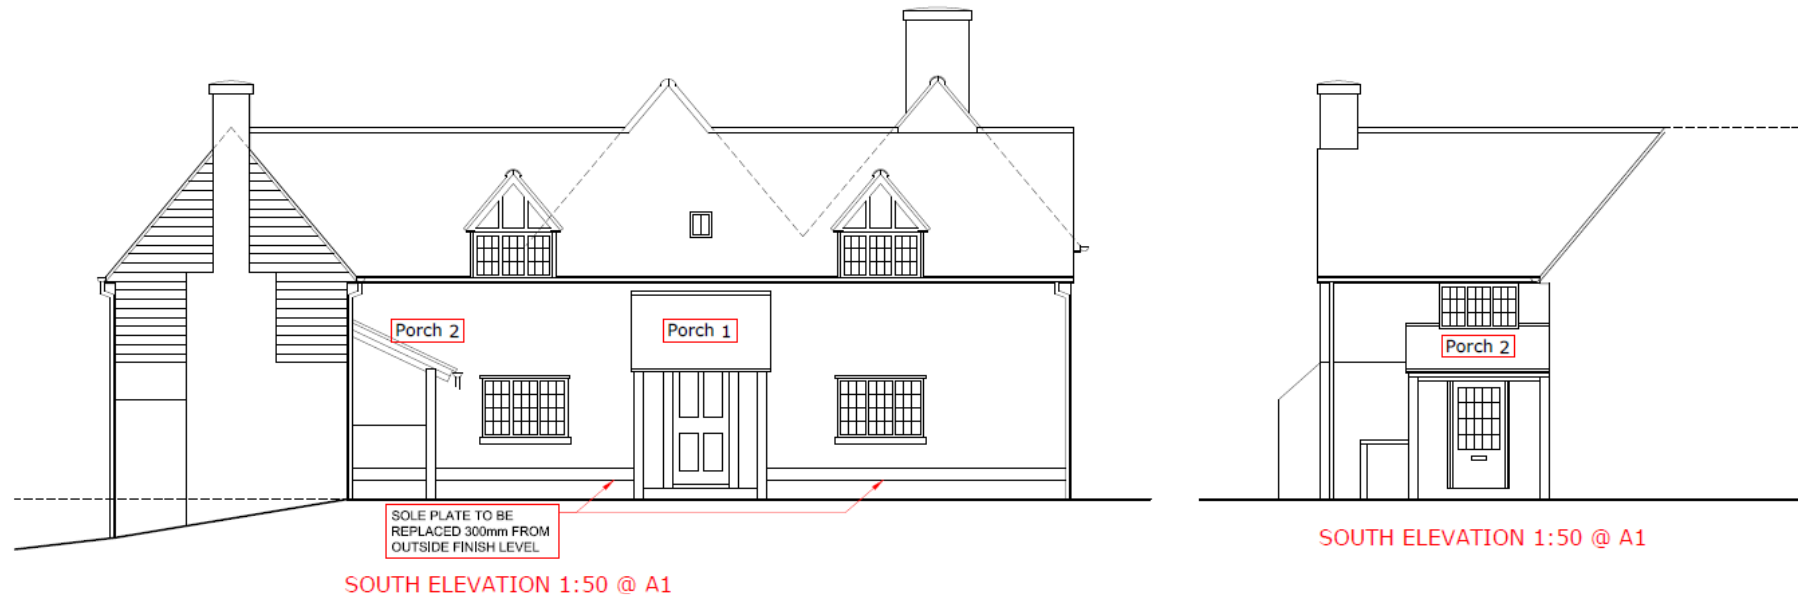
## 2.6. Diagrammatic Overview of South Elevation

- a. The South Elevation is completely finished in a concrete render; the client wants to restore this to a permeable and breathable lime based finish.

- a. The South and West elevation both have several areas where the brick faces are significantly damaged or decayed.
- b. In addition, Concrete Mortar has been used for historic repairs.

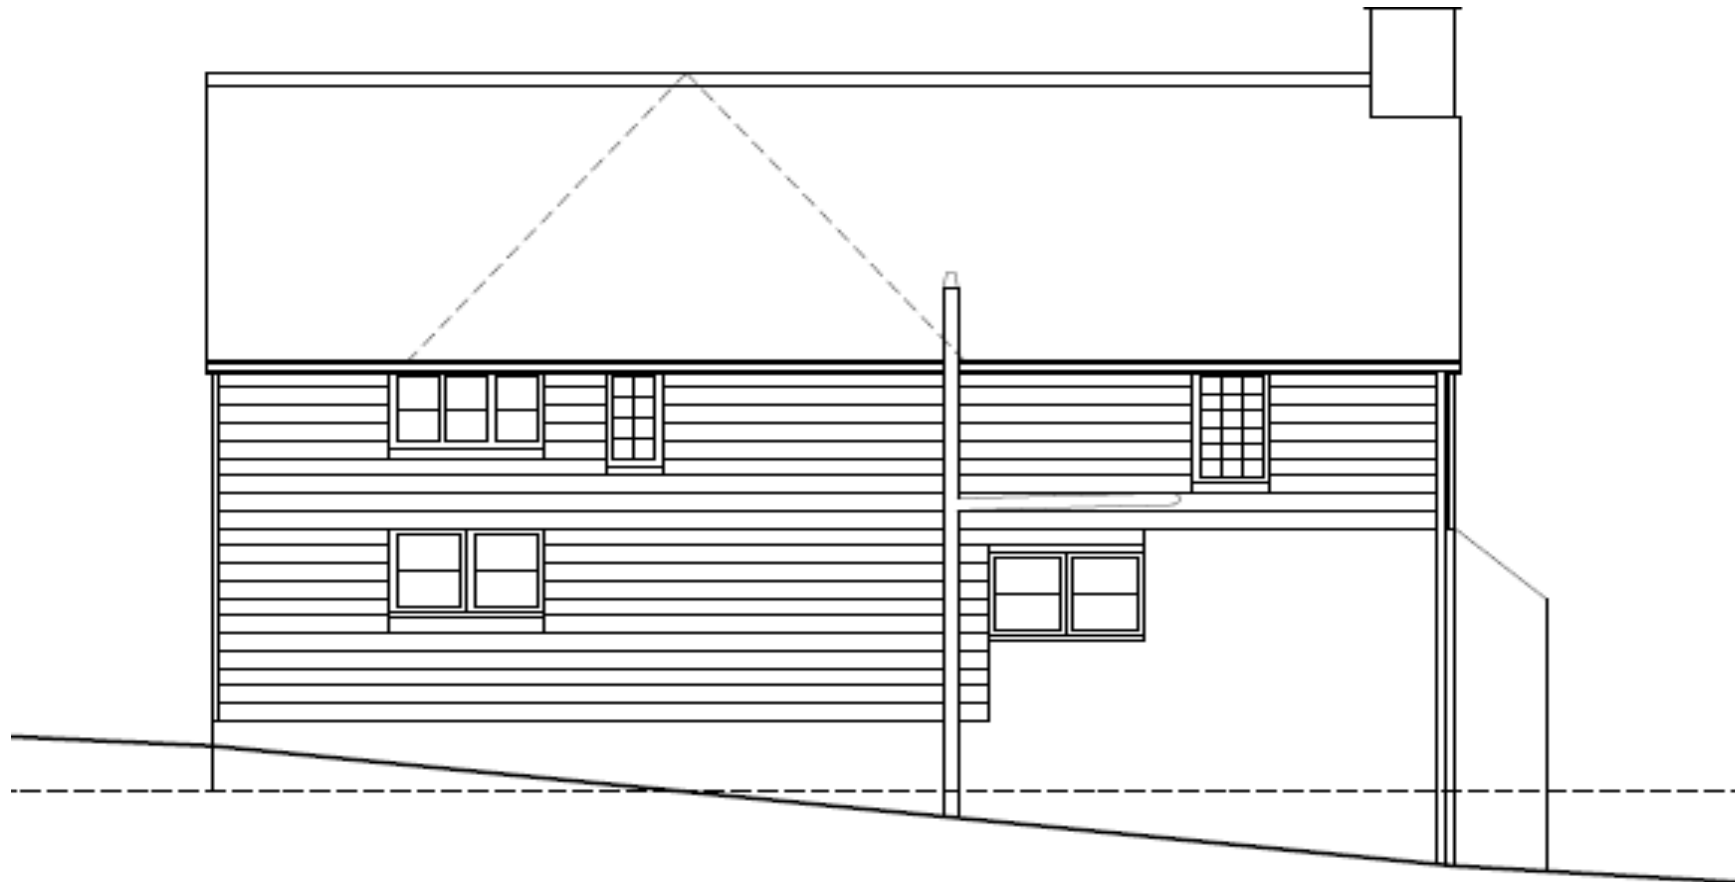
WEST ELEVATION 1:50 @ A1

- a. A survey appears to show significant decay in the sole plate.
- b. Other timbers cannot be inspected until the concrete render has been removed.
- c. Weatherboard on the West Elevation is decayed and requires replacement

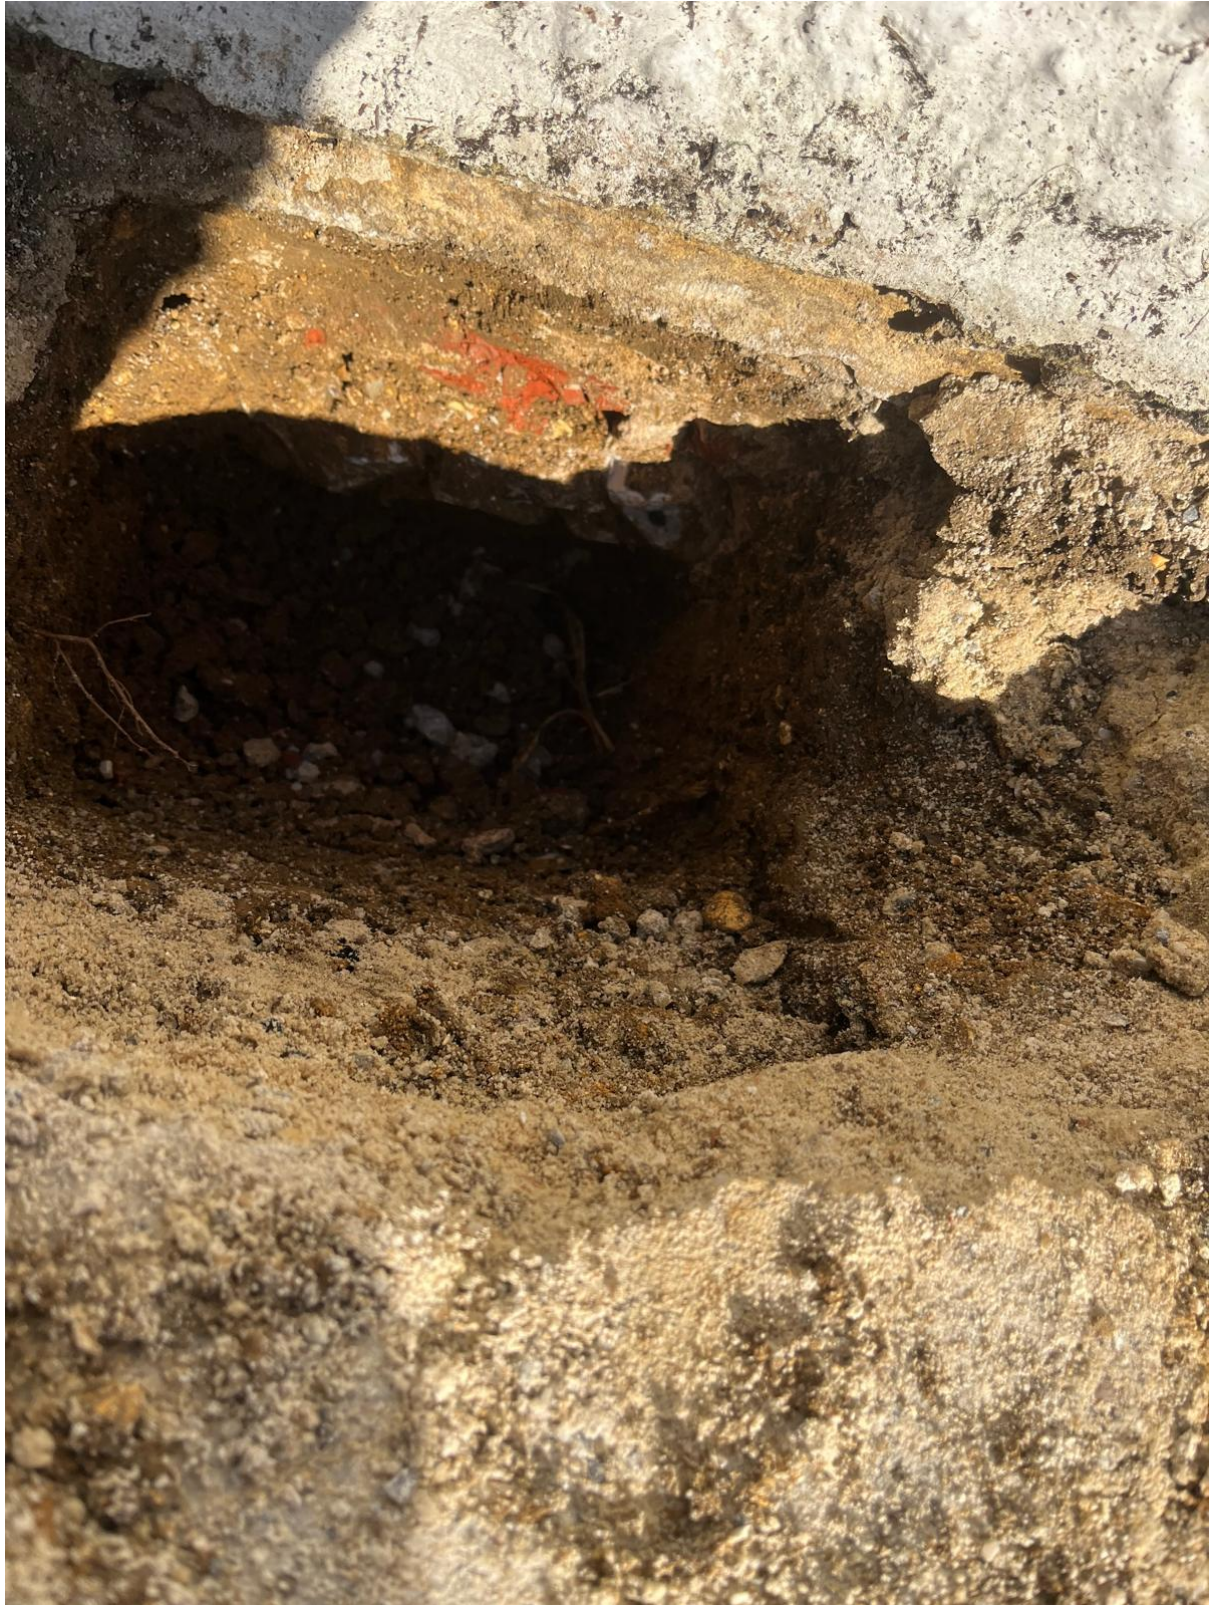
- a. Two Trial pits were excavated on the south elevation and inspected by the Structural Engineer.
- b. The trial pits showed that there are no foundations or spread brick footings, which is expected.

*Figure 2 - Trial Pit showing no foundation*

| No | Step | Responsible Party | Supporting Notes |
|---|---|---|---|
| 4 | Excavate and build foundation | InGeni | Excavate to depth specified withing structural engineer scheme and as directed by building control.<br><br>See Section 7 - Structural Engineering Scheme |
