**RE: APPLICATION FOR APPROVAL OF DETAILS RESERVED BY CONDITION  
for conditions 2, 4 relating to permission 22/02290/LBC**

**Underpin south-west corner and install helical bars followed by repointing. Re-roofing works including re-battening and installation of TLX Gold breathable roof insulation coupled with 50mm mineral wool between rafters at Bibbsworth Hall Farm, Bibbs Hall Lane, Ayot St Lawrence, Hitchin, Herts, SG4 8EN**

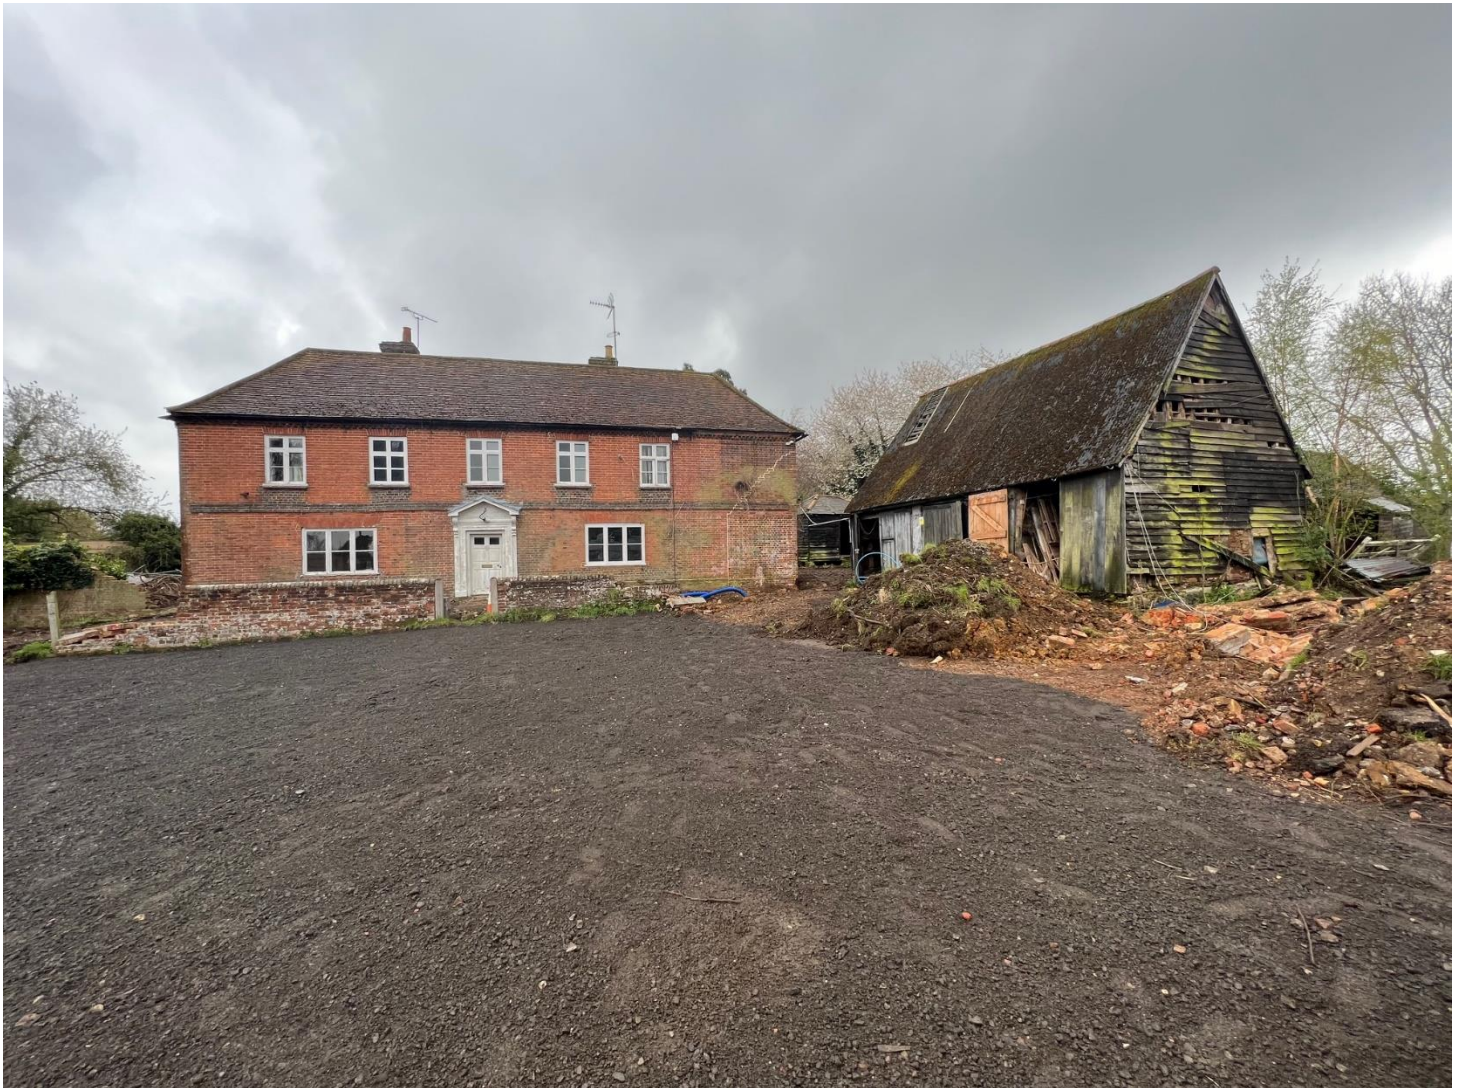
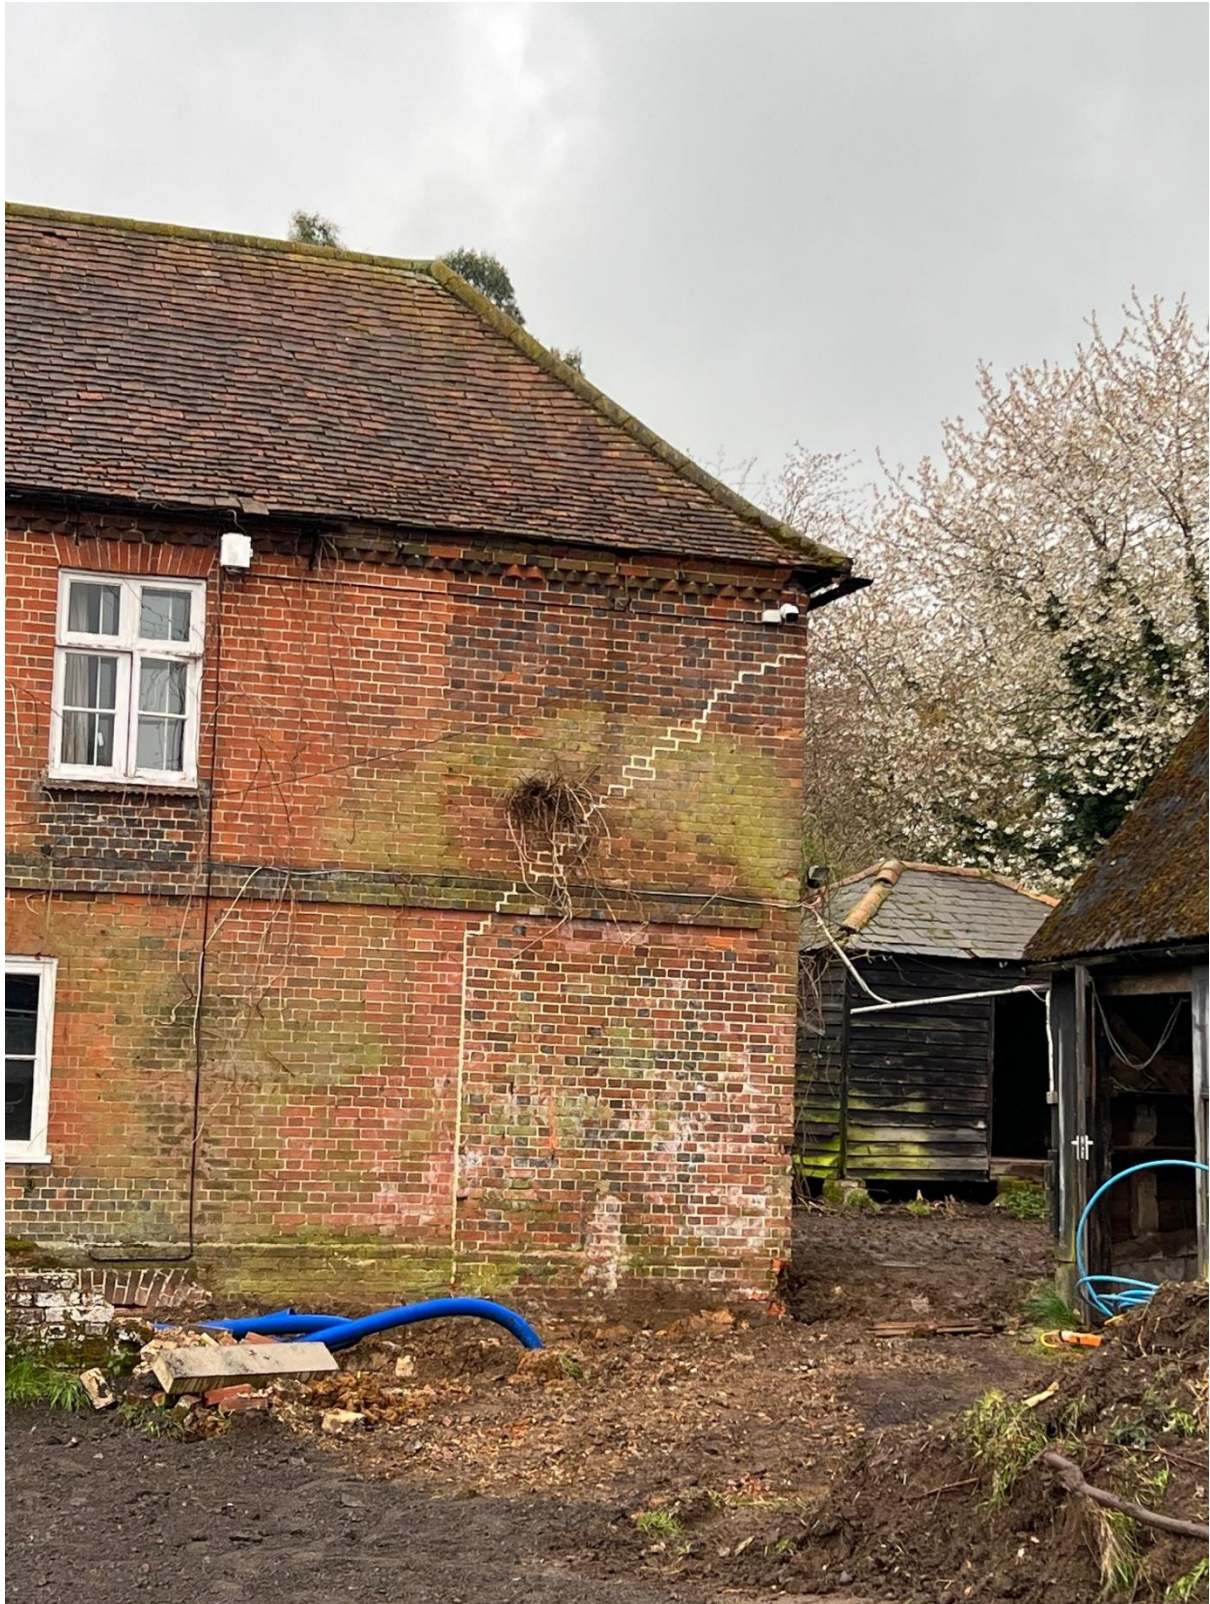
Photos prior to repair of wall

Please that when exploratory investigations of the footings were undertaken, it was found that the building had previously been underpinned but the walls had not been repaired.
