## Link Engineering

Project No. **251205**

MSCC5 Drain and Sewer Codes (SRM5 Scoring)

After surveying the drainage at Redwing's Lodge, Hinxworth, we recommend a re-visit with HPWJ van pack or a Jet/Vac to clean the lines that were not accessible during the time of survey, remarks at the end of each pipe section will specify the necessary remedial action to take. The main hotel building has two surface runs either side that lead to a rodding eye, however one of these was not able to be located, we assume it is buried. The inspection chambers that would give access to these SW6 and SW5 were UTL. If these covers are raised then that would allow us to confirm the surface run and its features. The restaurant on site uses a grease trap to clean the waste from the kitchen, we recommend that the grease trap and all surrounding drainage is cleared out and thoroughly cleaned then re-surveyed for the pipe condition. Following this, we located a buried manhole to the South East of the restaurant, this should be uncovered, lifted and surveyed.

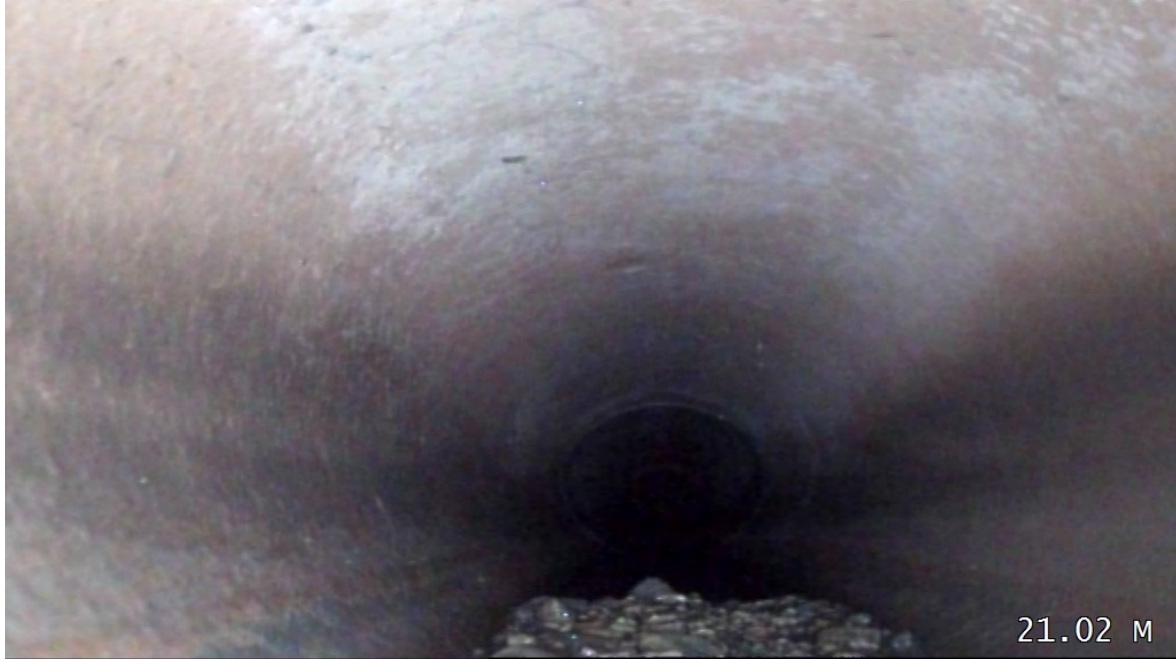
S11C5

Settled deposits hard or compacted 10% cross-sectional area loss

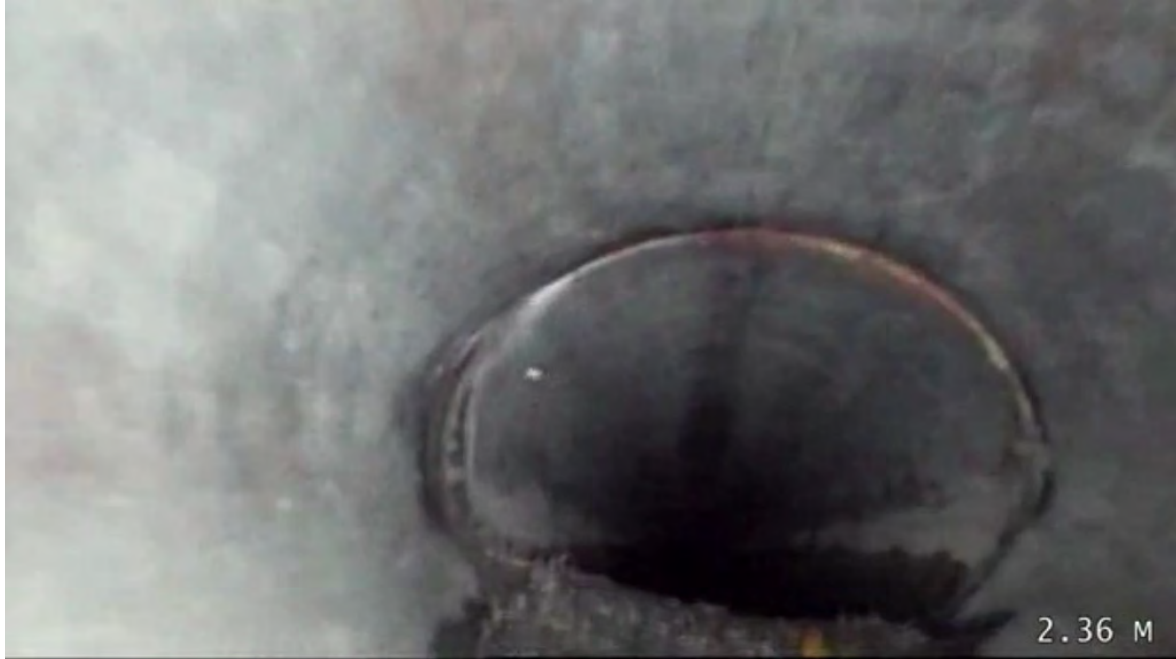
**S14C3**

Settled deposits fine 10% cross-sectional area loss at joint

HPWJ recommended to remove settled deposits.

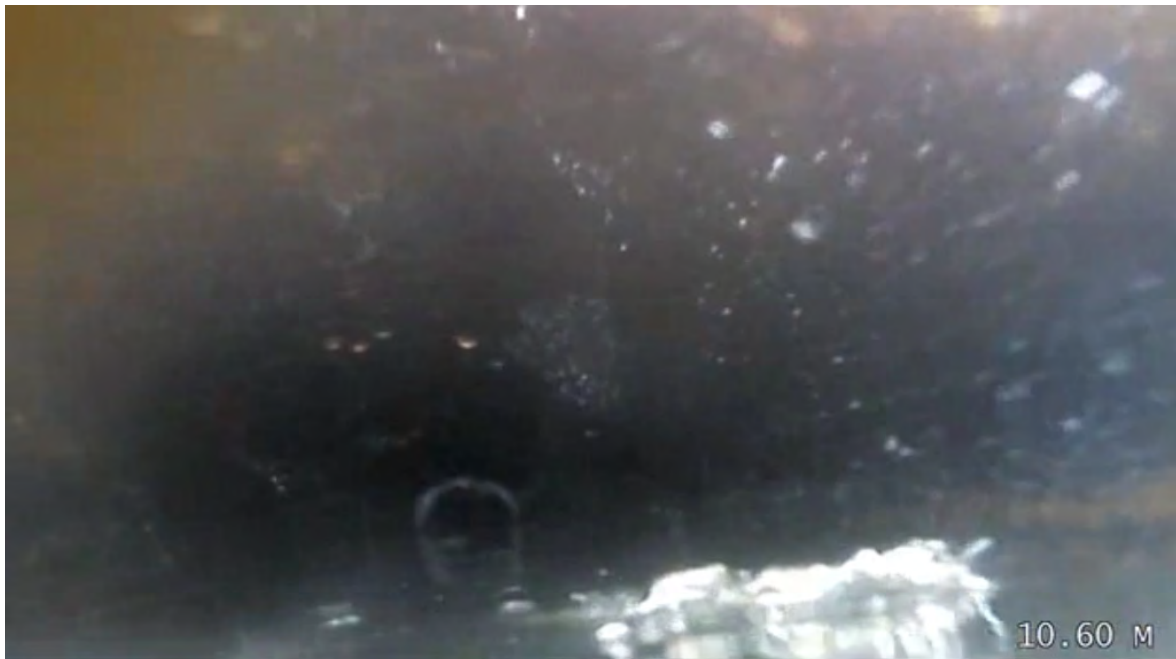
S17C6

00:01:03 - 10.60 m  
Settled deposits fine 10% cross-sectional area loss

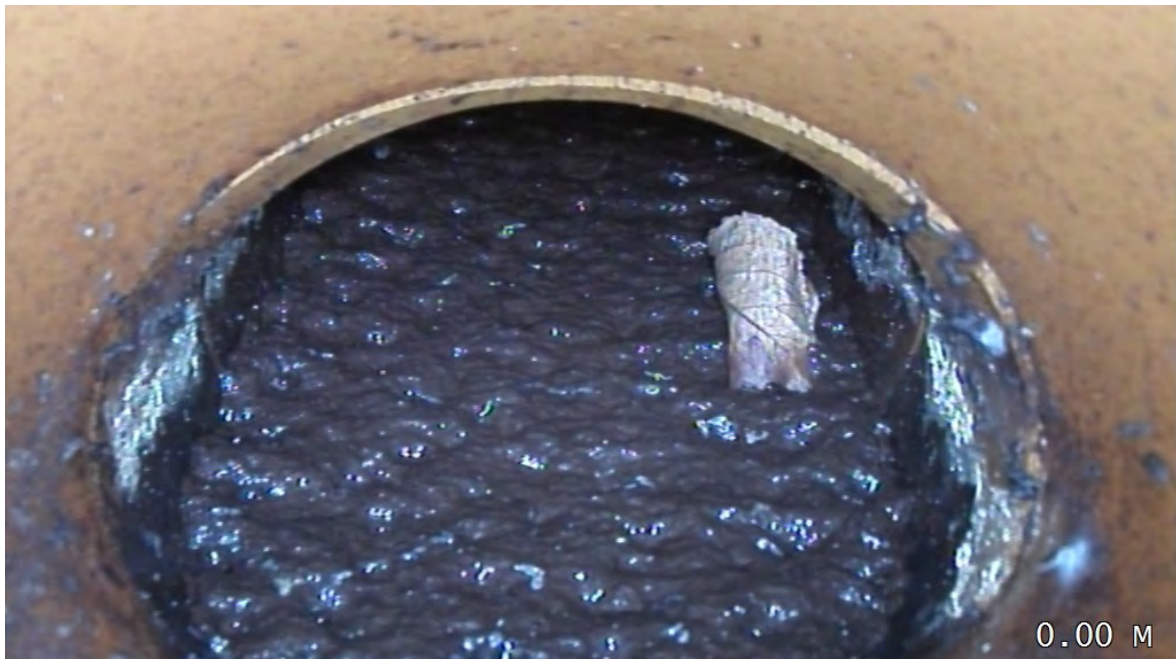
S21C4

00:00:04 - 0.00 m  
Settled deposits fine 75% cross-sectional area loss

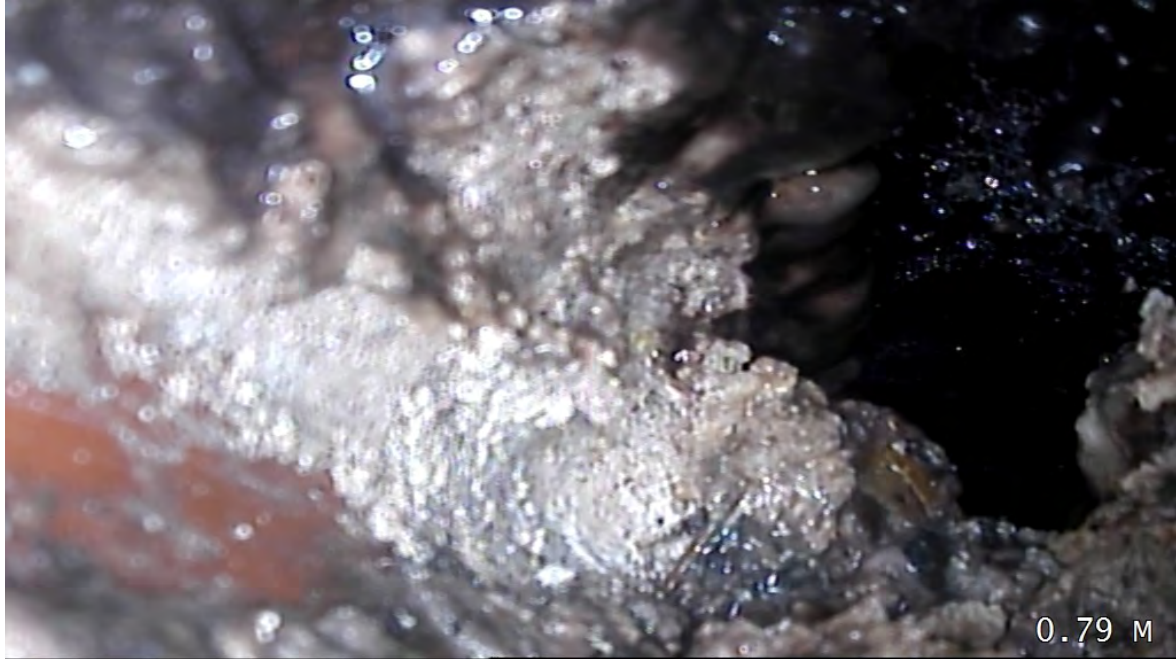
S24C5

Survey abandoned - Remark: Unable to continue survey
