# Conservation Repair Methodology Statement

Grade II Listed Ice House at Land off Waterdell Lane, St Ippolyts,  
Hertfordshire

**794-PLN-HER-02331**

## Structural Inspection Report

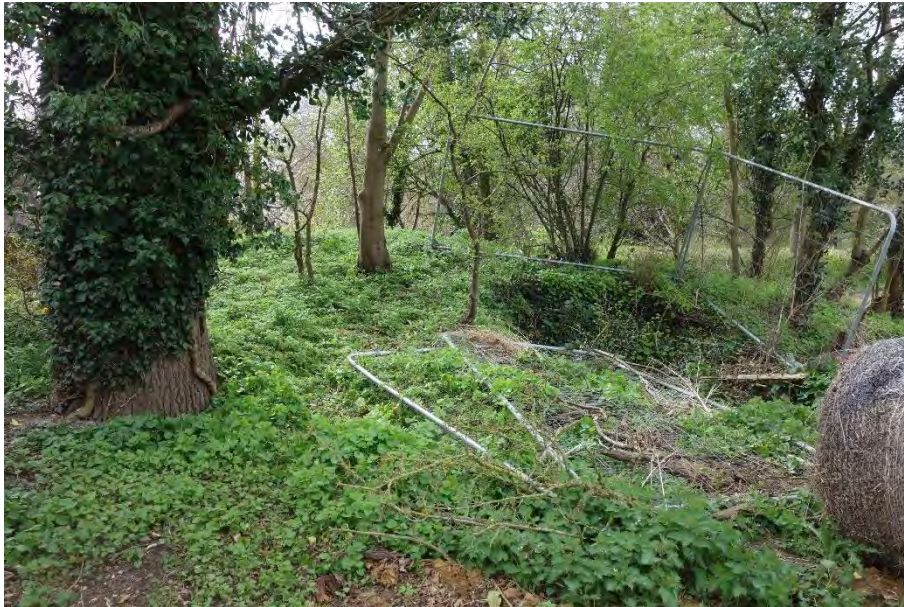
**Photograph 1: General view of the ice house mound and access location at the northern side.**

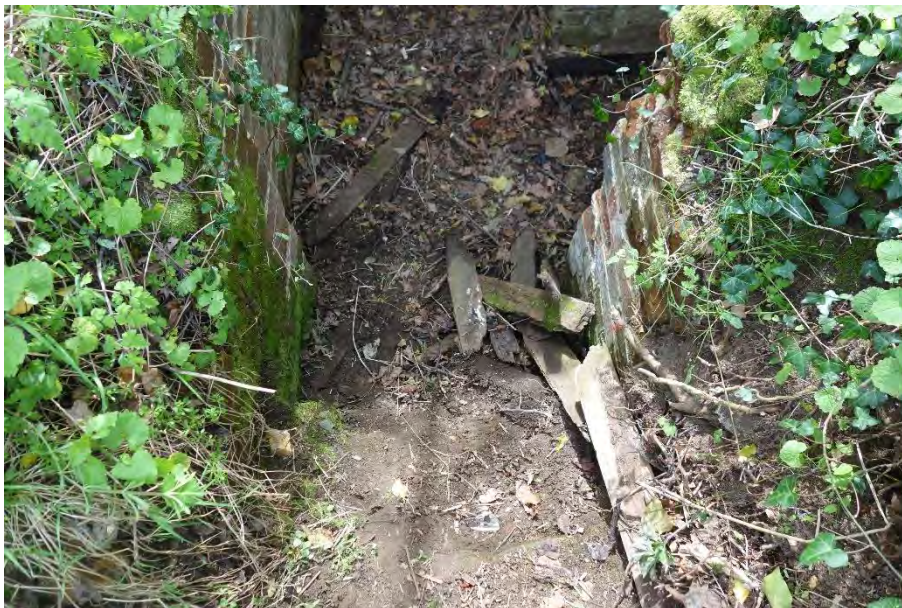
- 3.1.1 The access area to the chambers is now partially collapsed. There is no rubble currently present and it may be amongst other debris at the base of the chambers. Based on the remaining structure it seems that the passageway was originally entered via steps down from external ground level. The side walls of the steps remain, however the treads are now missing (Photograph 2).

**Photograph 2: Remains of step access down into the passageway**

- 4.1.10 Reinstatement of steps will be needed to provide safe access for viewing and maintenance together with consolidation of loose brickwork at the wall tops. Localised repointing is also needed to the brickwork in this area.

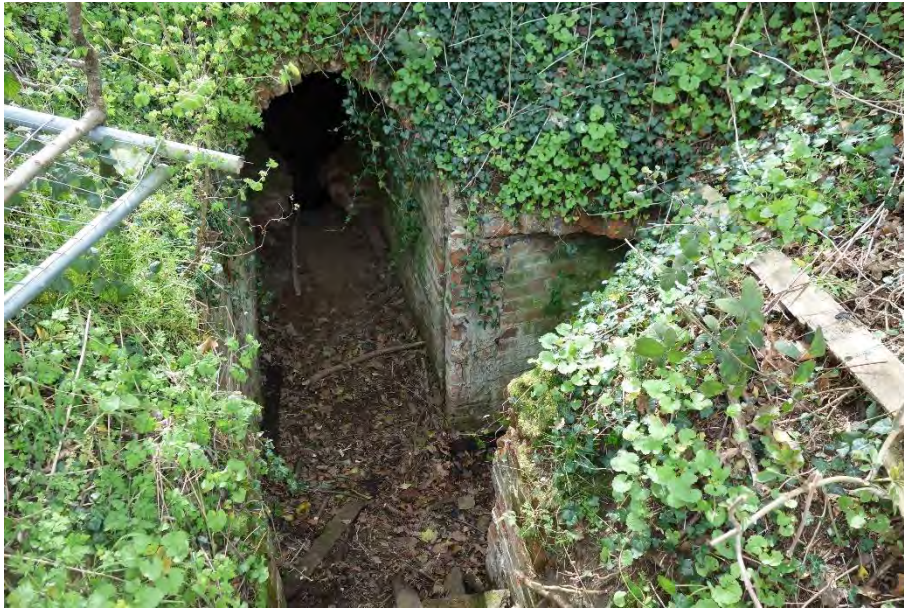
- 3.1.2 The main passageway height into No. 1 is around 1.6 metres and the access to No. 2 is around 1.3 metres, so there must either have been some kind of transitional roofed structure above ground level, or alternatively the steps may have terminated at a small lower-level open area with a doorway to the passage beyond.

**Photograph 3: General view of the access passageways**

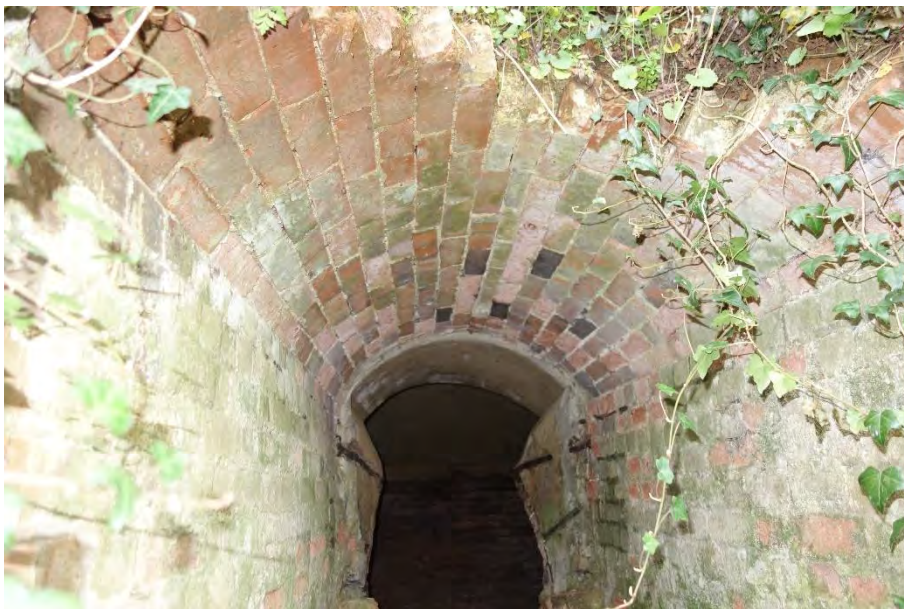
- 3.1.3 The remnant part of the passageway to No.1 comprises brickwork side walls laid in English bond with a half-brick thick barrel vault roof structure (Photograph 4). The bond pattern is not wholly consistent, however the brickwork is of overall reasonable quality.

**Photograph 4: Access passage to No. 1**

- 4.1.8 The condition of the access passageway area is more concerning, particularly if there is an intention to provide even supervised public access. The exposed edge of the brickwork arch at No.1 needs to be repaired and stabilised. The slope above also needs to be stabilised or perhaps slightly regraded to prevent erosion or localised slippage.

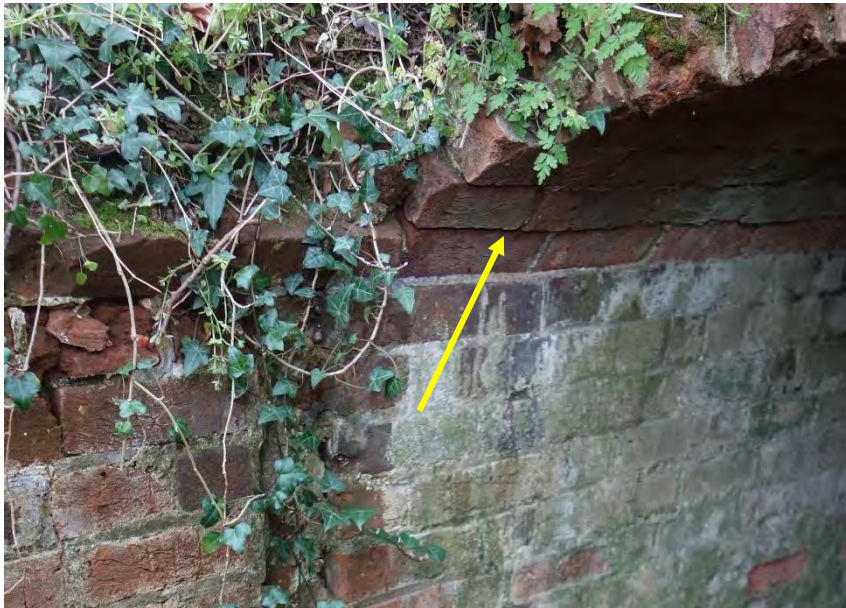
- 3.1.4 The remaining brickwork is in relatively good condition. The arched profile remains acceptable with no evidence of flattening. A small amount of slippage has occurred at the left-hand springing point (Photograph 5), likely due to erosion of mortar or effects of the adjacent collapse. Some localised spalling has occurred to individual bricks together with moderate erosion of pointing.

**Photograph 5: Slight displacement of brickwork at the arch springing point (arrowed)**

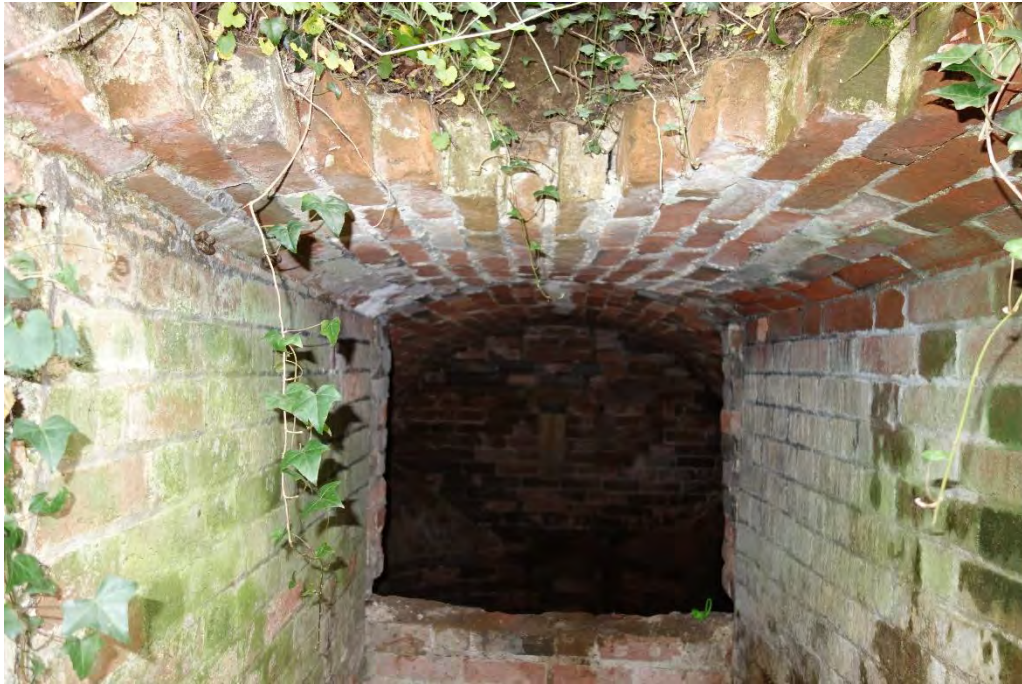
- 3.1.5 The access passage to No. 2 is structurally separate and the brickwork is laid in Flemish bond. The roof height is lower and the arch appears to have been originally constructed at a fairly shallow angle. It was described in 2018 as being 'remarkably flat' and comparison of current site observations and archive photographs indicates that further movement may have occurred. Some efflorescence is present at the soffit suggesting that water periodically percolates through the brickwork.

**Photograph 6: Flattened arch at the entrance passage to No.2**

- 4.1.9 The brick arch of the passage leading to No.2 has flattened excessively and is now close to failure. It cannot be reasonably repaired in-situ and needs to be rebuilt. This is relatively straightforward as it is separate from the roof of the chamber. It may be feasible to clean and reuse the existing bricks or potentially bricks found in the base of the chambers. The new brickwork will need to be laid in hydraulic lime mortar.

- Repoint approximately 3m<sup>2</sup> of brickwork to the roof soffit of No.2
- Reinstate approximately 0.5m<sup>2</sup> of brickwork to the end wall of No.2
- Carefully take down and rebuild the arched roof to the entrance of No.2
- Repair the edge brickwork to the entrance arch of No.1
- Consolidate/regrade the mound material over the entranceways
- Reinstate access steps to the passageway
- Carry out minor brickwork repairs and repointing to the passageway walls
- Remove trees and shrubs growing directly on the mound (tbc with arboriculturalist)
- Provide suitable access restrictions including edge protection and/or gates over the openings.

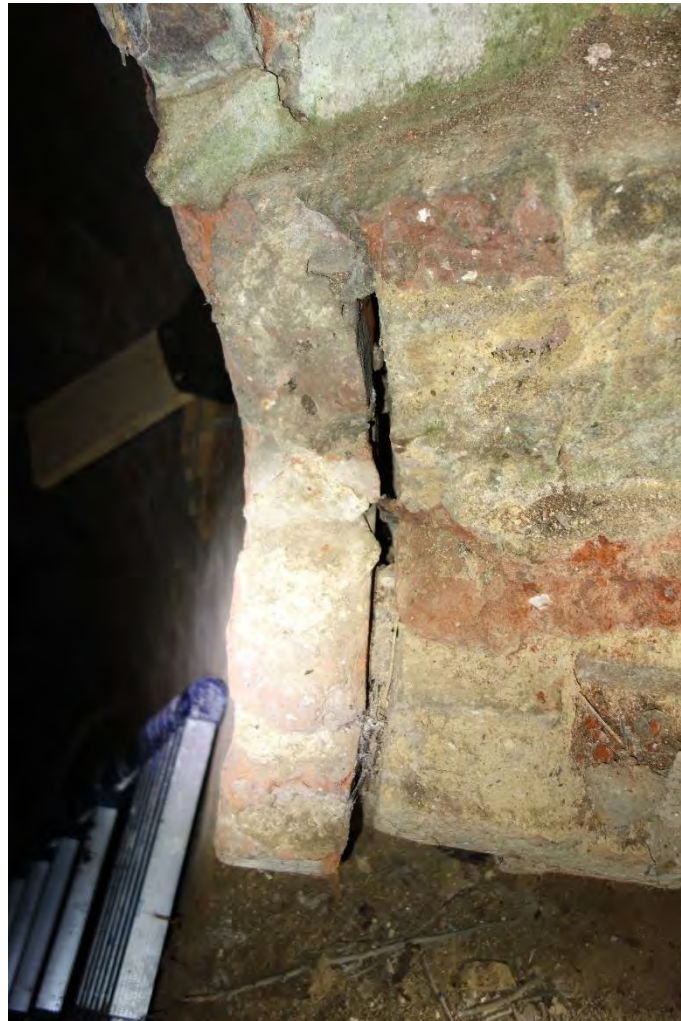
- 3.2.2 The brickwork is not laid in a consistent bond pattern, however it was noted that in the lower part below the springing point for the dome, the brickwork incorporates headers at regular intervals however the dome (where visible) is laid in stretcher bond only at the inner leaf.
- 3.2.3 Where the wall is visible in section at the entrance it appears that the dome may be formed from two separate leaves of brickwork laid in stretcher bond (Photograph 9).

**Photograph 9: Partial section view through the dome brickwork showing separate inner leaf**

- 4.1.3 There is some evidence in both No.1 and No. 2 that a form of cavity wall construction has been used, with two separate leaves of brickwork separated by a small gap. There do not seem to be any iron ties between the two as corrosion and cracking and spalling of the brickwork would reasonably be expected to have occurred by this point. The reason for this construction is not entirely clear but may be an attempt to slightly reduce heat gain and slow down melting of ice stored within.

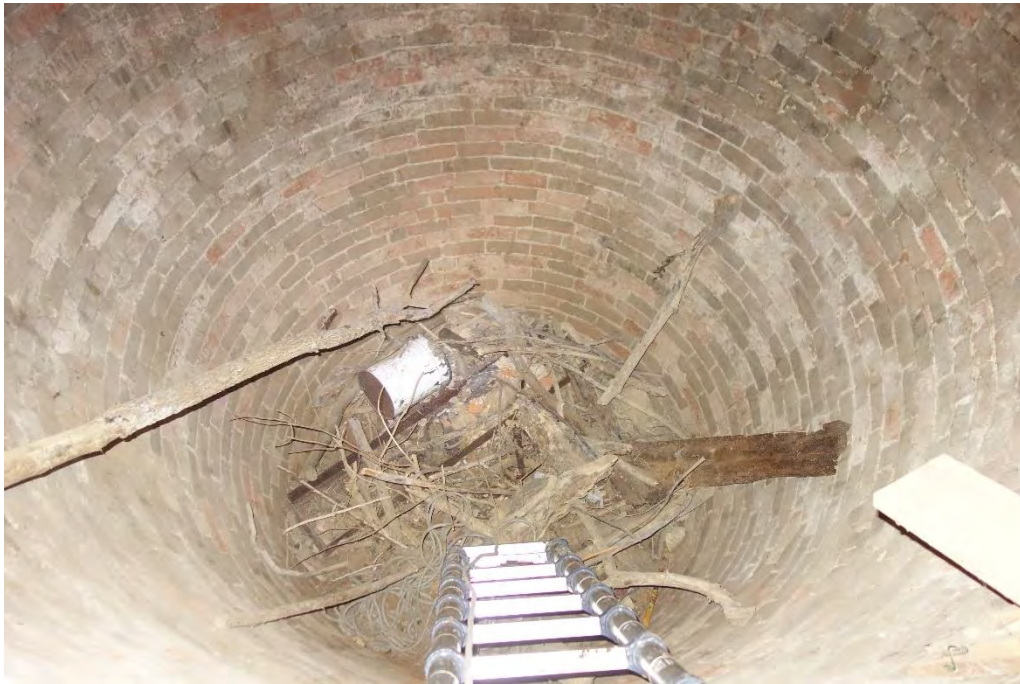
- 3.2.6 There is no general evidence of structural movement or cracking to the brickwork and the pointing remains in generally good condition.
- 3.2.7 A considerable quantity of debris and rubbish has accumulated at the base of the chamber (Photograph 10) and needs to be cleared. Much of this material seems to have been deliberately discarded.

**Photograph 10: Ice House No.1 – debris and rubbish within the chamber**

- 2.3.3 Prior to the undertaking of any internal repair to the Ice House chambers, the refuse/debris dumped in their bases is to be removed by hand. This is to ensure any areas of brickwork presently obscured from view are inspected for the need for repair.

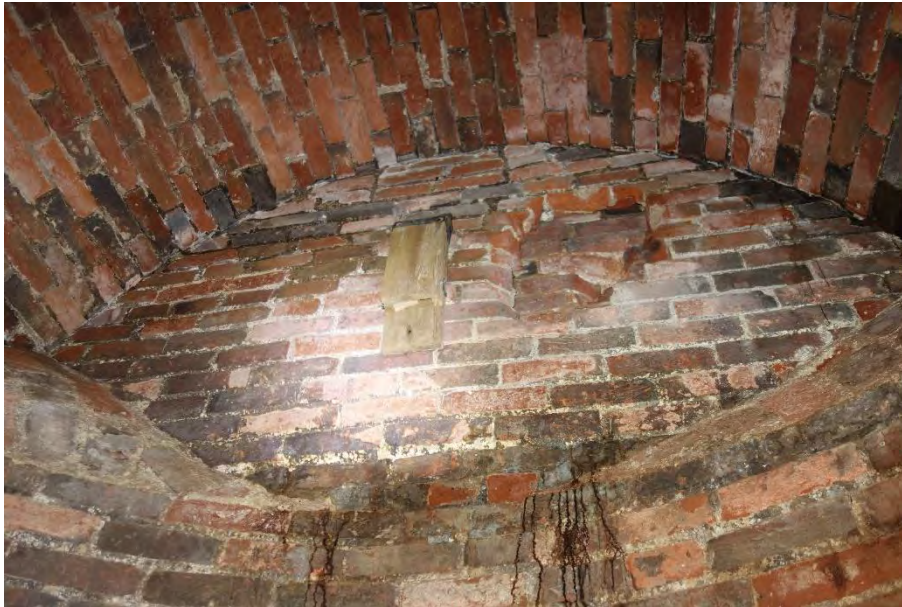
- 3.3.1 The smaller ice house is also of brickwork construction and comprises a tapering shaft which narrows towards the base. The roof structure arrangement is different and comprises a single barrel vault which is approximately square on plan. Infill walls are used to close the ends of the vault. Infill brickwork is also used at the corners to account for the different plan forms of the shaft and roof (Photograph 11).

**Photograph 11: Chamber interior showing part of the barrel vault roof, infill wall and corners.**

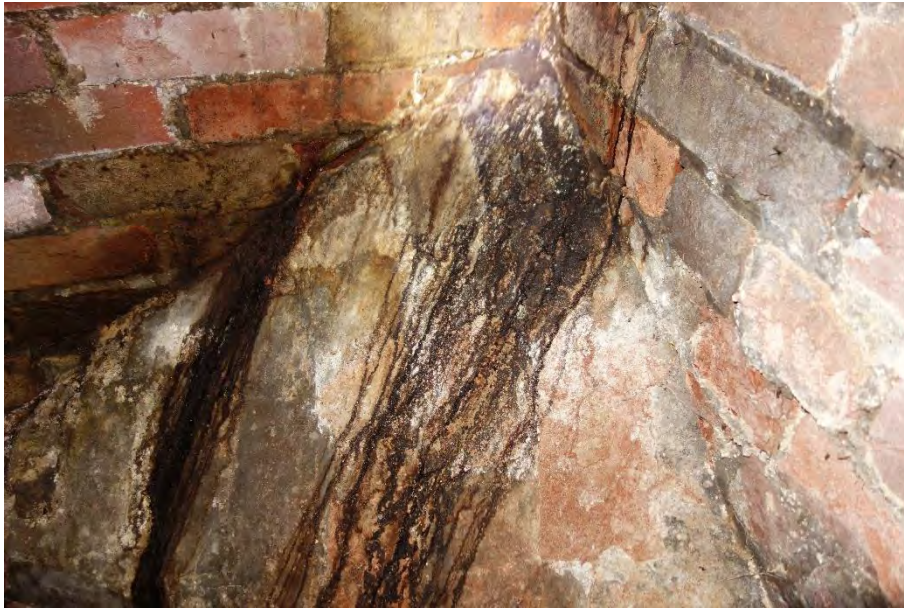
- 3.3.5 Water ingress has occurred at various locations (as evidenced by staining), mainly at the corners and junctions between the roof, wall and infill elements. This is wrongly identified as root growth in a previous report by CTP Consulting Engineers, but seems instead to be a soluble (organic matter?) deposit of some kind (Photograph 12). There was no evidence of penetration through the brickwork by either woody or fibrous roots.

**Photograph 12: Staining due to water ingress (typical example).**

- 4.1.7 No. 2 is in slightly poorer condition and some limited works are required. Repointing in lime mortar is required to parts of the roof soffit brickwork. The missing patch of brickwork at the end wall should be reinstated. The water ingress causing staining to the brickwork will be hard to halt without undesirable extensive and highly intrusive works externally. It does not appear to have resulted in any structural degradation and we do not therefore recommend that any action is taken at the current time.

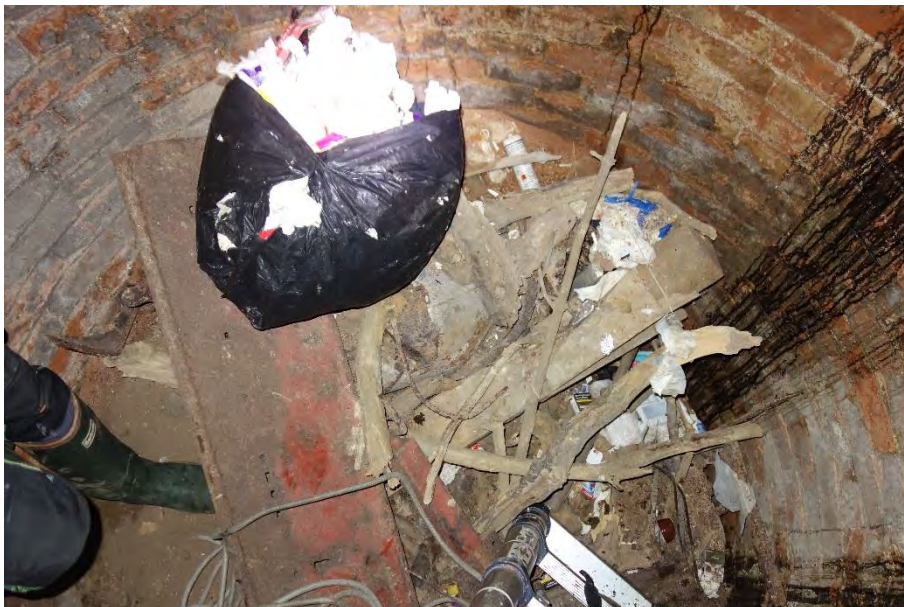
- 3.3.6 A large quantity of waste has also been deposited in at the base of this chamber (Photograph 13) with comparison of photographs from 2018 indicating that further material has been added since that time.

**Photograph 13: Ice House No. 2 – waste at the base of the chamber**
