**Structural Inspection at  
The Old Manor,  
Shaftenhoe End**

**Structural  
Engineers**  
Cambridge Ltd

**Project 24-722 for  
Mr & Mrs Noblet**

**Roof Inspection, June 2025: Bedroom 51-12**

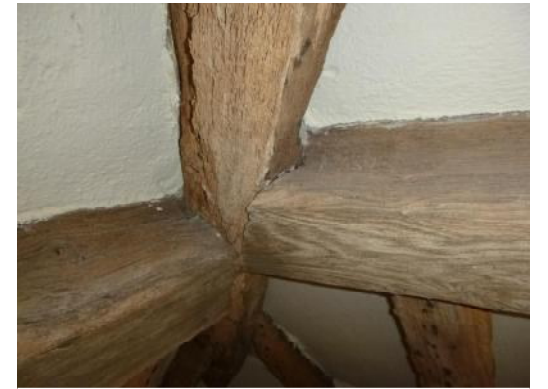
Purlins meet at hip - historic damage (17)

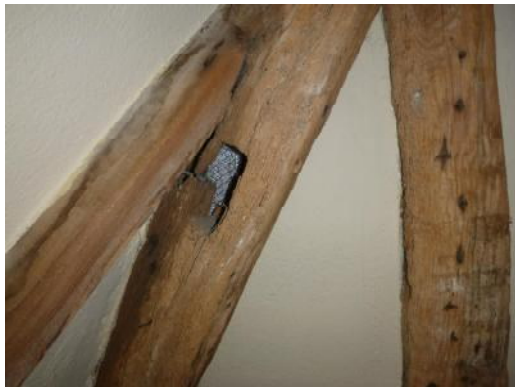
Empty mortise in hip beam, packed with wire mesh (17)

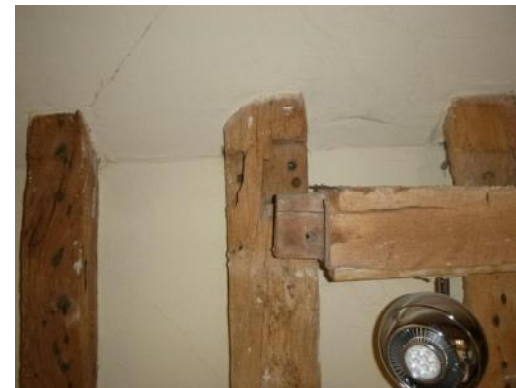
Detached tenon at end of purlin - historic damage (16)

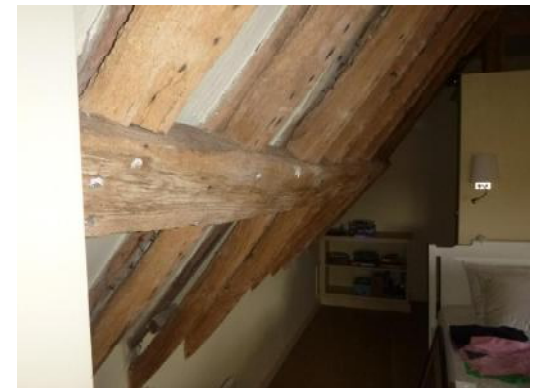
Rear (north) purlin sags due to removal of collars and relocation above head height (13)

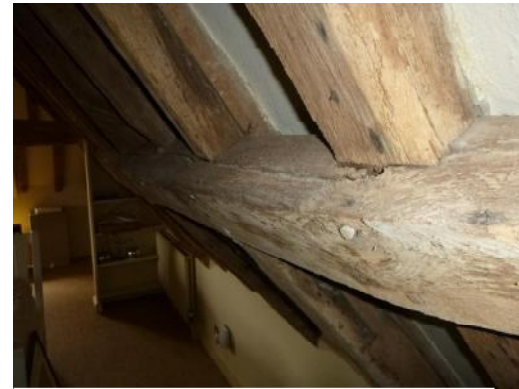
Historic sag to purlin (13)

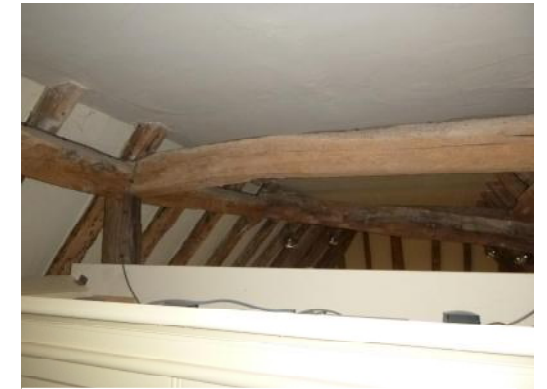
High-level collar above wardrobe, with posts introduced beneath (mainly to frame out wardrobe) (11)

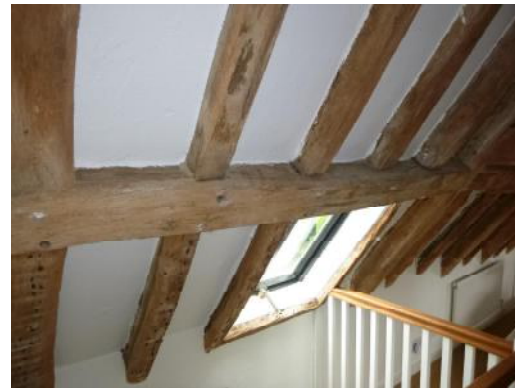
Rafters tenoned into purlin, with wrought iron repair strap below - historic (5)

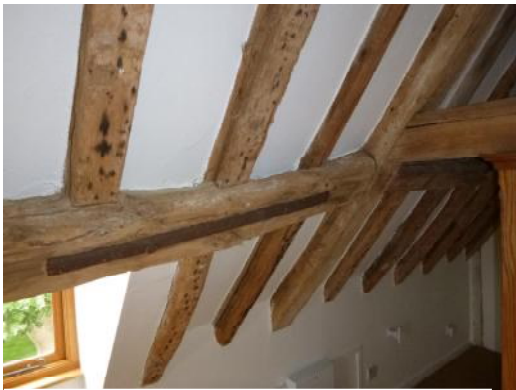
Front purlin with repair strap (5)

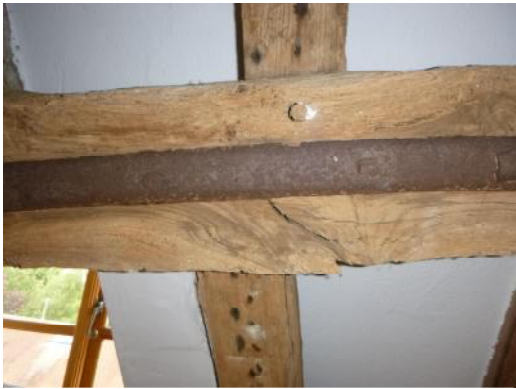
Fracture in front purlin, repaired with strap - judged historic (5)

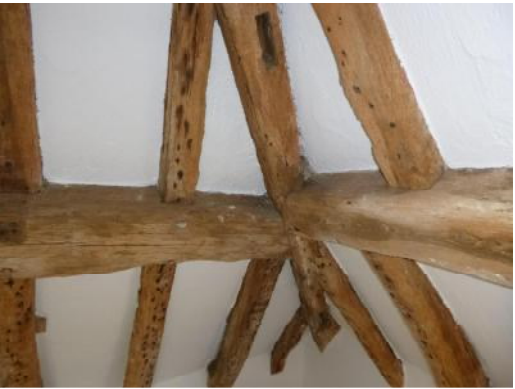
Empty mortises in hip beam suggest previous alterations (1)

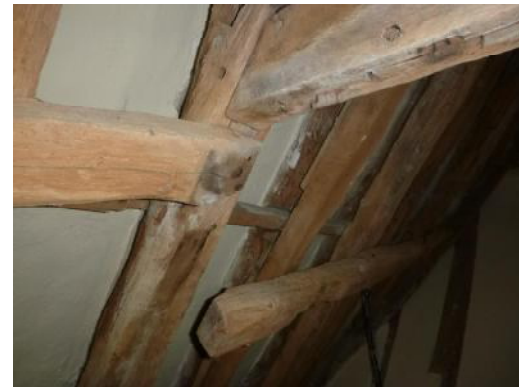
Detached purlin and sagging rafters, packed out roof profile - judged historic (22)

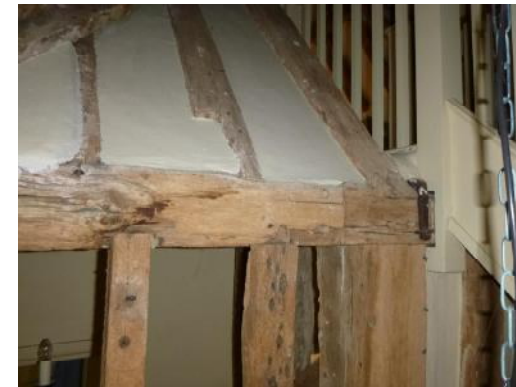
Head rail of house wall, showing witness of water damage - judged historic

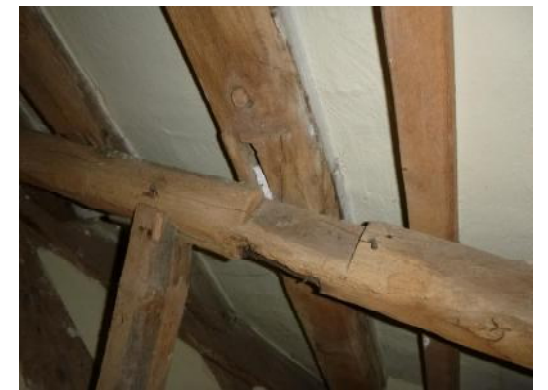
Detail of strut to purlin and empty mortise from removed collar (19)

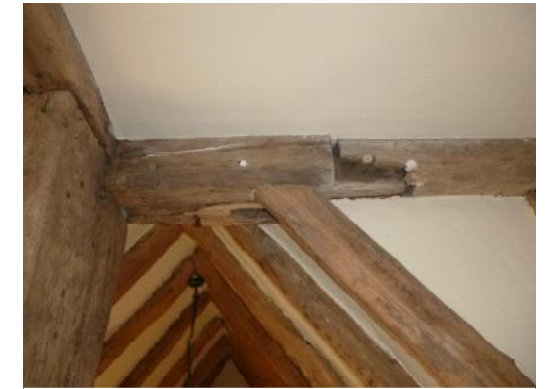
Historic damage to scarf joint in head plate, plus empty mortise (4)

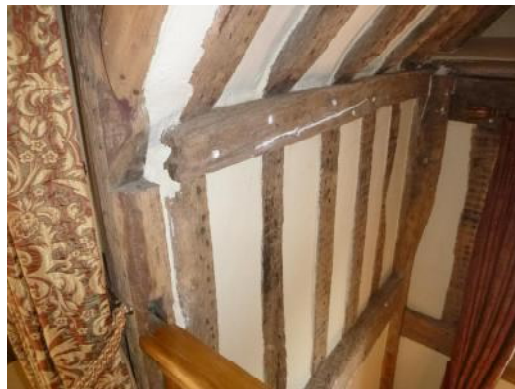
Eaves rail detached from post due to historic rot damage (5)

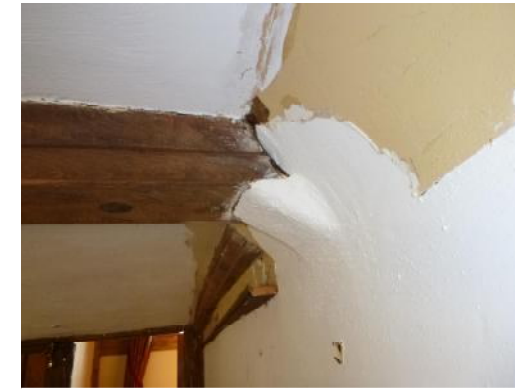
Repair at chimney end - possible related to removal of hearth at first floor level

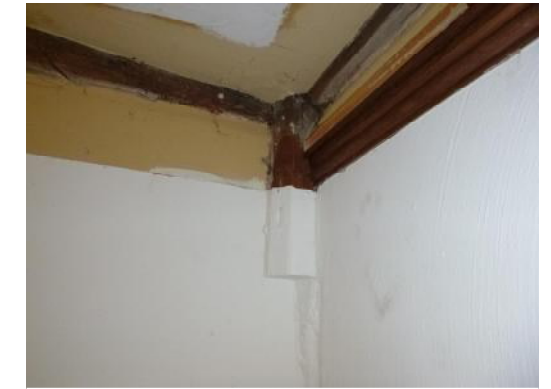
Repair at bearing in chimney - appears to be holding but potentially suspect. Investigation recommended

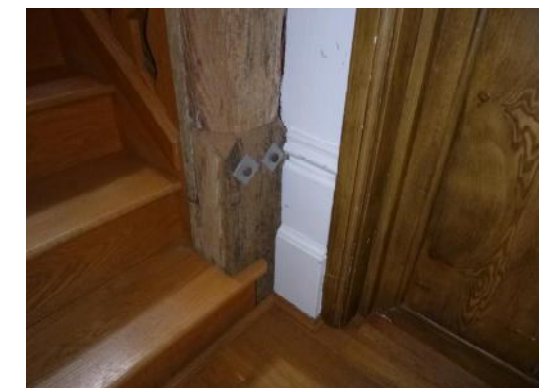
Repaired rot damage to principal post (7)

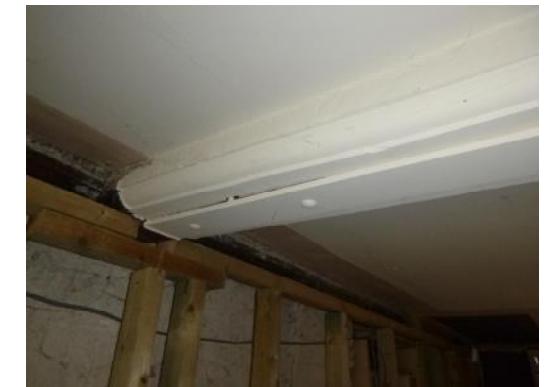
Beam at living room ceiling sags in line with sloping and sagging floor above (5)

Steel strap beneath beam is ineffective as many more screws would be needed to transmit shear forces effectively

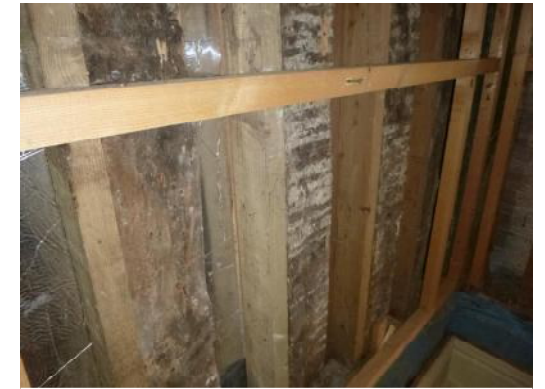
Replacement sole plate (6)
