S1822-J1-R1

# REPORT

on trees in relation to  
2 West Lane, Pirton, Hitchin, SG5 3RA

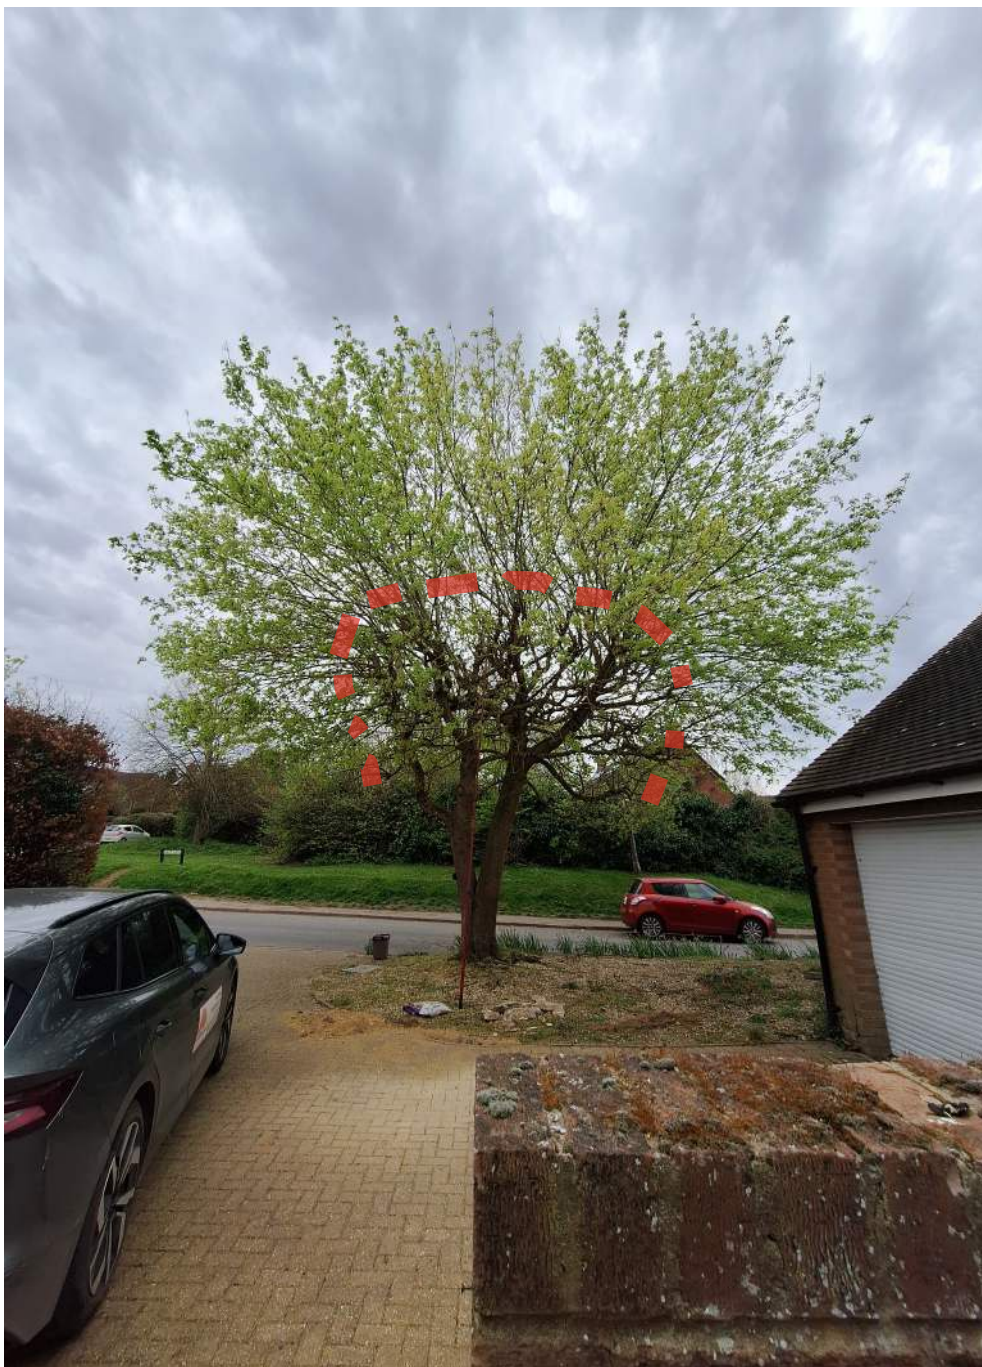
Reduction guide

In view of all the above, I consider that maintaining tree 1 on a biennial basis as a pollard at around 6 metres in height is likely to be successful in controlling subsoil drying close to the tree.

| Tree number | Tree type | Height (m) | Stem diameters (mm) | Proximity (m) | Comments |
|---|---|---|---|---|---|
| 1 | Norway maple | 11.0 | 405, 328 | 10.5* | *To house. Reduce to 6m in height, just above the old pollard points. |
