# SHIRE TREES LIMITED

## TREE HEALTH & SAFETY SURVEY & ARBORICULTURAL REPORT

Site at:  
Barley C of E First School  
Church End  
Barley  
Royston  
Hertfordshire  
SG8 8JW

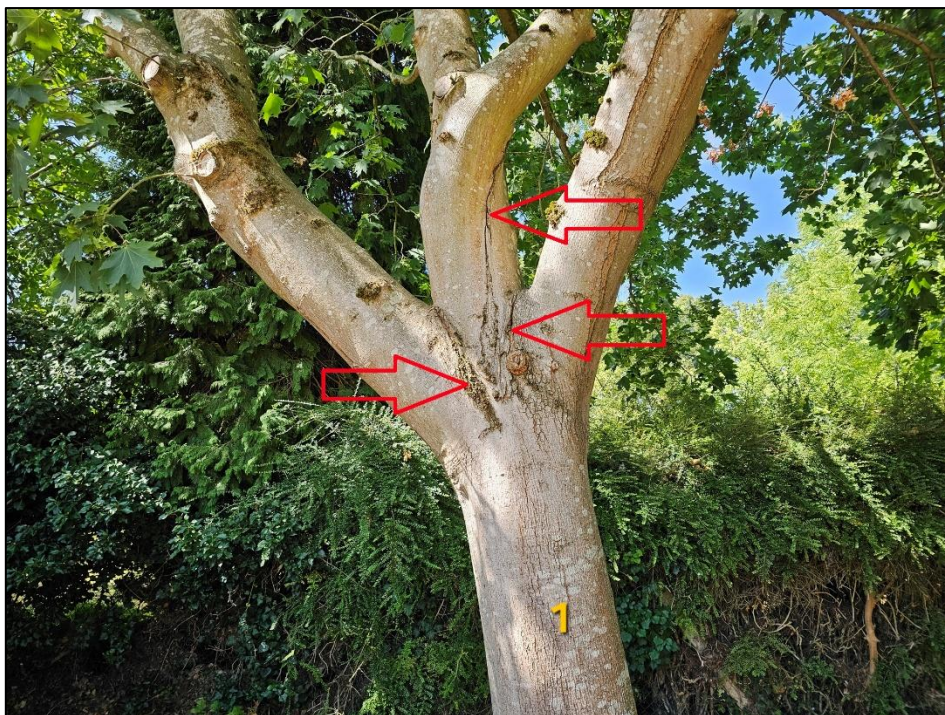
- 3.3 Tree 1 (Norway Maple) has numerous structural defects in the form of three bark included unions that on Maple especially are prone to spontaneous failure.

- Below: Tree 1 (Norway Maple) – Multiple bark included unions

| Site name: Barley First School<br>Surveyor: Ian Lorman | | | Date of survey: 11 <sup>th</sup> August 2026<br>Conditions: Clear / dry / still | | | | | |
|---|---|---|---|---|---|---|---|---|
| 1 | Norway Maple | 15 | 400 | 6 | Mature | Crown - Good, Stem - Poor, Basal Area - Good<br><br><b>Fell</b><br><br>Three stems from 2.5 metres. all with weak bark included unions | 2 | 1 |

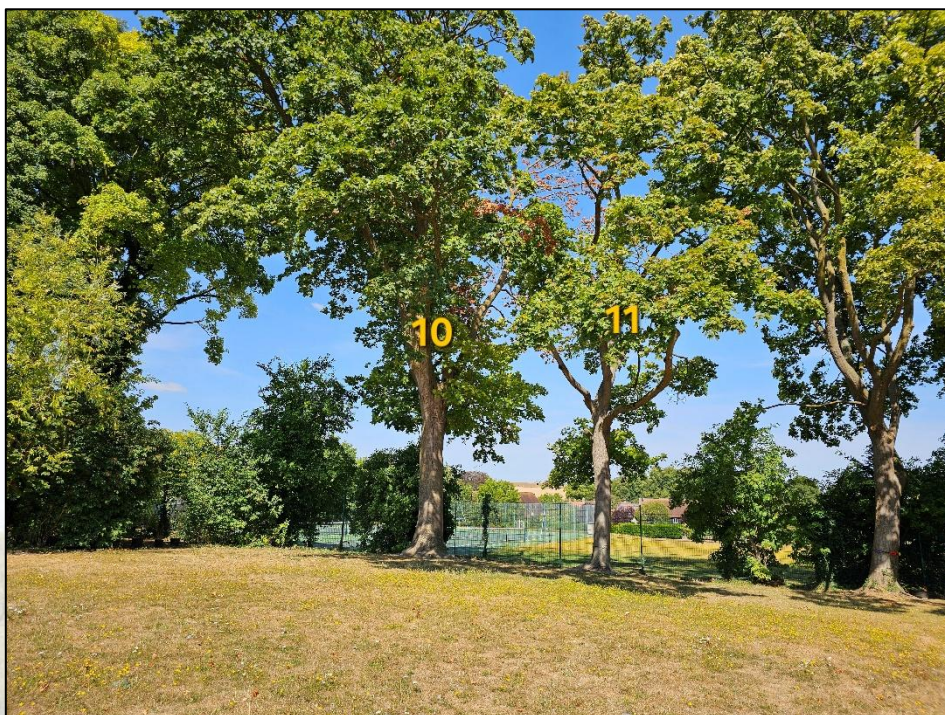
- 3.1 18 trees were recorded. 5 trees require attention. Out of these, 3 trees require removal. The tree survey schedule provides the specifications.
- 3.2 **URGENT** felling (or otherwise making safe) is required for Norway Maple trees 10 and 11. This work must be completed within 6 weeks of the date of the tree survey. These trees are in such a condition that they may shed very substantial parts at any time.

- Below: Trees 10 & 11 (N. Maple) – Both in very poor condition

| Site name: Barley First School<br>Surveyor: Ian Lorman | | | Date of survey: 11 <sup>th</sup> August 2026<br>Conditions: Clear / dry / still | | | | | |
|---|---|---|---|---|---|---|---|---|
| 10 | Norway Maple | 20 | 850 | 9 | Mature | Crown - Poor, Stem - Poor, Basal Area - Fair<br><br><b>Fell</b><br><br>Massive dead branch north side (half of the tree's crown). Vascular dysfunction in trunk throughout. Rapid decline expected. Branch shedding likely | 1 | 1 |
| 11 | Norway Maple | 18 | 450 | 8 | Mature | Crown - Poor, Stem - Fair, Basal Area - Fair<br><br><b>Fell</b><br><br>Very sparse. Strip lesions on underside of some branches. Lion-tailing of some laterals. Rapid decline expected. Branch shedding likely | 1 | 1 |
