**TECHNICAL REPORT ON A SUBSIDENCE CLAIM**

**Crawford Reference: SU2300596**

**Finlandia  
Kings Walden Road  
Hitchin  
SG5 3DT**

**SUBSIDENCE CLAIM**

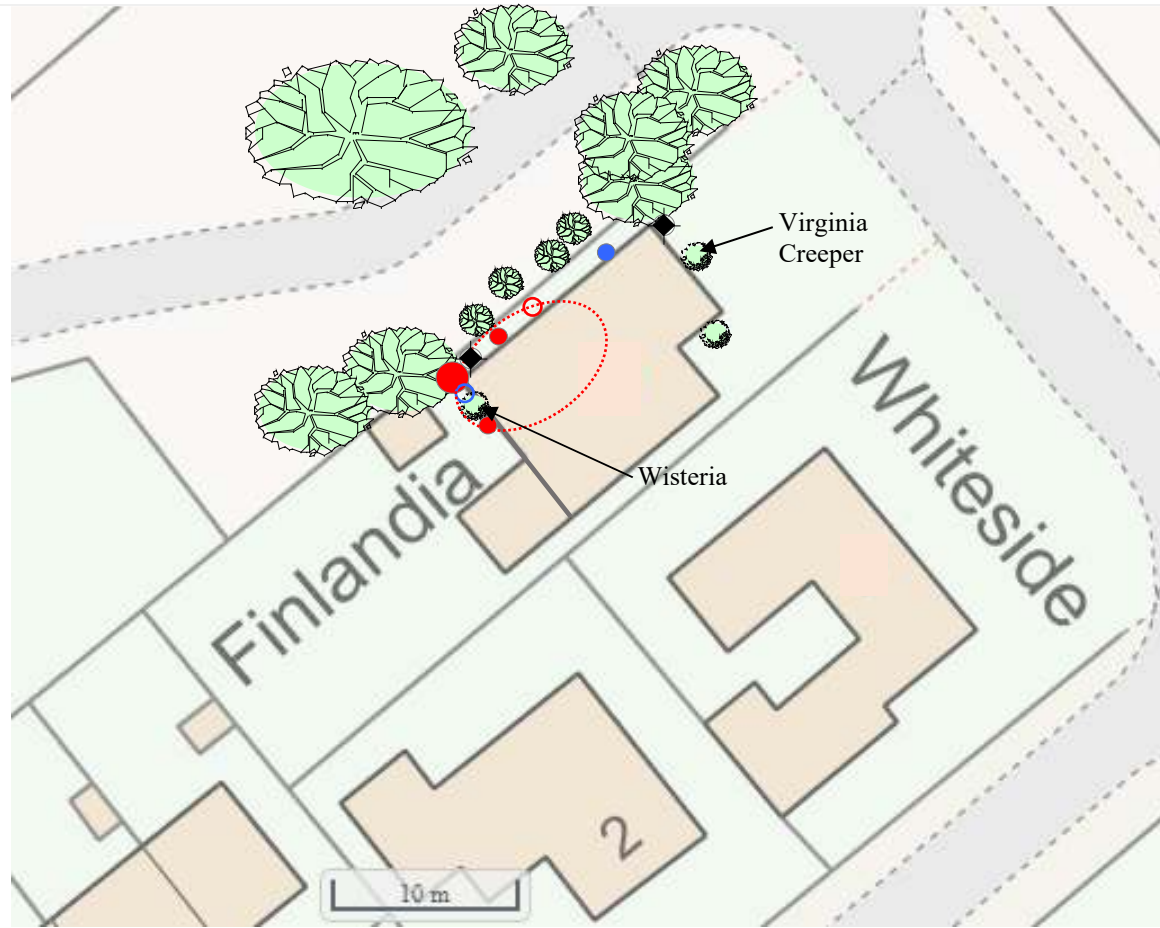
**Site Plan****This plan is Not to Scale**

There are several trees and shrubs nearby, some with roots that may extend beneath the house foundations. The following are of particular interest:-

| Type | Height | Distance | Ownership |
| Deciduous | 20 m | 2 m | Neighbour 5 |
| Climbers | 10 m | 1 m | Owners |
| Climbers | 7 m | 1 m | Owners |
