# Arboricultural Appraisal Report

## Subsidence Damage Investigation at:

Finlandia  
Kings Walden Road  
Hitchin  
SG5 3DT

| REPORT DATE: | 30/06/2023 |

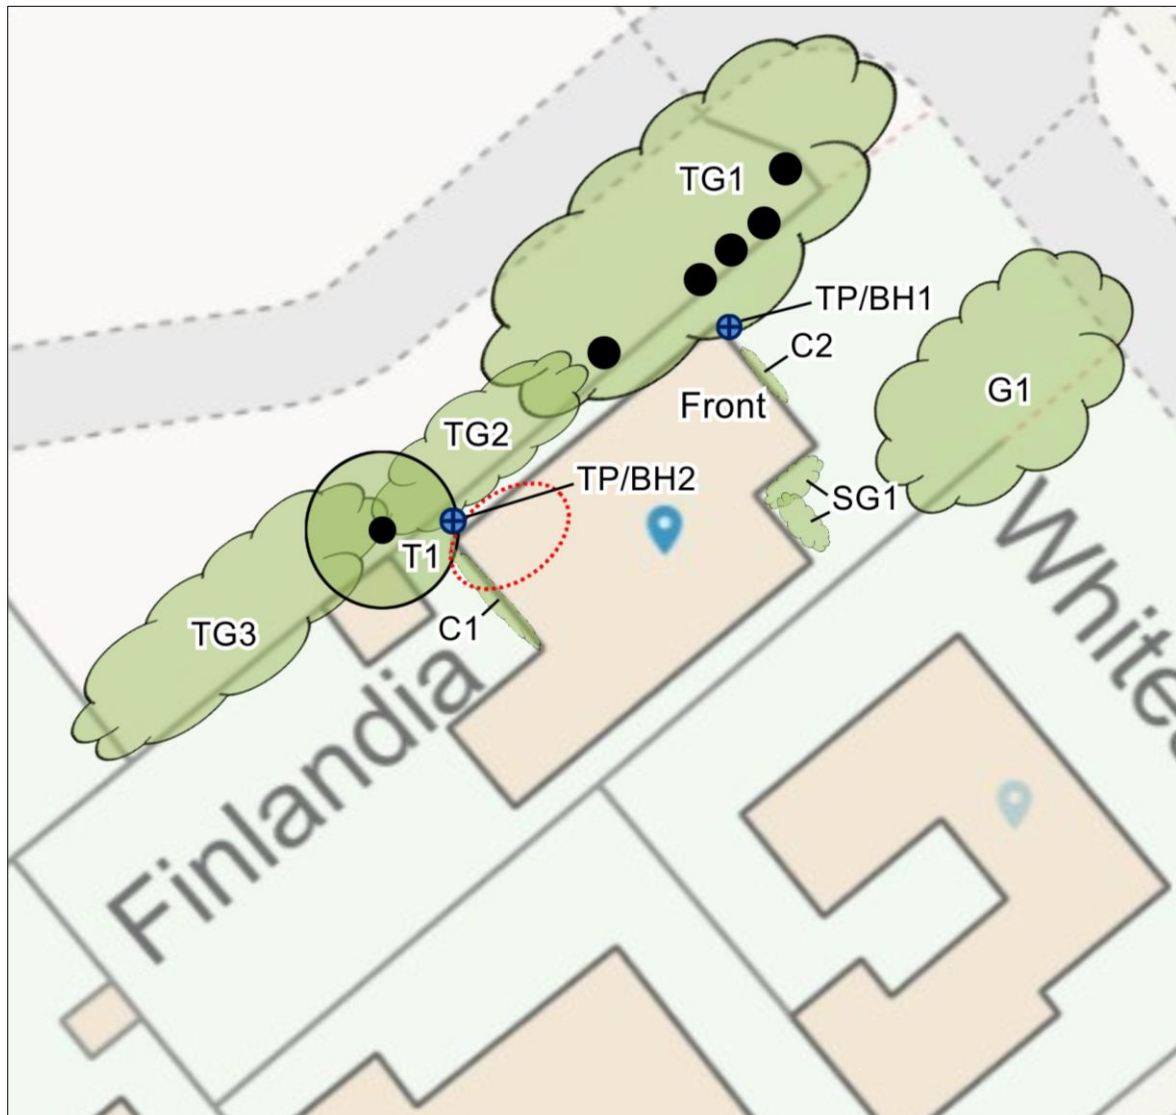
Approximate areas of damage
