**21298**  
**The Cloisters**  
**Letchworth**

Inspection 29<sup>th</sup> November 2021

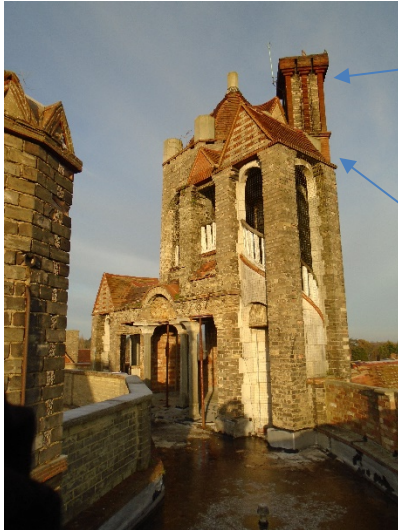
Chimney on side of stair tower.

Chimney formed with creasing tiles laid flat to form quoins and string course head and detailing to brick masonry stack.

Lower string course.

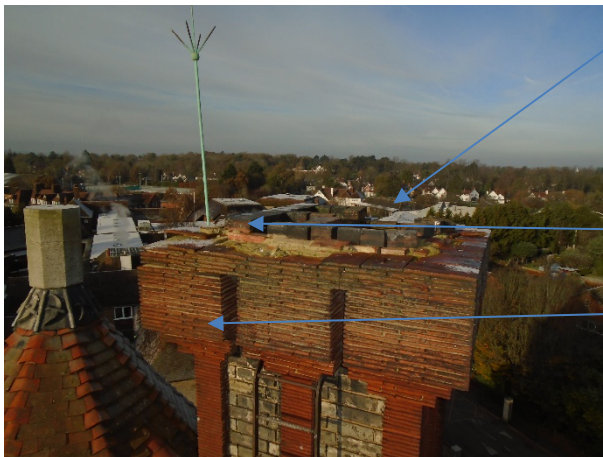
The mid feathers are loose with bricks lying loose.

Lightening conductor fixings are decaying and causing jacking.

Corbelled string head to stack is loose and leaning away from the stack.

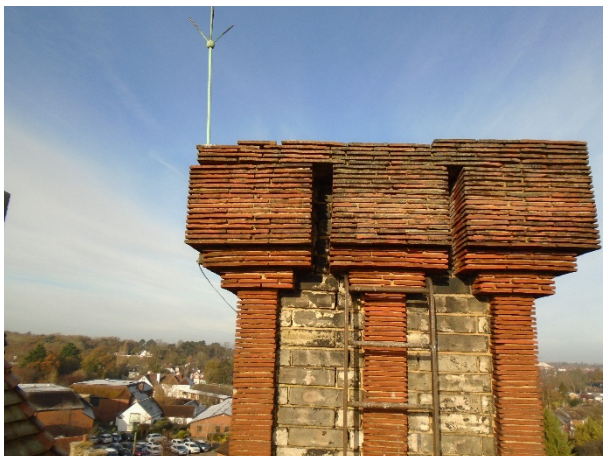
Corbelled string head to stack is loose and leaning away from the stack. Loose tiles are evident and there is a significant loss of pointing.

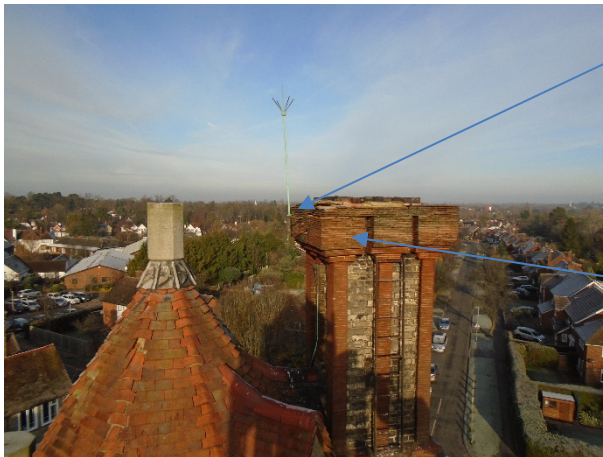
Lightening conductor fixings are decaying and causing jacking.

Corbelled string head to stack is loose and leaning away from the stack.

Loose tiles are evident and there is a significant loss of pointing.

The head of the stack is losing its structural integrity with loss of the tie effect of the mid feathers and articulation of the tile corbelling.

The fixings to the lightening conductor are expanding causing further distress.

The stack is considered to be dangerous with the possibility of elements falling to ground.

We therefore consider that the stack should be temporarily dismantled.

Subject to inspection as the works progress it is likely to need to be lowered to the lower string course.

It would be prudent to consider a safety cordon around the base of the tower and stack.
