# STRUCTURAL CALCULATIONS

## 57 HIGH STREET- ASHWELL

### Repairs and restoration to chimney base- in lower ground floor area

Project No: 3035

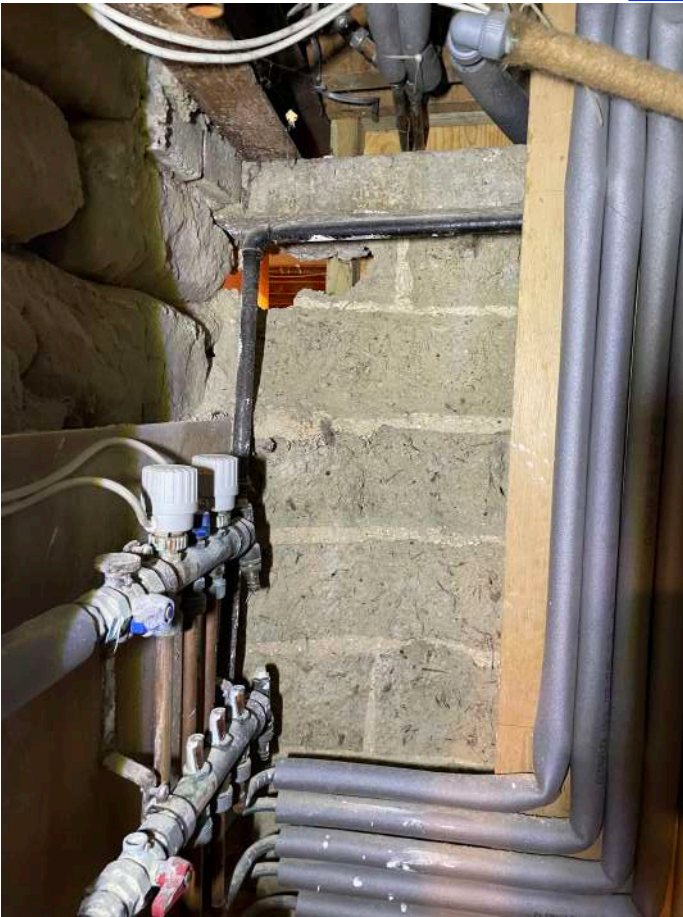
The steel beam supporting the ground floor above cantilevers over a precast concrete lintel over a patch of thin cob (soft clay mixed with straw/ twigs). The beam has been temporarily propped as the lintel is inadequately supported.

Wall 1  
soft clay blocks to be replaced

Prop existing beam and lintel. Replace damaged/ soft cob infill with soft bricks (yellow stocks) dressed to match existing with lime putty mortar finished as noted below.

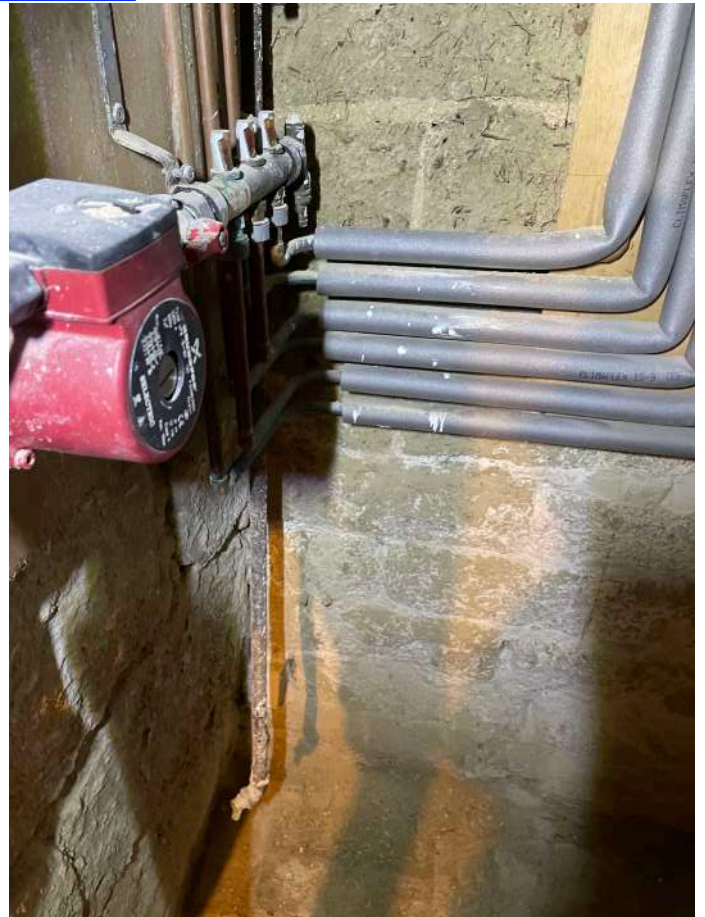
Wall 1  
clunch below soft clay blocks

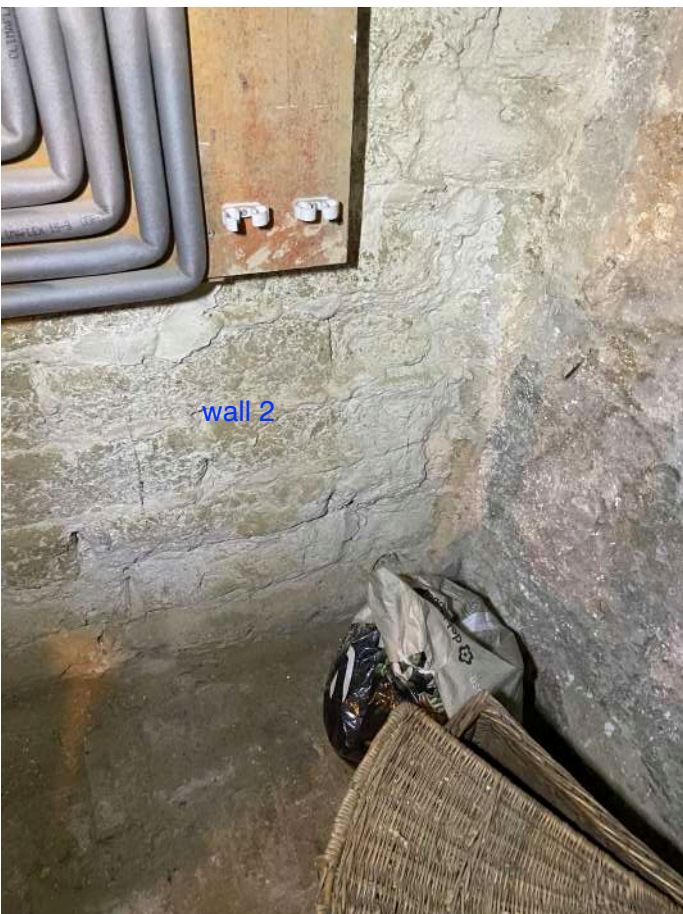
Wall 1/2 junction

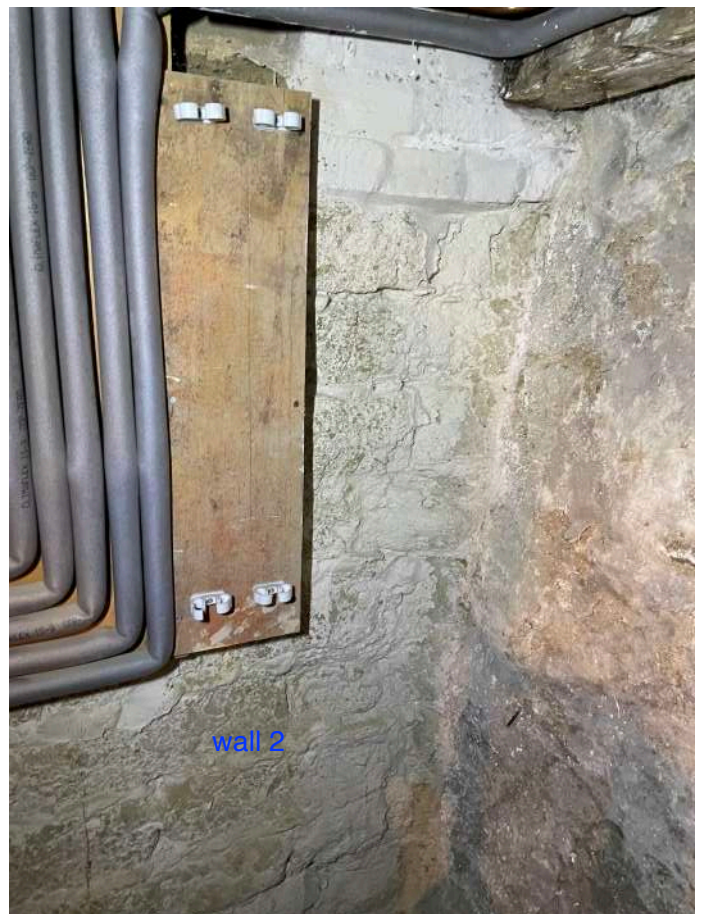
Wall 1/2 junction

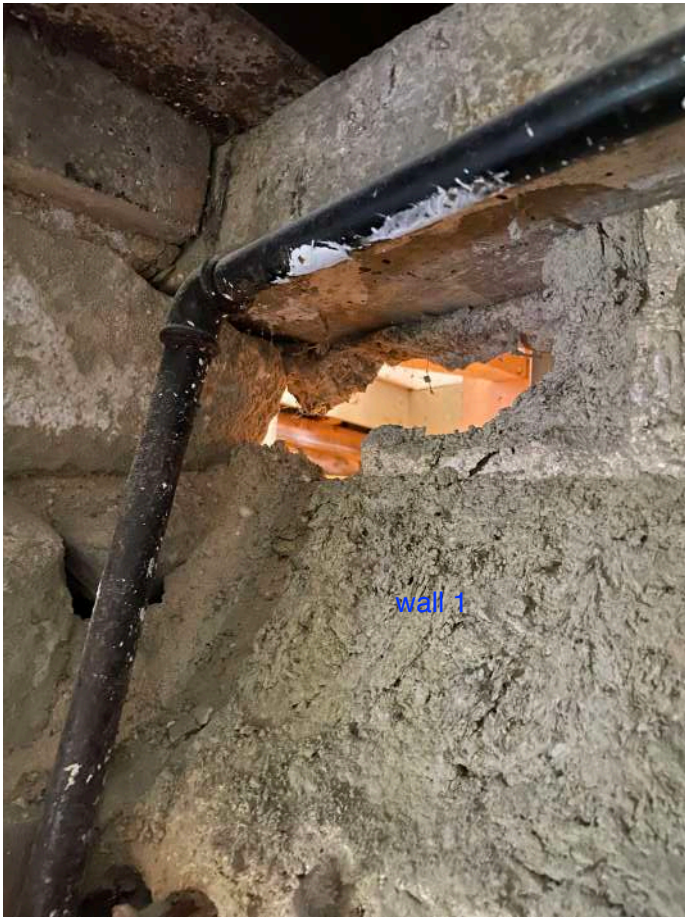
[Void at top of Wall 1](#)

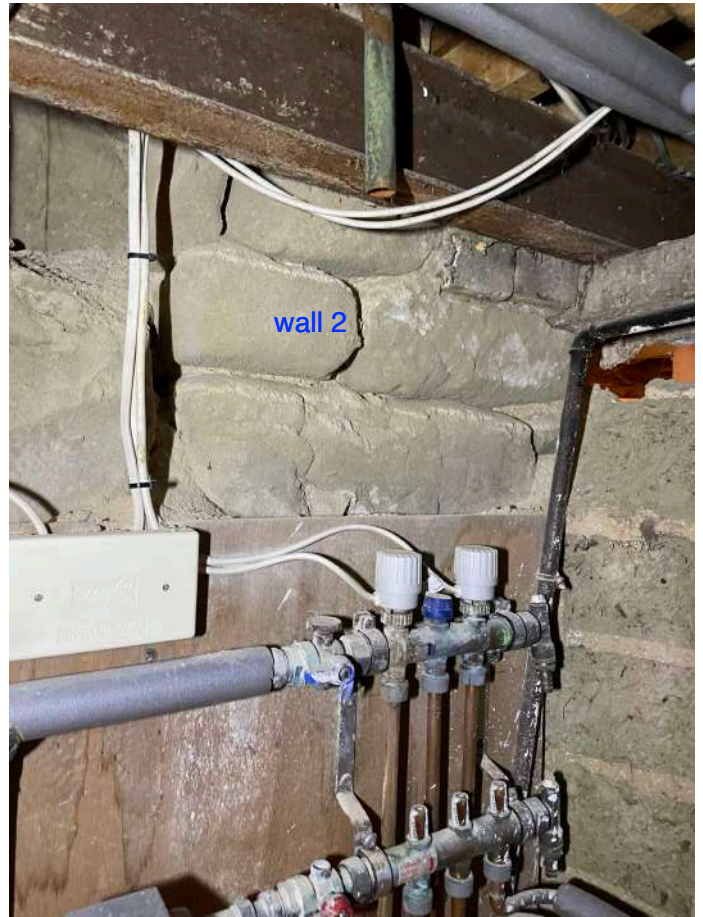
[Beam supported on Wall 1 lintel](#)

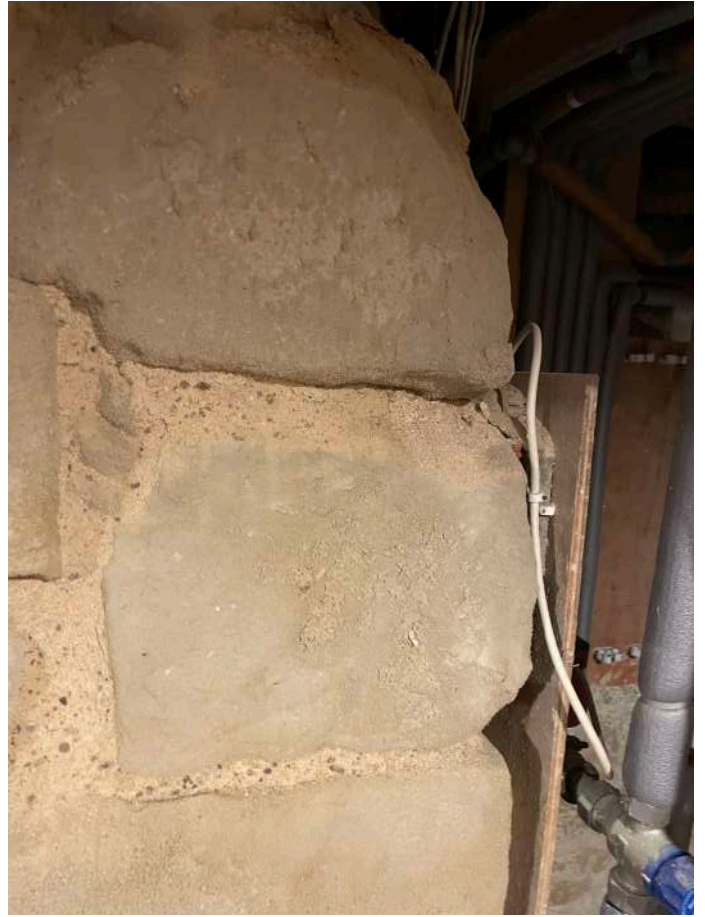
The house has been extended to the rear within the last 25 years. It appears that the extension works have compromised the natural ventilation in the basement ventilation ducting has been added to reduce the humidity within the area. It is likely that a period of high humidity has caused degradation to the clunch stonework supporting the central chimney stack. The surface of the stonework exhibits softening to 5-10mm depth and the lime mortar joints to the stonework are soft and crumbling.

[Wall 2 loose mortar](#)

Remove existing soft mortar with hand tools (light chiselling, wire and soft brushes) in maximum 450mm bays. Cut back the mortar to form a square edge with care taken to avoid damaging the stone. Thoroughly wet the mortar/ stone surface and allow time for water to soak into the stone (typically 8-12 hours) rewetting during this period.

Re-point with lime putty mortar. When filling joints, ensure that the mortar is thoroughly pressed home applying sufficient pressure to the tool forcing mortar into the whole of the joint. When placing the mortar, avoid filling large voids with mortar. Pack out with appropriately sized stones that act as aggregate thus reducing the mortar mass. Finish the pointing fully flush avoiding ledges to the stone.
