This report has been prepared for our client in accordance with the terms and conditions of our appointment for 3-5 Bucklersbury, Hitchin. Mason Navarro Pledge Ltd cannot accept any responsibility for any use of or reliance on the contents of this report by any third party.

## 1.0 Introduction

### 3-5 Bucklersbury, Hitchin

Langham Mansions Properties Ltd

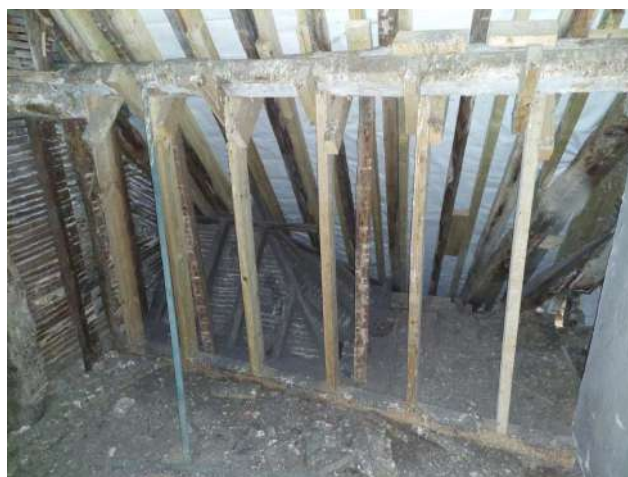
Figure 1. Purlin support and rafter strengthening as installed

Due to the lack of access, it was difficult to inspect the rafter strengthening, but we assume that the new rafters installed are adequately packed off the previous rafters and to the original purlins.

The additional timber used has added additional load to the steel structure. This structure and all of the connections showed no signs of structural distress.

1. The connections and splices for the steelwork should be checked to confirm they can safely transfer the load. For example, one of the main steels is hung from another, with bolts in tension, which need to be checked.

1. We suggest strengthening this connection with a top plate over the steel with some threaded bolts installed between the top plate and the top flange of the supported steel, through new holes. Lindapter clamps can be used to clamp the top plate to the main steel. Conclusions and Recommendations

7. Contractor to bolt the two timbers forming the 'Y' shaped studs together using 2No. M12 bolts.

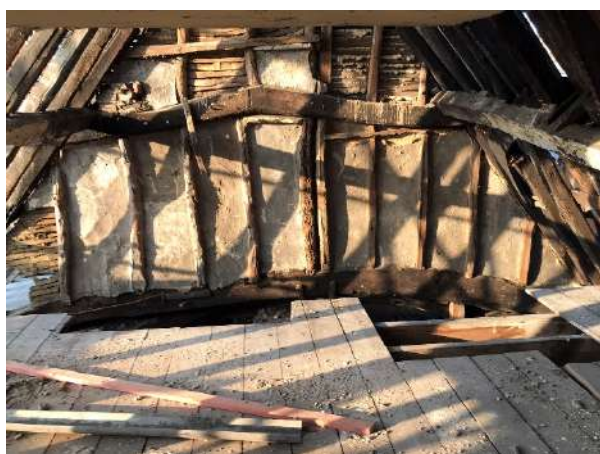
It was noted that existing timbers and wattle and daub had been removed to the frame on Gridline 4 (frame 4 under the previous job number), see image below prior to the works commencing, image from our site visit on 15<sup>th</sup> September 2025 and an extract from the REVIT model showing the timbers remaining.

Figure 2. Existing wall prior to previous works commencing

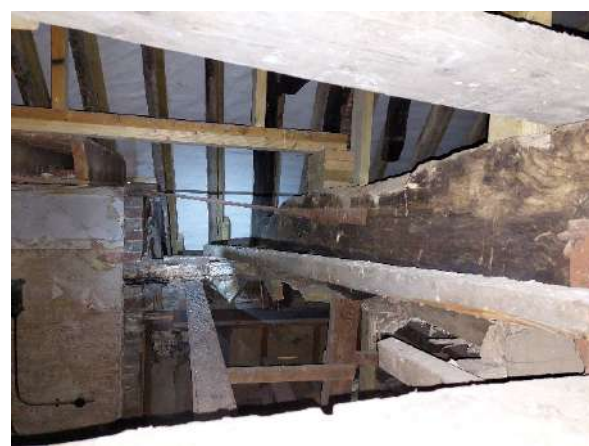
Figure 3. Photo from site visit showing vertical members and wattle and daub removed

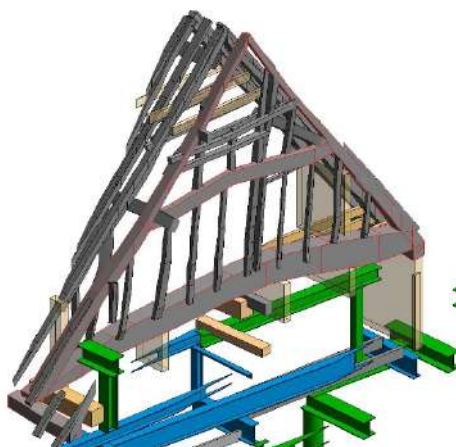
Figure 4. Measured survey showing existing timbers prior to 2022

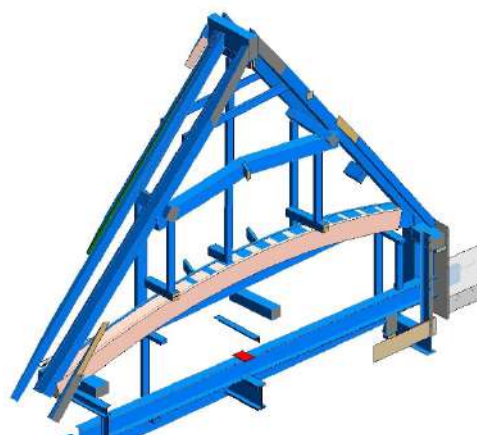
Figure 5. Measured survey showing timbers removed as part of 2022 works (but not agreed works)

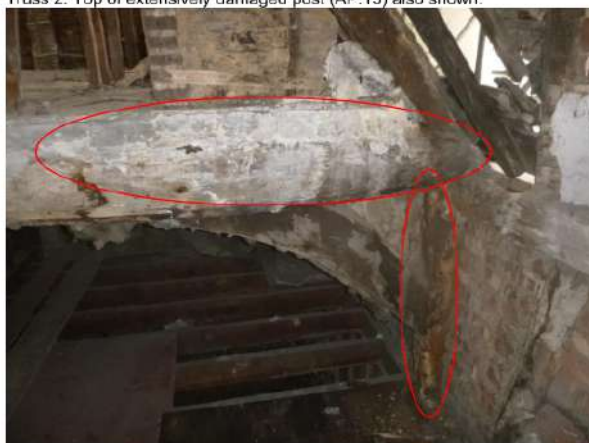
**Photograph 1.** AP.1 There is severe insect damage in the core of the tie beam at the east end of Truss 2. Top of extensively damaged post (AP.15) also shown.

Figure 6. Extract from BM Trada survey confirming condition of existing bottom member of truss 2 (Gridline D)

5. Review rotten end of truss on gridline D (Truss 2) and provide a repair detail. It would appear this has been strengthened with a timber post down to a first floor steel. This steel has not been checked for the load from the truss and therefore will need to be checked.

5. There was no access to inspect this and this will need to be done on site. Remedial works, including a potential scarf joint fixing a new section of timber to the existing, should be allowed for, but the full extent will need to be confirmed on site when this can be reviewed safely. Further steel strapping to the scarf joint maybe required also. An alternative would be to extend existing timber post down to ground floor level.

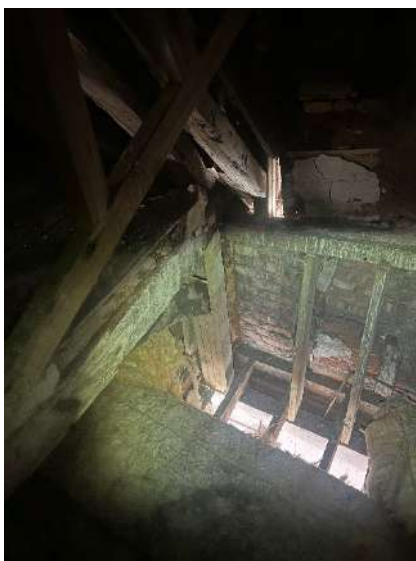
It wasn't possible to inspect the rotten end of the truss in detail, however see below a photograph of the truss (figure 7), which appeared to have been propped down to an existing steel beam at first floor level with a quadrupled timber post. A timber survey was carried out by BM Trada with a report issued on 11<sup>th</sup> October 2021, showing the condition of the truss, see below extract from the survey:

Figure 7. Rotten end of truss supported off timber post

1. Review rotten end of truss when safe access is possible to confirm strengthening detail as item 5 in section 4.1.
2. Review support of wall to No. 5 Bucklersbury when safe access is possible.

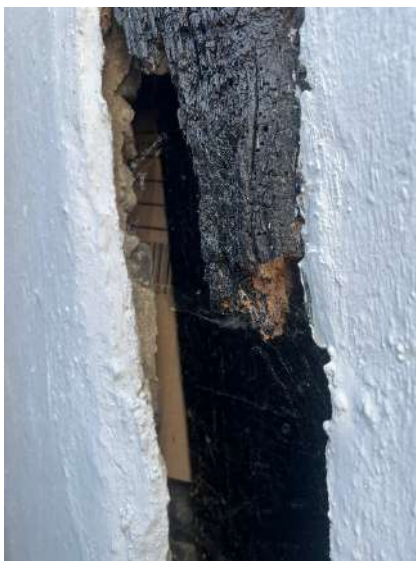
There was one section of the rear Tudor wall, where sections of the timber studs have rotten and decayed over time. Remedial works are required to make good. See example of the missing section of one of the studs below, which has OSB fixed internally to provide 'weatherproofing' and painted black to match the timber studs, so difficult to see unless looking close up.

Figure 8. Stud is missing from wall plate up to 1m above wall plate

The bearings of the studs should be exposed for inspection and the wall plate condition checked. The contractor should use half lap joints to decayed posts (lap 2.5 x section depth. Screwed and glued with resin. Slip tenons can be used at base of new posts if needed to join into the sole plate. The rotten sections of the sole plate can either be replaced with new sections scarfed into the existing, or alternatively they can also use screwed and glued half-laps, with lap 3 x section depth, as this is easier to do in-situ.

Further investigation into the condition of the timbers are required. Any rotten sections of the sole plate and studs should be carefully removed and replaced with new oak, scarfed into the existing studs/sole plate. The section of missing post should also be reinstated with a new section of oak.

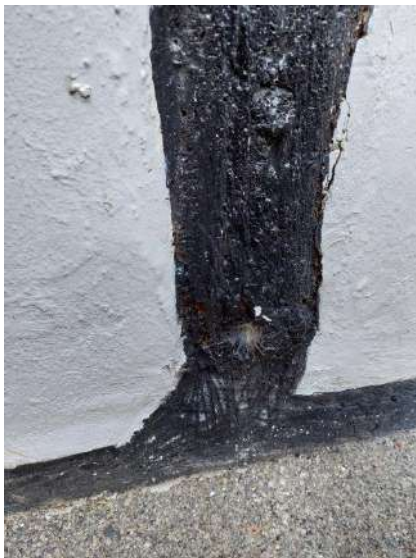
There is also a further stud which appeared that the end had decayed and replaced by some painted render at low level, see photograph below.

Figure 9. Bottom of stud appeared decayed and infilled with painted render

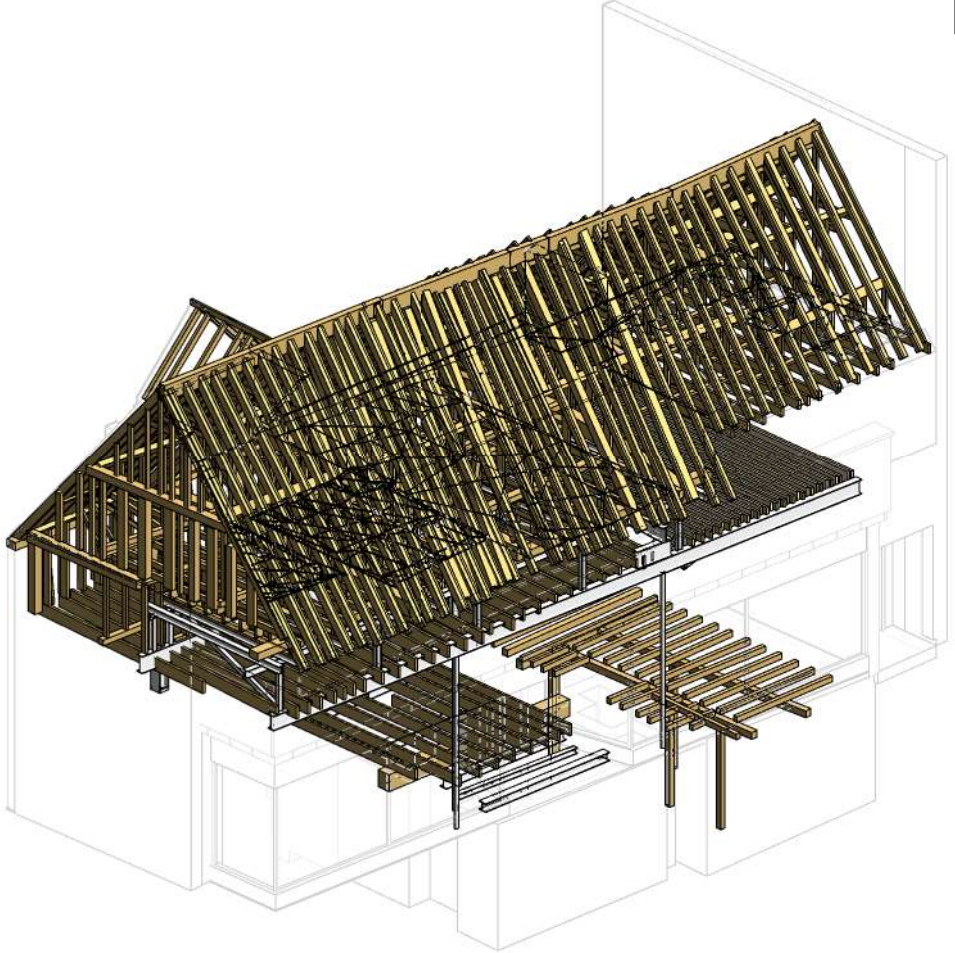
Stud wall on this line removed by previous contractor as part of non-consented works

See detail 1100.1 or  
MNP drawing 2110

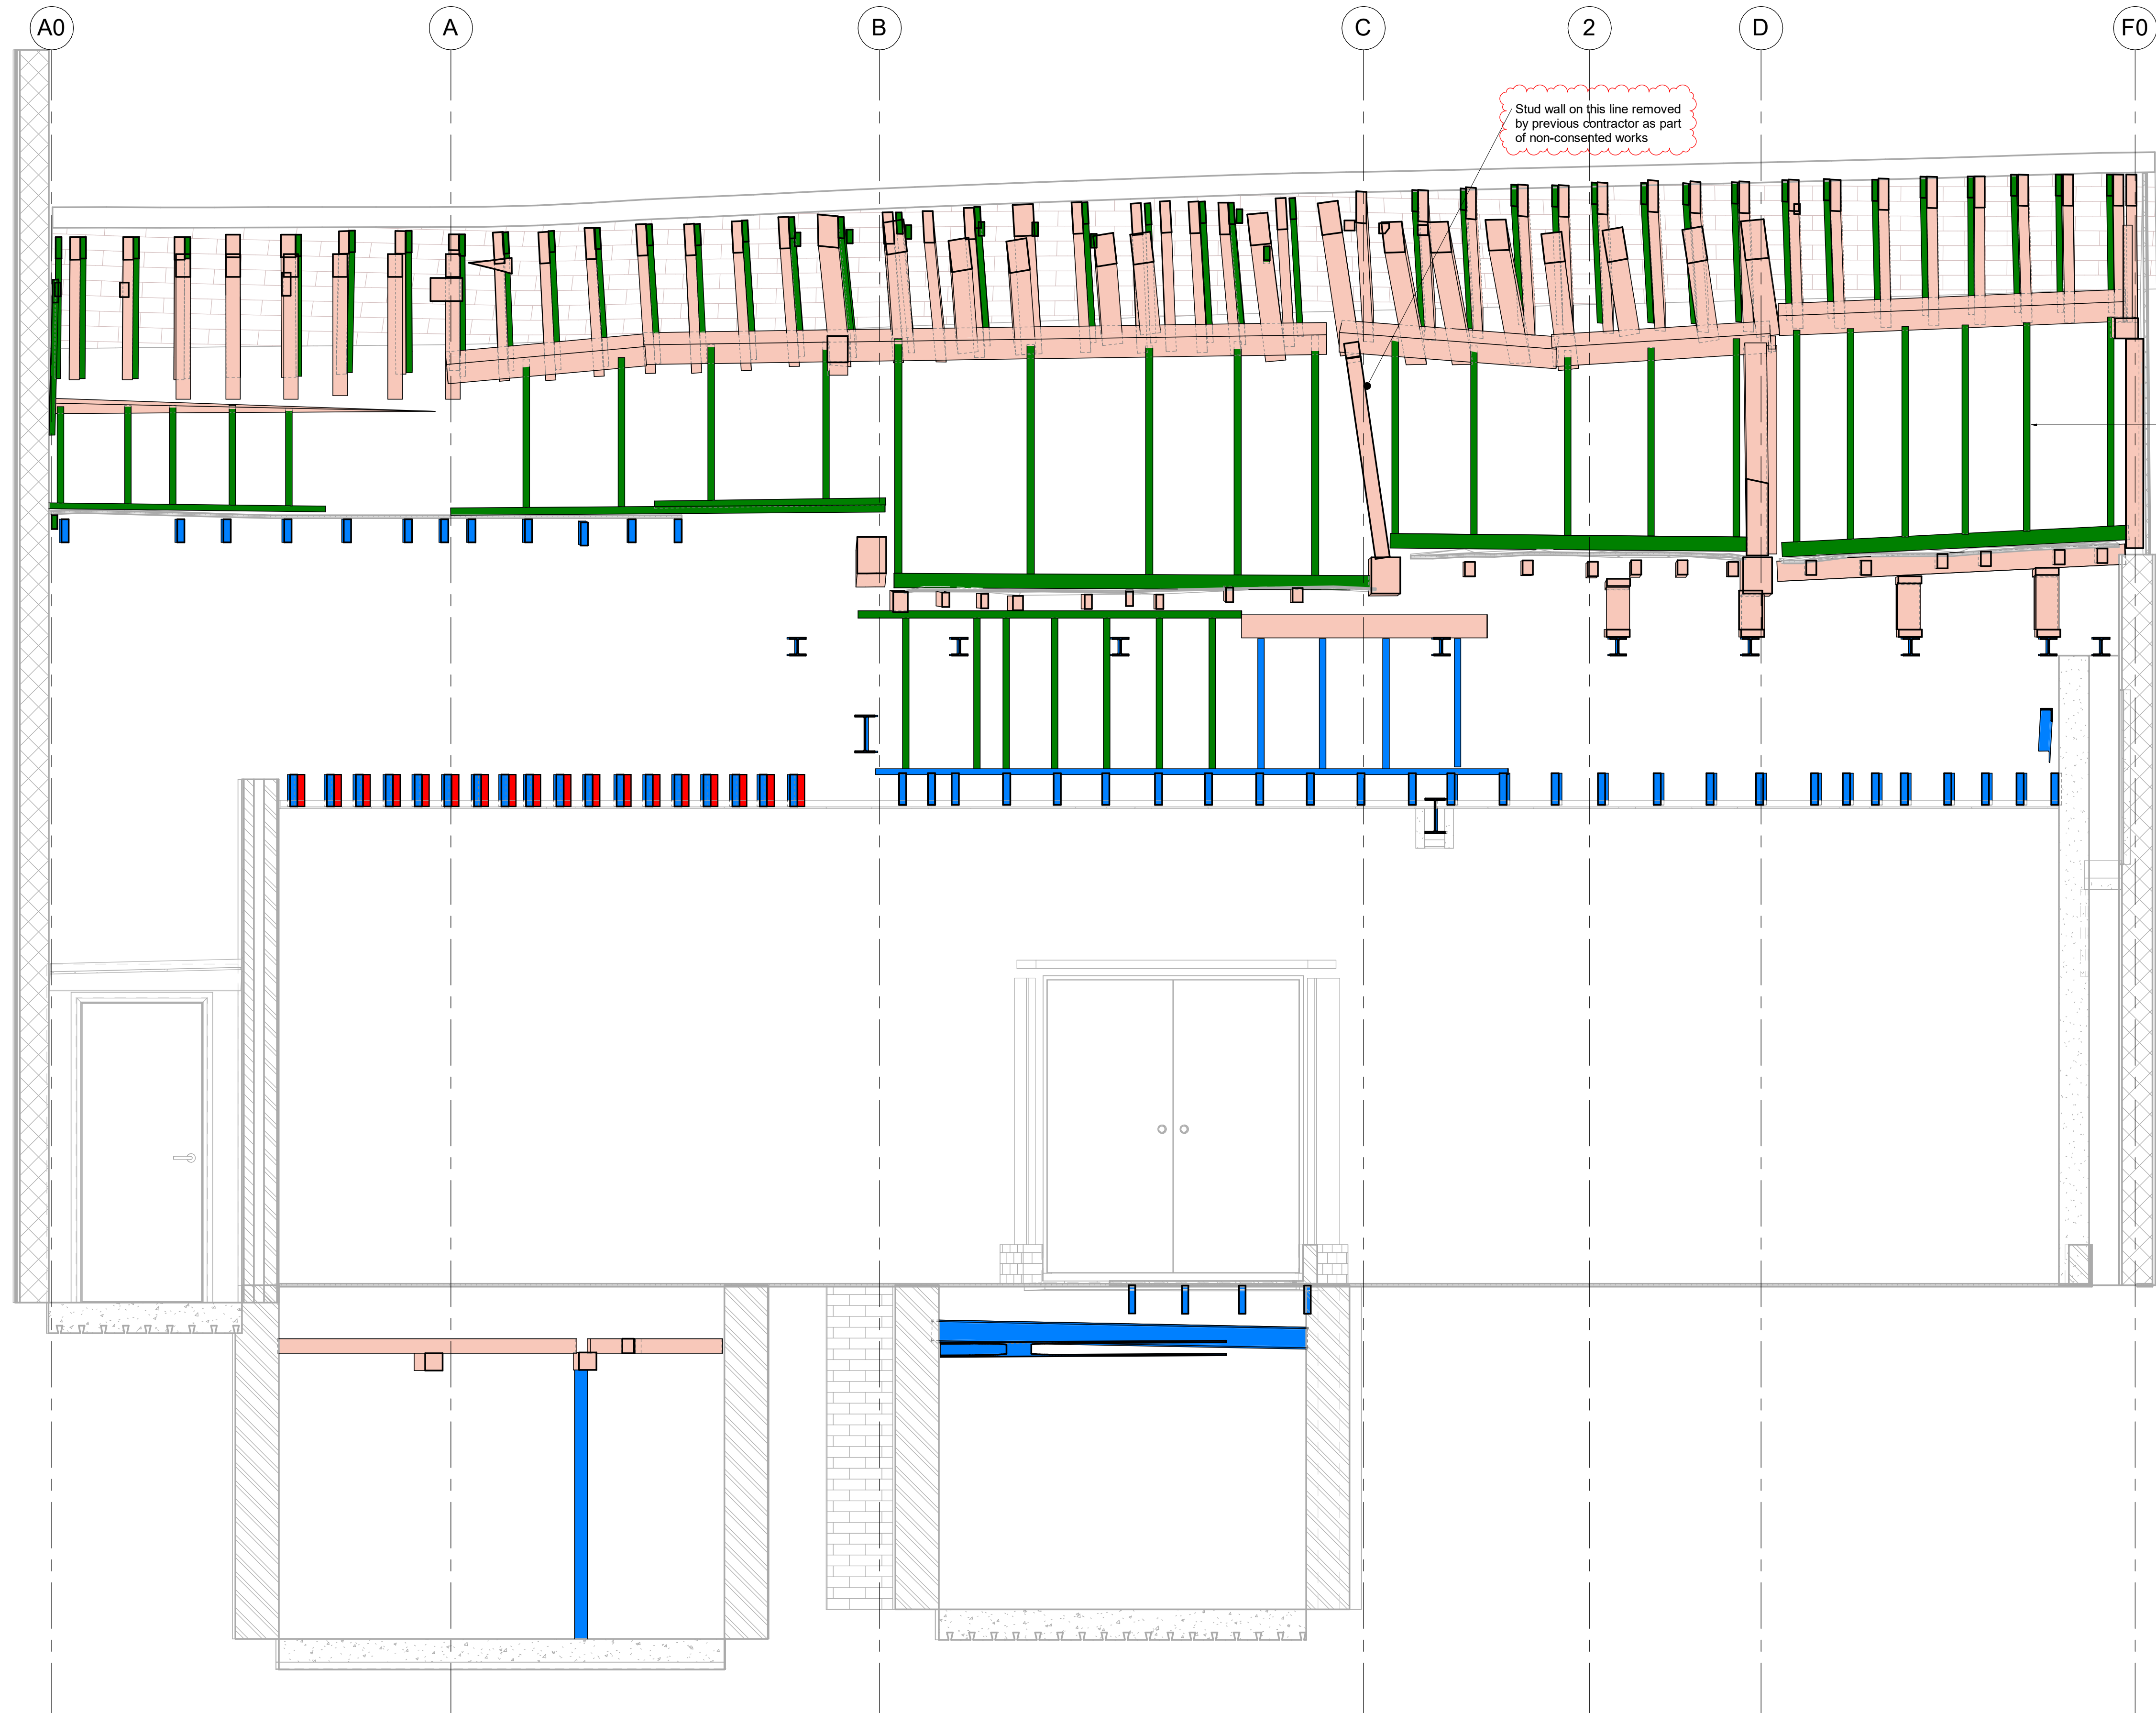
Modern structure, whilst not compliant with agreed proposal from MNP in 2020, appears to adequately strengthen existing medieval structure

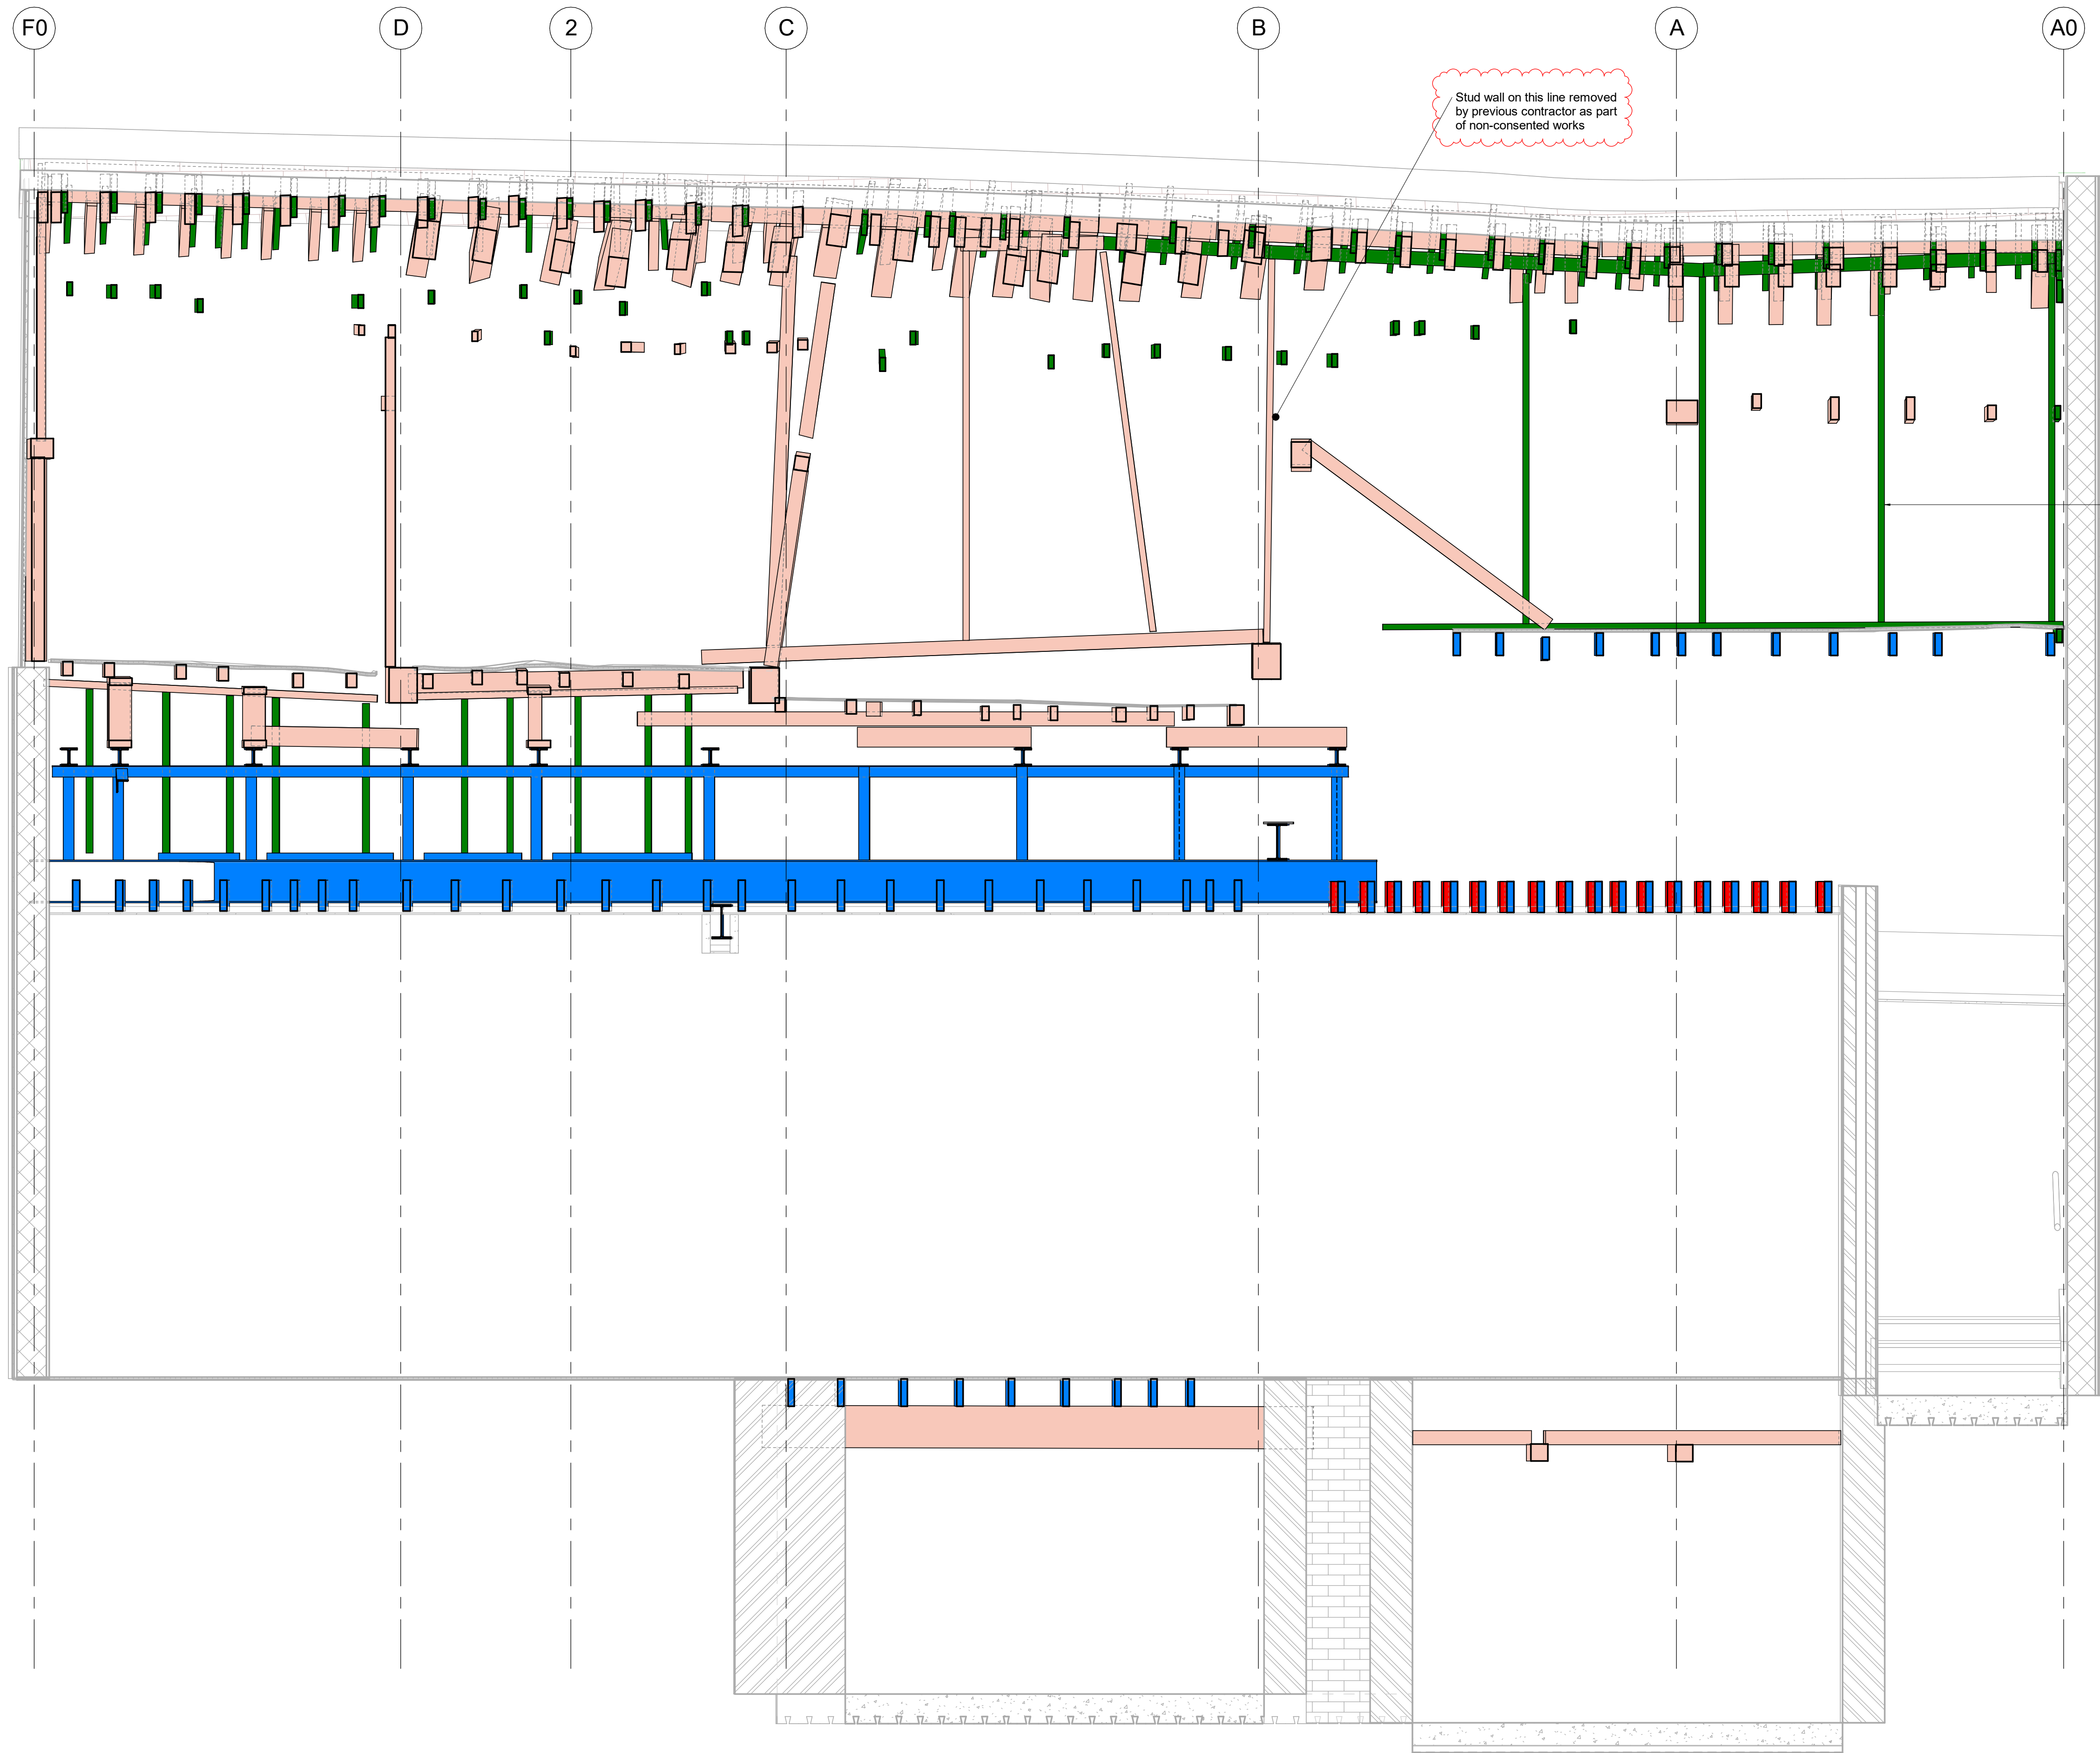
Modern structure, whilst not compliant with agreed proposal from MNP in 2020, appears to adequacy strengthen existing medieval structure

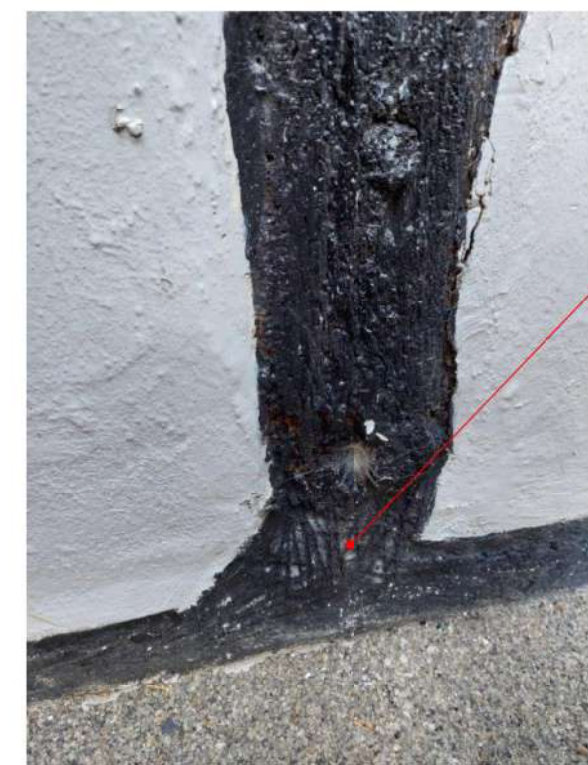
Stud 2 - Bottom of post may have been replaced with mortar infill. Further investigation required. Allow to provide new section of timber post, fixed as other missing section of stud
