## Youngloves Farmhouse – South Elevation – Timber Repairs

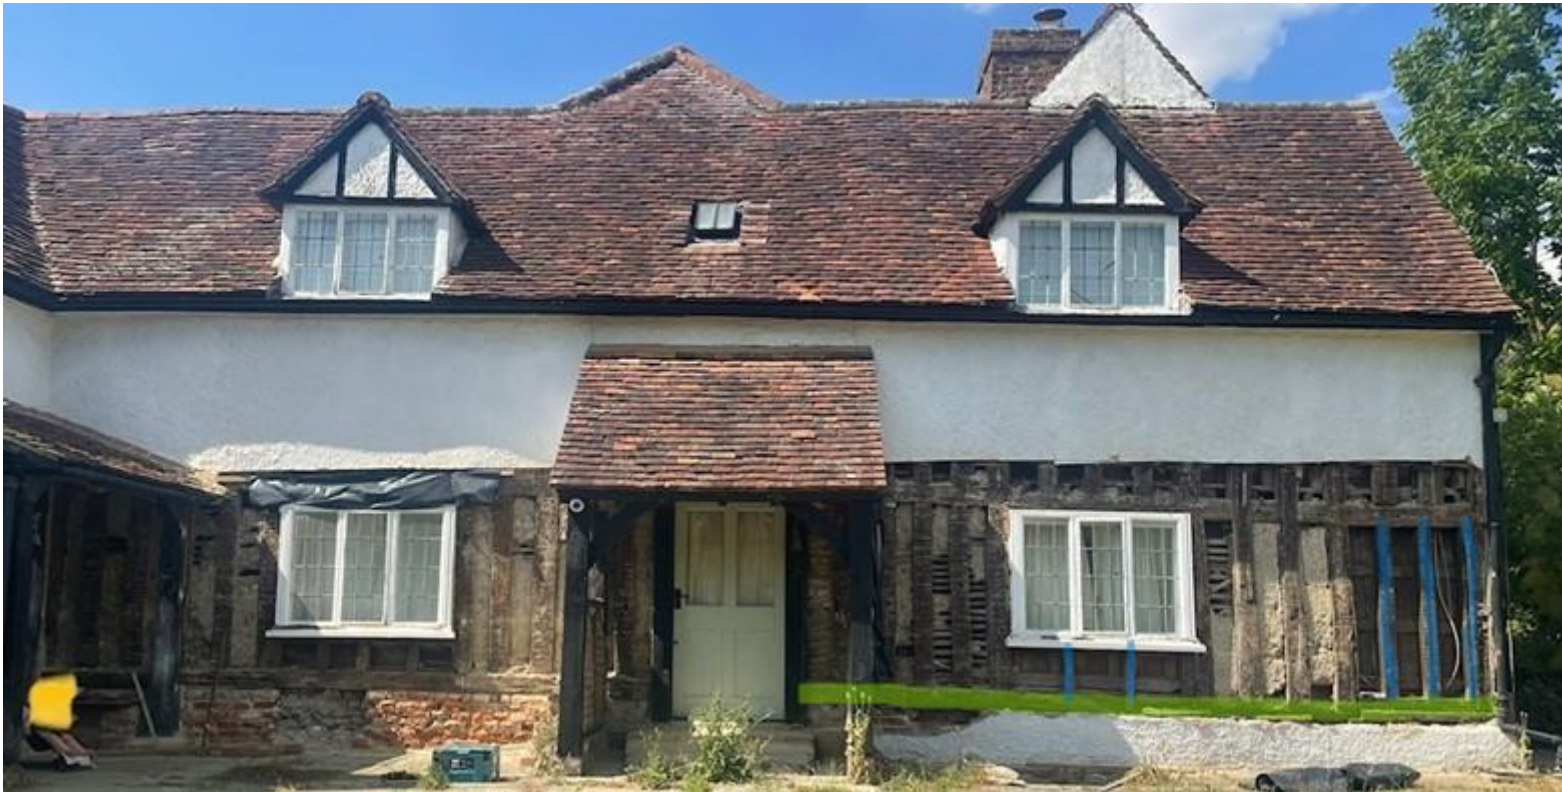
On the 24<sup>th</sup> June 2024 the cementitious render was removed from the ground to the mid-rail to expose the timbers for inspection. The plinths were found to be in poor condition without any footing, the render was left on the RHS to not disturb the brick work any further. Generally the majority of the timber frame is in good condition, with the exception of the soleplate to the right of the door. On the section to the right of the door there are also a couple of previous repairs, were we propose replacing the studs in oak to match the original construction.

Blue – Replace softwood studs and replace in oak.

Green – Replace rotten and damaged section of soleplate
