### TREE SURVEY & ARBORICULTURAL REPORT

Site at:  
Land West & South of Reed First School  
Reed  
Royston  
Hertfordshire

| Job ref | Report Version | Author | Checked | Date |
|---|---|---|---|---|
| ATS1024 | V1 | IL | IL | August 2026 |

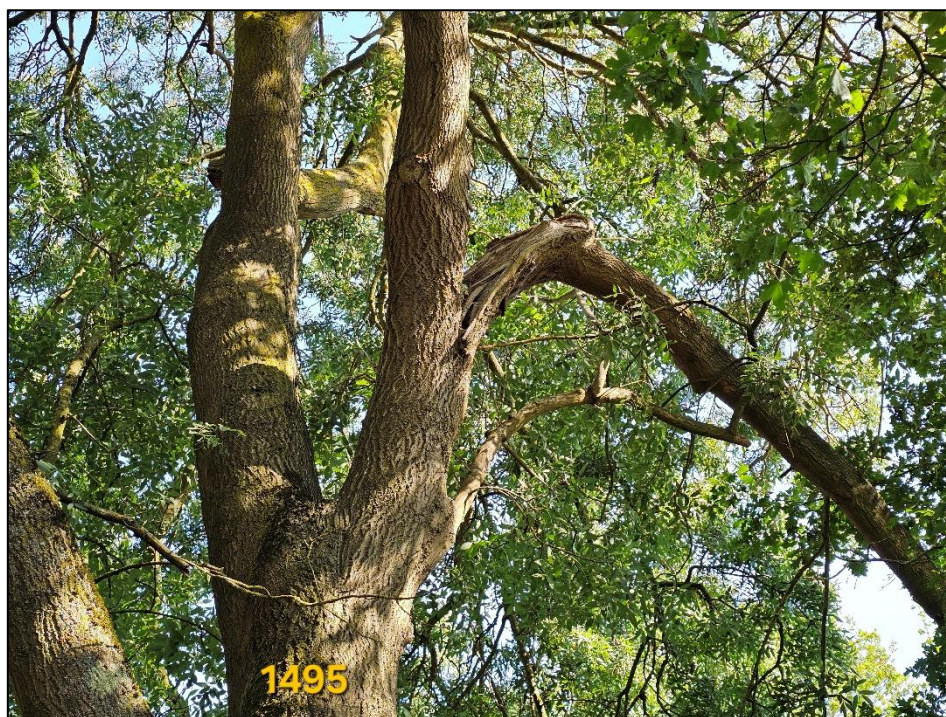
- Below: Tree 1495 (Ash) – Broken, hanging branch

| Site name: Land west & South of Reed 1 <sup>st</sup> School<br>Surveyor: Ian Lorman | | | Date of survey: 11 <sup>th</sup> August 2026<br>Conditions: Clear / dry / still | | | | | |
|---|---|---|---|---|---|---|---|---|
| Tag 1495 | Common Ash | 18 | 650 | 8 | Mature | Crown - Good, Stem - Fair, Basal Area - Good<br><br><b>Remove broken hanging branch</b><br><br>Large branch snapped and hanging up 5 metres east side | 2 | 1 |

- 3.3 One tree must have a large, rotten lower branch overhanging the school grounds removed URGENTLY (1498).
- 3.4 One tree must have a large, broken, hanging branch removed (1495).

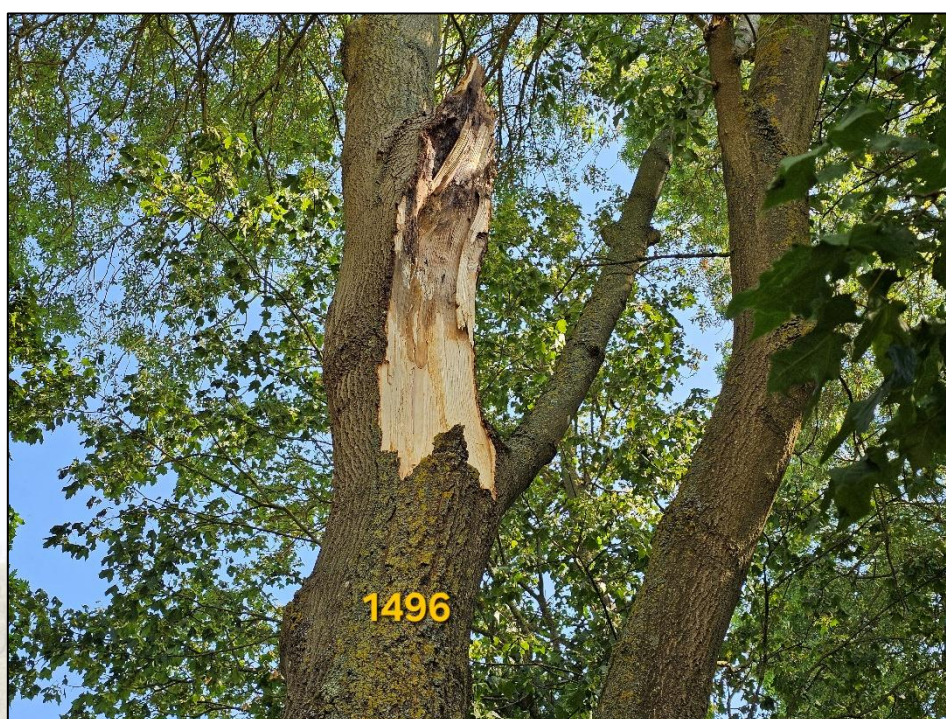
- Below: Tree 1496 (Ash) – Massive wound from loss of co-dominant stem

| Site name: Land west & South of Reed 1 <sup>st</sup> School<br>Surveyor: Ian Lorman | | | Date of survey: 11 <sup>th</sup> August 2026<br>Conditions: Clear / dry / still | | | | | |
|---|---|---|---|---|---|---|---|---|
| Tag 1496 | Common Ash | 20 | 650 | 5 | Mature | Crown - Good, Stem - Poor, Basal Area - Good<br><br><b>Fell</b><br><br>Co-dominant leader recently snapped out at 5 metres on south side leaving gaping wound deep into the centre of the trunk that equals or exceeds 50% of the circumference of the trunk. Tree is likely to snap off at this point, especially when decay sets in, if not before | 1 | 1 |

- 3.1 The site is a mature woodland belt around the western and southern boundary to Reed First School.
- 3.2 Two mature trees must be felled URGENTLY in the interests of health and safety (1496 and 1499). Ash tree 1496 has shed a co-dominant stem due to a failed bark included union. The resultant tear has deeply penetrated the remaining trunk to the point that it is likely to snap off at that point, potentially falling towards the school. Maple 1499 is dead and in an advanced state of decay, immediately adjacent to the school field.

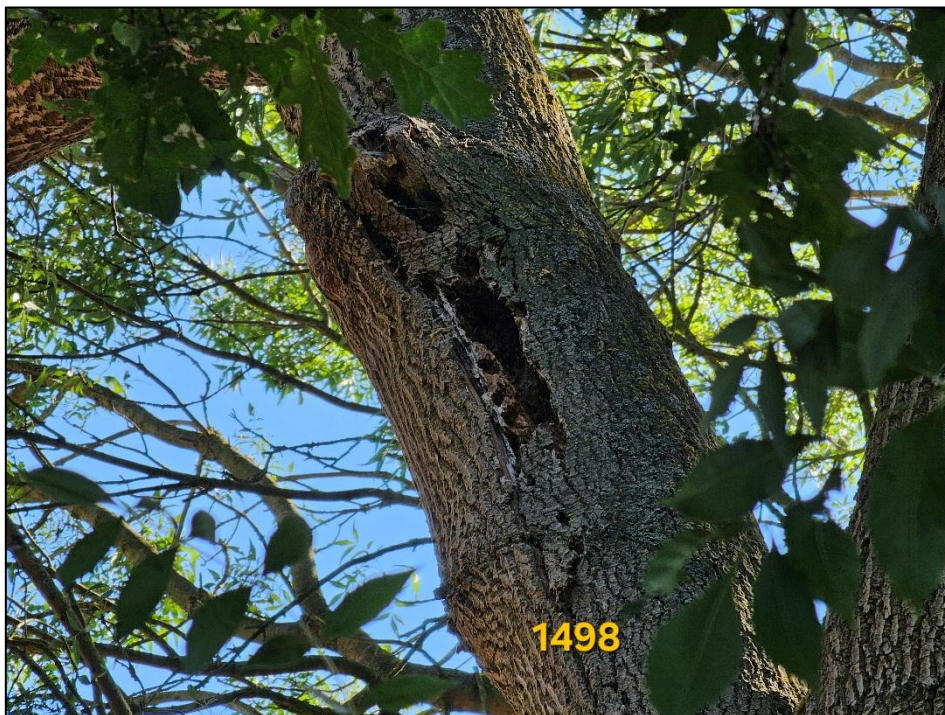
- Below: Tree 1498 (Ash) – Rotten base of large branch overhanging school grounds

| Site name: Land west & South of Reed 1 <sup>st</sup> School<br>Surveyor: Ian Lorman | | | Date of survey: 11 <sup>th</sup> August 2026<br>Conditions: Clear / dry / still | | | | | |
|---|---|---|---|---|---|---|---|---|
| Tag 1498 | Common Ash | 20 | 700 | 8 | Mature | Crown - Fair, Stem - Good, Basal Area - Good<br><br><b>Remove faulted/rotten lower branch on north side overhanging school field</b><br><br>Massive live lower branch on north side at 6 metres with advanced decay at base overhanging school playing field | 1 | 1 |
