## CONSERVATION TEAM CONSULTATION APPLICATION RESPONSE

| <b>APPLICATION REF:</b> | 26/00612/FP & 26/00613/LBC |
| <b>APPLICATION SITE:</b> | The Biggin, Queen Street, Hitchin, Hertfordshire SG5 1AB |

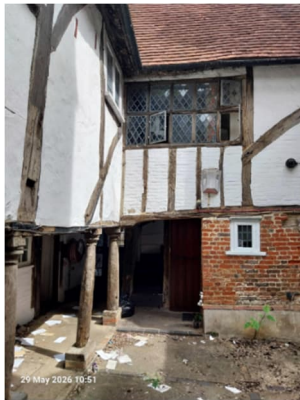
**Small open courtyard**

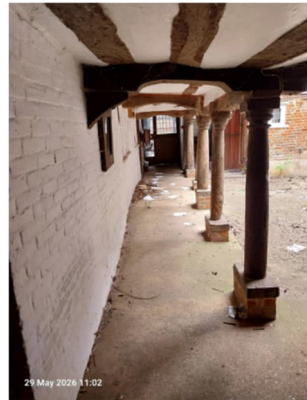
**Cloister formed by a Small Tuscan colonnade along one side**

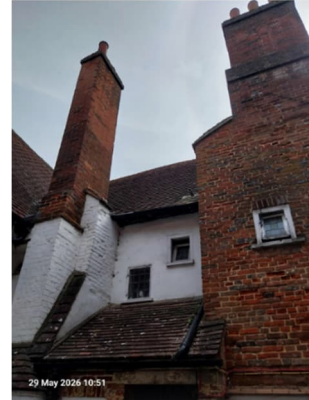
**Some old brickwork in tall chimney stacks**

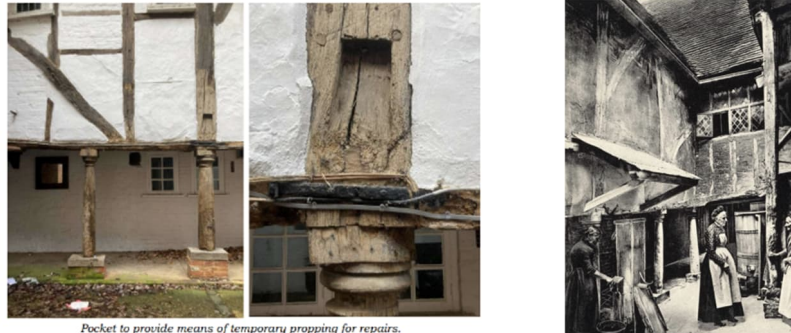
3.66. One interesting feature was a raking cut to form a pocket in the side of the central post above the cloister. This was almost certainly introduced to provide a 'jacking' point, such that a robust and

*slightly overlong timber strut could be located into the pocket at an angle to the ground. As the base of the strut was driven sideways, towards the pocket, the structure above would be lifted, taking load off the ground floor elements for repair: an early form of Acrow Prop.*

**This point of interest should be retained (images below left and centre) and is in the vicinity of the lean-to shelter in the image at page 10 of the SofSig (below right).**

*Pocket to provide means of temporary propping for repairs.*

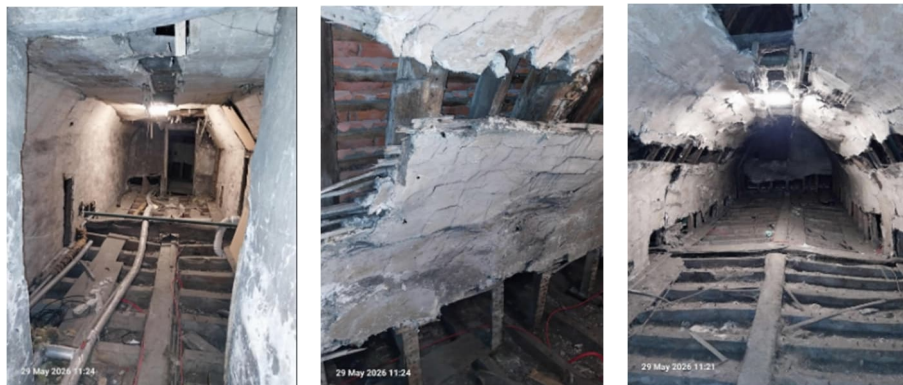
There is an extensive attic space which is generally in poor condition with significant panels of failing lath-and plaster.

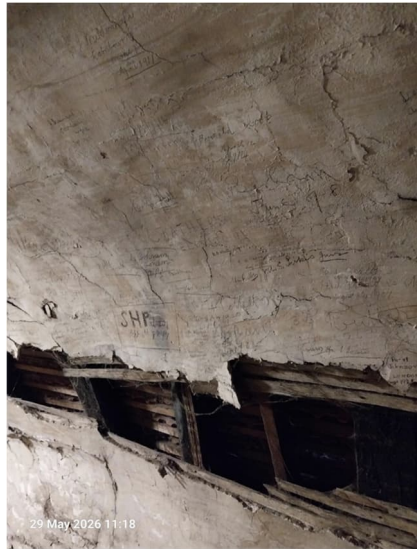
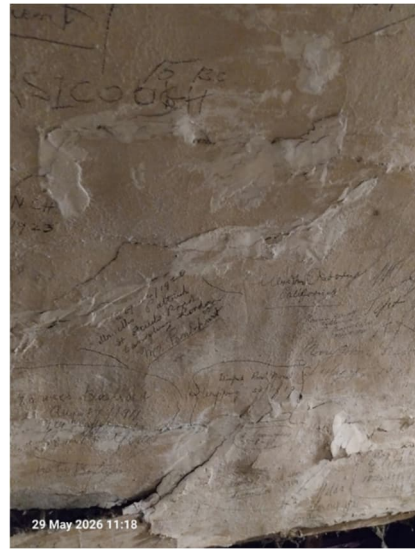
The significance of the smoke blackening is noted, and I am interested in 3.58 to 3.62. As stated, there are significant areas of signed/graffiti plaster and in the photo below left there are dates from 1899, 1900, 1907, 1921 etc. whilst in the image below right places referred to include California, Wapping, Bermondsey(?) etc. This clearly indicates significant use of the attic floor but there is no reference to the 'attic' or indeed the 'roof space', in the SofSig.

**The significance of these inscriptions is not fully understood but a level of recording is advised in case of further loss considering the need to undertake duct work and install walkways in the loft. This has the potential to be important archive information.**

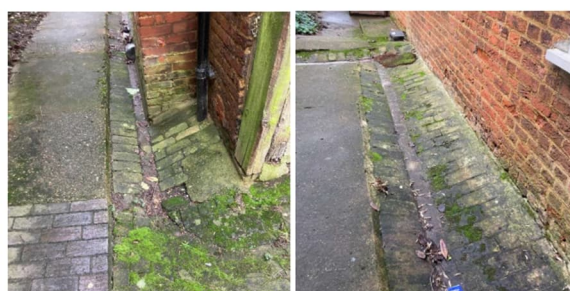
3.37. The condition of the drainage channel meant that much water would escape and stay in the vicinity of the wall thus causing the damp.

*Damp in the base of the south wall caused by the drainage channel*

The French drain detail around the building's perimeter is a very practical and beneficial proposal and would sit alongside restored brick sett paving as noted on drawing no. 002 Rev R02 and is acceptable.
