**Fears End, Sandon, Buntingford, Herts SG9 0QZ**

Class Q Barn Survey and Structural Assessment Report

| Project Name: | Poultry shed at Fears End, Sandon, Buntingford, Herts SG9 0QZ |
| Report Title: | Class Q Barn Survey and Structural Assessment |

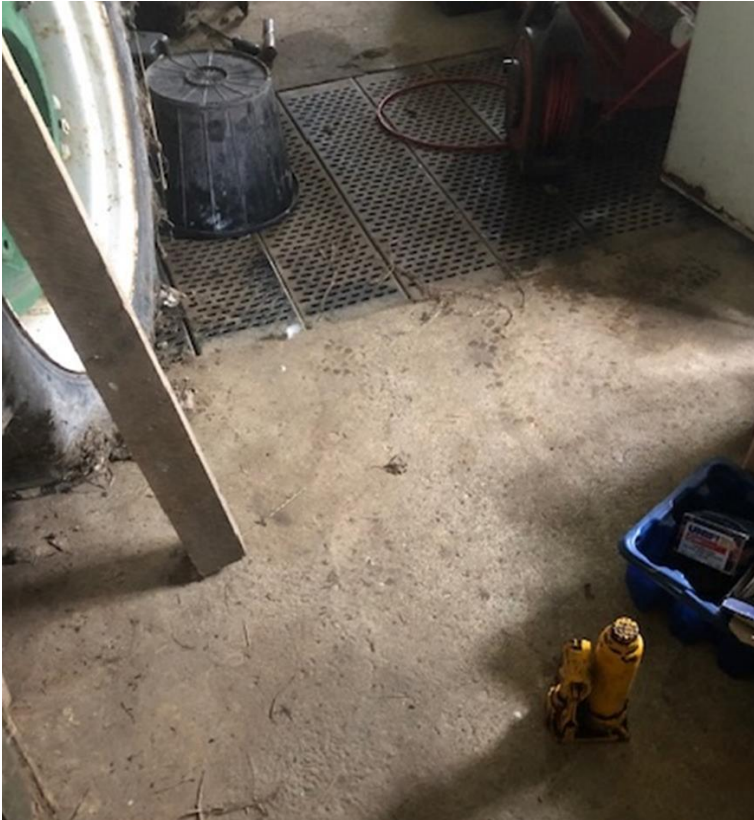
- 4.6 The floor slab presents in a generally good condition where visible, being robustly free from significant cracking or hollow soundings where tested. Some uneven patch repairs are visible. This work is required irrespective of any conversion works to maintain the building in a serviceable condition.

- 5.2 The floor slab appears to be in a sound condition, and will be subject to a reduction in imposed load within a residential dwelling, as currently there is a great deal of heavy storage. The existing floor slab should therefore be suitable to form a sound base from which to raise partitions and install insulation and floor finishes appropriate to a domestic floor.

Concrete floor slab.

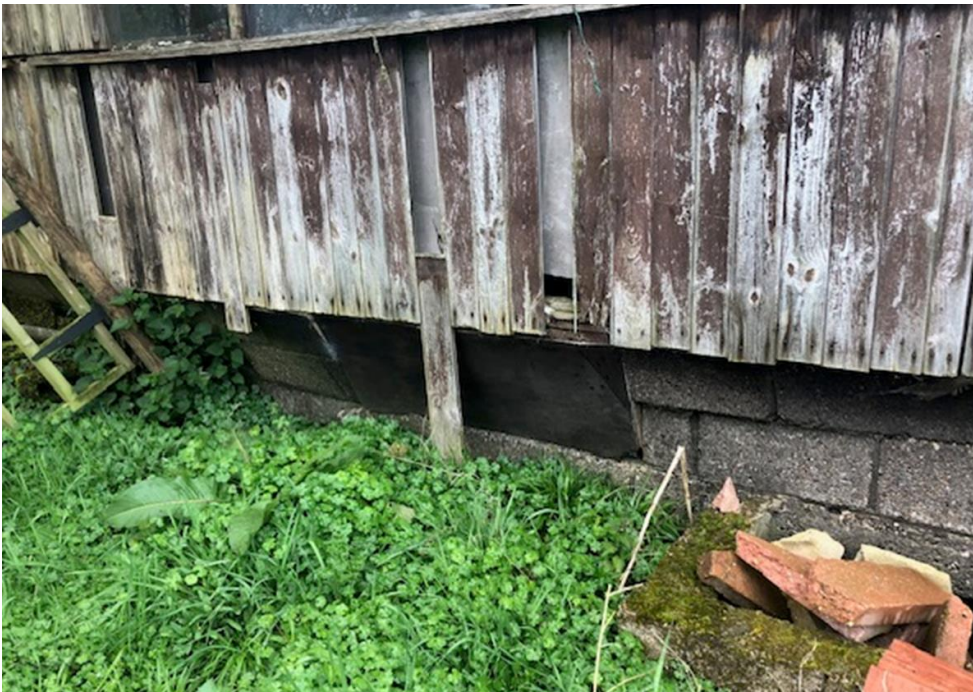
- 3.7 The floor of the shed is ground bearing concrete slab. There are two channels running most of the length of the shed with iron coverings.
- 3.8 A small section of wall to the southern end has displaced out, this appears to be from an impact internally based upon the distortion visible .

Damage to southern wall.

- 4.4 Part of the side wall requires repair and partial rebuilding where pushed out. This work is required irrespective of any conversion works to maintain the building in a serviceable condition.
