**Fears End, Sandon, Buntingford, Herts SG9 0QZ**

| Project Name: | Poultry shed at Fears End, Sandon, Buntingford, Herts SG9 0QZ |
| Project Reference: | 7417 |
| Report Title: | Class Q Barn Survey and Structural Assessment |

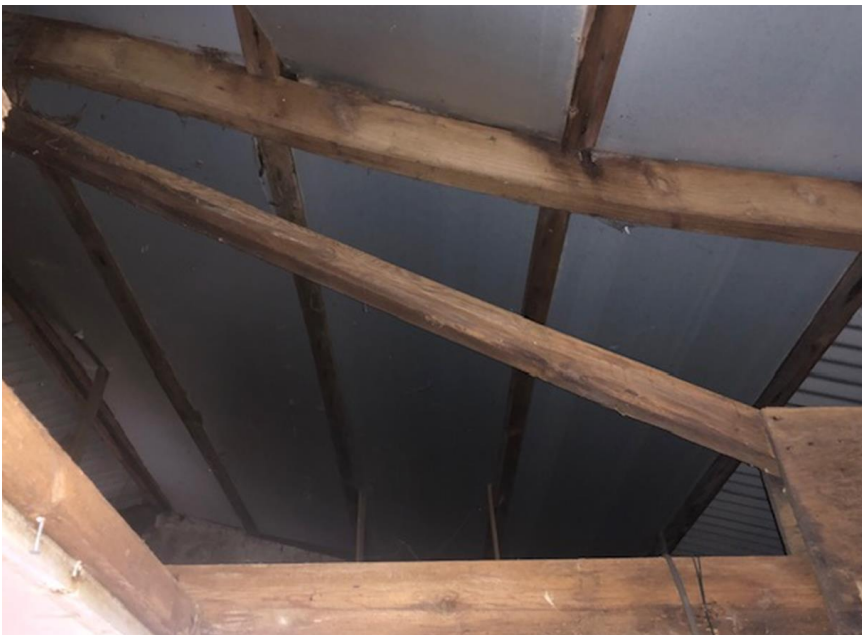
- 4.3 A truss close to the front entrance has failed, the liner ceiling has fallen away, some water staining is visible
- 4.4 In other respects, the roof trusses appear generally in a adequate condition and attention to the relatively localised issues noted should readily restore the entire roof structure to a robust state. This work is required irrespective of any conversion works to maintain the building in a serviceable condition.

Failed rafter member in truss near front of building.

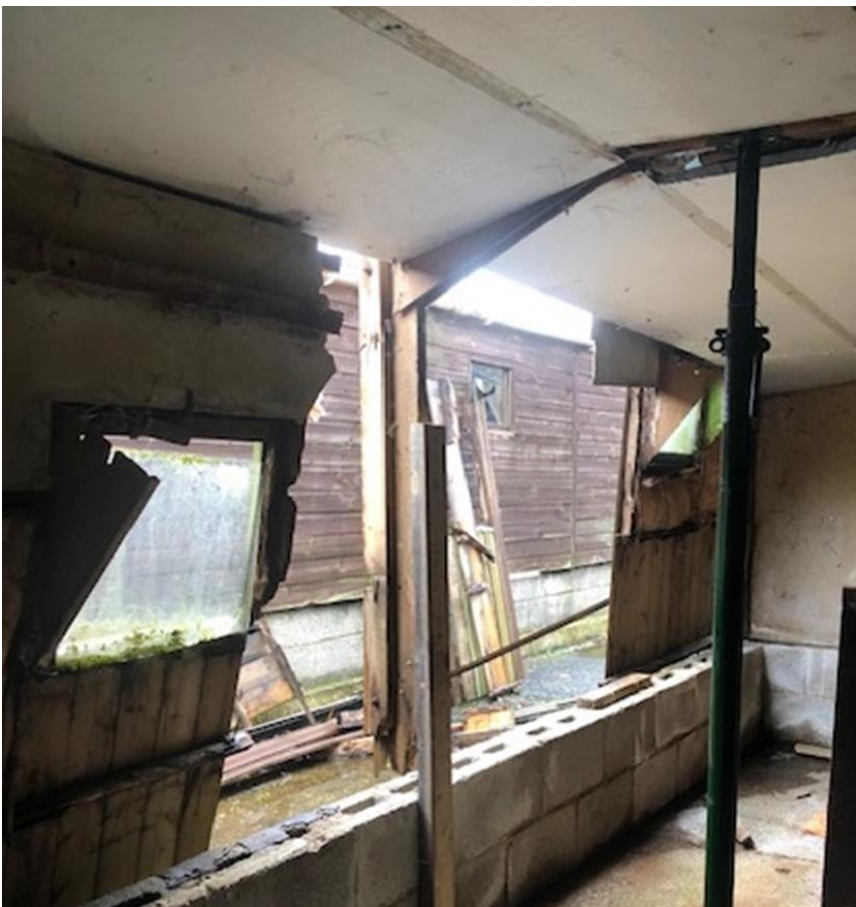
- 4.5 The side wall has partially collapsed over two bays with the low level block wall rotated, this will need to be replaced and repaired. This work is required irrespective of any conversion works to maintain the building in a serviceable condition.

Collapsed wall to rear northern elevation.
