**Fears End, Sandon, Buntingford, Herts SG9 0QZ**

| Project Name: | Barn at Fears End, Sandon, Buntingford, Herts SG9 0QZ |
| Project Reference: | 7417 |
| Report Title: | Class Q Barn Survey and Structural Assessment |

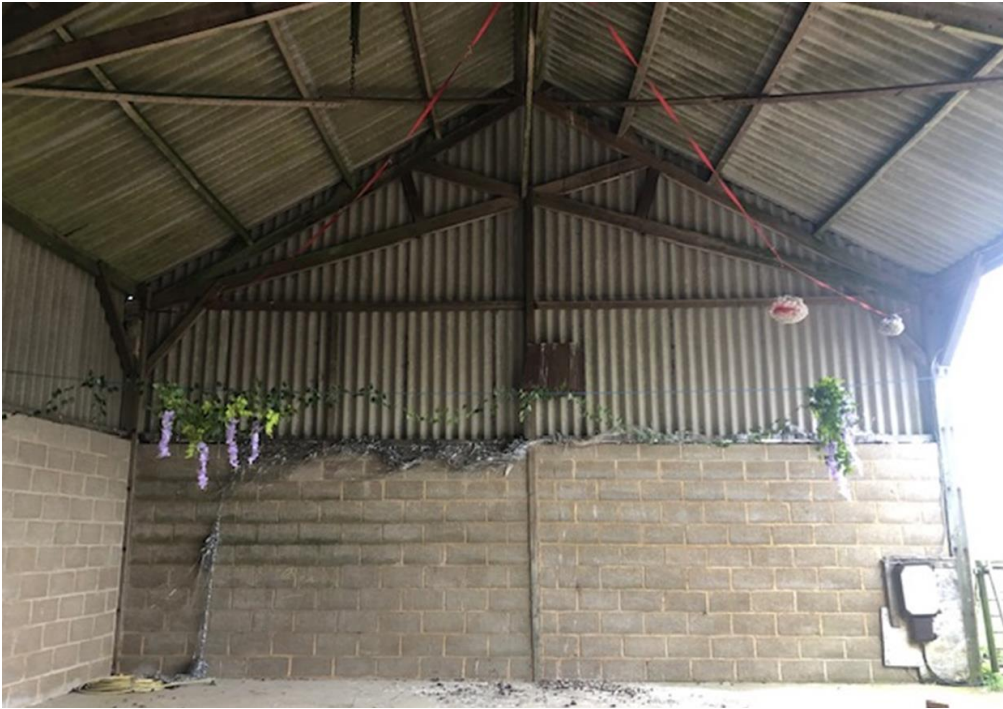
Internal framing to main barn.

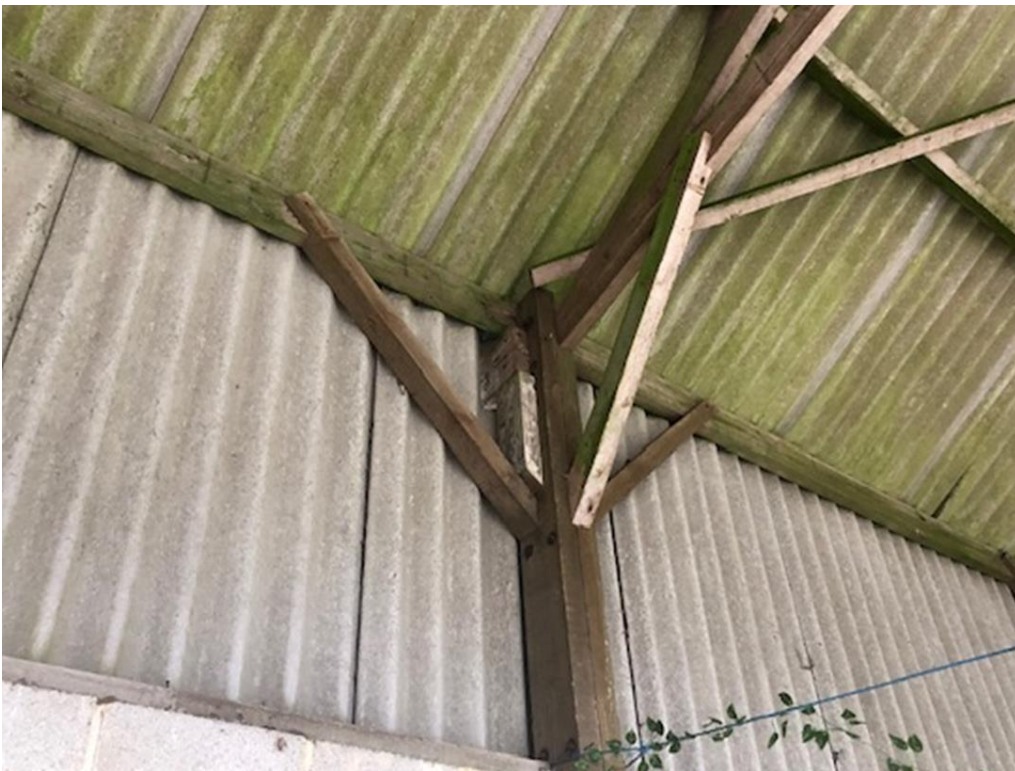
- 4.4 In other respects, the roof trusses appear generally in a satisfactory condition and attention to the relatively minor localised issues noted should readily restore the entire roof structure to a robust state. This work is required irrespective of any conversion works to maintain the building in a serviceable condition.

Roof truss arrangement at post.

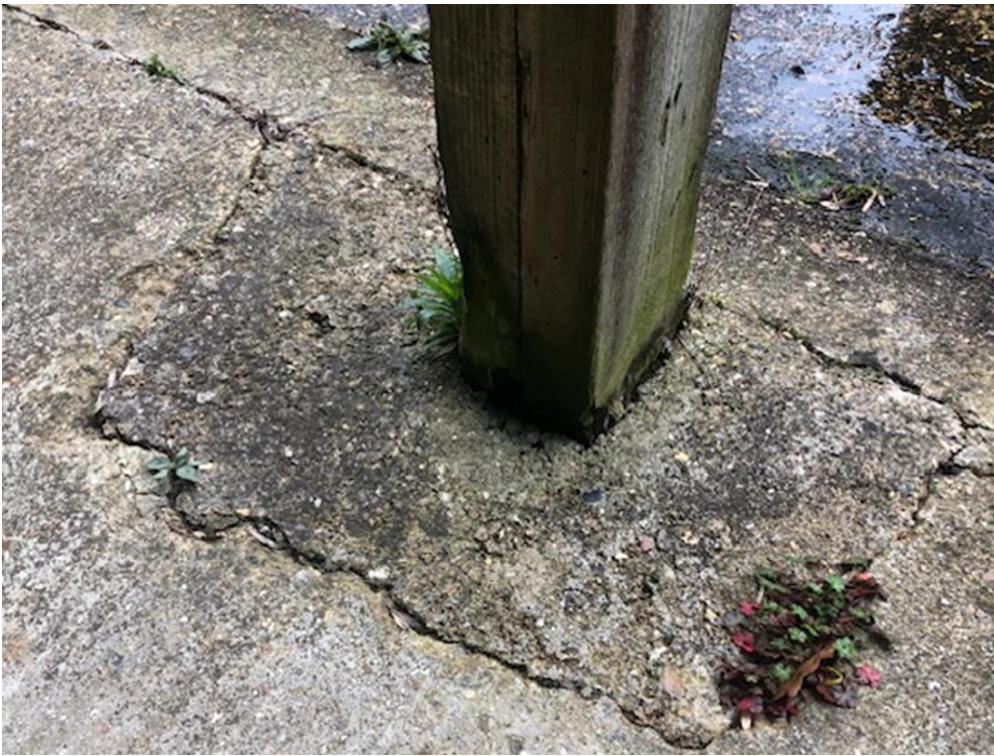
- 4.3 Some timber purlins to the lean to roof have been replaced or repaired, there is some water staining where guttering has been displaced, this might require attention. Where timber posts are in contact with the ground some loss of section is visible.

Timber post at ground level.

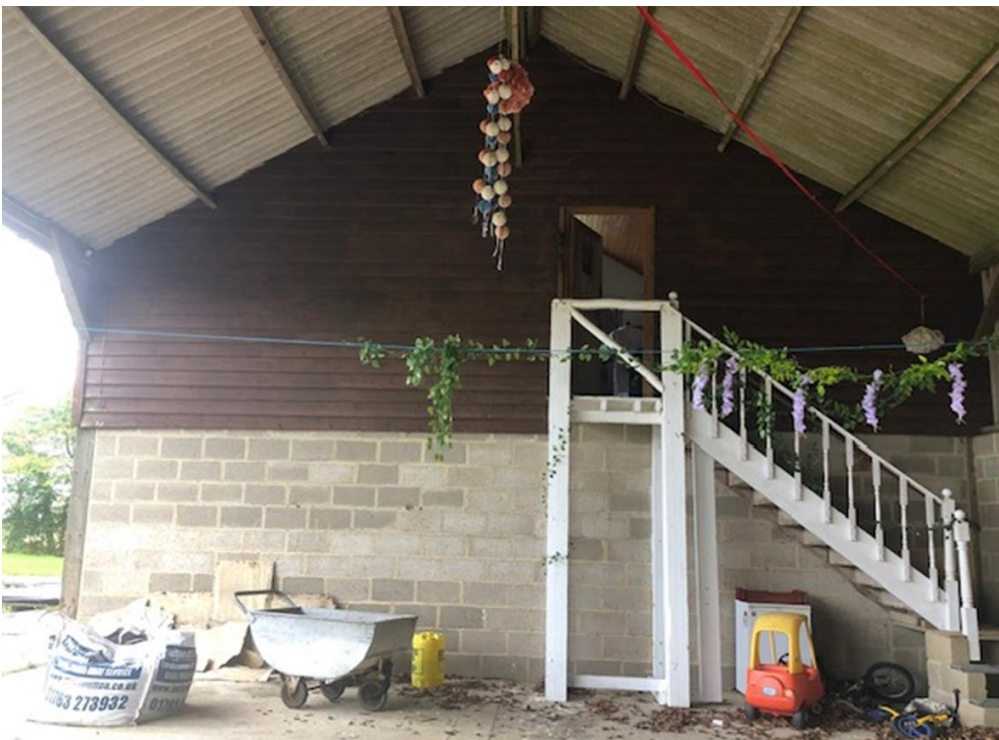
Access to mezzanine floor.

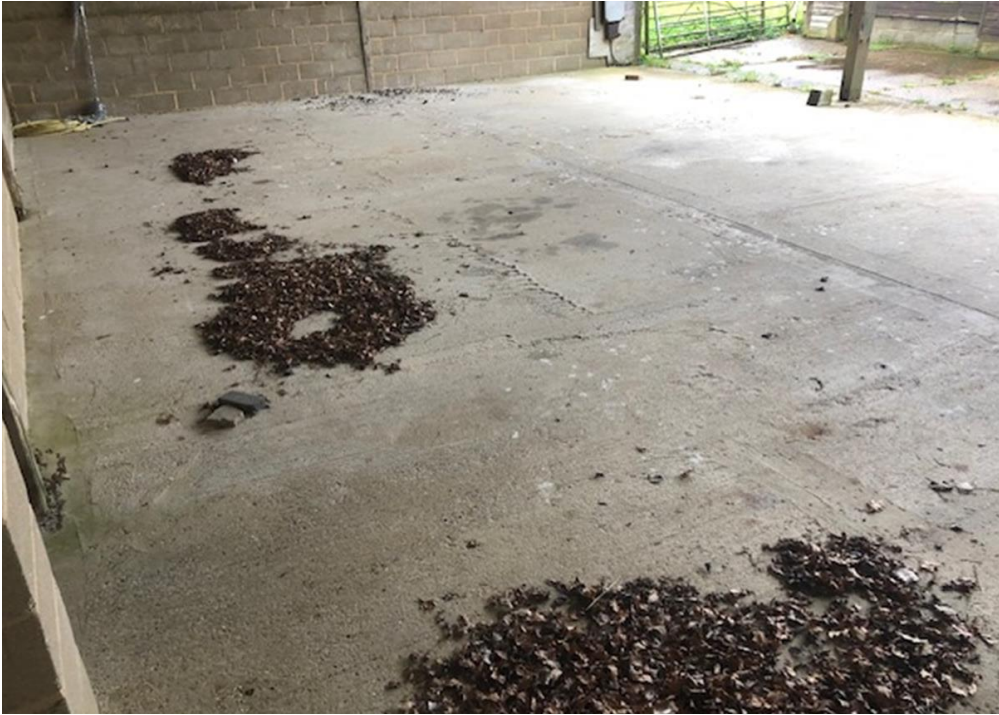
- 4.7 The floor slab presents in a generally good condition to the main building, being robustly formed and free from significant cracking or hollowing soundings, indicative of sub-floor voiding. The lean to floor slab does have some cracking.

Ground floor slab to main barn.

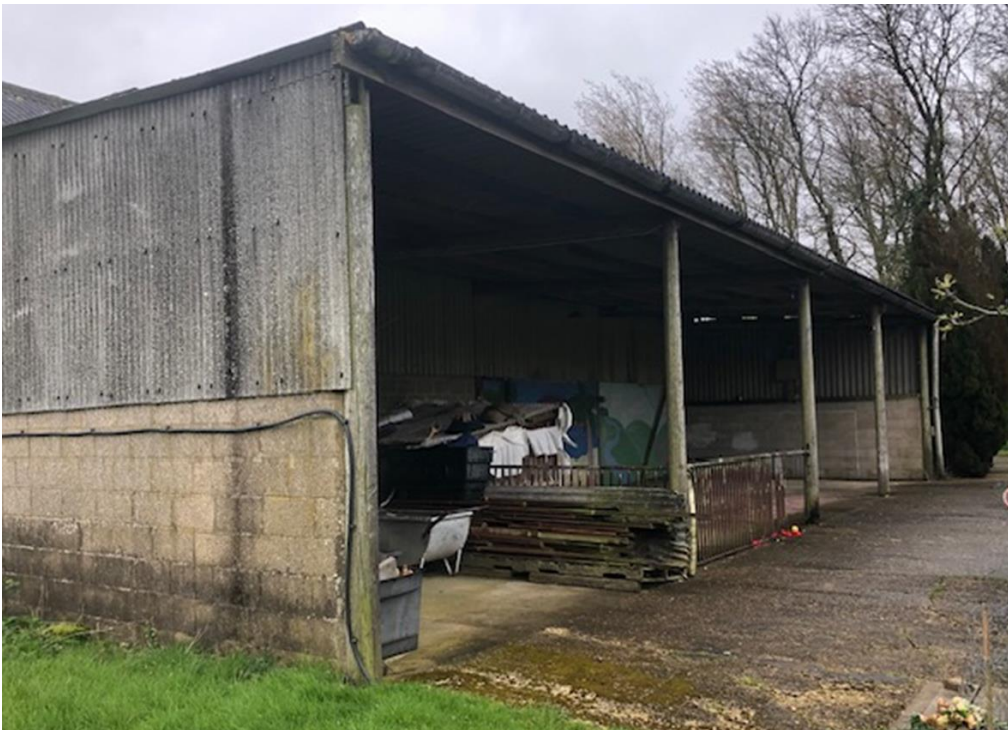
Lean to barn to side.

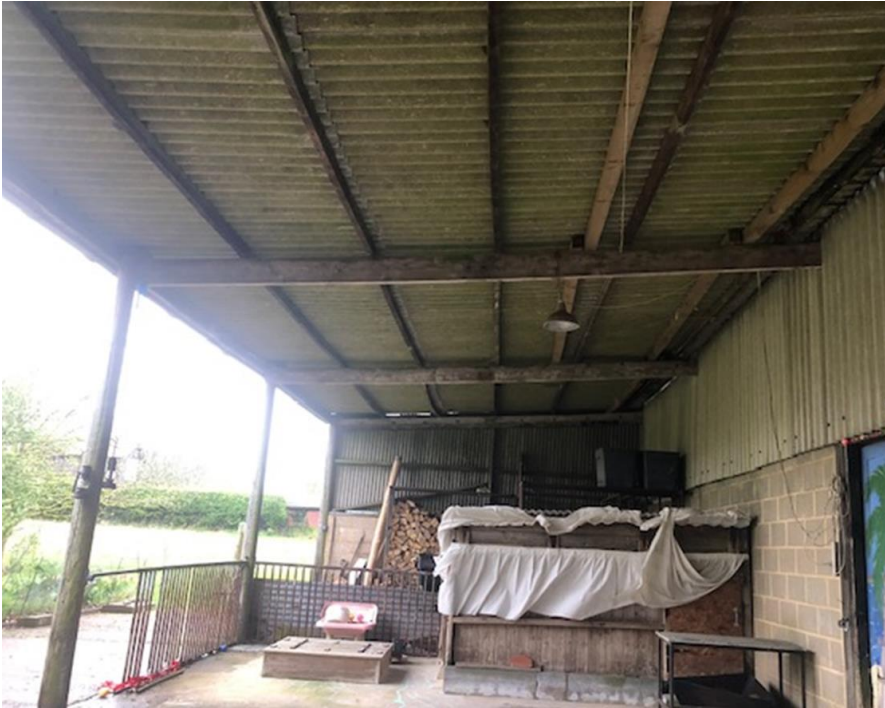
Internal framing to lean to barn.

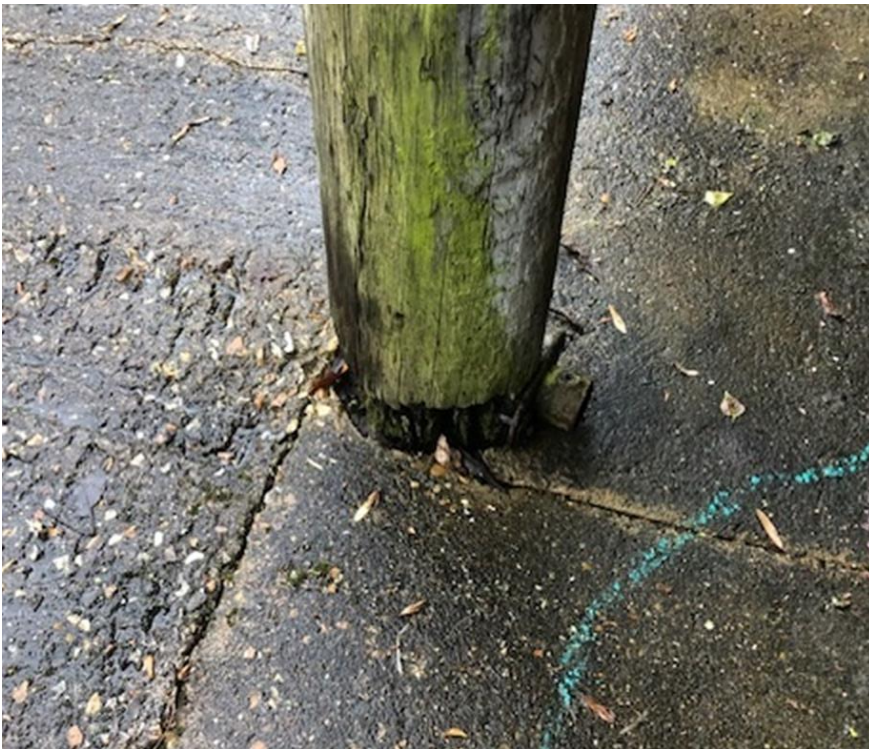
Timber post at ground level to lean to barn.
