# Arboricultural Report

SUBSIDENCE INVESTIGATION AT:

**1 Colemans Close  
Pirton  
Hitchin  
SG5 3FJ**

| Reference No: | 1786838 |

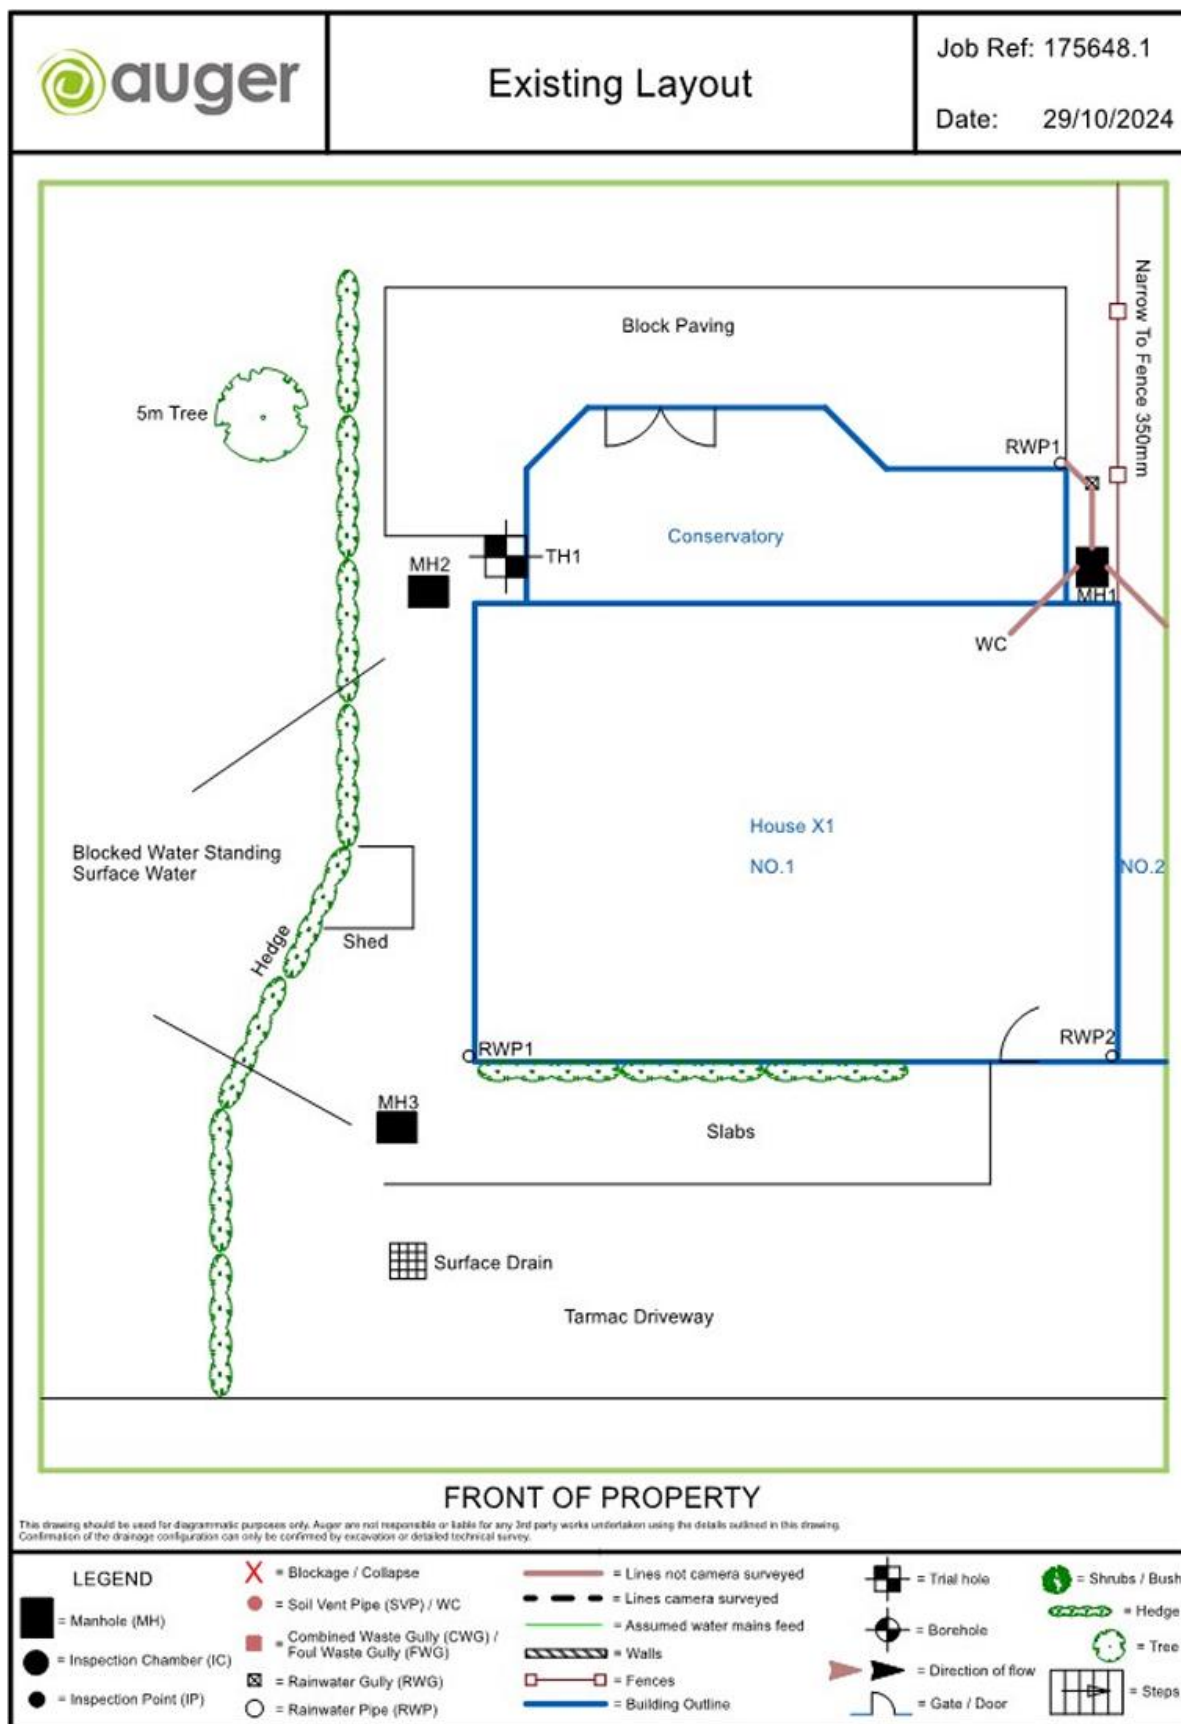
## Site investigation plan showing location of boreholes

| TP/BH Number | Type | Depth at Underside (mm) |
|---|---|---|
| TP1 | Concrete | 700 |

| TP/BH Number | Roots observed to depth (mm) | Identification | Root Dia. (mm) | Starch |
|---|---|---|---|---|
| BH1 | 700 | Examined root: the family VITACEAE (includes Vitis (Grape-Vine) and Parthenocissus (Virginia Creeper etc.)). | - | Alive, recently |
| BH1 | 1200 | Examined root: the family VITACEAE (includes Vitis (Grape-Vine) and Parthenocissus (Virginia Creeper etc.)). | - | Alive, recently |
| BH1 | 1700 | Examined root: ACER (Maples, Sycamores). | - | Alive, recently |

| TP/BH Number | Description | Plasticity Index % | Volume Change Potential (NHBC) |
|---|---|---|---|
| BH1 | Light brown fine to medium gravelly silty CLAY | 42-46 | High |

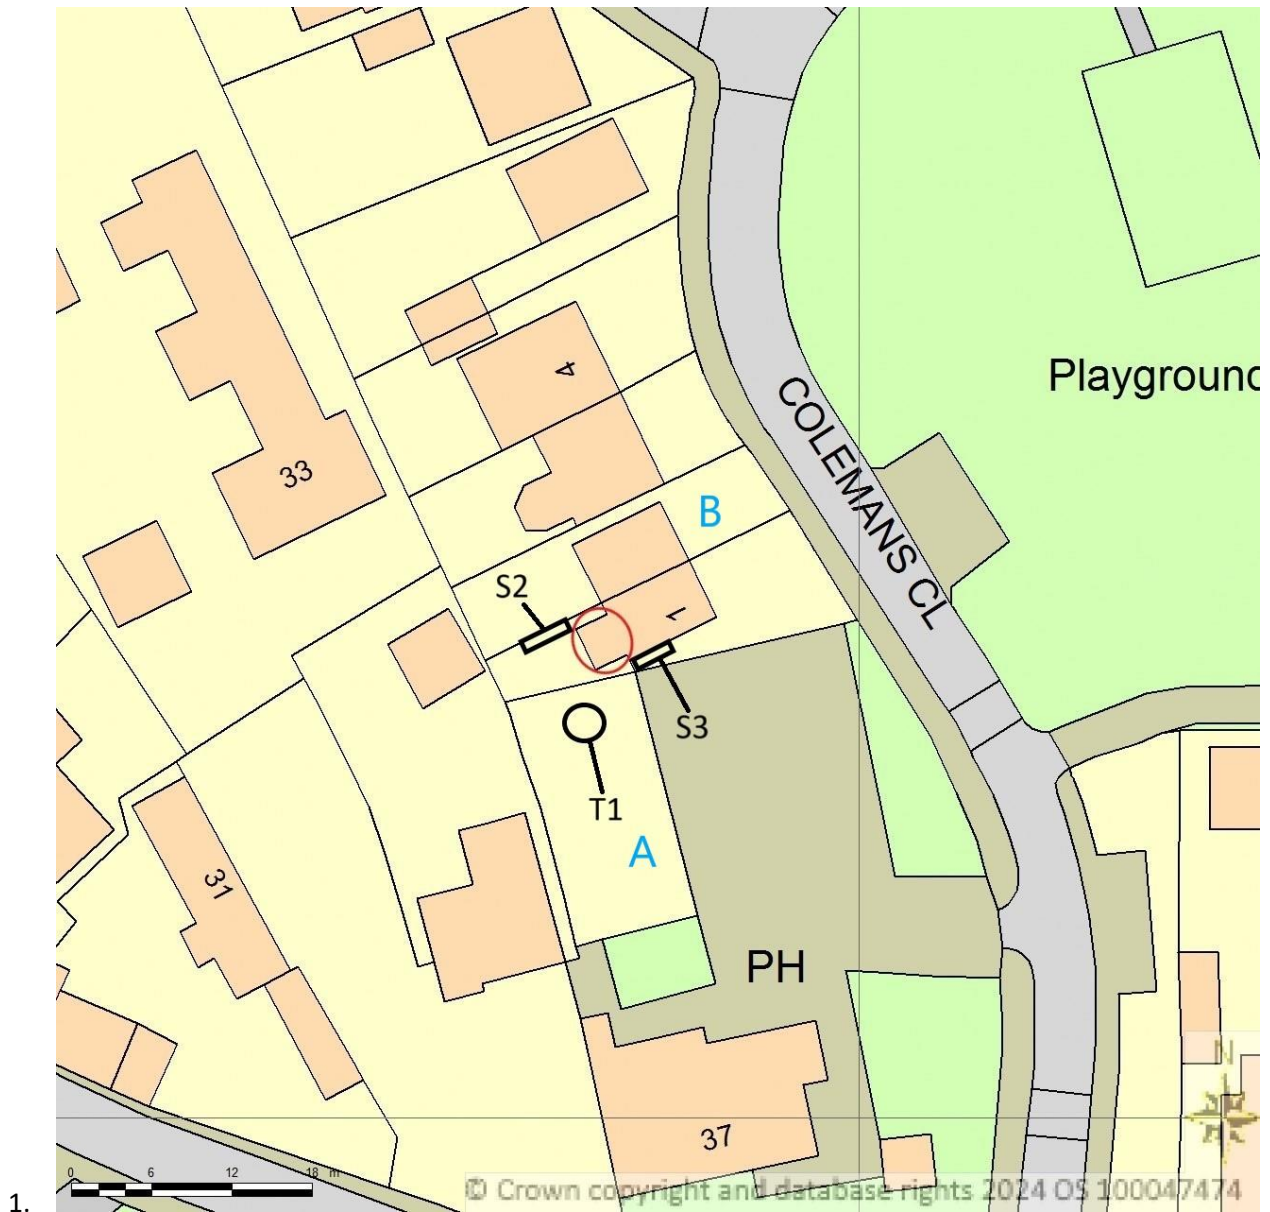
## Tree plan

Tree plan showing area of damage with red circle and location of neighbours as detailed below.

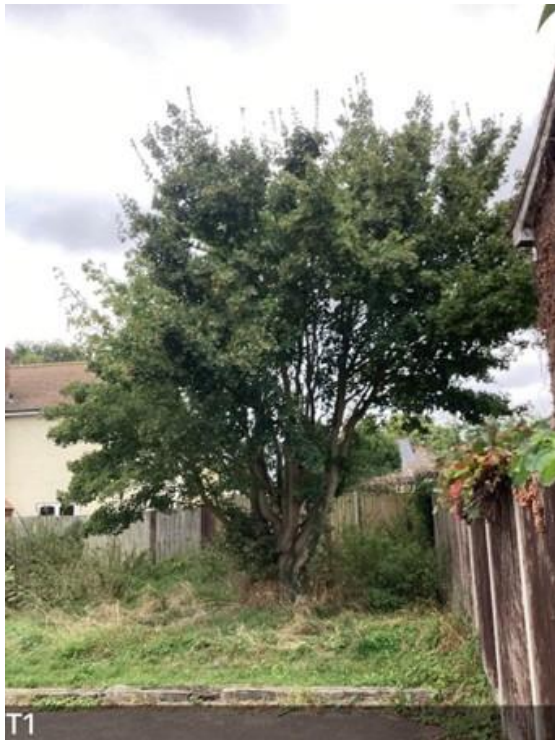
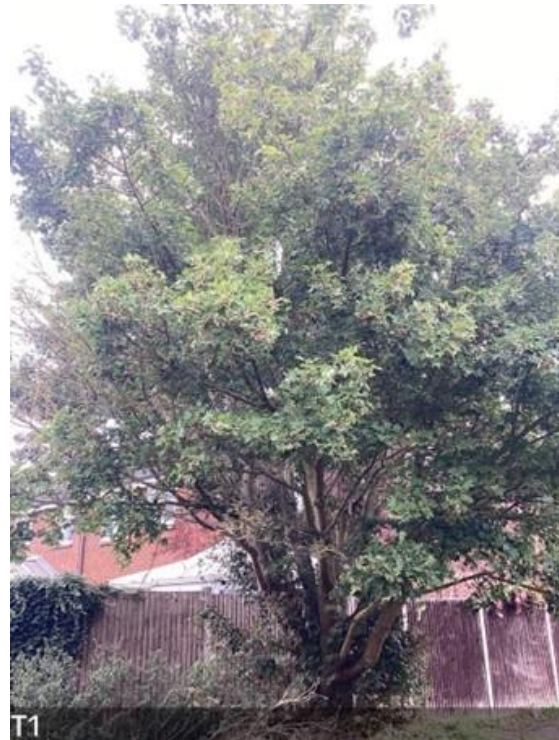
T1

| Ref. | Species | Height (m) | Canopy radius (m) | DBH (cm)<br>No. of stems | Life stage | Age relative to property | Distance to property (m) | Tree owner/ location | Vitality, previous works, comments | TPO/ CA |
|---|---|---|---|---|---|---|---|---|---|---|
| <b>T1</b> | Maple | 7 | 3.7 | 55 #<br>9 | Early-mature | Older | 3.1 | Neighbour<br>(The Fox, 37 High Street) | Fair.<br>Moderate-water demand. | CA |

- Maple (T1) is within the 50% distance for damage in the C&R study. Laboratory analysis of the roots found below foundation depth during the site investigation identified them as Acer spp.
- Ivy (S2) is within 50% of the radius of influence defined by NHBC.
- Virginia Creeper (S3) is within 50% of the radius of influence defined by NHBC. The roots match those identified below foundation depth during the site investigation.
- At time of writing, no level monitoring reports were available to confirm seasonal movement therefore any recommendations to mitigate current or future risk are based on the limited data available.

| Ref. | Species & age (relative to property) | Height DBH (m) | Dist. to dmg. (m) | Vitality & previous works | Tree owner/ location | Recommendation | TPO CA |
|---|---|---|---|---|---|---|---|
| <b>T1</b> | Maple<br>Early-mature (Older) | 7 (0.55) | 3.1 | Fair | Neighbour (The Fox, 37 High Street) | Remove close to ground level and treat stumps with herbicide to inhibit regrowth. | CA |

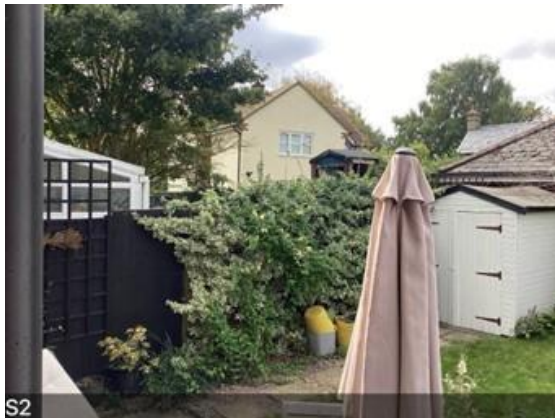
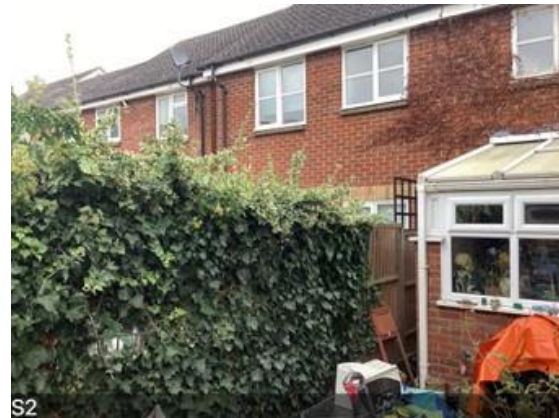
S2

| Ref. | Species | Height (m) | Canopy radius (m) | DBH (cm)<br>No. of stems | Life stage | Age relative to property | Distance to property (m) | Tree owner/ location | Vitality, previous works, comments | TPO/ CA |
|---|---|---|---|---|---|---|---|---|---|---|
| <b>S2</b> | Ivy | 2.5 | | | Early-mature | Younger | 0.4 | Neighbour<br>(2 Colemans Close) | Good.<br>Moderate-water demand. | No |

| Ref. | Species & age (relative to property) | Height DBH (m) | Dist. to dmg. (m) | Vitality & previous works | Tree owner/ location | Recommendation | TPO CA |
|---|---|---|---|---|---|---|---|
| <b>S2</b> | Ivy<br>Early-mature (Younger) | 2.5 | 0.4 | Good | Neighbour (2 Colemans Close) | Remove close to ground level and treat stumps with herbicide to inhibit regrowth. | No |

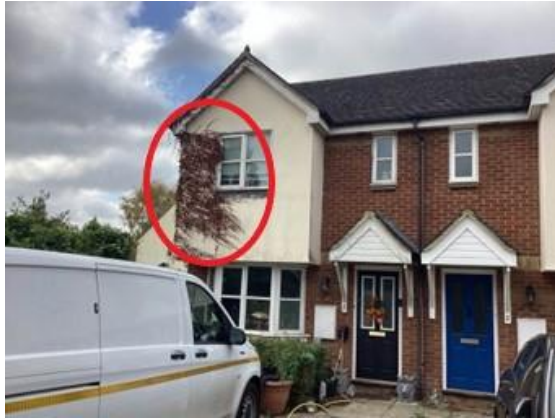
S3

| Ref. | Species | Height (m) | Canopy radius (m) | DBH (cm)<br>No. of stems | Life stage | Age relative to property | Distance to property (m) | Tree owner/ location | Vitality, previous works, comments | TPO/ CA |
|---|---|---|---|---|---|---|---|---|---|---|
| <b>S3</b> | Virginia Creeper | 7 | 1 | | Mature | Younger | 0.2 # | Insured | Good.<br>Moderate-water demand. | No |

| Ref. | Species & age (relative to property) | Height DBH (m) | Dist. to dmg. (m) | Vitality & previous works | Tree owner/ location | Recommendation | TPO CA |
|---|---|---|---|---|---|---|---|
| <b>S3</b> | Virginia Creeper<br>Mature (Younger) | 7 (0.02) | 0.2 # | Good 0 | Insured | Remove close to ground level and treat stumps with herbicide to inhibit regrowth. | No |
