**Fears End, Sandon, Buntingford, Herts SG9 0QZ**

| Project Name: | Poultry shed at Fears End, Sandon, Buntingford, Herts SG9 0QZ |
| Project Reference: | 7417 |
| Report Title: | Class Q Barn Survey and Structural Assessment |

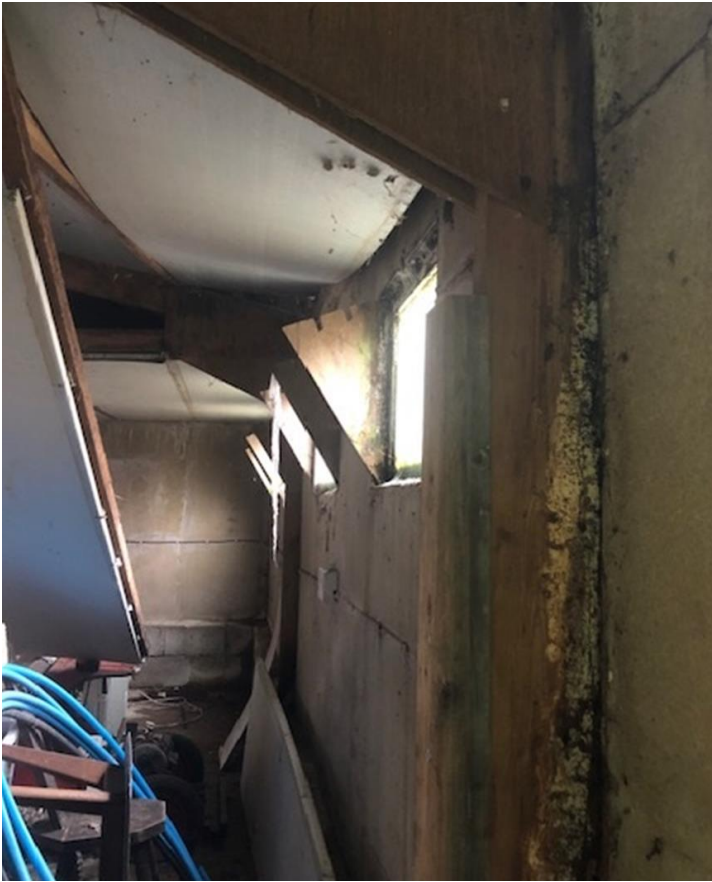
Internal framing arrangement..

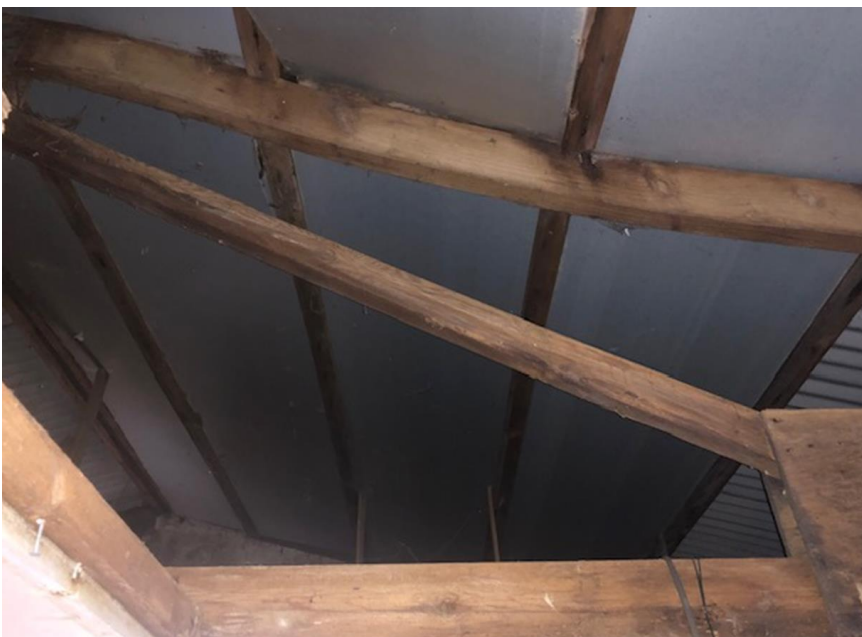
- 4.3 A truss close to the front entrance has failed, the liner ceiling has fallen away, some water staining is visible
- 4.4 In other respects, the roof trusses appear generally in a adequate condition and attention to the relatively localised issues noted should readily restore the entire roof structure to a robust state. This work is required irrespective of any conversion works to maintain the building in a serviceable condition.

Failed rafter member in truss near front of building.

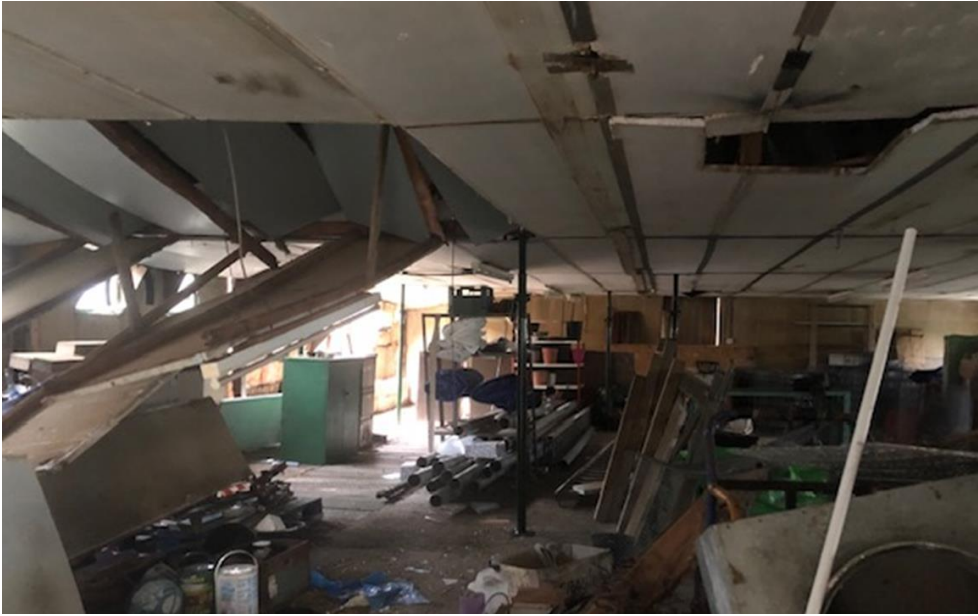
- 3.7 To the north eastern end of the shed, temporary props support the sagging roof where the timber trusses over have failed. Two bays of external wall to the northern elevation has collapsed with rotation of the block wall under.

- 4.2 Externally, the roof presents a reasonably satisfactory alignment however there is an area requiring significant repair and replacement. The remainder suggests the trusses are largely performing adequately. The roof sheeting is largely intact except as noted above, and robustly fixed to the underlying structural elements.

Failed roof near rear of building.

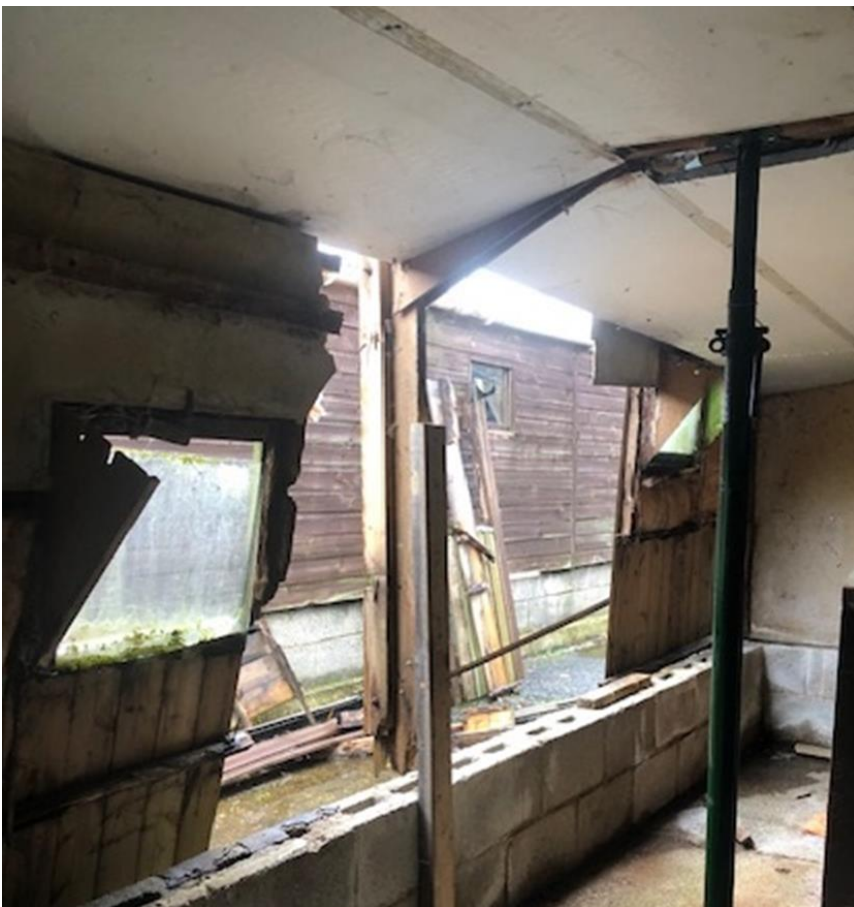
- 4.5 The side wall has partially collapsed over two bays with the low level block wall rotated, this will need to be replaced and repaired. This work is required irrespective of any conversion works to maintain the building in a serviceable condition.

- 4.6 The rainwater goods are generally in a poor condition with many sections of guttering either missing or distorted, rendering them ineffective. The rainwater goods ideally require replacement in their entirety It is our opinion that the failure of these items has significantly contributed to the roof and wall failure noted. This work is required irrespective of any conversion works to maintain the building in a serviceable condition.

Collapsed wall to rear northern elevation.

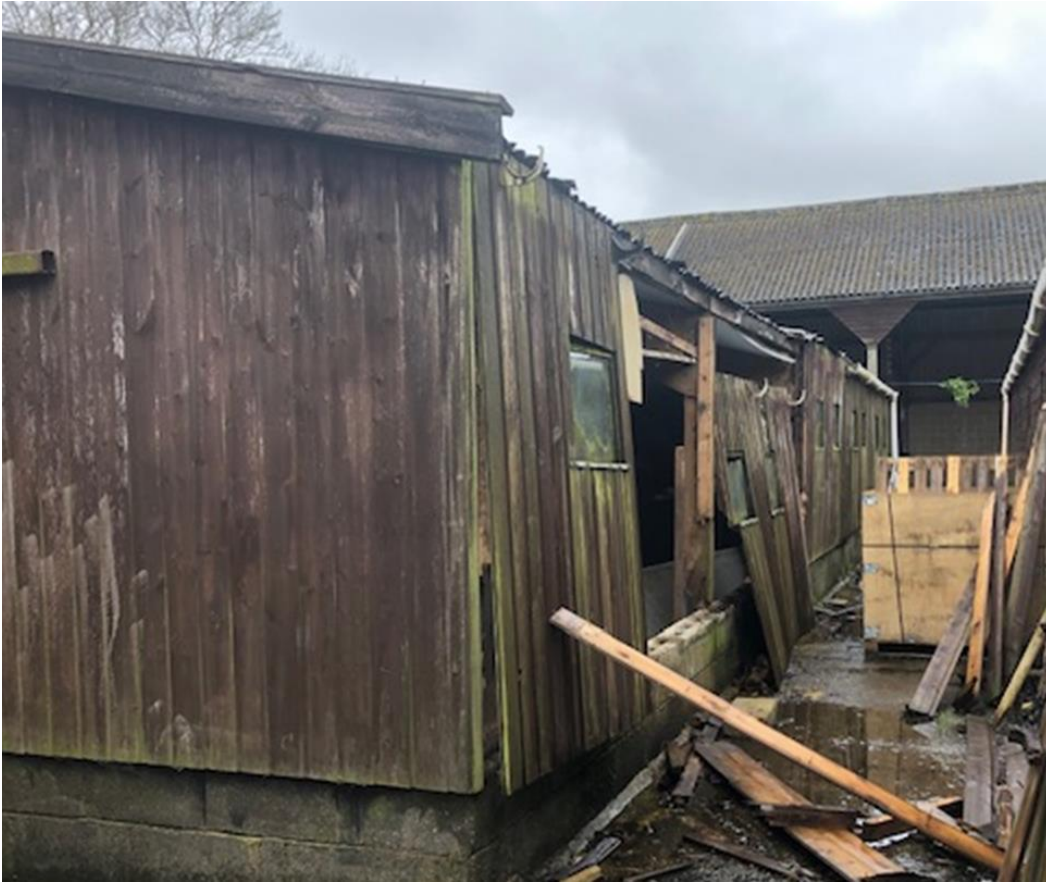
Collapsed wall to rear northern elevation viewed externally.
