**Fears End, Sandon, Buntingford, Herts SG9 0QZ**

Class Q Barn Survey and Structural Assessment Report

| Project Name: | Poultry shed at Fears End, Sandon, Buntingford, Herts SG9 0QZ |
| Report Title: | Class Q Barn Survey and Structural Assessment |

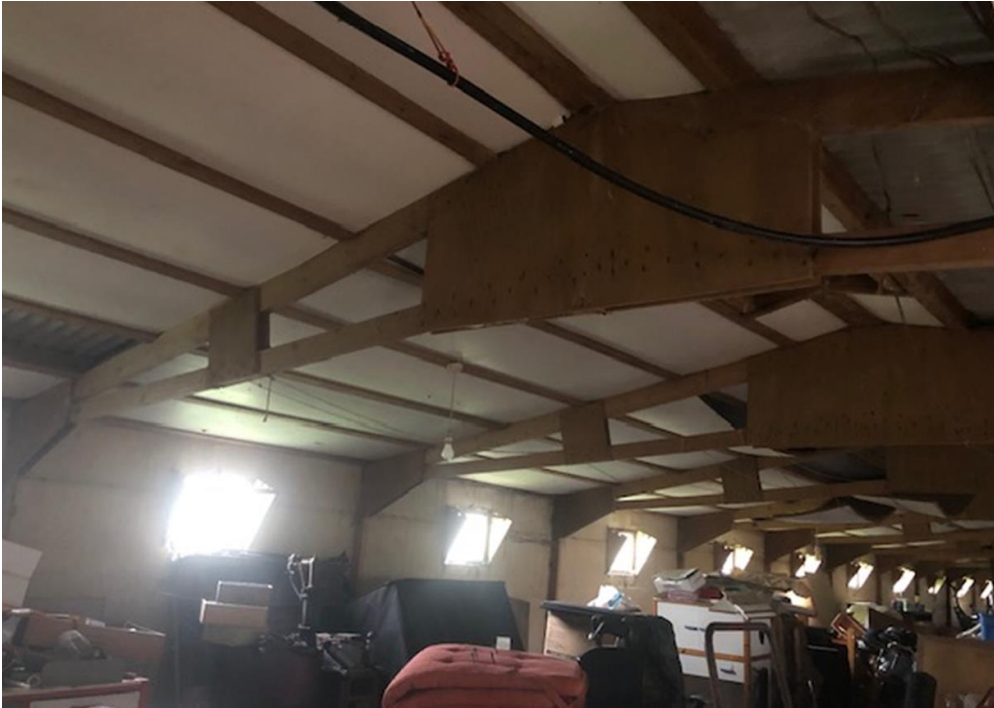
Internal framing arrangement.

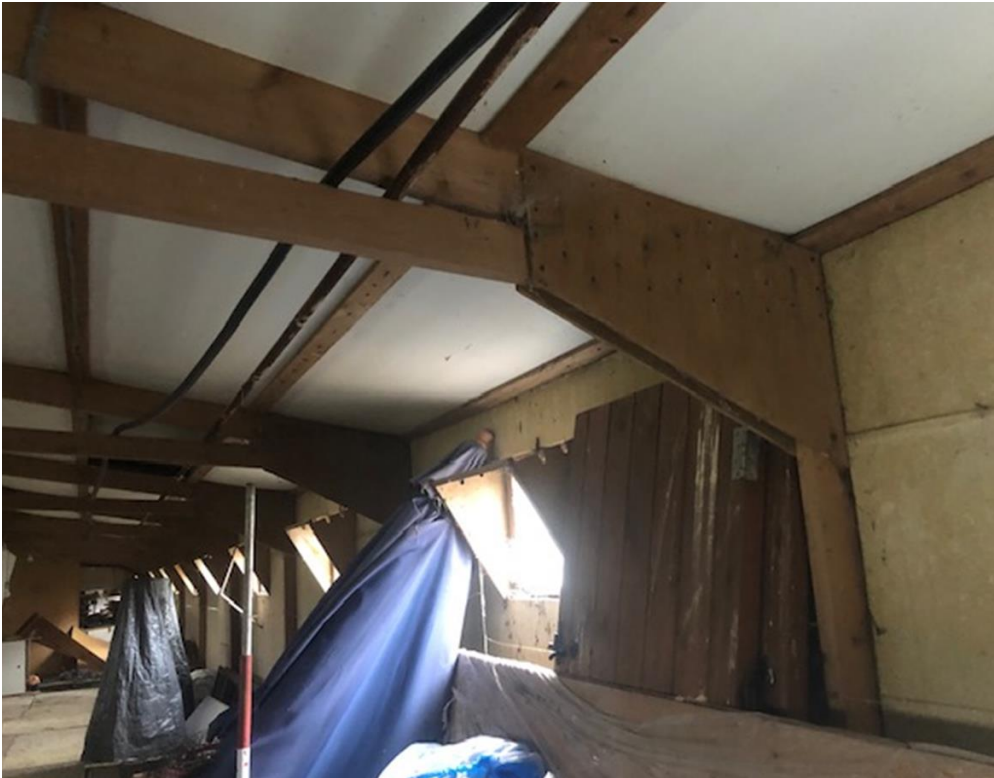
Main frame detail at eaves.

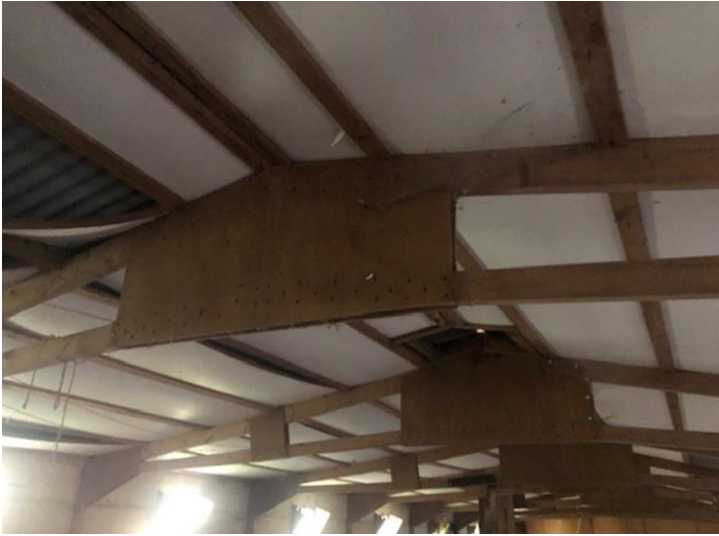
Main frame detail at ridge.

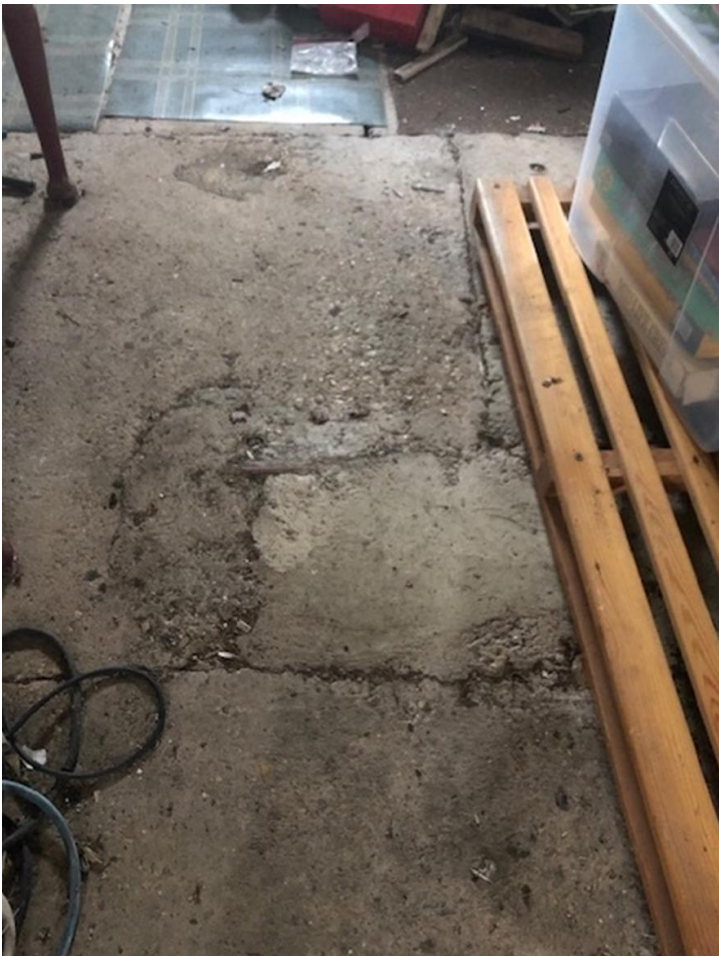
- 4.5 The floor slab presents in a generally good condition where visible, being robustly free from significant cracking or hollow soundings where tested. Some channel covers are loose or missing. This work is required irrespective of any conversion works to maintain the building in a serviceable condition.

Uneven flooring and opened joints around suspected repairs.
