**Fears End, Sandon, Buntingford, Herts SG9 0QZ**

| Project Name: | Poultry shed at Fears End, Sandon, Buntingford, Herts SG9 0QZ |
| Project Reference: | 7417 |
| Report Title: | Class Q Barn Survey and Structural Assessment |

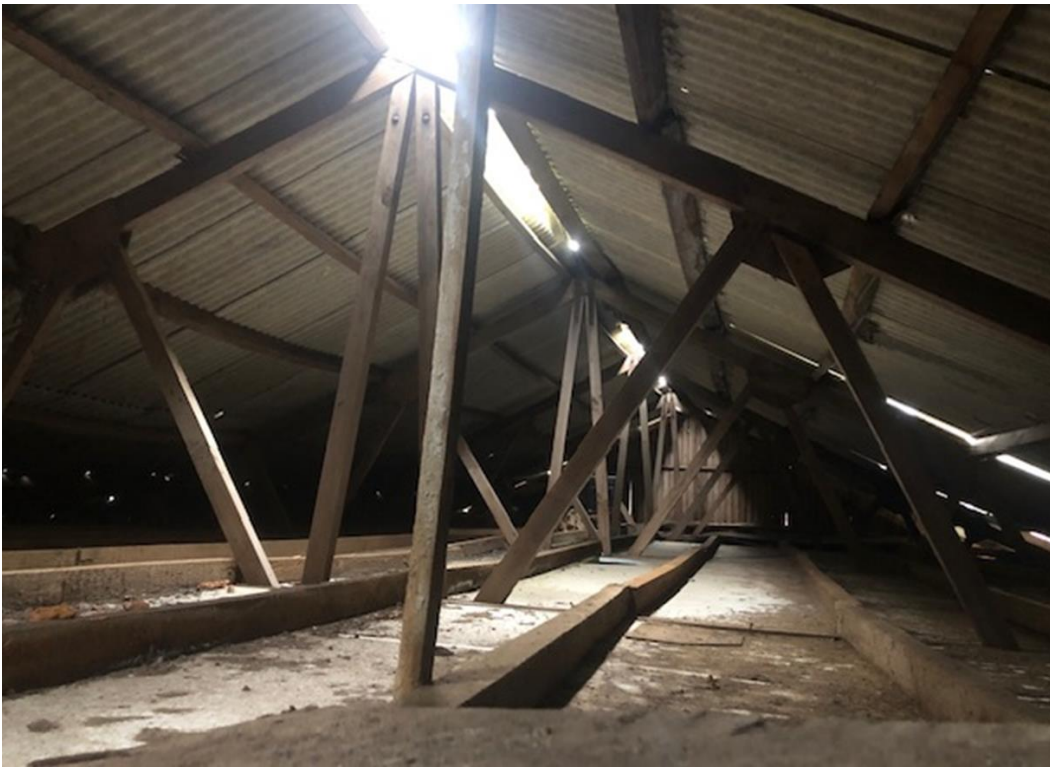
- 4.3 In other respects, the roof trusses appear generally in an adequate condition and attention to the relatively localised issues should readily restore the entire roof structure to a robust state. This work is required irrespective of any conversion works to maintain the building in a serviceable condition.

Internal roof truss profile.

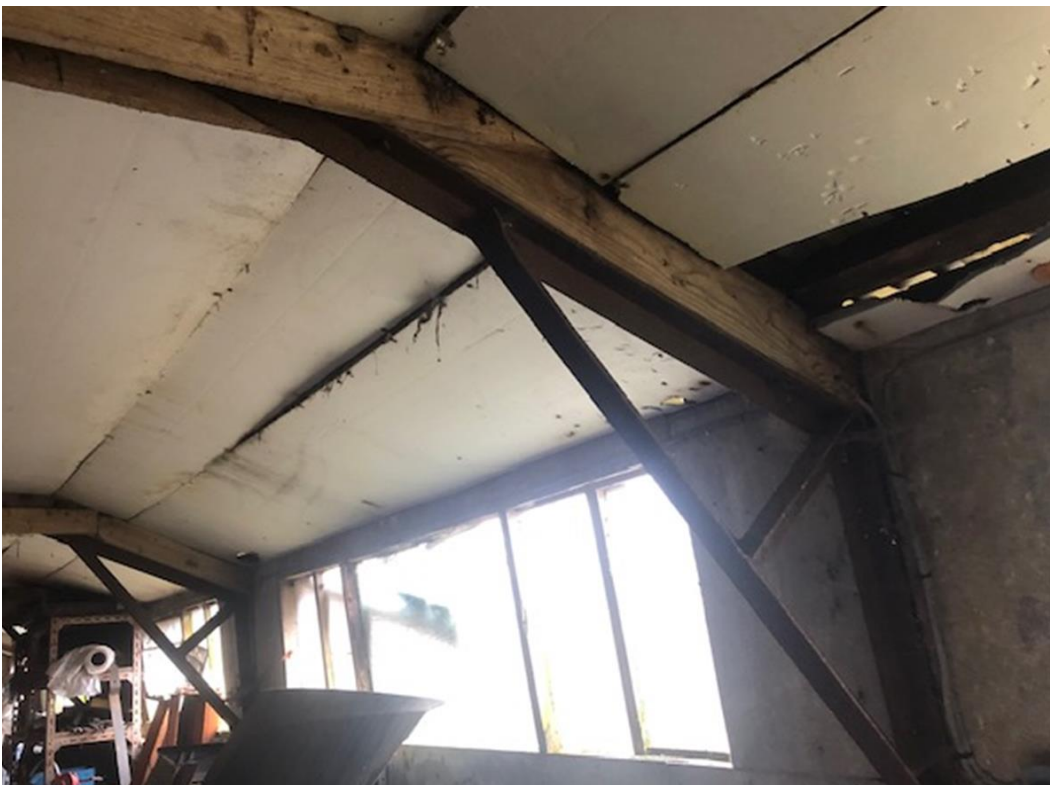
Main frame detail at eaves.

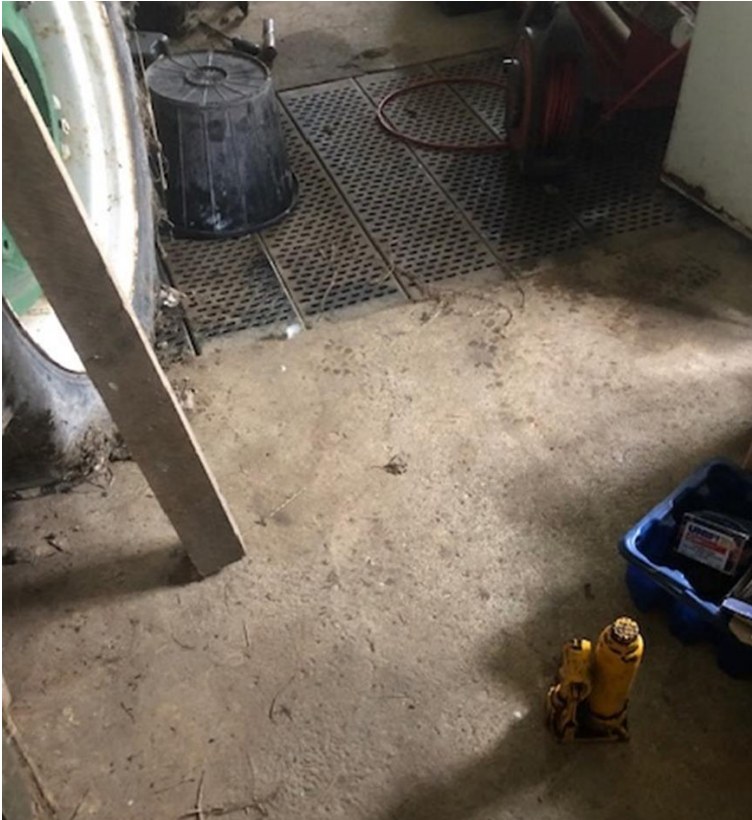
- 4.6 The floor slab presents in a generally good condition where visible, being robustly free from significant cracking or hollow soundings where tested. Some uneven patch repairs are visible. This work is required irrespective of any conversion works to maintain the building in a serviceable condition.

- 5.2 The floor slab appears to be in a sound condition, and will be subject to a reduction in imposed load within a residential dwelling, as currently there is a great deal of heavy storage. The existing floor slab should therefore be suitable to form a sound base from which to raise partitions and install insulation and floor finishes appropriate to a domestic floor.

Concrete floor slab.

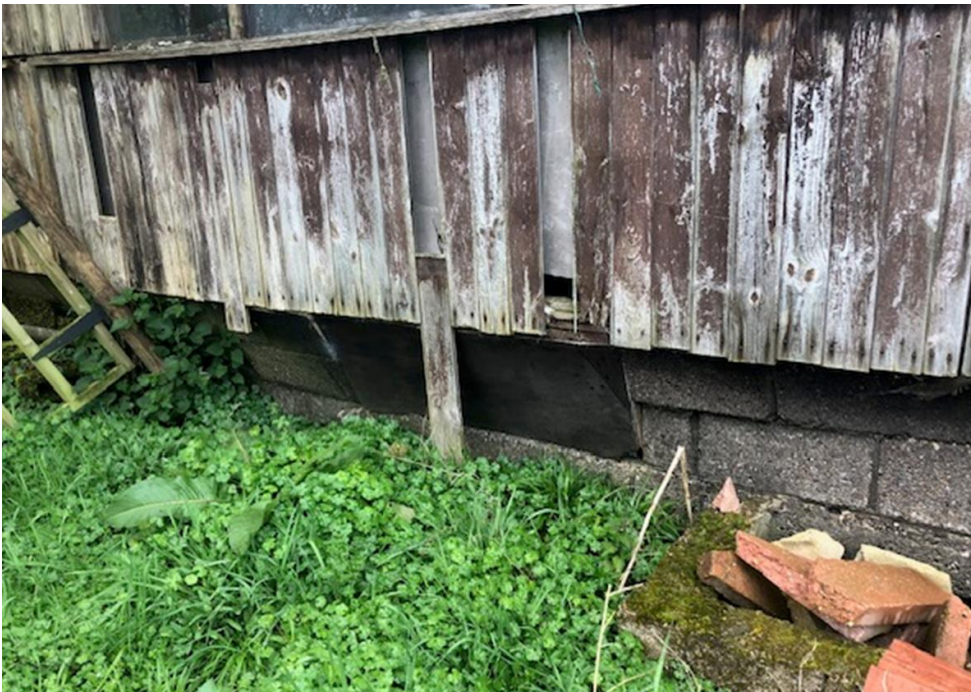
- 3.7 The floor of the shed is ground bearing concrete slab. There are two channels running most of the length of the shed with iron coverings.
- 3.8 A small section of wall to the southern end has displaced out, this appears to be from an impact internally based upon the distortion visible .

Damage to southern wall.

- 4.4 Part of the side wall requires repair and partial rebuilding where pushed out. This work is required irrespective of any conversion works to maintain the building in a serviceable condition.
