**Fears End, Sandon, Buntingford, Herts SG9 0QZ**

Class Q Barn Survey and Structural Assessment Report

| Project Name: | Barn at Fears End, Sandon, Buntingford, Herts SG9 0QZ |
| Report Title: | Class Q Barn Survey and Structural Assessment |

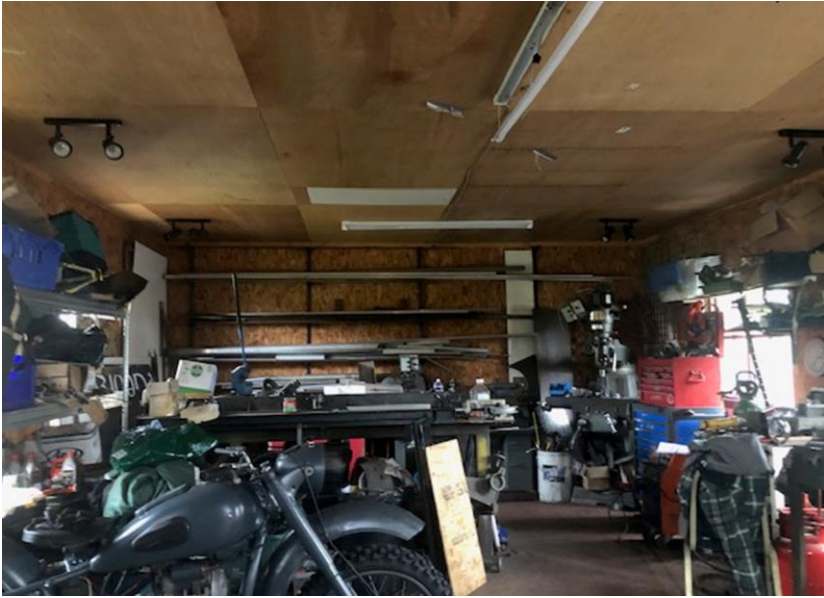
Internal arrangement.

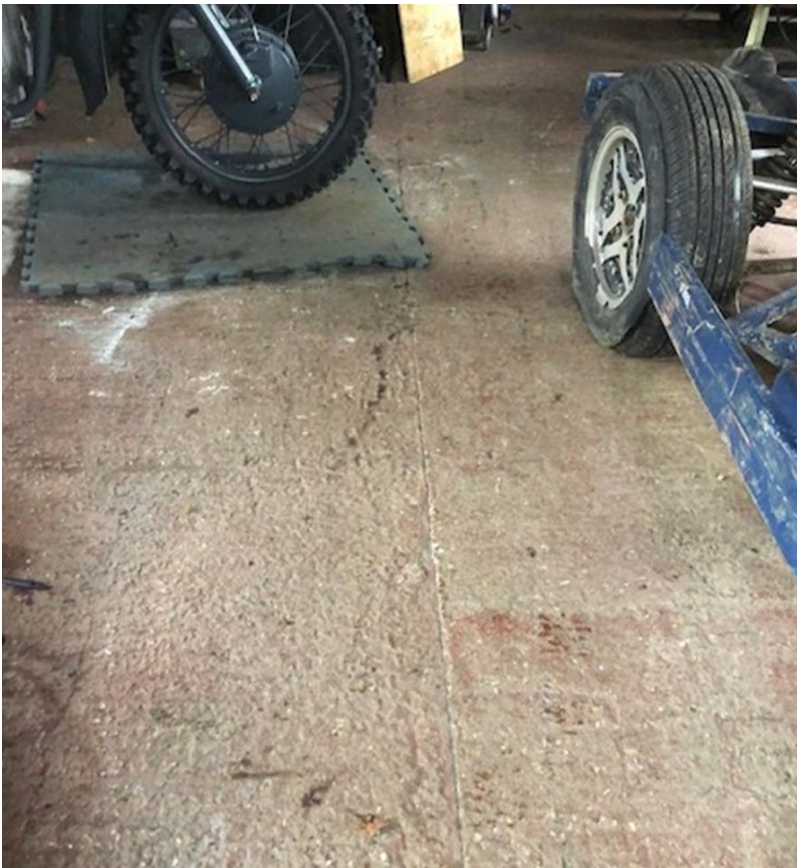
- 5.2 The floor slab appears to be in a sound condition, and will be subject to a reduction in imposed load within a residential dwelling, as currently there is a great deal of heavy storage. The existing floor slab should therefore be suitable to form a sound base from which to raise partitions and install insulation and floor finishes appropriate to a domestic floor.

Concrete floor slab.
