**Fears End, Sandon, Buntingford, Herts SG9 0QZ**

| Project Name: | Barn at Fears End, Sandon, Buntingford, Herts SG9 0QZ |
| Project Reference: | 7417 |
| Report Title: | Class Q Barn Survey and Structural Assessment |

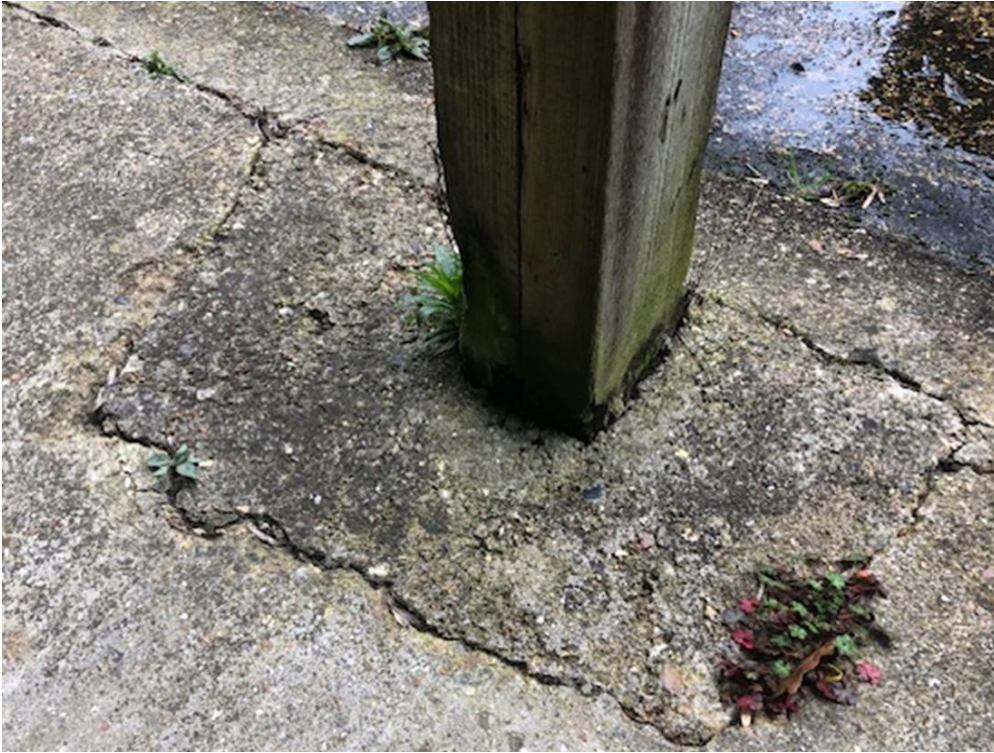
- 4.1 The barn is in a generally good state of repair, but does exhibit some issues requiring repair to main timber posts at ground level.
- 4.2 Externally, the roof presents a reasonably satisfactory alignment with no evidence of significant deflection or distortion noted, suggesting the trusses are largely performing adequately. The roof sheeting is largely intact and robustly fixed to the underlying structural elements.

Timber post at ground level.
