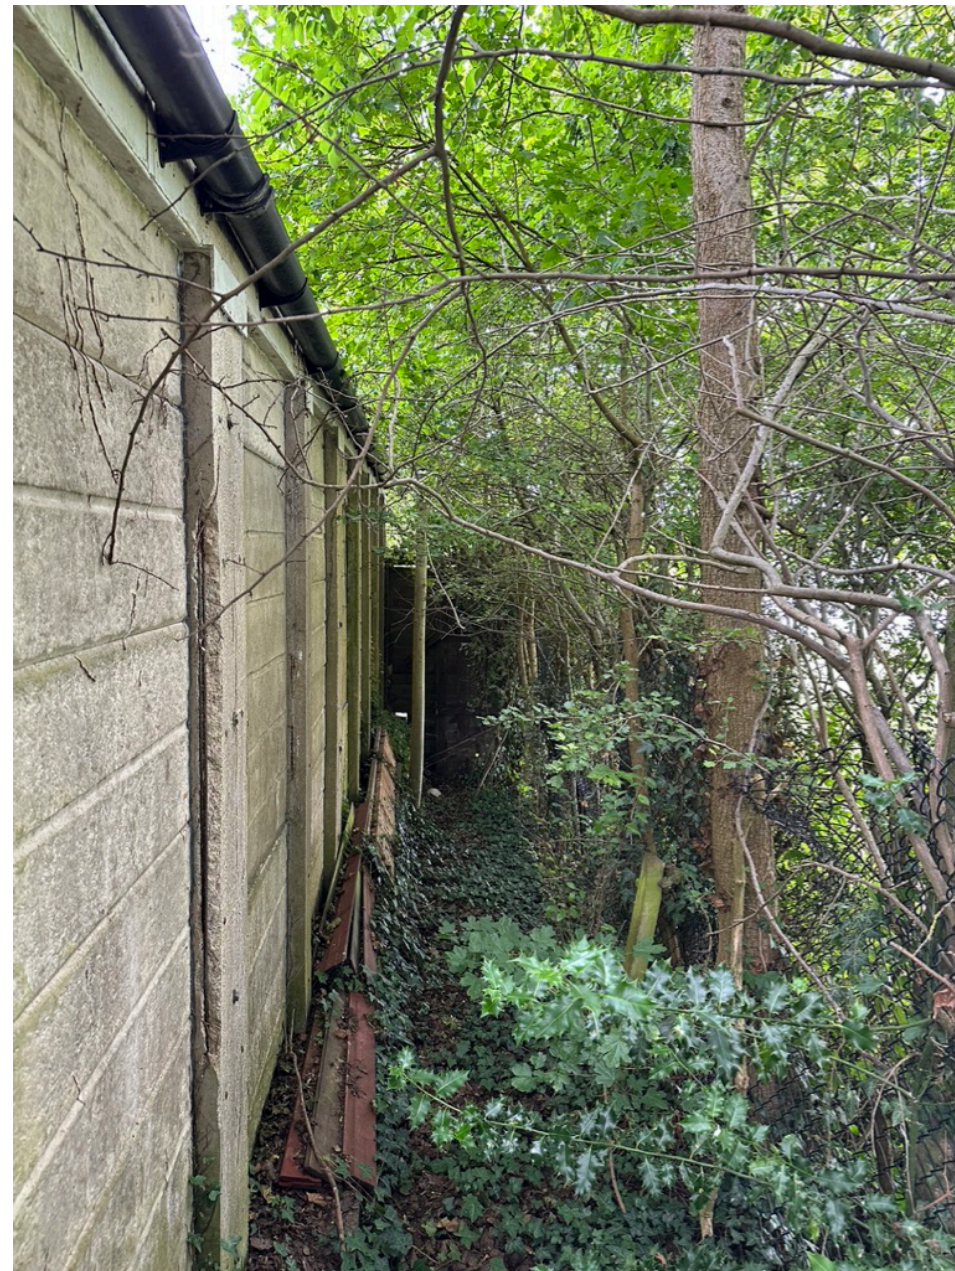
East facing external wall  
showing rainwater run off  
and trees and hedges on border
