**Structural Report – LBC application for Maintenance Repair to front  
Porch and internal wall removals to non-original section of property.**

Hallam Consulting Project Number: 1534

| | Mill Cottage |

This report has been prepared in support of an application for **Listed Building Consent** for minor alterations, repair and maintenance works to Mill Cottage, a Grade II listed property located in Purwell, Hitchin, Hertfordshire.

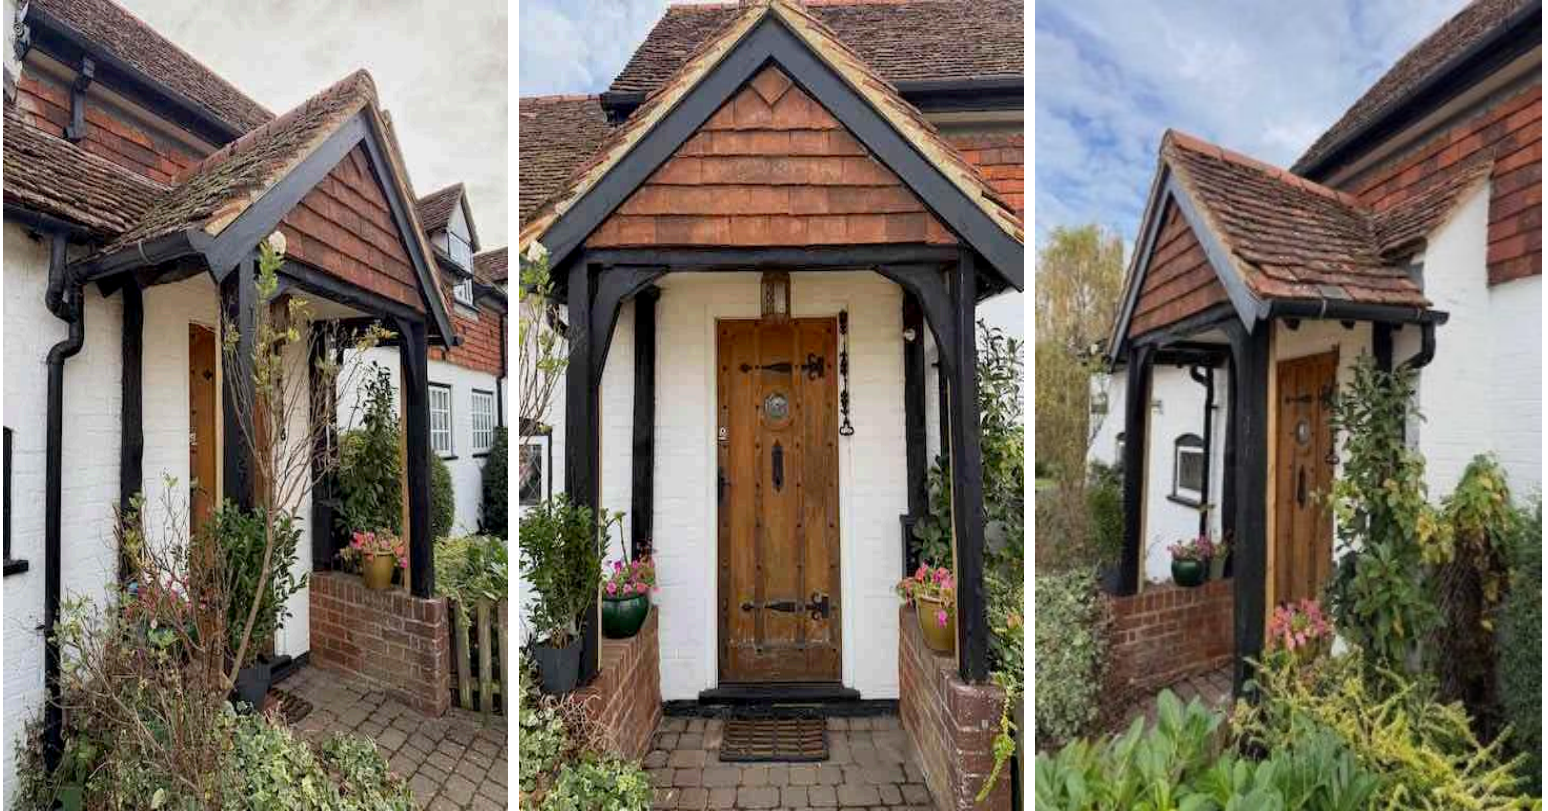
Quarter side and Front elevations of Porch, noting deflection at eaves level

The front porch exhibits a combination of historic and later fabric. The **vertical timber posts** appear to be of historic origin, hand-finished and painted. In contrast, the **knee braces and front fascia** are later insertions, crudely fixed with nails rather than traditional mortise-and-tenon joints. The front of the porch is now set significantly lower than the front, perhaps by 100mms, meaning the gutters won't drain.

The **brick plinth** consists of six stretcher courses plus a soldier course, clearly a 20th-century intervention. The brickwork has been built tight around the base of the timber posts, forming a recess which retains moisture. This, combined with **ivy growth** and **poorly graded gutters**, has led to softening and decay of the lower 300–400mm of both front posts, most significantly on the left hand side which also has a much reduced cross sectional area at the base, down to perhaps only 50% or the cross sectional area above.

1. **Temporary propping** of the porch structure to relieve the front posts of vertical load.
2. **Careful lifting** of the front frame as far as feasible without causing damage, sufficient to remove any deformation without inducing cracking to the junction with the main façade.

3. **Removal of upper brick corners** of each plinth to install **galvanised steel plate** recessed below the existing timber posts. Each plate will include dowel pins to secure into the sound timber above the decayed section.

4. The **decayed timber bases** will be trimmed and spliced with **seasoned oak sections**, treated with natural linseed oil preservative.
5. The original front posts will be visually retained; any additional strengthening will take the form of a **concealed secondary oak post**, black-painted and set behind the existing member to carry residual load.

6. **Gutters** to be re-graded to fall correctly to downpipes to avoid further water discharge onto the brickwork below.

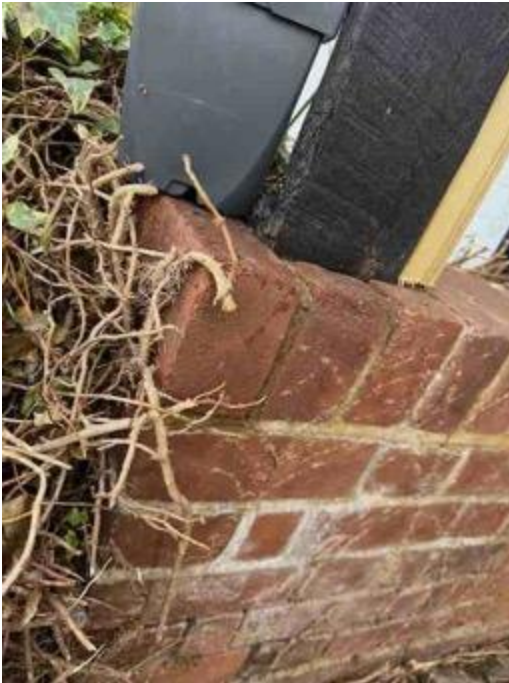
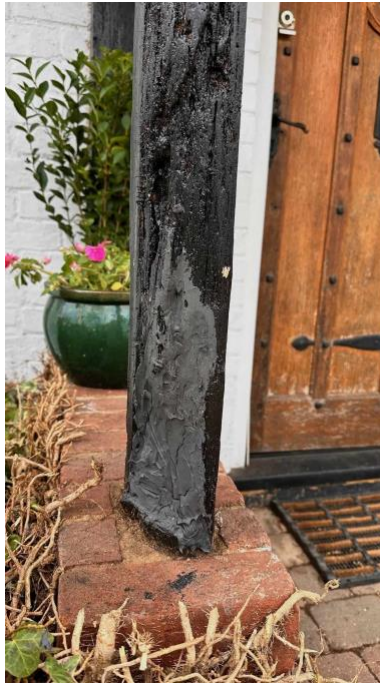
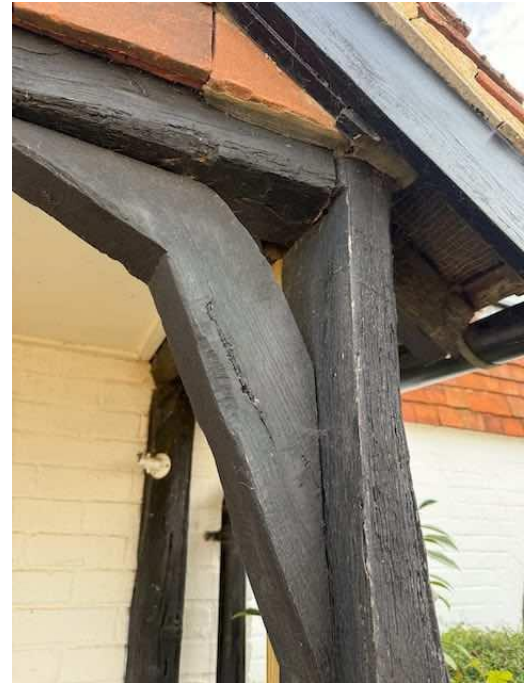
### Detail photos

Shows the mixed historic and later components. Note ivy damage and pockets for moisture retention at the base. Demonstrates the need for localised repair rather than replacement. Confirms the need for lifting and bracket support detail.

Right hand photo reveals mortice and tenon pegged jointing typical of 18th/19th-century construction, confirming heritage value and informing the proposed minimal intervention strategy.

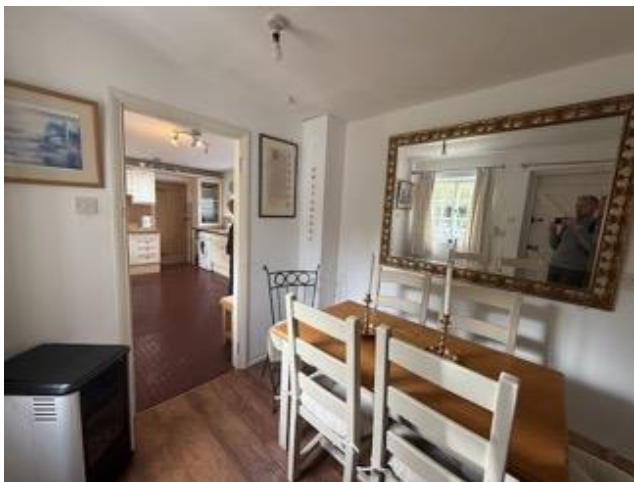
**Kitchen & corridor walls to be removed**

The internal walls proposed for removal are located between the **kitchen** and **corridor**, in an area clearly constructed as a **modern extension or later subdivision**, likely dating from the mid-20th century. The walls are of straight, plumb brick/block construction, not consistent with the irregular geometry of the original timber-framed building.

Existing openings already exist in the kitchen wall with evidence of modern plastered finishes. The ceiling joists above are likely to be modern softwood joists spanning independently across the space.

- Removal of lightweight non-original walls achieve improved internal layout.
- Retention of existing structural piers (~300mm on lhs and ~600mm on rhs) at each end of openings to maintain load paths.
- Installation of a small **steel beams** expressed beneath the ceilings, bearing on **padstones** discretely formed within existing walls.
- Positioning the steels beneath the floors minimises and fabric intrusion.
- All structural supports to be **reversible** and **non-invasive to historic fabric**.

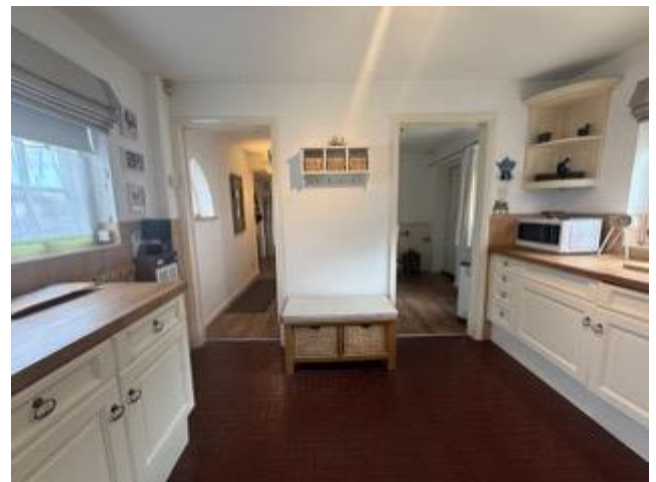
Depicts flat plasterboard walling of modern type. Confirms non-original construction. Understood to be modern timber joists running parallel to the kitchen opening; load transfer is minimal and can be retained safely. Demonstrates spatial improvement potential from proposed minor alterations. Historic elements remain untouched. The installation of beams would sit beneath the existing floor joists and affect only the internal walls. The profile of previous cellular spaces would remain evident through the downstands.
