LEVEL 2

# Your survey report

5 Pryors Court, Baldock, Herts, SG7 6QU

30<sup>th</sup> June 2025

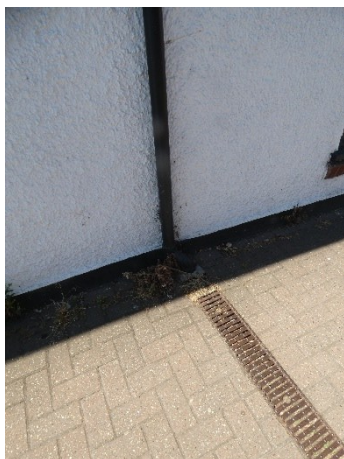
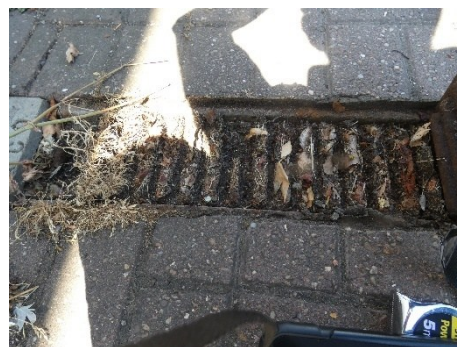
One of the downpipes (to the A507) appears to discharge directly onto the road via a drainage channel set within the pavement. This was noted to be choked at the time of inspection and may be leading to backing up within the downpipe, there being increased levels of dampness to the interior walls where the downpipe is located.

Again, this is likely to fall within the Management Company remit and details should be confirmed.

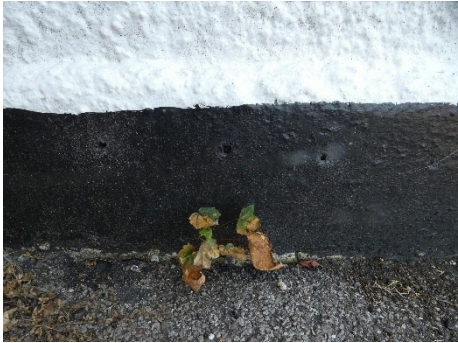
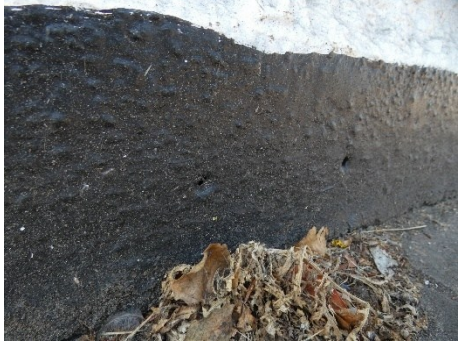
## D4 Main walls

| <p>An inspection of the external surfaces of the main walls was made from ground level, with the aid of binoculars, a spirit level and a standard surveyor's ladder. The inspection was also facilitated from readily accessible windows.</p> <p>Where there are openings in the walls, either beams or lintels should transfer the weight from above and around the openings to the support point. The thrust created at the support point is resisted by the frame on each side of the opening.</p> <p>The property is believed to be of masonry construction with render present to the elevations, with walls varying in thickness between 350 (inner courtyard) to 490mm (outside walls at base) where measured (including the render finish). These are likely to be a combination of solid brick and cavity brick construction but we are unable to confirm details in this respect.</p> <p>There are tie-bars to the externals, inserted to tie the structure together., most likely installed at the time of conversion although this cannot be confirmed. We saw no evidence of continuing issues in this respect. Although, ideally, details of the works should be obtained.</p> <p>The base of the walls are located below ground level, approximately 600-650mm in depth. This will leave the walls vulnerable to water penetration from the surrounding ground. As will be noted later in our report, there are high levels of dampness apparent to the sections of wall and details of any protective waterproofing should be obtained.</p> <p>It was noted that there is evidence of retrospective damp proofing works to the property although, in our opinion, these are unlikely to provide any benefit to the property.</p> <div></div> | <div>2</div> |

| <p>We are unable to confirm whether or not there is any original damp proof course to the property.</p> <p>The roughcast render to the elevations was generally found to be in a serviceable condition. Responsibilities for the exterior walls to the property should be established.</p> <p>Condition Rating : 2</p> | |

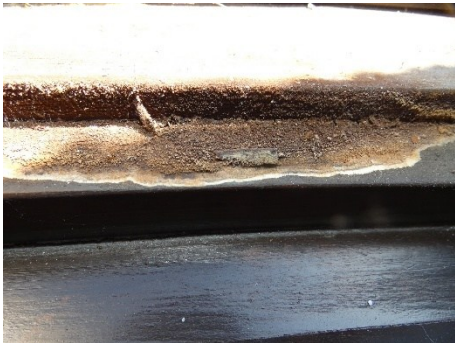
## D5 Windows

| <p>Windows have been inspected both internally and externally where accessible.</p> <p>These are of timber construction and trickle vents are installed to windows. These are an important method of controlling levels of humidity and moisture allowing the passage of fresh air within internal spaces if operated correctly.</p> <p>The windows show evidence of deterioration as a result of wet rot, one of the windows showing a fruiting body which appears to be a member of the wet rot family (Phellinus contiguous) although this cannot be confirmed and you should obtain specialist advice in this respect. There is a possibility that this is a dry rot and hence why specialist identification is required. It is likely that this window (to the bedroom) will require replacement.</p> | <div>3</div> |

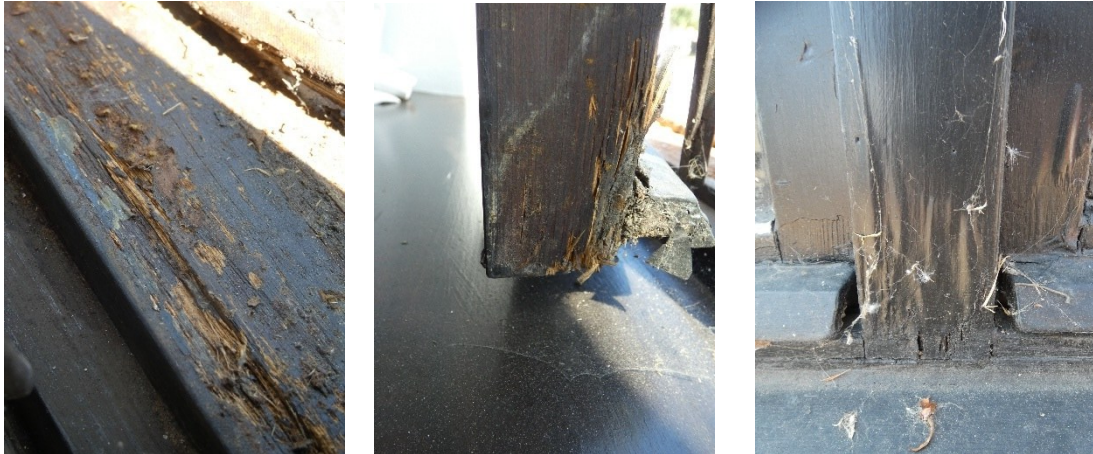
Elsewhere there is evidence of wet rot attack to the other windows although it is likely that these are repairable.

There is evidence to suggest that the design of the windows is causing rainwater to penetrate the frames and the walls surrounding and general replacement may be beneficial although this will be required to be undertaken in accordance with covenants on the property.

In addition, seals will require renewal.

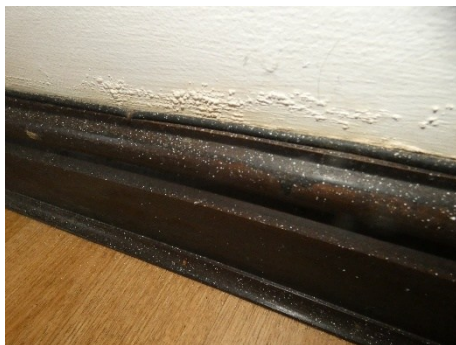
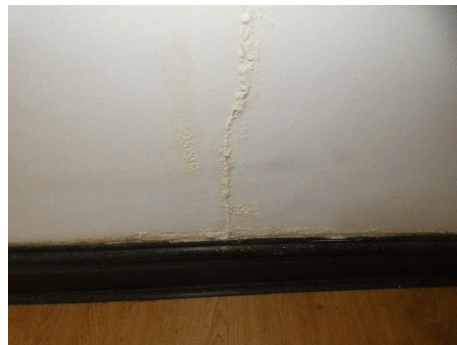
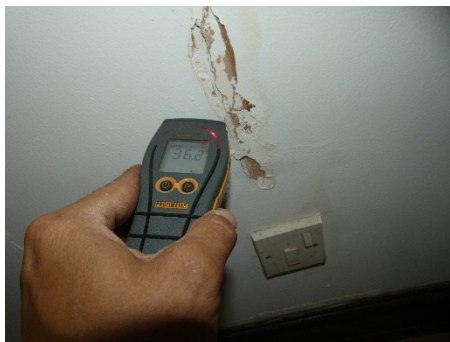
Walls were tested with an electronic moisture meter and this gave indications of high levels of moisture within the walls below ground level and also around the window openings. Indications were also present to the timber skirting boards, indicative of this being moisture penetration as opposed to salt contamination to the plaster.

Within the living room, some dampness was also noted to the party wall between the subject property and number 6. The reasons for this are unclear as the layout of Flat 6 is unknown but it is suggested that this is likely to be penetrating dampness from an issue within Flat 6.

If you choose to proceed with the purchase of the property, we recommend that a more detailed specialist investigation be undertaken although these are likely to require some destructive works. This will enable the true extent of the issue and likely remedial works to be assessed.

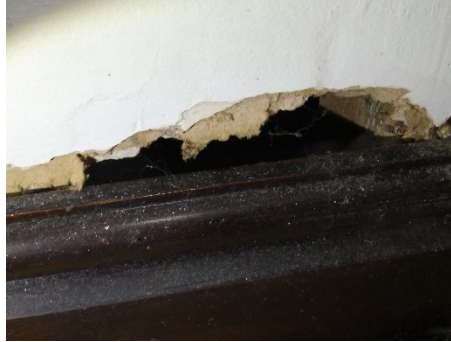
Internal walls are of plasterboard lined studwork and were generally found to be in a good condition. However, there is evidence of damage to the bathroom/hallway wall and repairs will be required.

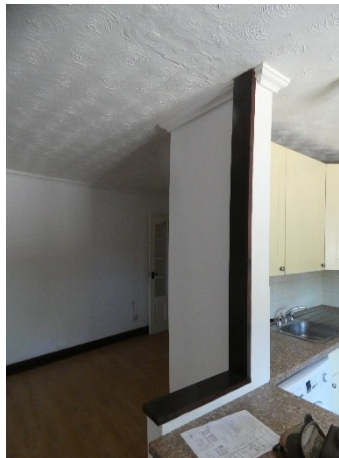
It was noted that a small section of internal wall to the kitchen has been removed but this is not considered significant.

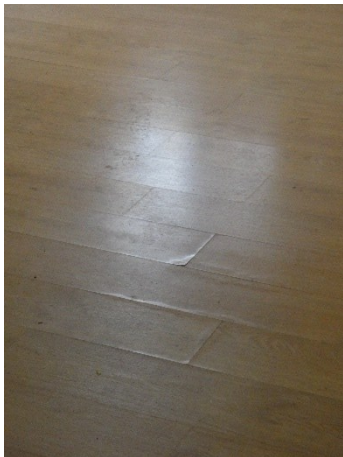
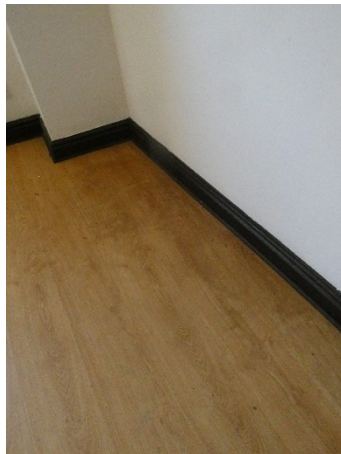
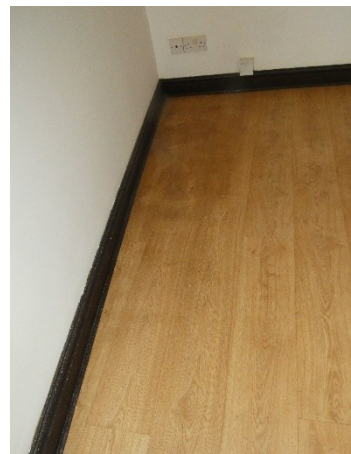
It was noted that there are some areas of deterioration to the laminate flooring in the living room area. Additionally, some change in colour was visible to areas of the flooring adjacent to the passageway wall.

Where the discolouration has been noted, there is a possibility of moisture having affected the flooring but this cannot be confirmed without lifting the coverings.

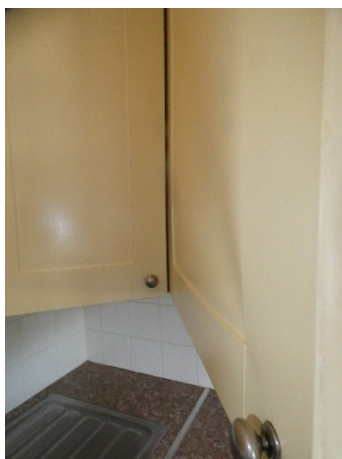
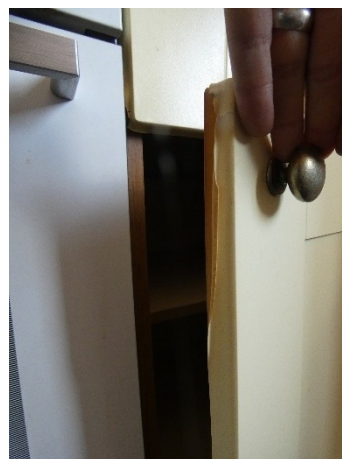
However, it was noted that many of the vinyl coverings to the doors have separated from the substrate. Additionally, damage was noted adjacent to the cooker where the units have been placed too closely to the appliance.

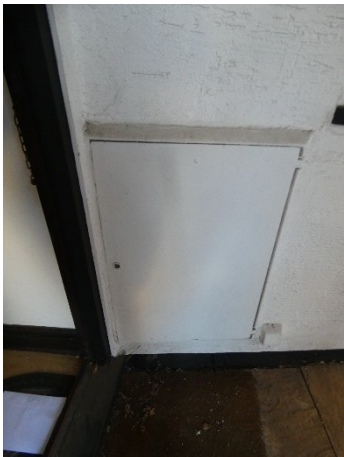
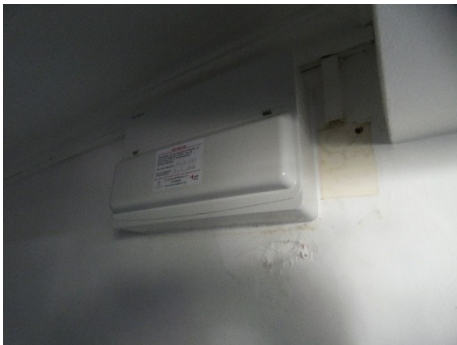
Upon opening the meter box, we noted that the installation appears to be a three phase supply, although only a single phase appears to be in use.

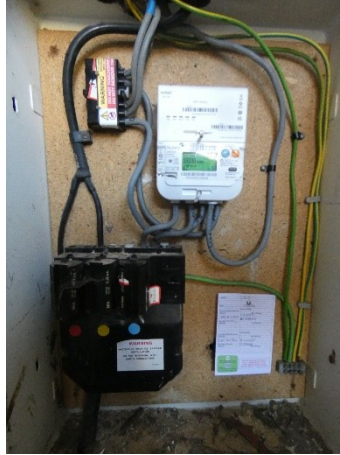
It is believed that alterations have been made to the installation since its original installation and all appropriate works should be certified. This has including updating of the consumer unit which appears to conform to current Regulations. All appropriate certification for this work should be obtained.

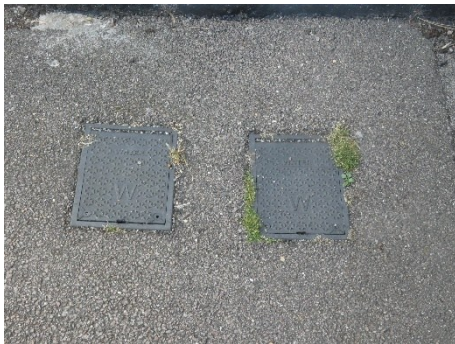
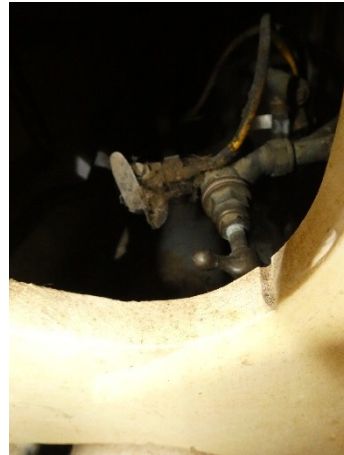
Internal pipework, where visible, is run in copper and pipework. It was noted that there is some apparent corrosion to the supply pipework visible at the base of the airing cupboard where the copper enters the floor screed. It may be prudent to have this checked by a suitably competent plumber.

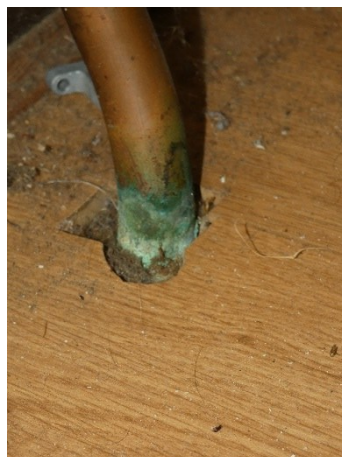
However, it should be noted that most of the pipework is concealed within the floor screed. There have been many instances from this period of construction where a poorer quality pipe was used, leading to failures within the floor screed where not properly lagged. There is no indication that this is the case here, but it should be borne in mind.
