# **NORTH HERTS LEISURE CENTRE**

## **Tree Survey Report and Arboricultural Impact Assessment**

5268\_771  
Tree Survey Report and  
Arboricultural Impact  
Assessment  
P05  
02 April 2025

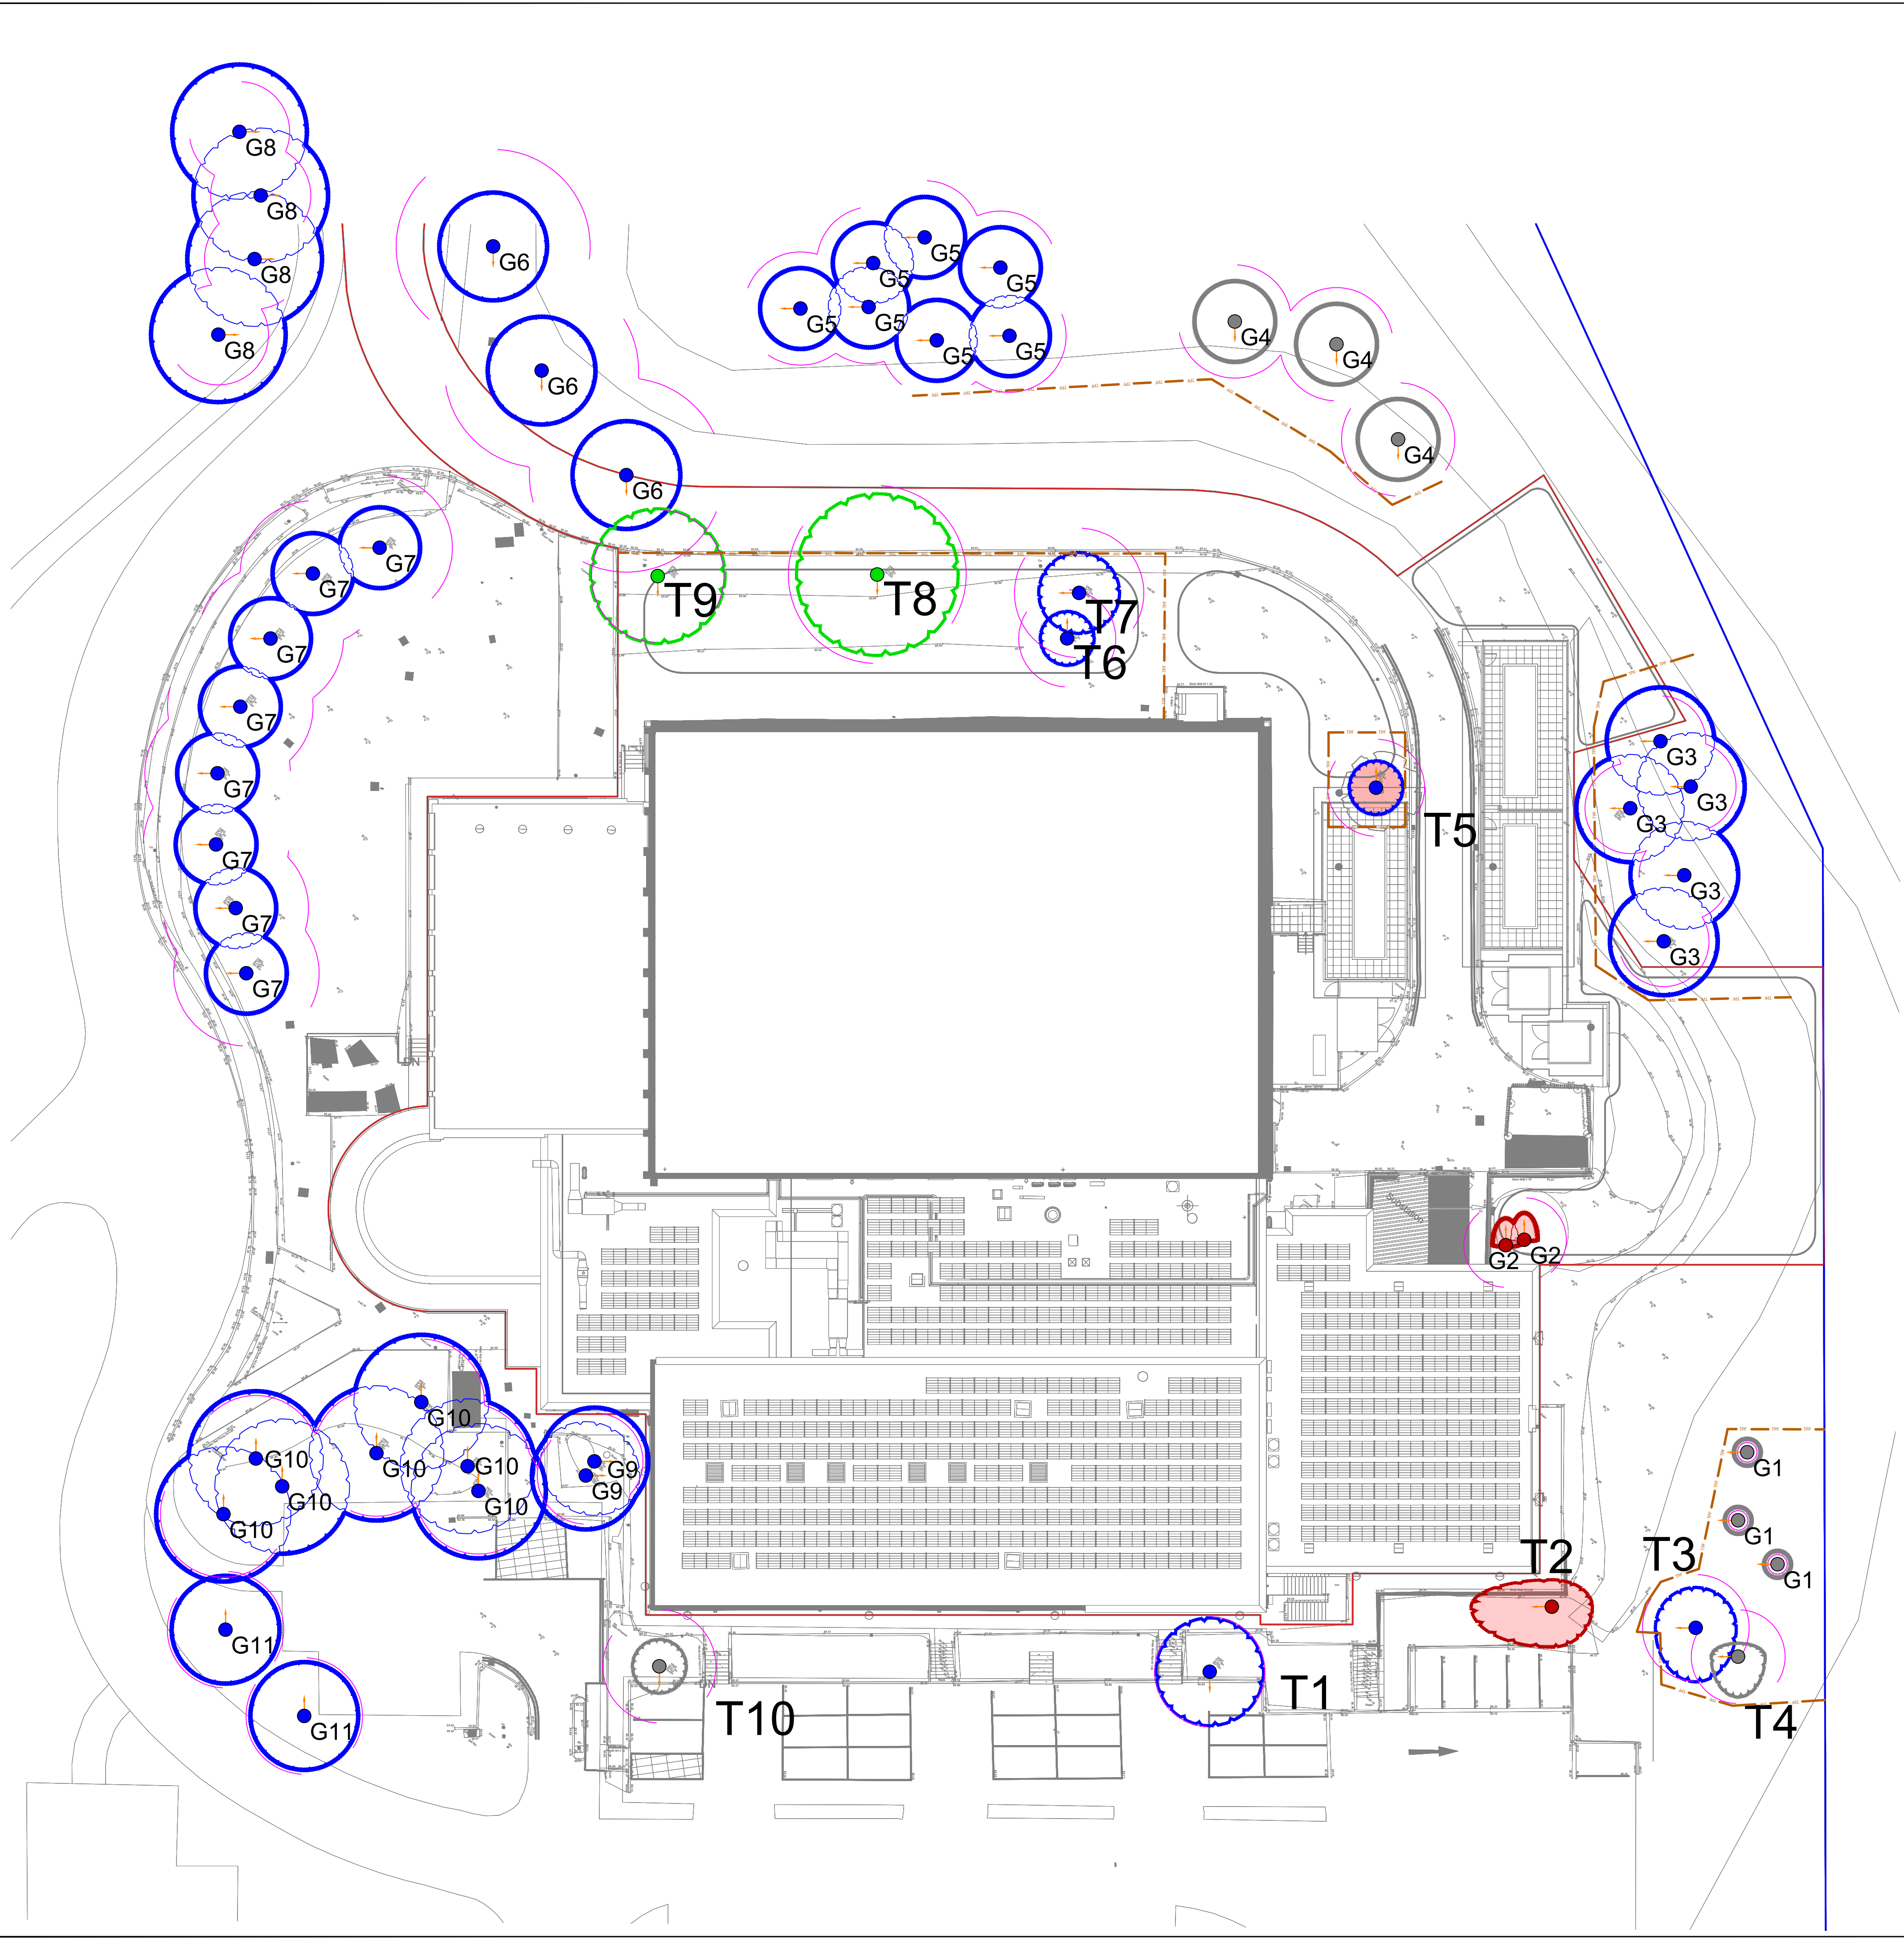
### Tree Removal & Protection Plan

- 5.11 To facilitate the proposed development, there is a requirement to remove 1 individual tree (T5).
- 5.12 It is our recommendation to remove 1 individual tree (T2) and 1 tree group (G2) under sound arboricultural management practices.
- 5.13 The majority of the arboricultural features on site are to be retained, with >95% of the individual trees surveyed on site being retained within the context of the proposed development.
- 5.14 The removals of T2 and G2 are recommended to be carried out, regardless of the implementation of the development proposals. These specimens are structurally compromised and have limited life expectancy, which is why they have been recorded as retention category U.

- 8.9 The removals of T2 and G2 are recommended to be carried out, regardless of the implementation of the development proposals. These specimens are structurally compromised and have limited life expectancy, which is why they have been recorded as retention category U.
