# PRELIMINARY BAT ROOST ASSESSMENT

NHDC Decarbonisation Project: Hitchin Swimming Pool

794-ENV-ECO-21554  
B  
November 2024

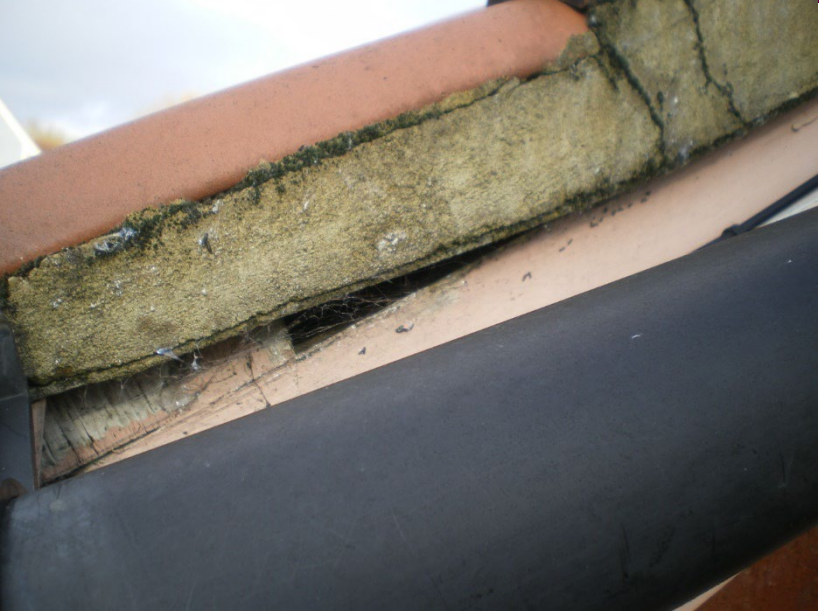
| Feature | Description | Photo |
|---|---|---|
| 30 | Gap between the edge of the wood and roof. South elevation | |
